DOE/NASA/20370-20
NASA TM-82594

Aluminum-Blade Development for the Mod-0A 200-Kilowatt Wind Turbine

Bradford S. Linscott and Richard K. Shaltens
National Aeronautics and Space Administration
Lewis Research Center

December 1981

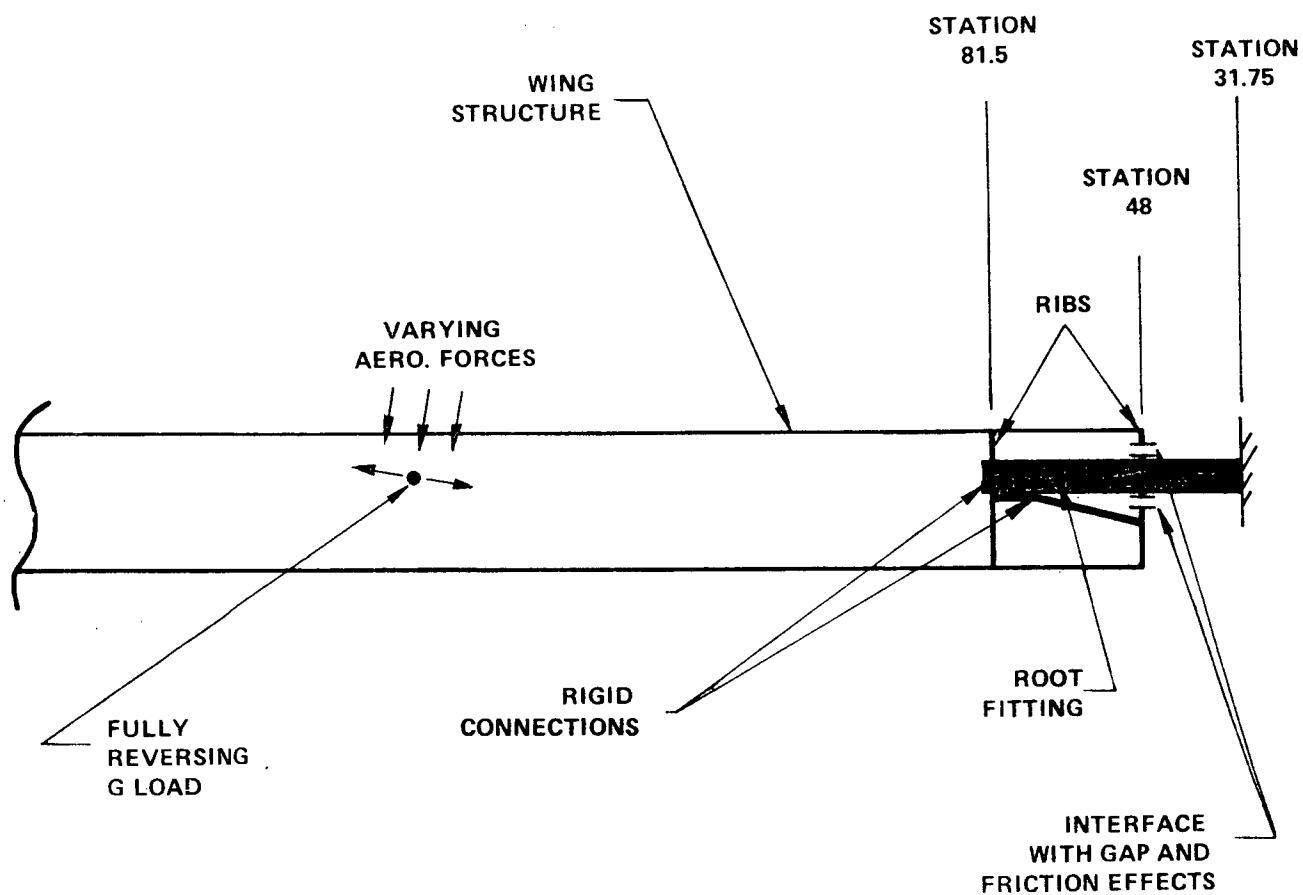
Figure 13. - Mod-0A transition section structural model.

Figure 13 shows a simplified structural model of the transition section. Note that the blade axial loads such as the gravity load (and centrifugal load) are transferred from the wing skins to the root fitting through the station 81.5 rib and the tip of the D-spar web. The gravity load fully reverses each half revolution of the rotor, and this reverses the deflections of the rib and web producing a continuous sliding motion at the root fitting/station 48 rib interface. The blade bending loads are transferred to the root fitting primarily as shear loads at the two root fitting/rib interfaces. Note that, if the gap at the station 48 interface increases due to wear, bending of the station 81.5 rib will occur as the gap at station 48 opens and closes. Also, significant shear forces will develop at the root fitting/station 81.5 bolts and the root fitting/D-spar web bolts. In addition, the steel root end fitting will cyclicly impact the station 48 rib.

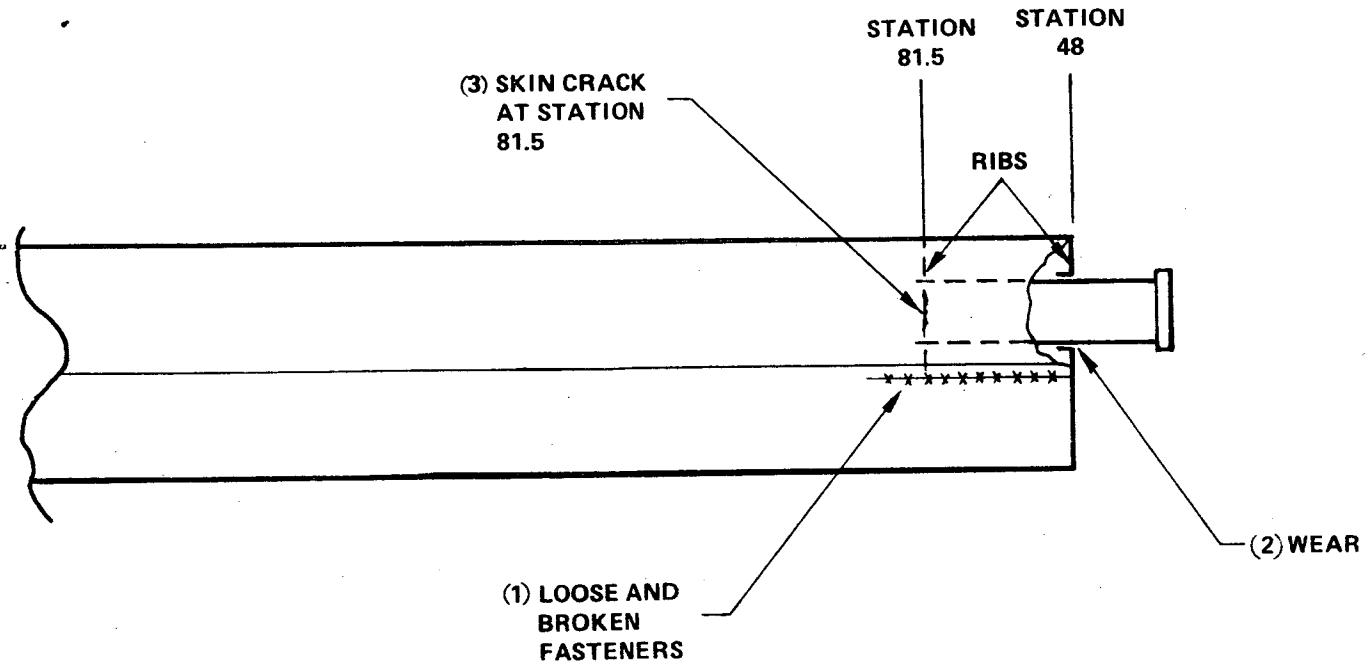
Figure 14. - Mod-0A blade damage.

In April 1978, NASA Lewis inspected the blades at Clayton. As a result of the inspection, two broken fasteners and several loose fasteners were found in the transition section on one of the blades. These fasteners were located between station 48 and 80 along the joint connecting the trailing edge to the D-spar. Because blade structural damage was found, the blades were removed from the wind turbine in June 1978. The blades were then sent

During the blade inspection at the Lewis Research Center, three types of blade damage were found. Figure 14 illustrates the nature and location of the damage. The damage included (1) loose and broken fasteners, (2) wear, and (3) cracking. It was concluded that damage at (1) was due to a design deficiency located along the line of fasteners joining the trailing edge skin to the D-spar (fig. 15). It was determined that the joint could not carry the applied shear loads shown in figure 15. The shear loads occur primarily due to the chordwise bending moments, blade weight being a major contributor. As a result, broken and loose fasteners were found, and cracks were found in several angle stringers located in the root end of the D-spar. This design deficiency was corrected by adding doublers on the exterior of the blade between station 48 and 100 as shown in figures 16 and 17.

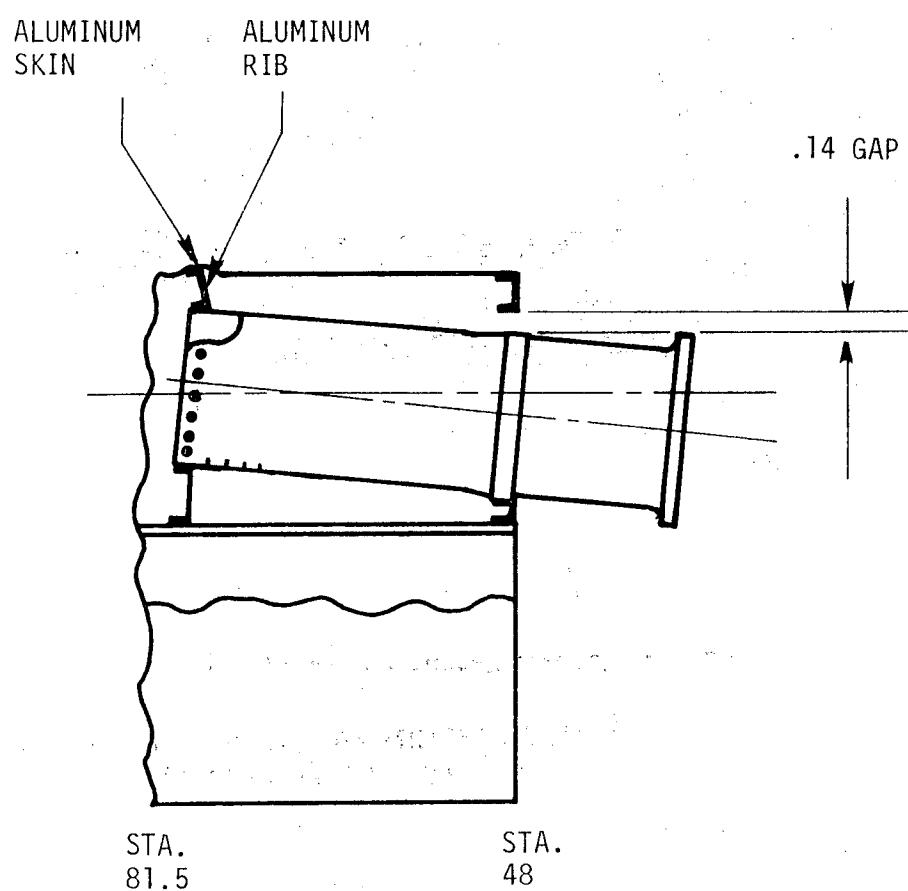
A second design deficiency was located at the bearing interface between the aluminum rib, at station 48, and the steel root end fitting, shown in figure 18. It was observed during the blade inspection at the Lewis Research Center that the steel root end fitting had rubbed extensively on the station 48 aluminum rib during operation (fig. 8 shows the detail design). This rubbing action caused excessive wear (damage at (2) in fig. 14) of the aluminum rib. The wear resulted in a radial clearance of up to 0.14 inch between the root end fitting and the rib on the blade. Because of the increased radial clearance at station 48, a large bending moment was applied to the rib at station 81.5. It was concluded that the high bending moments applied to the station 81.5 rib caused the rib to crack and that the rib/D-spar skin contact forces caused the 0.25-inch thick D-spar skin to crack (damage at (3) in fig. 14). The D-spar crack was repaired by the doublers shown in figures 16 and 17 which also effectively increase the skin thickness. A special bearing assembly (figs. 19 and 20) was designed and installed to solve the wear problem at the rib/root fitting sliding interface at station 48. The redesign included a Be-Cu liner bonded to the inside diameter of the rib and a removable shim inserted between the rib and the root fitting.

Figure 18. - Mod-0A blade station 48 interface wear problem.

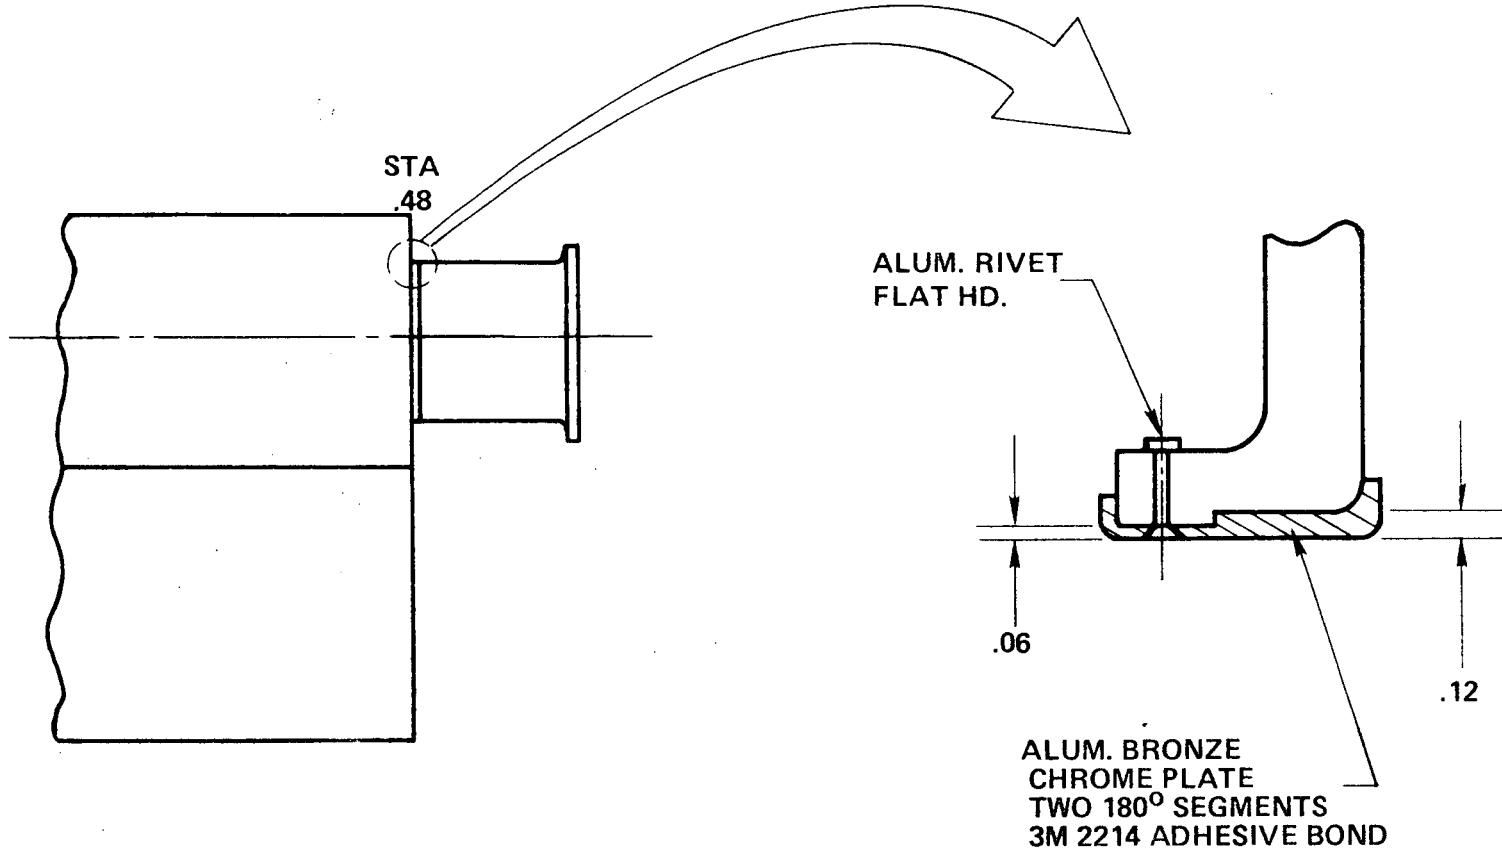
When the Be-Cu liner bond joint at station 48 rib failed, the liner shifted out of the rib producing a large gap (0.032 in.) between the root end fitting and rib. It was concluded that bending overloads in the station 81.5 rib had occurred again as the station 48 joints opened and closed, thus producing the observed amage. A new and modified liner (redesigned Be-Cu ring) was installed in each blade. A shoulder was provided on the outside

Figure 21. - Aluminum bronze liner for station 48 rib.
