The International Corrosion Forum Sponsored by the
National Association of Corrosion Engineers / March
22-26, 1982 / Albert Thomas Convention Center, Houston,
Texas

EXAMINATION OF TURBINE DISCS FROM NUCLEAR POWER PLANTS

CARL J. CZAJKOWSKI
JOHN R. WEEKS

Department of Nuclear Energy
Brookhaven National Laboratory
Upton, New York 11973

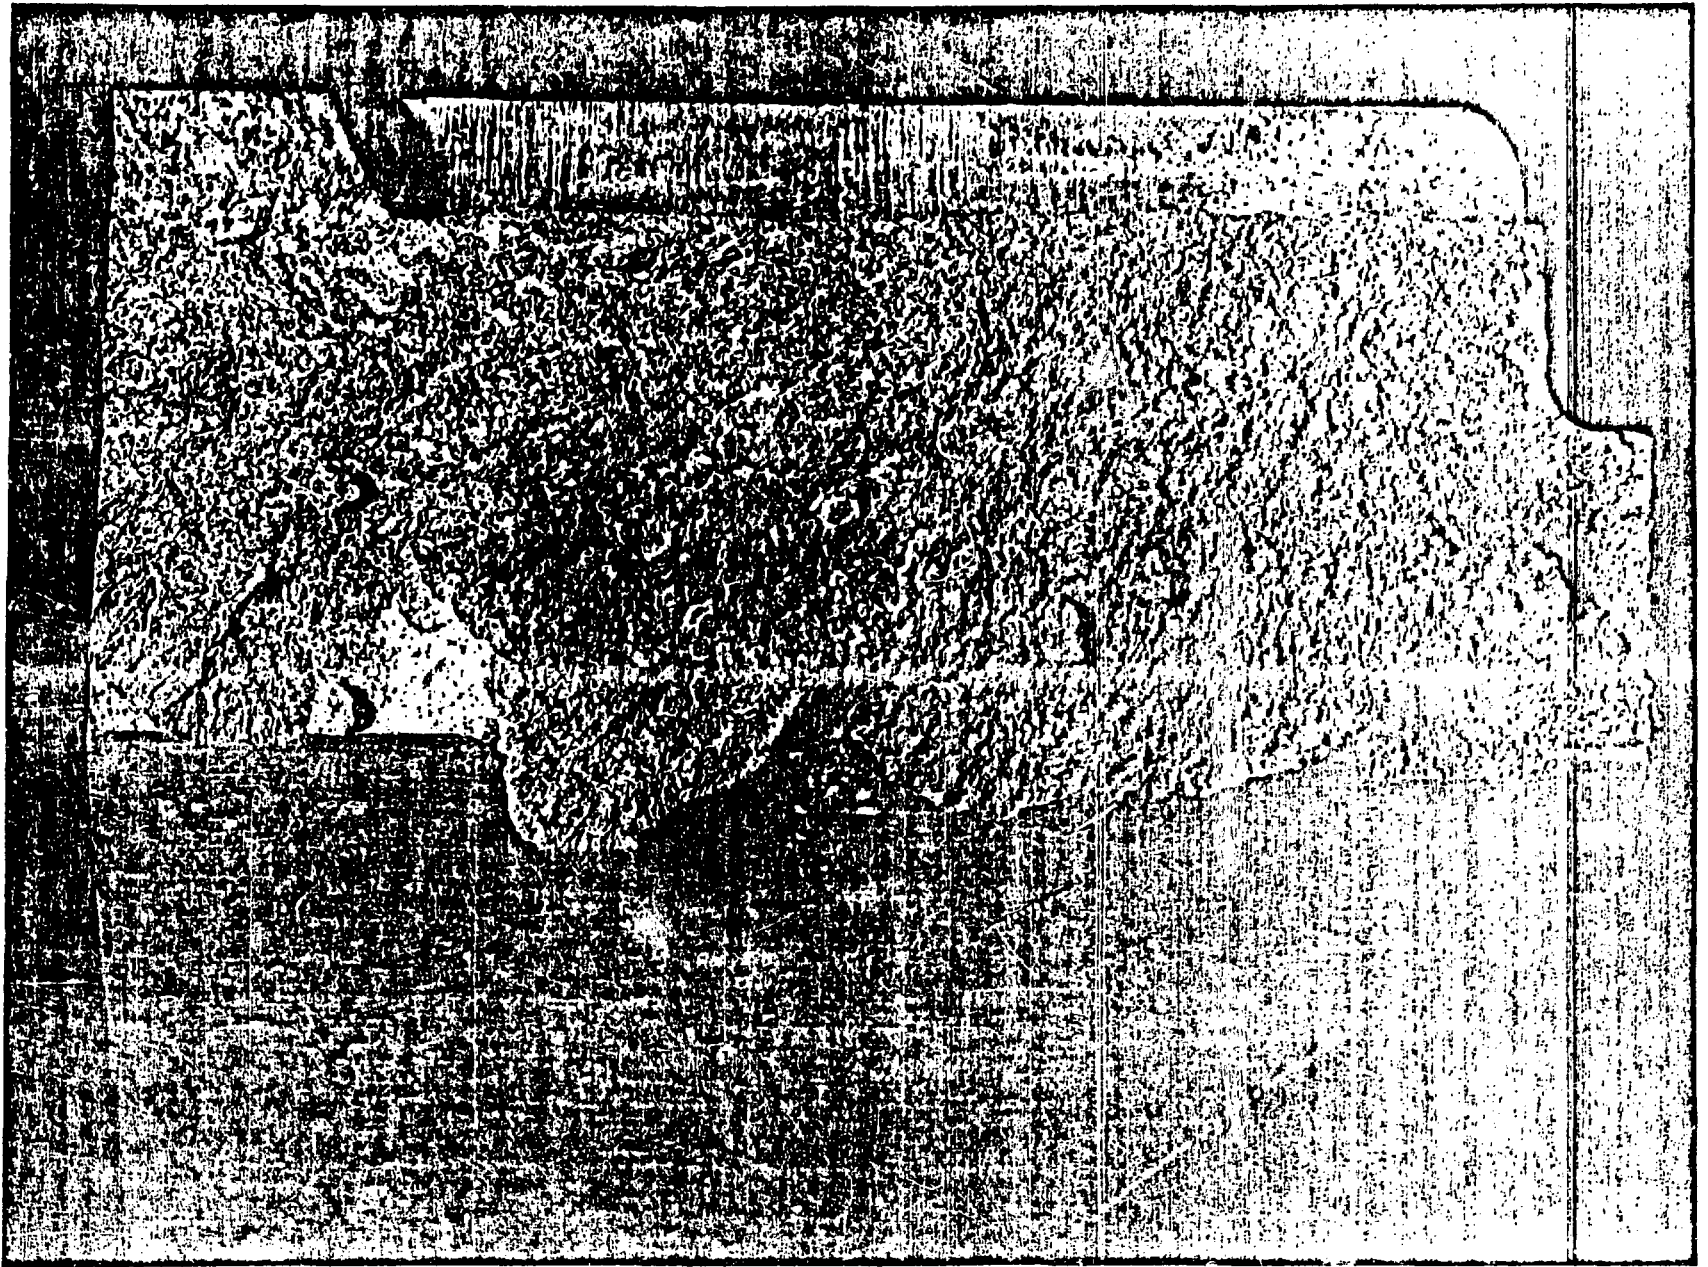
tester. The resulting fracture face is shown in Figure 2. The remainder of the turbine disc was then liquid penetrant tested again to determine if the entire crack had been removed. This examination showed that some of the cracks still remained. The disc was then cut approximately one inch further along the crack direction, and the above steps repeated. The fracture faces were then reassembled and measurements taken of the crack dimensions (Figure 3). The crack's length measured 13.45 cm (approximately 5.3") at its longest dimension, and 5.564 cm (approximately 2.1") at its greatest depth.

The crack was characterized by a black adherent film covering the fracture face and appeared to be mixed intergranular and transgranular in nature as viewed through a stereo microscope. Visual examination disclosed no arrest lines or beach marks, suggesting that once the crack initiated, it progressed with no apparent cyclic frequency.

Figure 2 Fracture face of turbine disc after opening of crack with compression tester. Cooper Turbine

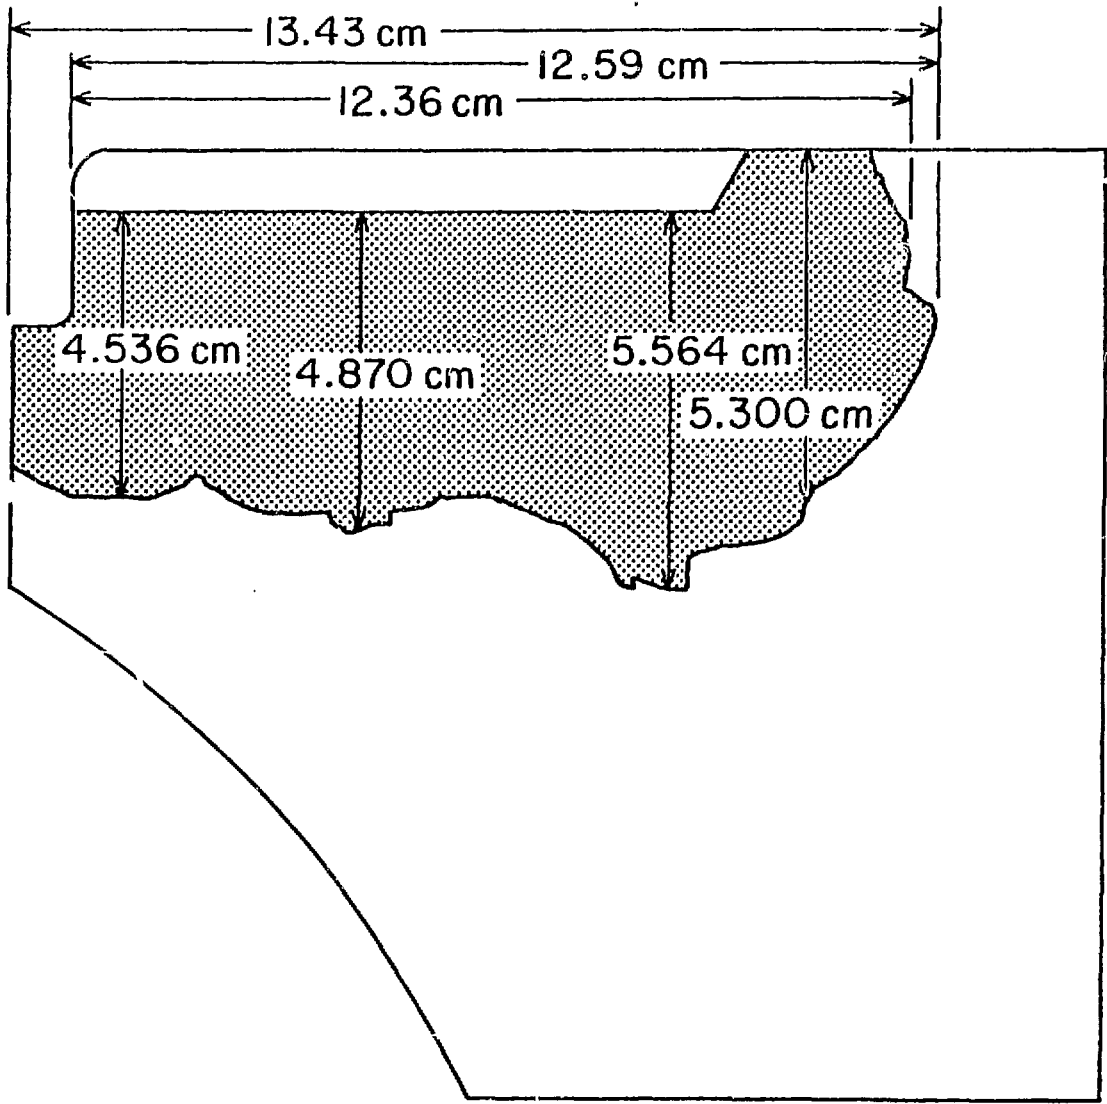
Figure 3
(Cooper Turbine Disc)

DIMENSIONS OF ONE HALF OF CRACK FACE
(NOT TO SCALE)

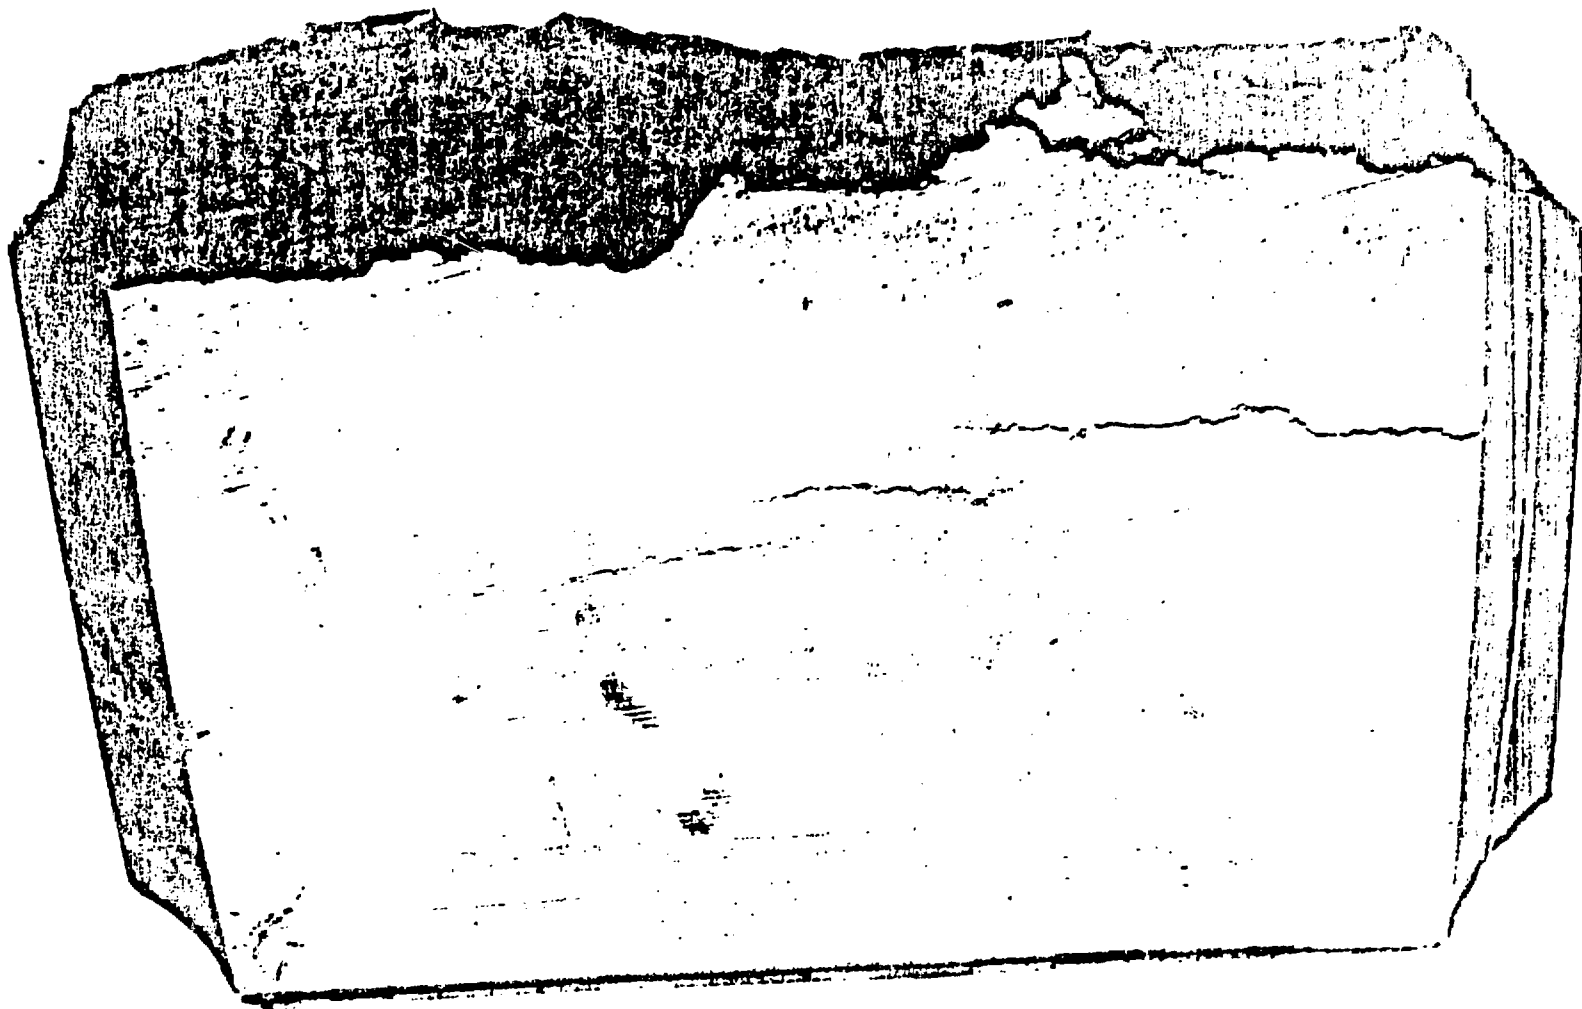
After being photographed, the two sections were cut to allow the bore surfaces to be examined more readily. The section of the generator disc was characterized as having numerous axial cracks running perpendicular to the circumferential direction of the hub. The fracture faces contained thumbnail corroded areas, which appeared to be mostly intergranular as viewed through a stereo microscope. (Prior to photographing this section, the visible thumbnail cracks were outlined with chalk.) The fracture faces were also characterized as having a tight black adherent oxide film on them in the thumbnail areas, similar to the film observed on the Cooper turbine disc. The balance of the fracture surface was clean and appears to have failed by cleavage after the stress corrosion crack reached a critical size. There was evidence of a grayish graphite-like substance on the hub which appeared to have been applied by brushing, as evidenced by the marked brush strokes in the photograph. These brush strokes were applied in the circumferential direction of the hub and were generally perpendicular to the cracks. There was also evidence of secondary cracking not necessarily associated with the intergranular cracks shown in Fig. 8, which is assumed to be a result of the fast fracture mode of the failure.

Figure 8 Cut portion of Generator End Disc showing amount of secondary cracking after failure (Yankee-Rowe Turbine)

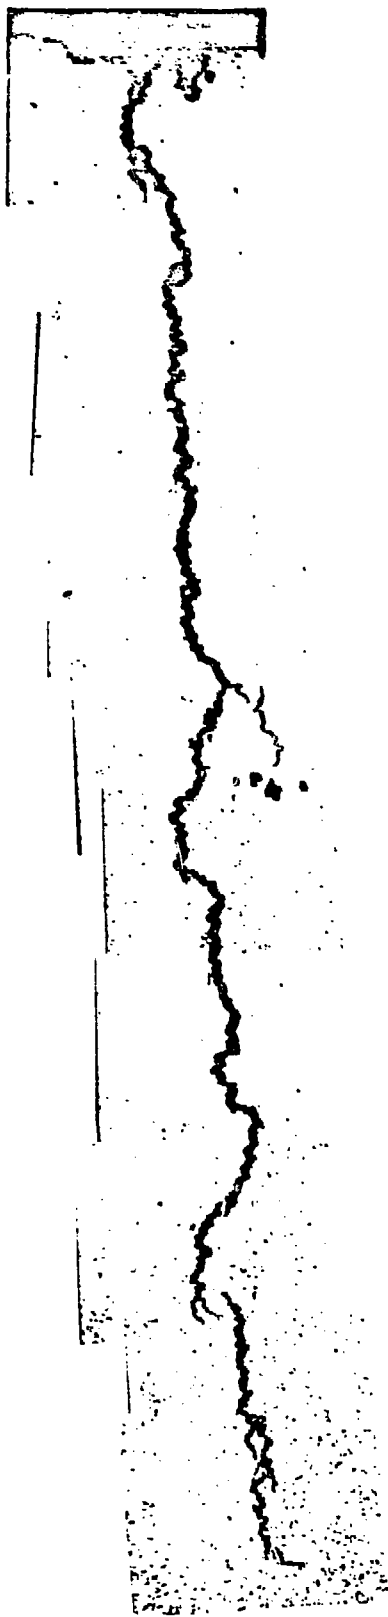
100 X

Two cracks from the generator end disc were sectioned and mounted, with the polished face perpendicular to the growth direction of the cracks. In the photomicrographs (Figs. 9 and 10), the cracks appear to be generally intergranular in nature with very little crack branching. The metal matrix appeared to be tempered martensite (bainite) with areas of proeutectoid ferrite. This structure would be consistent with that expected by quenching and tempering a low alloy high strength steel. There was no significant difference in the microstructures of the two discs.

Fig. 9 Photomicrograph of axial crack (typical) Generator End Disc, 6.7 mm in length (Yankee-Rowe Turbine)

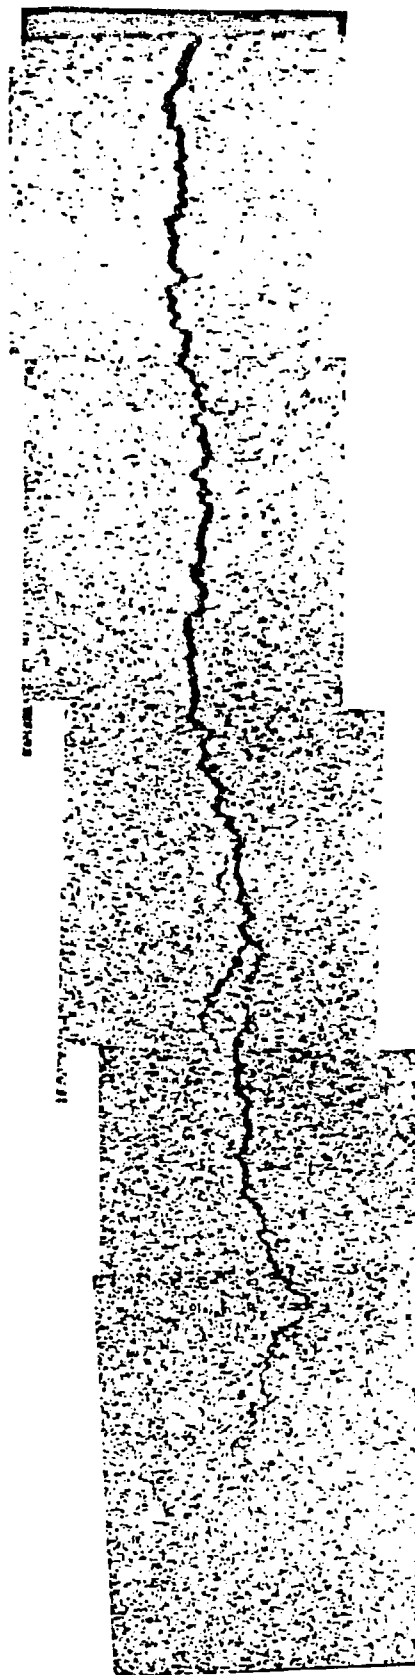
100 X

Fig. 10 Photomicrograph of second axial crack (typical) Generator End Disc, 4.1 mm in length (Yankee-Rowe Turbine)

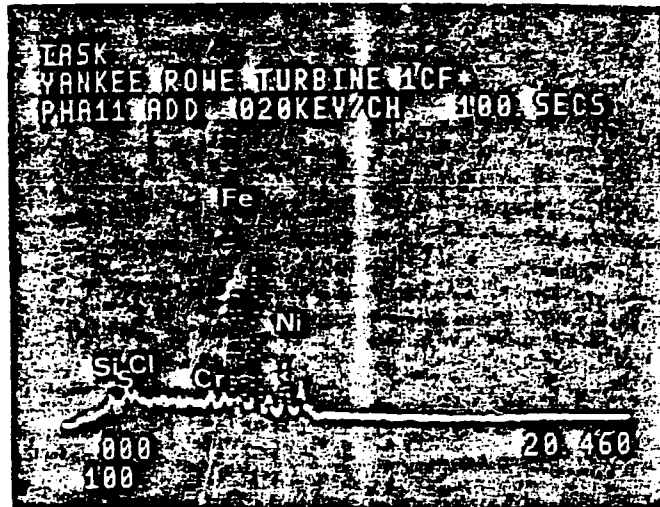
Various axial cracks from the generator disc were broken open after cooling the cut sections in liquid nitrogen. The fracture faces appeared to be generally intergranular in nature (Fig. 11) and had traces of Si, S, Cl, Mn with the Fe, Cr and Ni, as shown in a representative EDS scan (Fig. 12).

Figure 12
EDS scan showing representative elements present in fracture faces

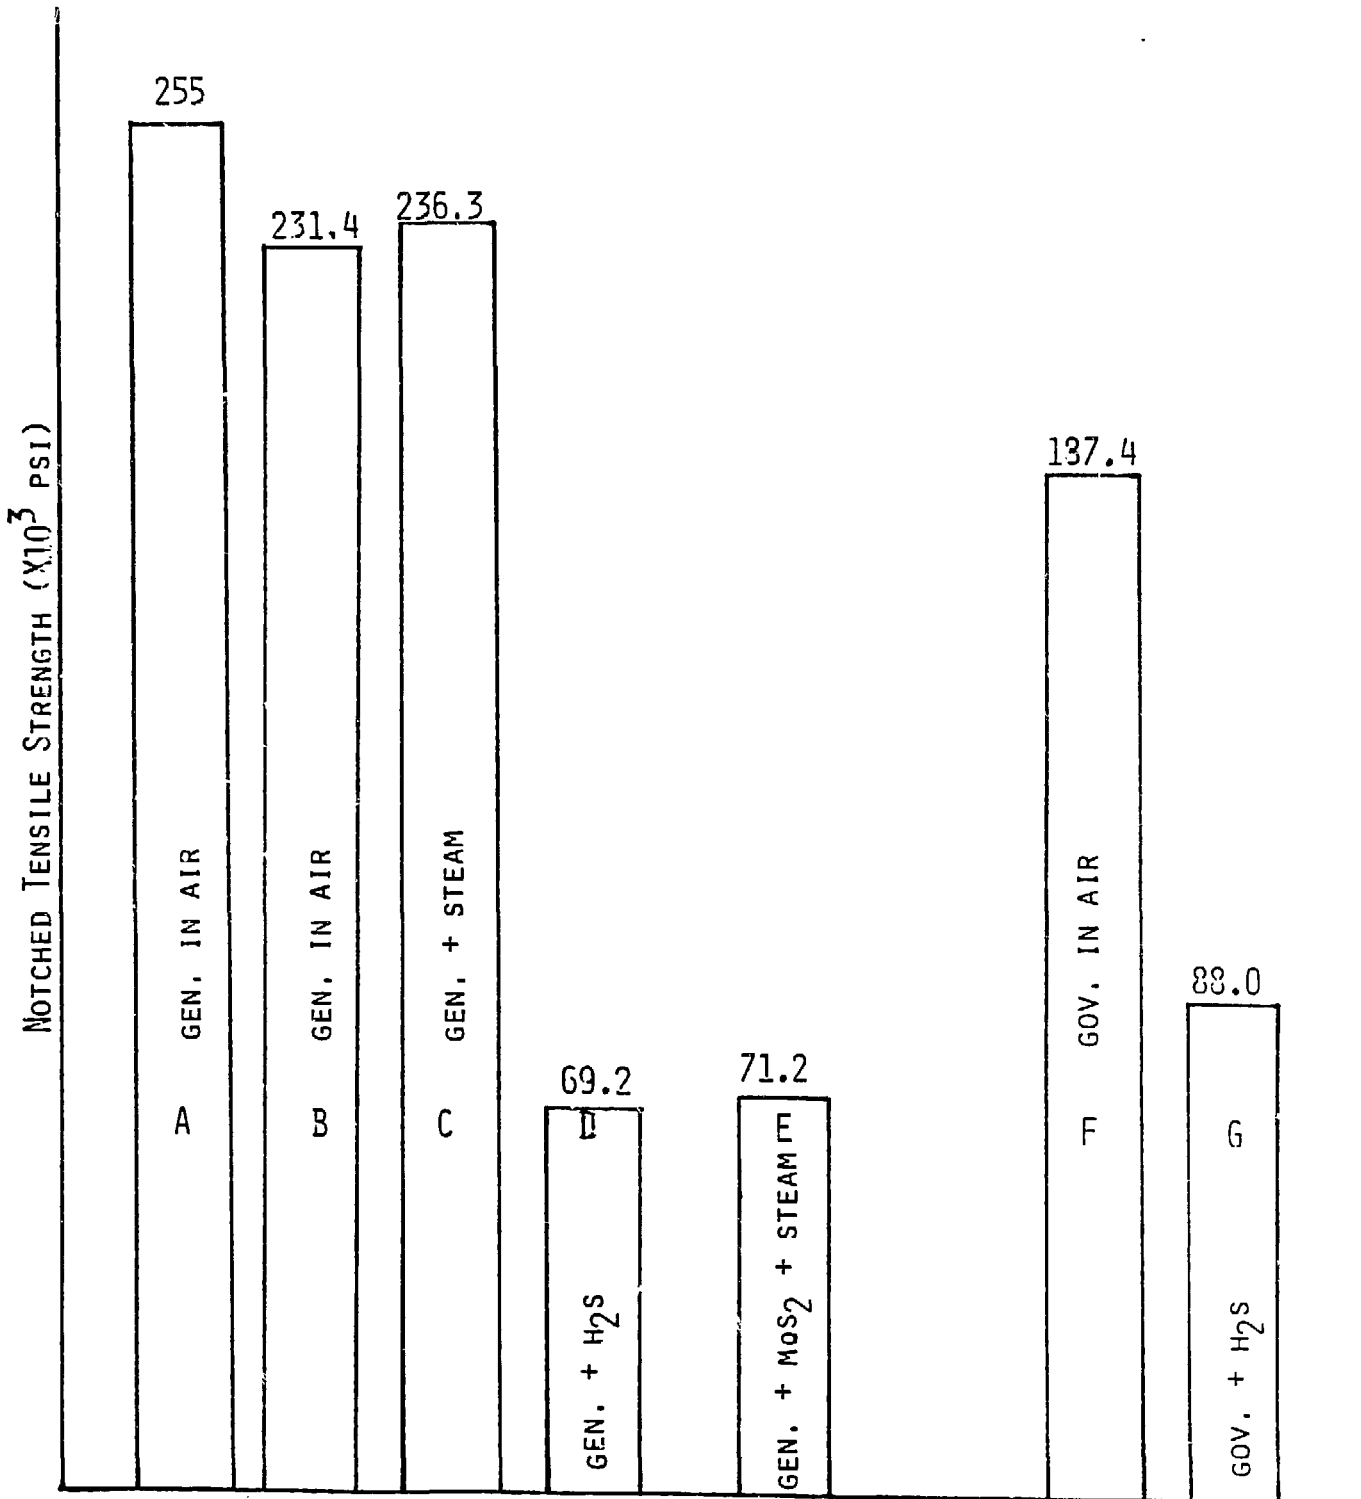
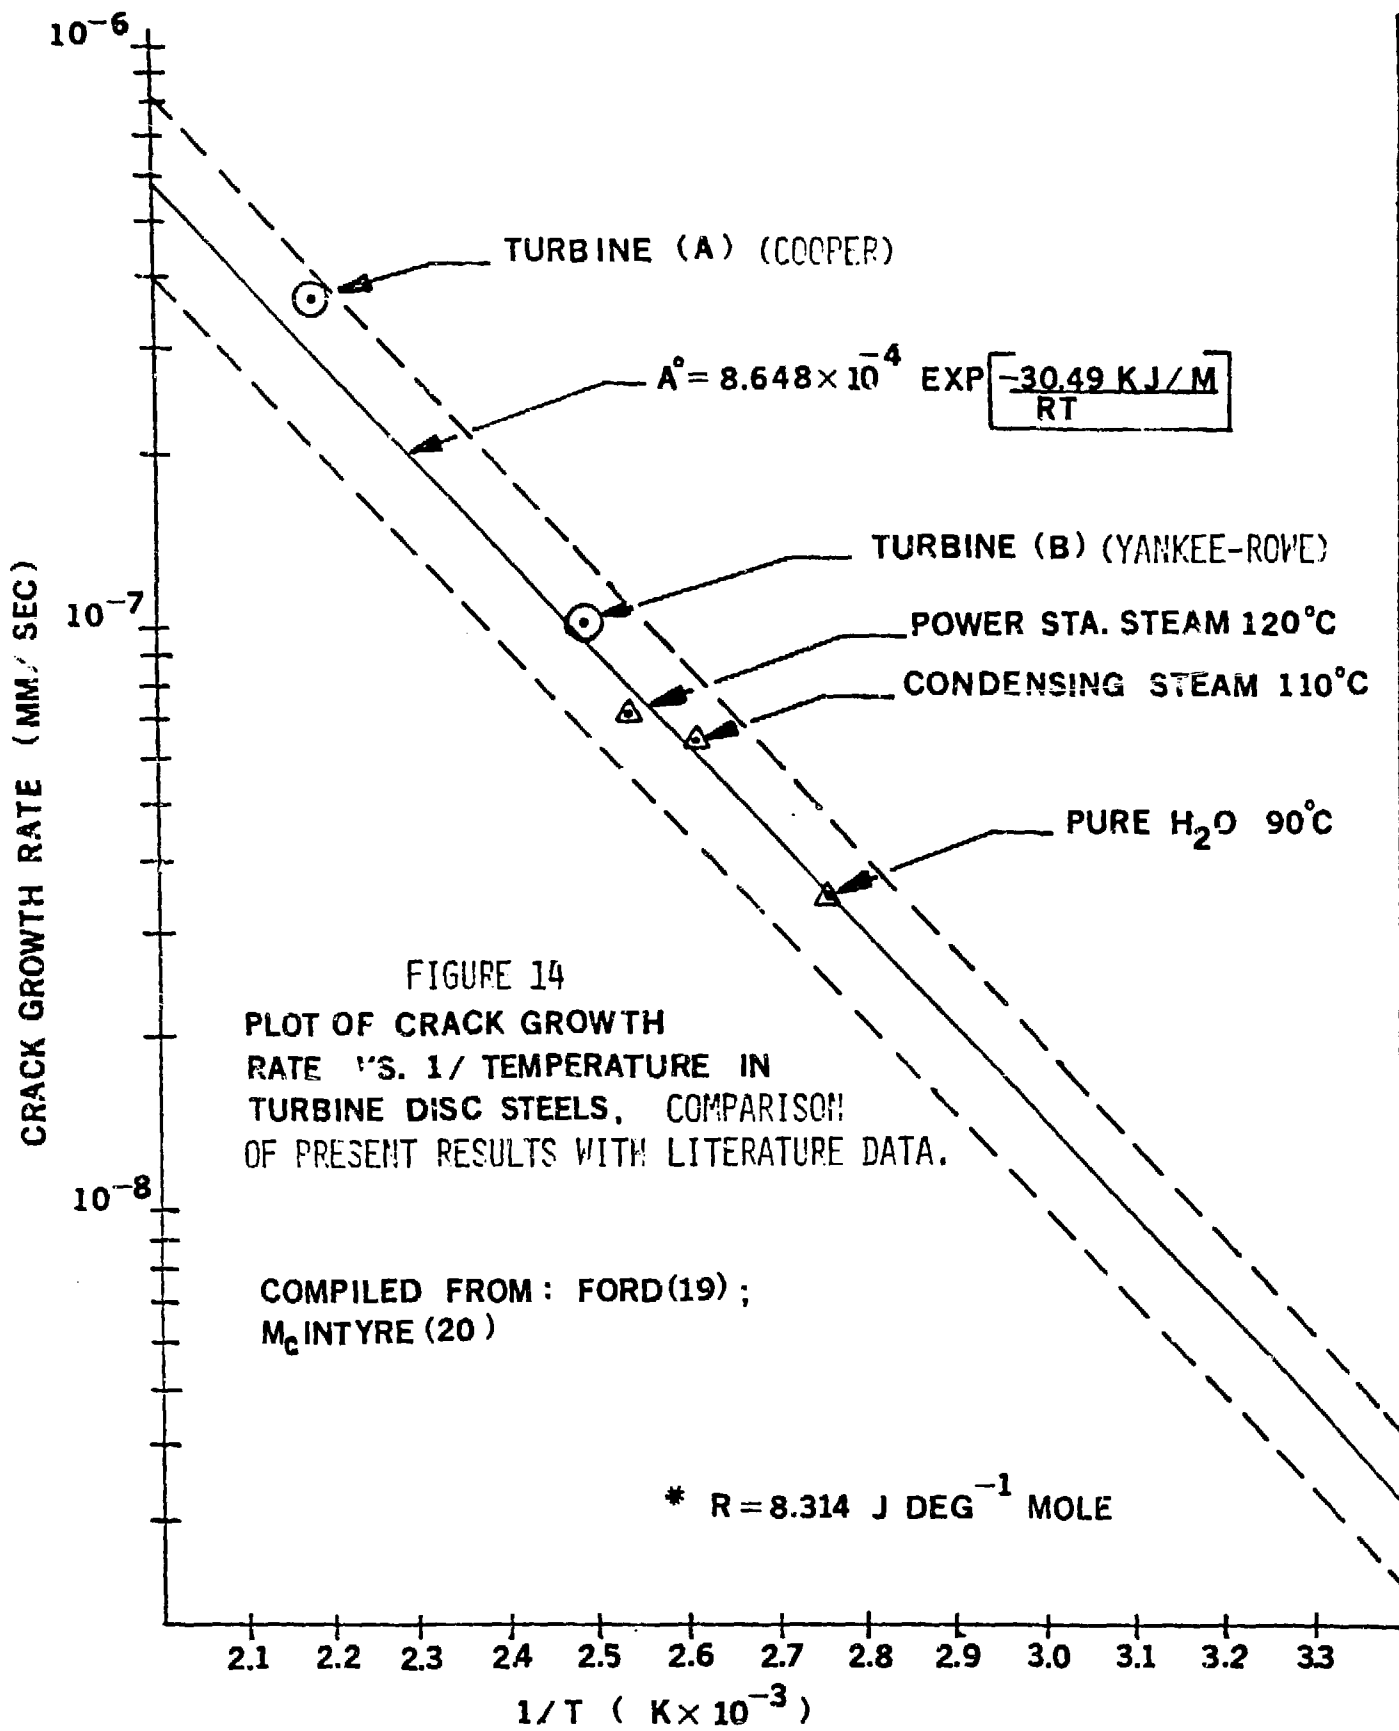
FIGURE 13
RESULTS OF NOTCHED TENSILE TESTS
YANKEE-ROWE TURBINE DISCS

Although previous investigators, cited in Ref. 2, had suggested that caustic deposition in the LP turbines was responsible for much of the cracking, there was no concrete evidence that caustic played a role in the cracking at either unit investigated. Indeed, Cooper is a BWR, in which no attempts are made to raise the pH of the coolant, so that caustic deposition would be less likely to occur than in a PWR turbine, where steam generator pH is usually greater than 9.0. Consequently, the common factor that might have led to crack initiation appeared to be the MoS₂ lubricant identified from this investigation as having been used in assembling both turbines. To this end, notch tensile tests were performed on specimens cut from both Yankee-Rowe discs, both in air and in clean steam. Since, when MoS₂ was sprayed on the specimens, a distinct odor of H₂S was observed during exposure to steam, comparative tests were also performed in an H₂S environment. The results are shown in Fig. 13.

Whereas steam appears to have little effect on the notched tensile strength of the material, the presence of steam plus MoS₂ and the presence of H₂S caused a 3.5-fold reduction in this property on the generator disc. The governor disc specimens appeared to be less sensitive to H₂S attack, since the reduction in notched tensile strength was only 2.1-fold for this disc.
