# RESULTS FROM THE RUN-BEYOND-CLADDING-BREACH IRRADIATION OF A PREFECTED FUEL PIN (RBCB-7)

## Hanford Engineering Development Laboratory

D.C. Langstaff  
M.Y. Almassy  
D.F. Washburn

February 1980

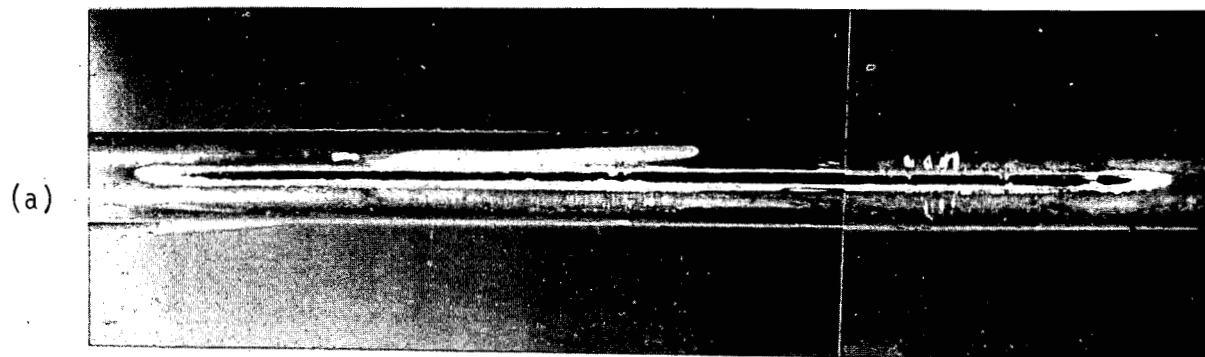
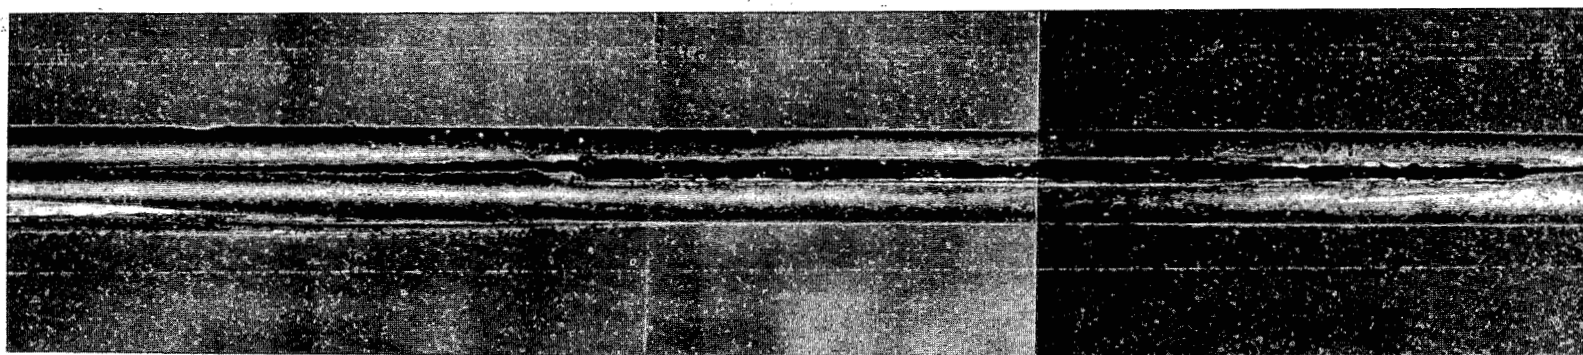
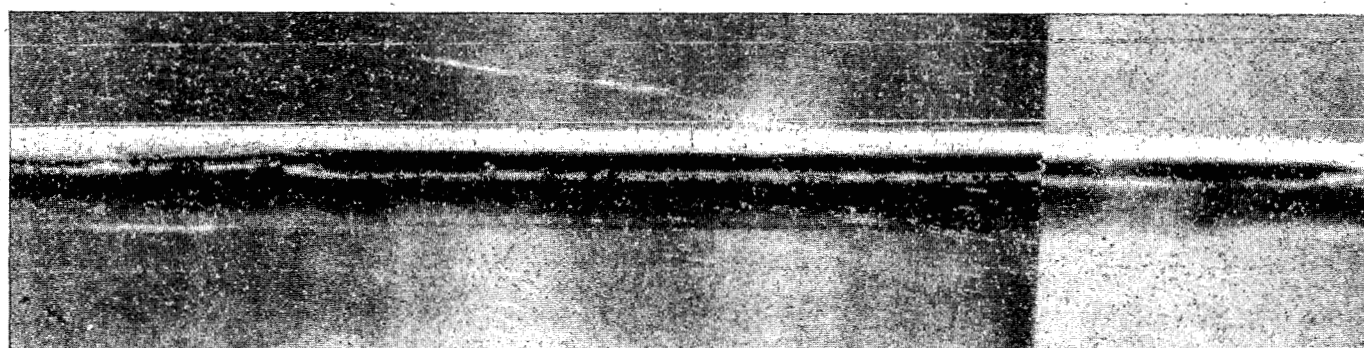
Visual examination of the predefected pin showed slit extensions at each end of the slit. The final defect appearance is shown in Figure 13. The original 58-mm (2.3-in.)-long slit extended 8 mm (0.31 in.) toward the top of the fuel pin and 32 mm (1.25 in.) toward the bottom. The upward slit extension extended about 5.5 mm (0.21 in.) over the UO<sub>2</sub> insulator region. The final dimensions of the defect are shown in Table 8 along with the initial dimensions. The total area of the defect increased from 0.35 cm<sup>2</sup> to 0.71 cm<sup>2</sup>, an increase of 103%.

FIGURE 13. The Breach Appearance of RCB-7 (ZP-5-42): a) As-Fabricated and Post-RBCB Irradiation, b) at HFEF/N and c) at HEDL (As-Received) After Filling the Breach with Resin and Shipping from HFEF/N. Neg 7909733-15

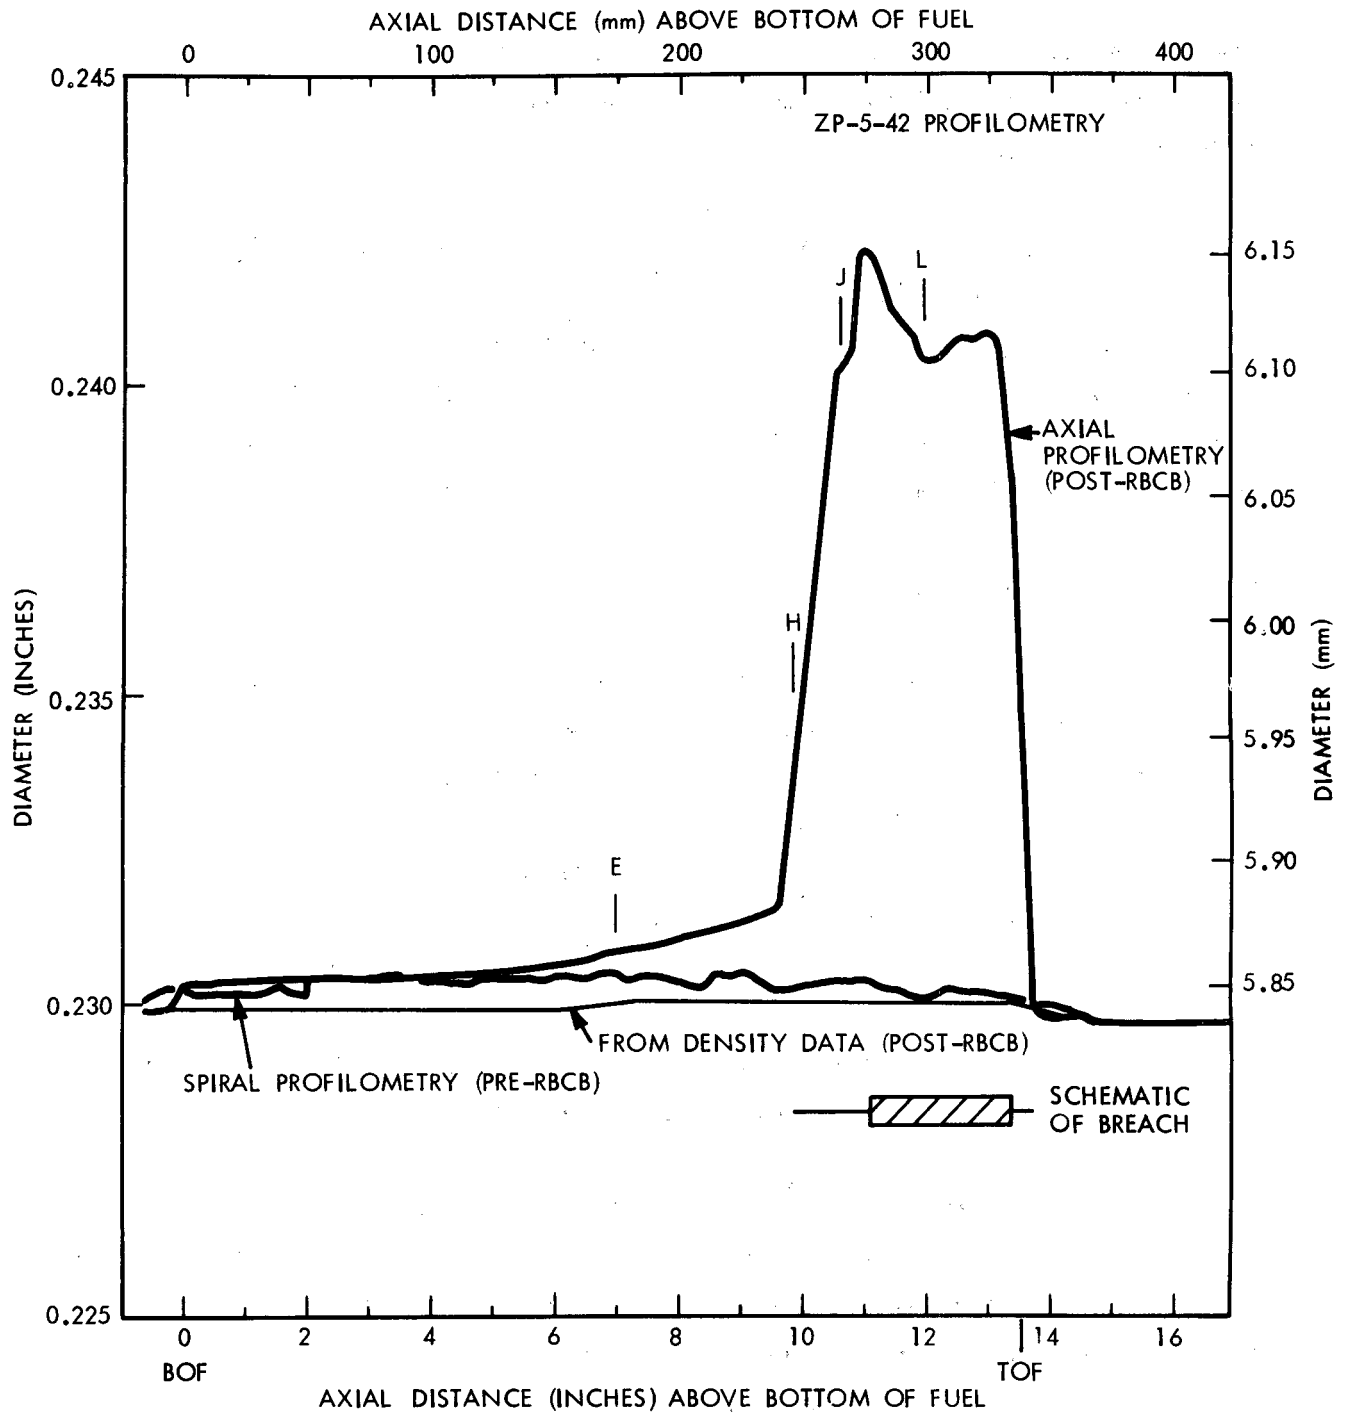
The pre-RBCB diameter prior to machining the slit was about 5.855 mm or 0.2% greater than the as-fabricated diameter. The neutron-induced cladding swelling (as determined from post-RBCB irradiation cladding density measurements) was less than 0.01% ( $\frac{\Delta V}{3V} \times 100$ ). Machining the slit in the cladding may have allowed relaxation to occur which would affect the final pin diameter. No attempt was made to measure the pin diameter after the slit was machined. However, the effects of relaxation on pin diameter are expected to be small. The net increase in pin diameter during RBCB irradiation is attributed to the effects of the sodium-fuel reaction.

The diameter change at the ends of the slit extension provide an indication of the strain required to cause crack extension. An estimate of the cladding strain for crack extension is 0.7%.

FIGURE 17. Diameter of RBCB-7 Fuel Pin ZP-5-42 Before and After RBCB Irradiation. Neg 7909733-5

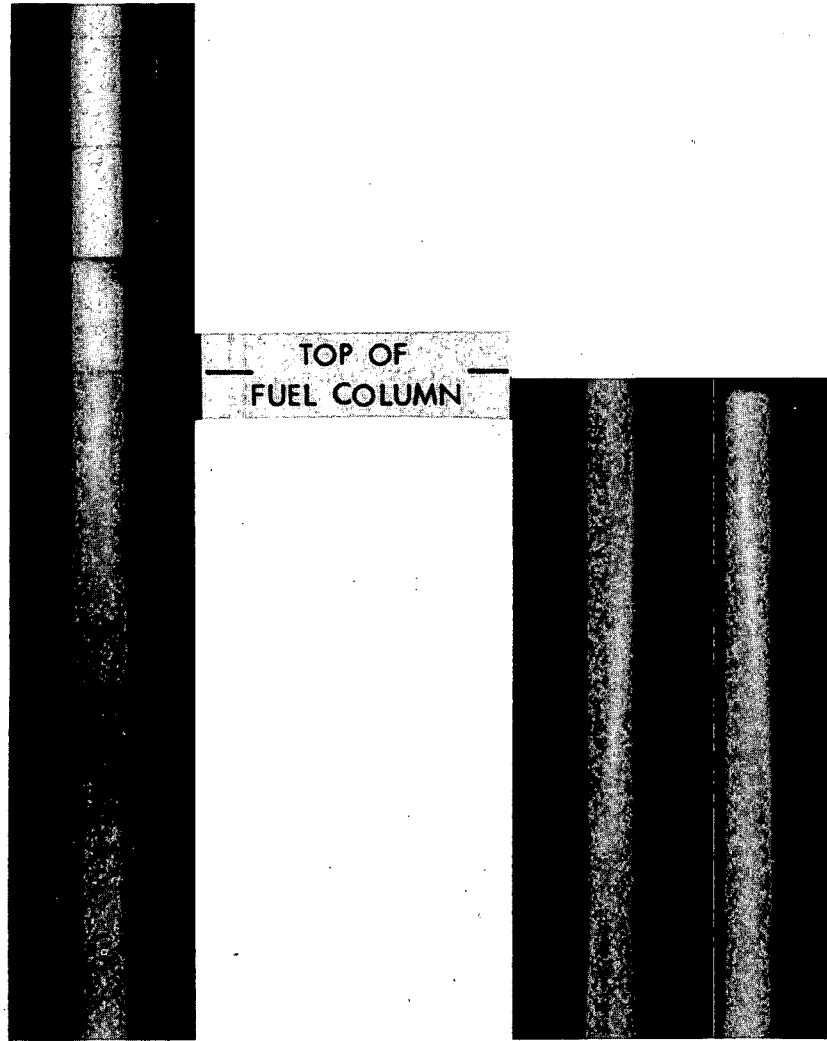
FIGURE 18. Radiography of Two Prefected Fuel Pins After RBCB Operation: a) Betatron Radiograph Showing the Breached Area of RBCB-6 (ZP-8-24), b) Neutron Radiograph Showing the Breach Area of RBCB-7 (ZP-5-42) and c) Neutron Radiograph Showing the Unfailed Fuel Pin (ZP-5-34). Neg 7909-094.1

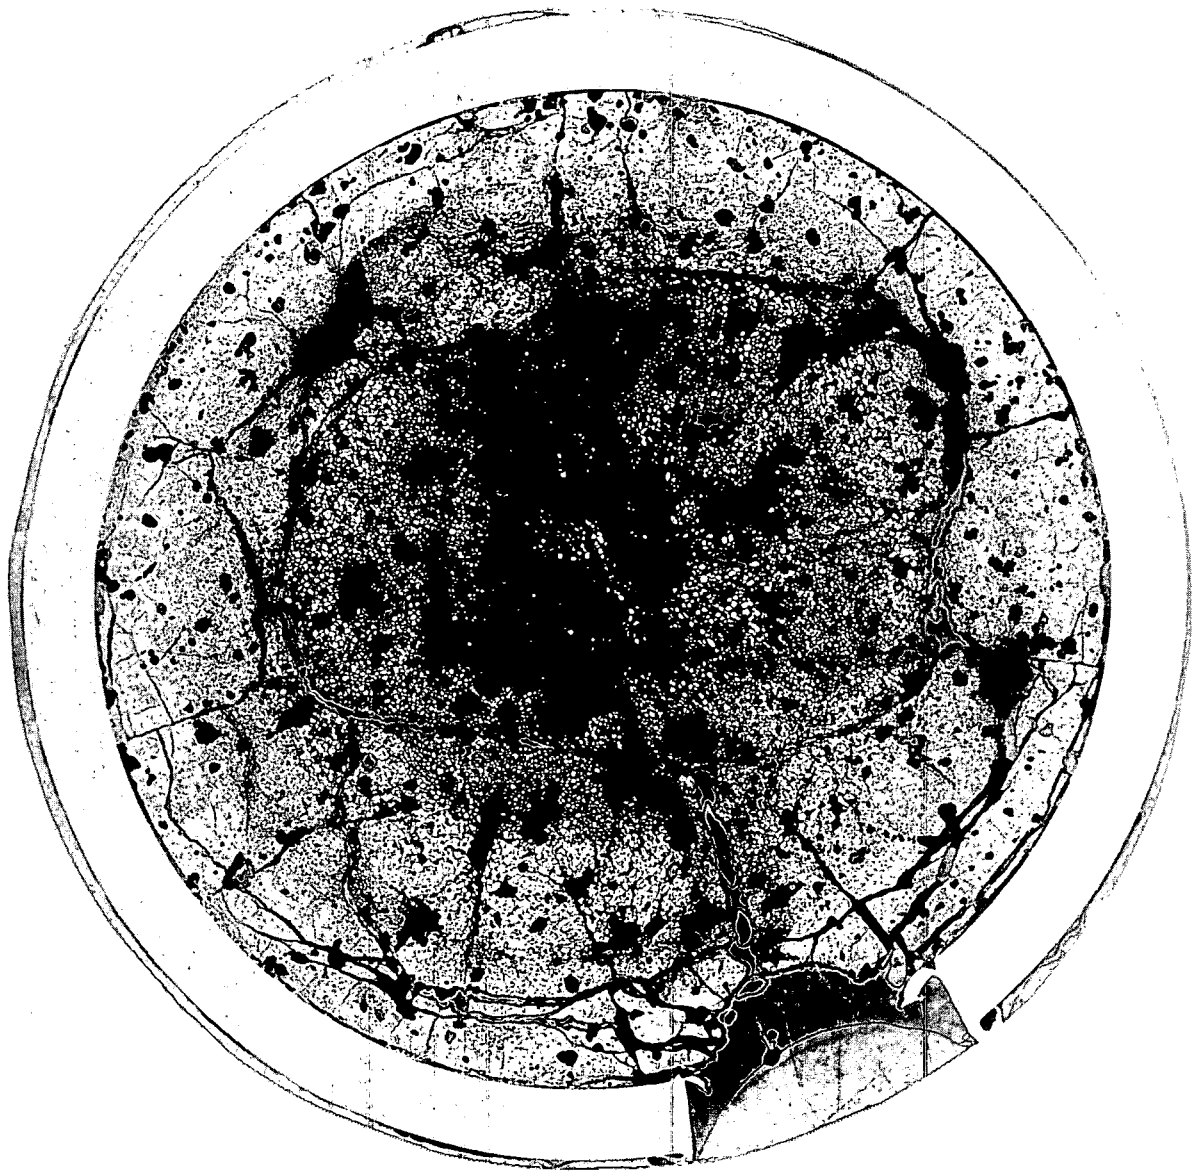
HEDL-ZP-5-42  
Sample L  
As Polished  
1 Diamond and Hyprez

FIGURE 20. Microstructure of HEDL-ZP-5-42 Sample L. Neg 7909733-10

Section L (Figures 20 and 21) was 30.6 cm from the BOF. The reaction product distribution in the fuel-cladding gap was discontinuous. Little reaction product was evident overall, varying from 0.01 mm to 0.03 mm in thickness. Intergranular reaction was very limited and closely followed existing fuel cracks. Radial cracks had opened in the outer ring of the fuel. Intermittent segments of a circumferential crack were evident. A large number of artifacts were introduced during metallographic preparation of this specimen, especially in the fuel center. Section L was assumed to be atypical of the other sections in ZP-5-42.

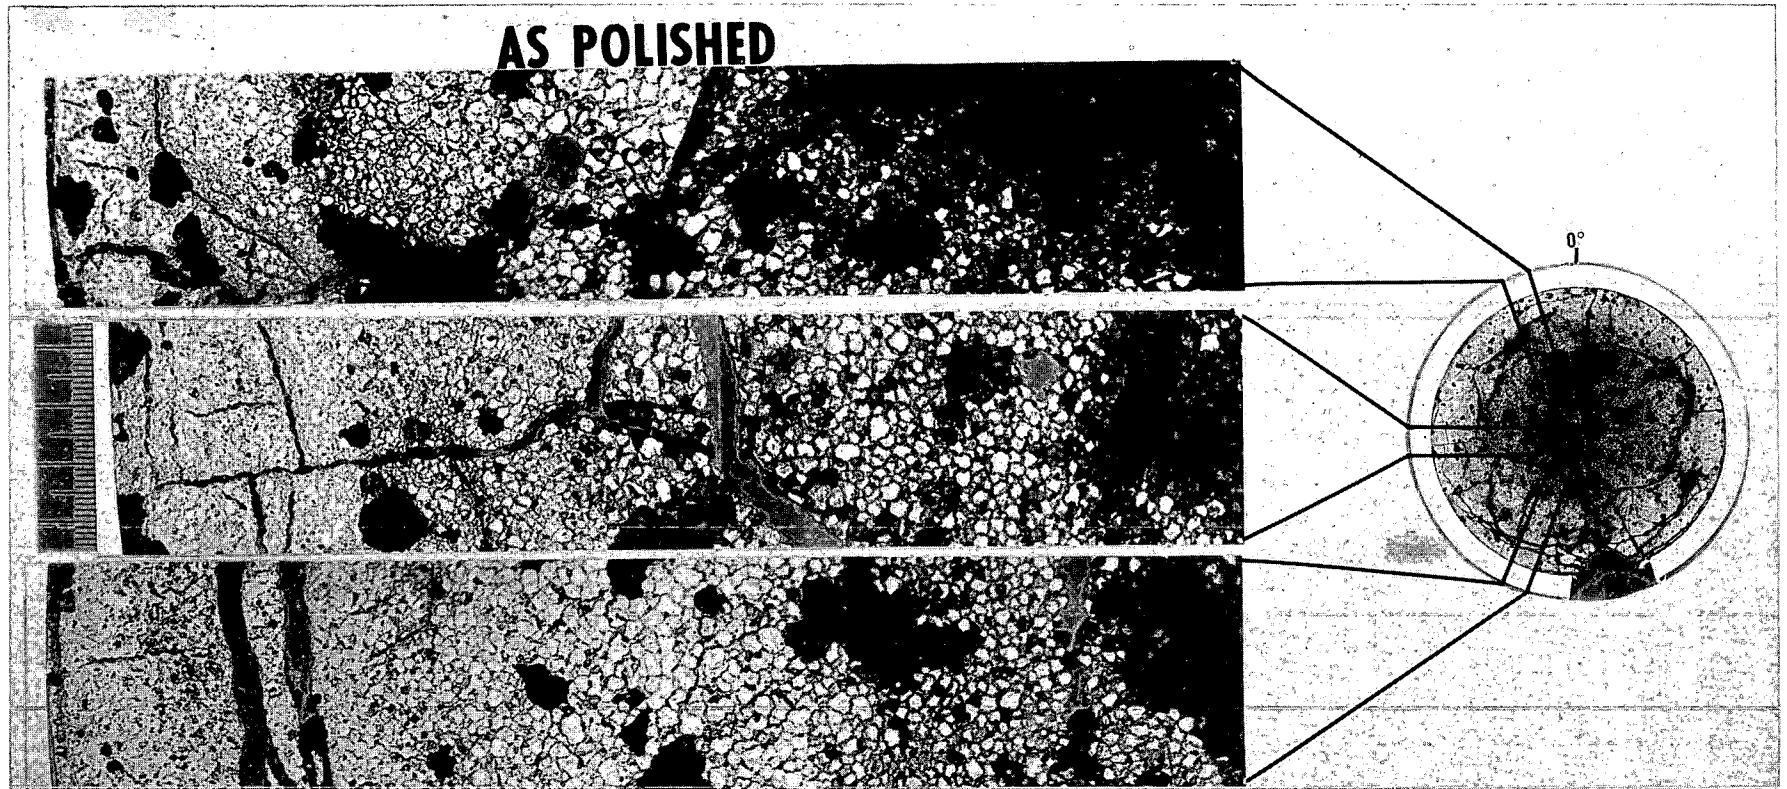
HEDL-ZP-5-42  
Sample-L

FIGURE 21. Microstructure of HEDL-ZP-5-42 Sample L - Radial Strips.

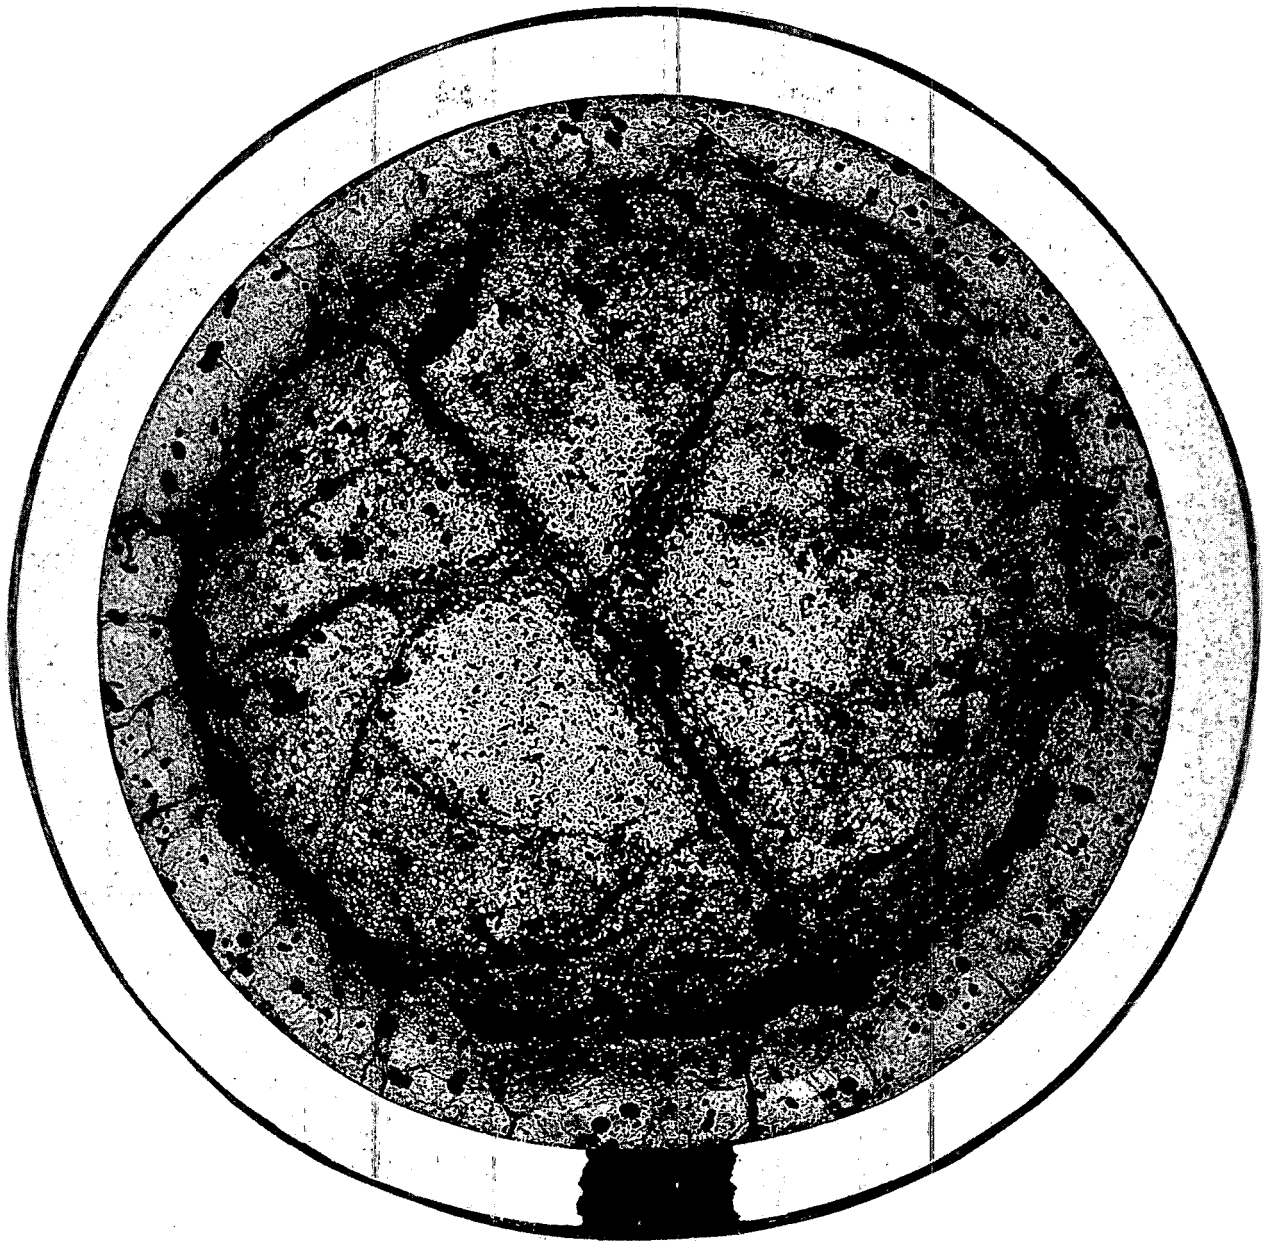
HEDL-ZP-5-42  
Sample J  
As Polished  
1 Diamond and Hyprez

FIGURE 22. Microstructure of HEDL-ZP-5-42 Sample J. Neg 7909733-12

Section J (Figure 22, 23 and 24) was along the lower slit extension (27.0 mm from BOF). The reaction product layer in the fuel-cladding gap was discontinuous. The layer ranged from less than 0.01 mm to 0.04 mm thick. Intergranular reaction in Section J was more extensive than in Section L.

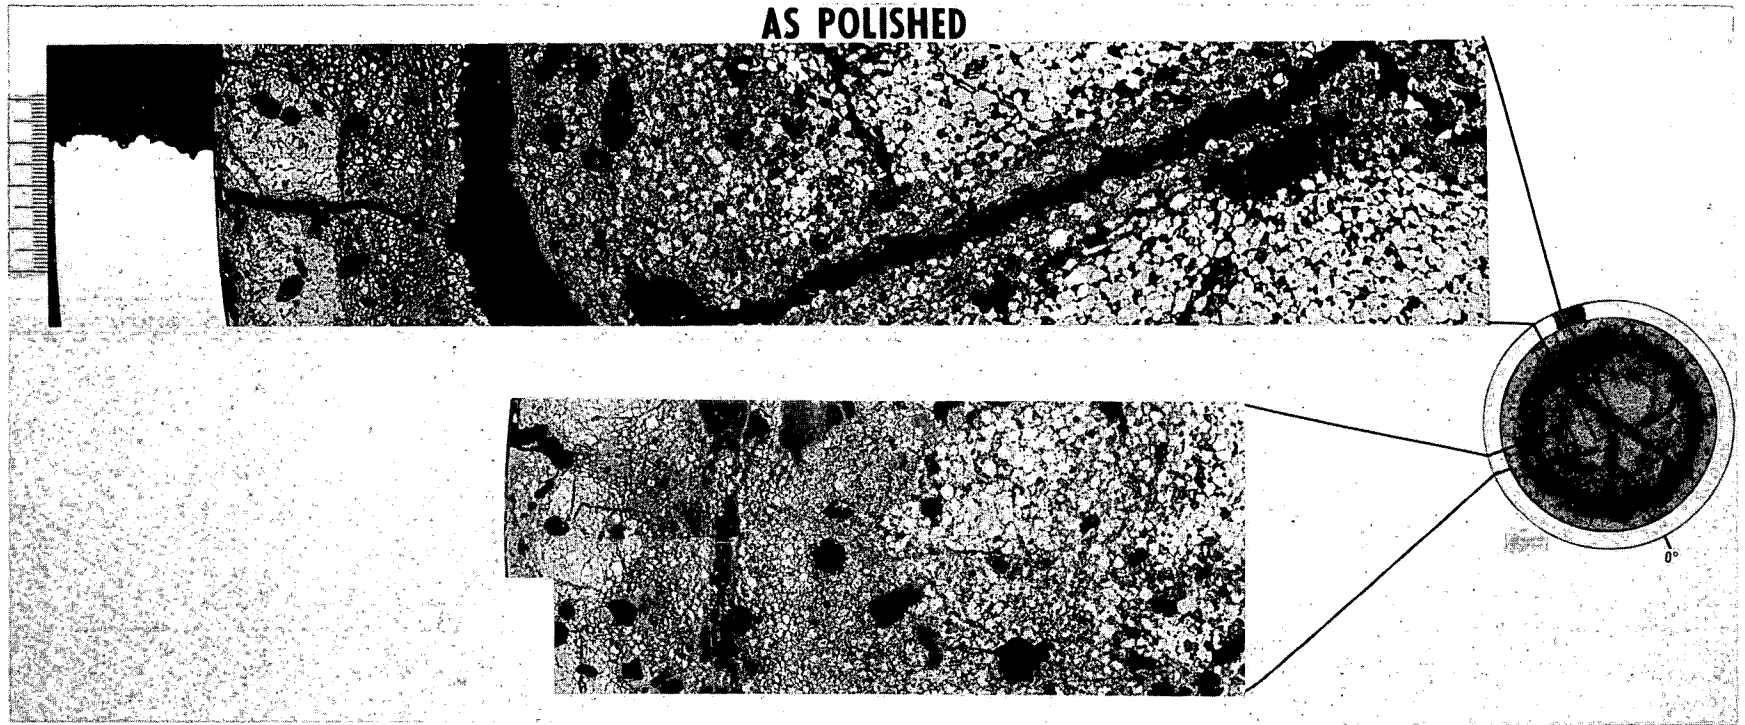
FIGURE 23. Microstructure of HEDL-ZP-5-42 Sample J - Radial Strips.

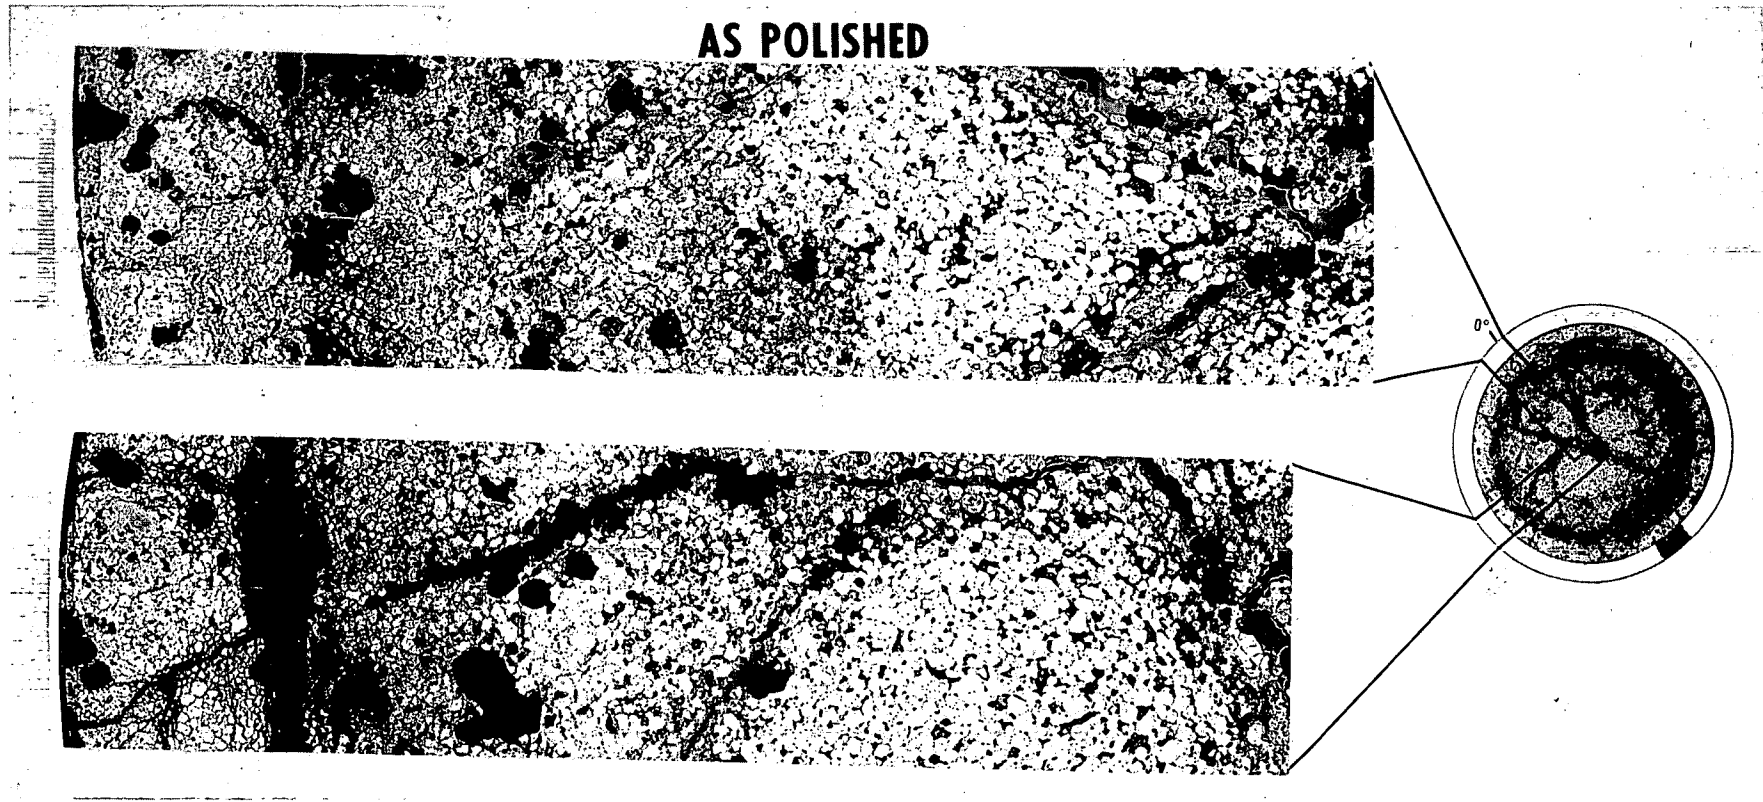
FIGURE 24. Microstructure of HEDL-ZP-5-42 Sample J - Radial Strips.

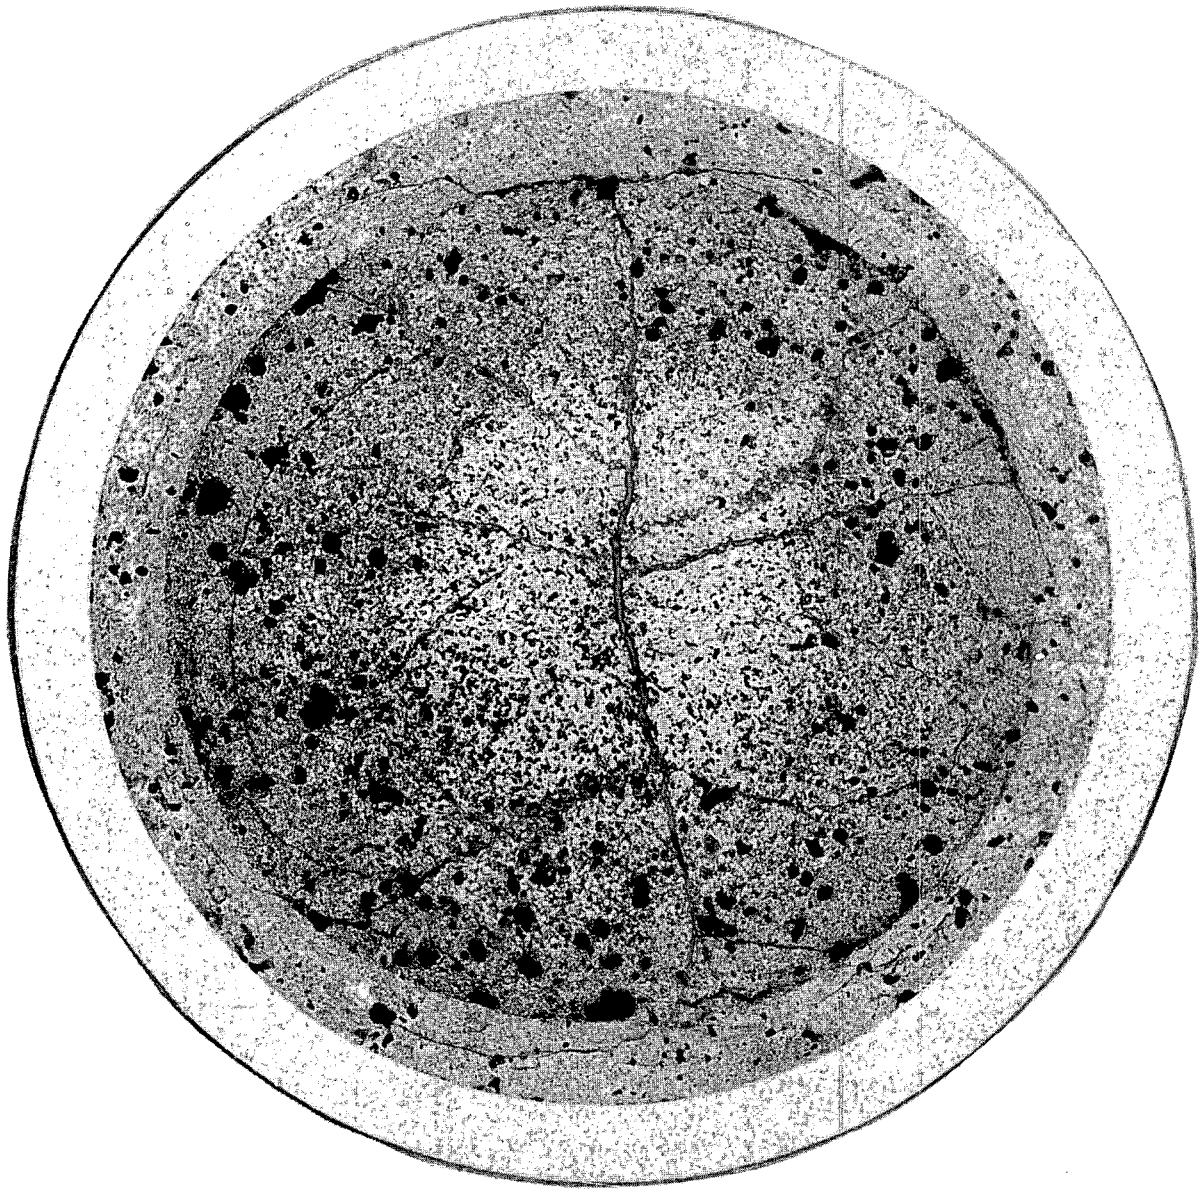
HEDL-ZP-5-42  
Sample H  
As Polished  
1 Diamond and Hyprez

FIGURE 25. Microstructure of HEDL-ZP-5-42 Sample H. Neg 7812109

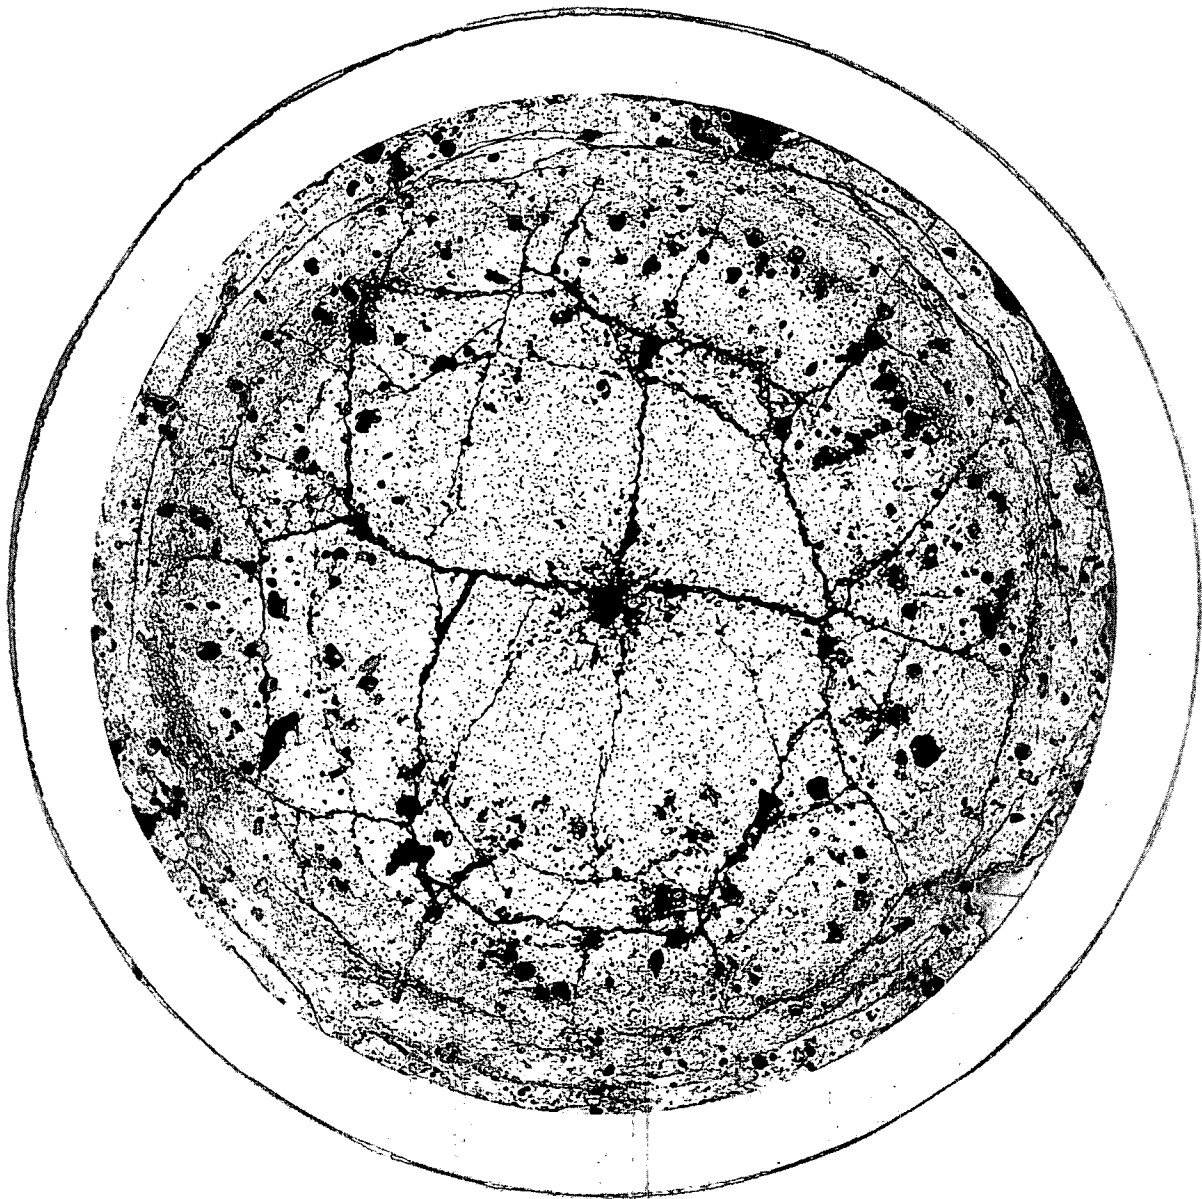
HEDL-ZP-5-42  
Sample E  
As Polished  
1 Diamond and Hyprez

FIGURE 26. Microstructure of HEDL-ZP-5-42 Sample E. Neg 7810290

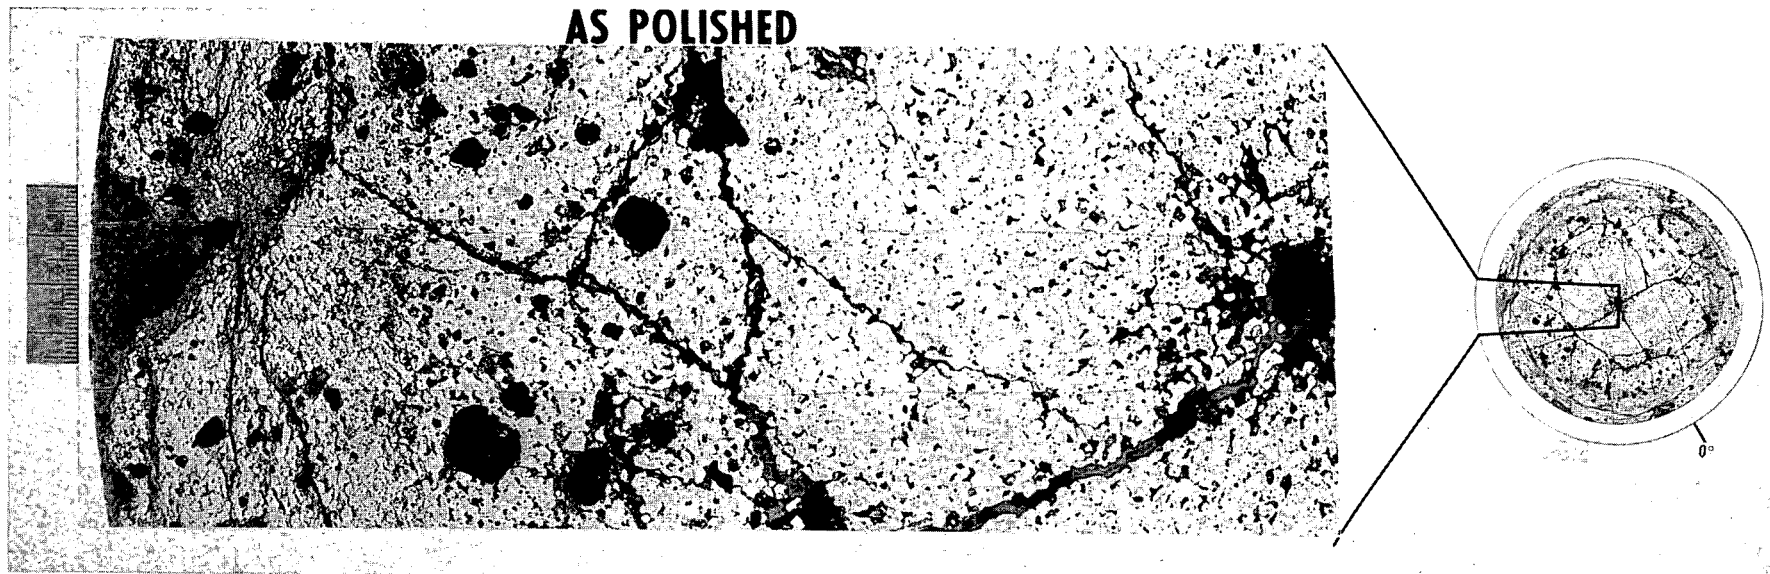
FIGURE 27. Microstructure of HEDL-ZP-5-42 Sample E - Radial Strip.

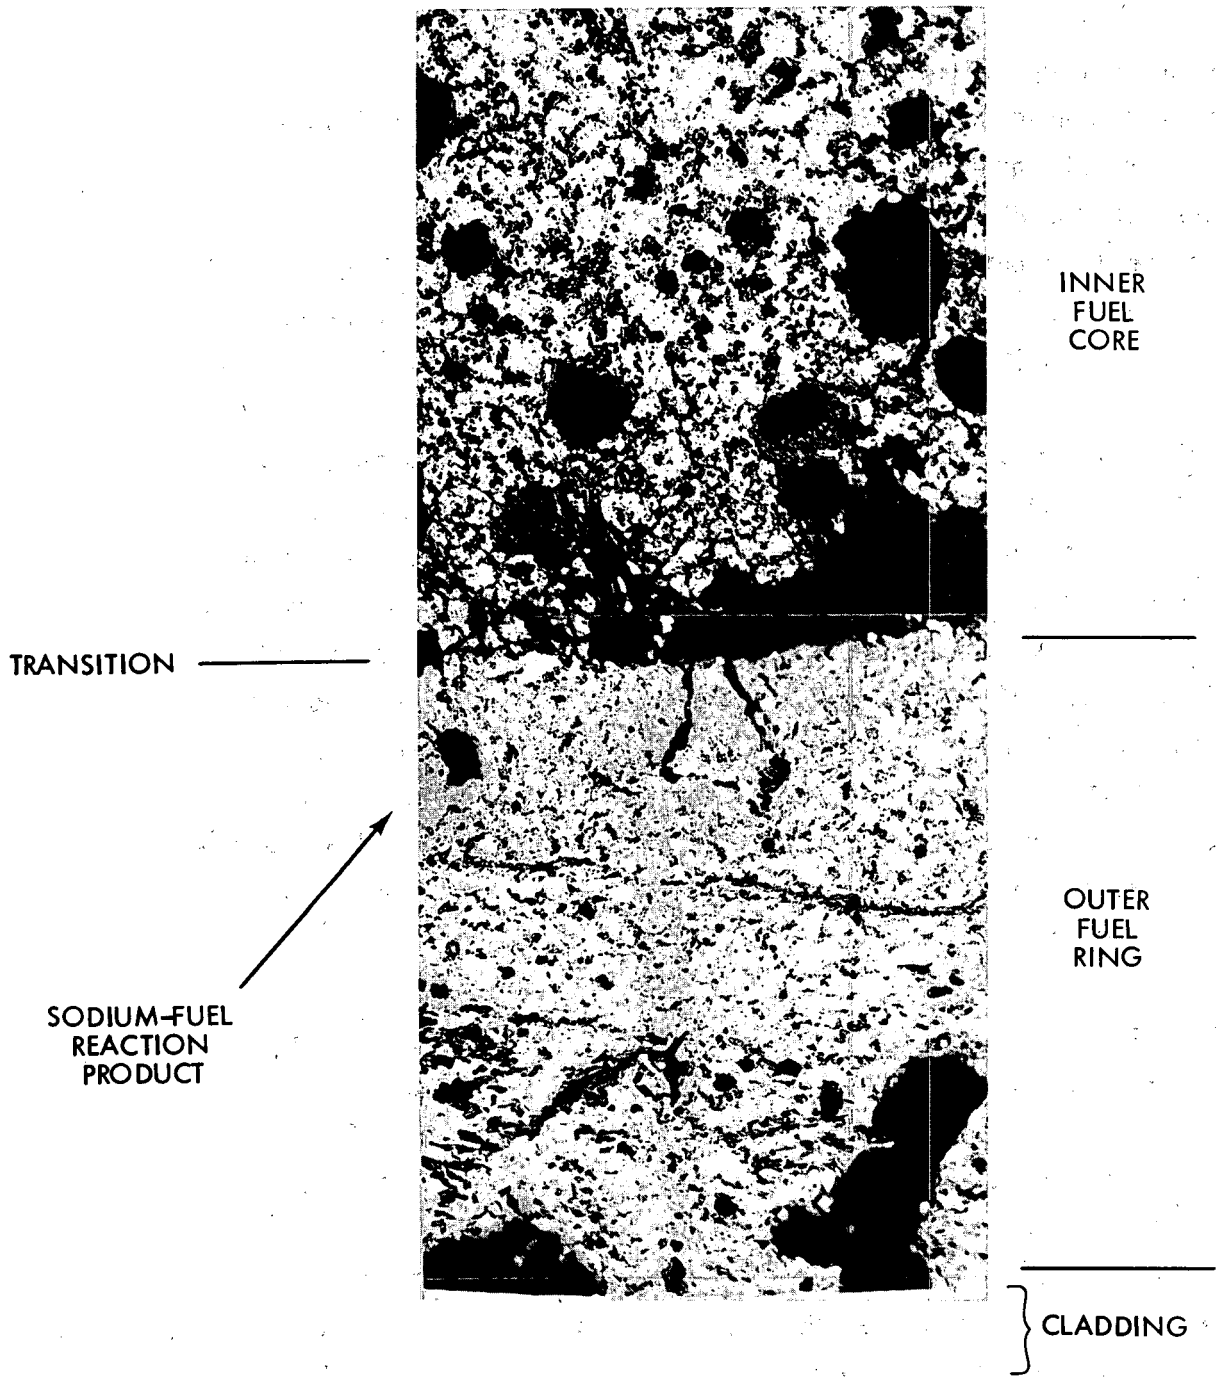
HEDL 7908-020.8

FIGURE 28. Transition Zone in the Fuel from ZP-5-42 Sample H Showing Transition in Fuel Structure and Morphology of Sodium-Fuel Reaction Product. Neg 7909733-21

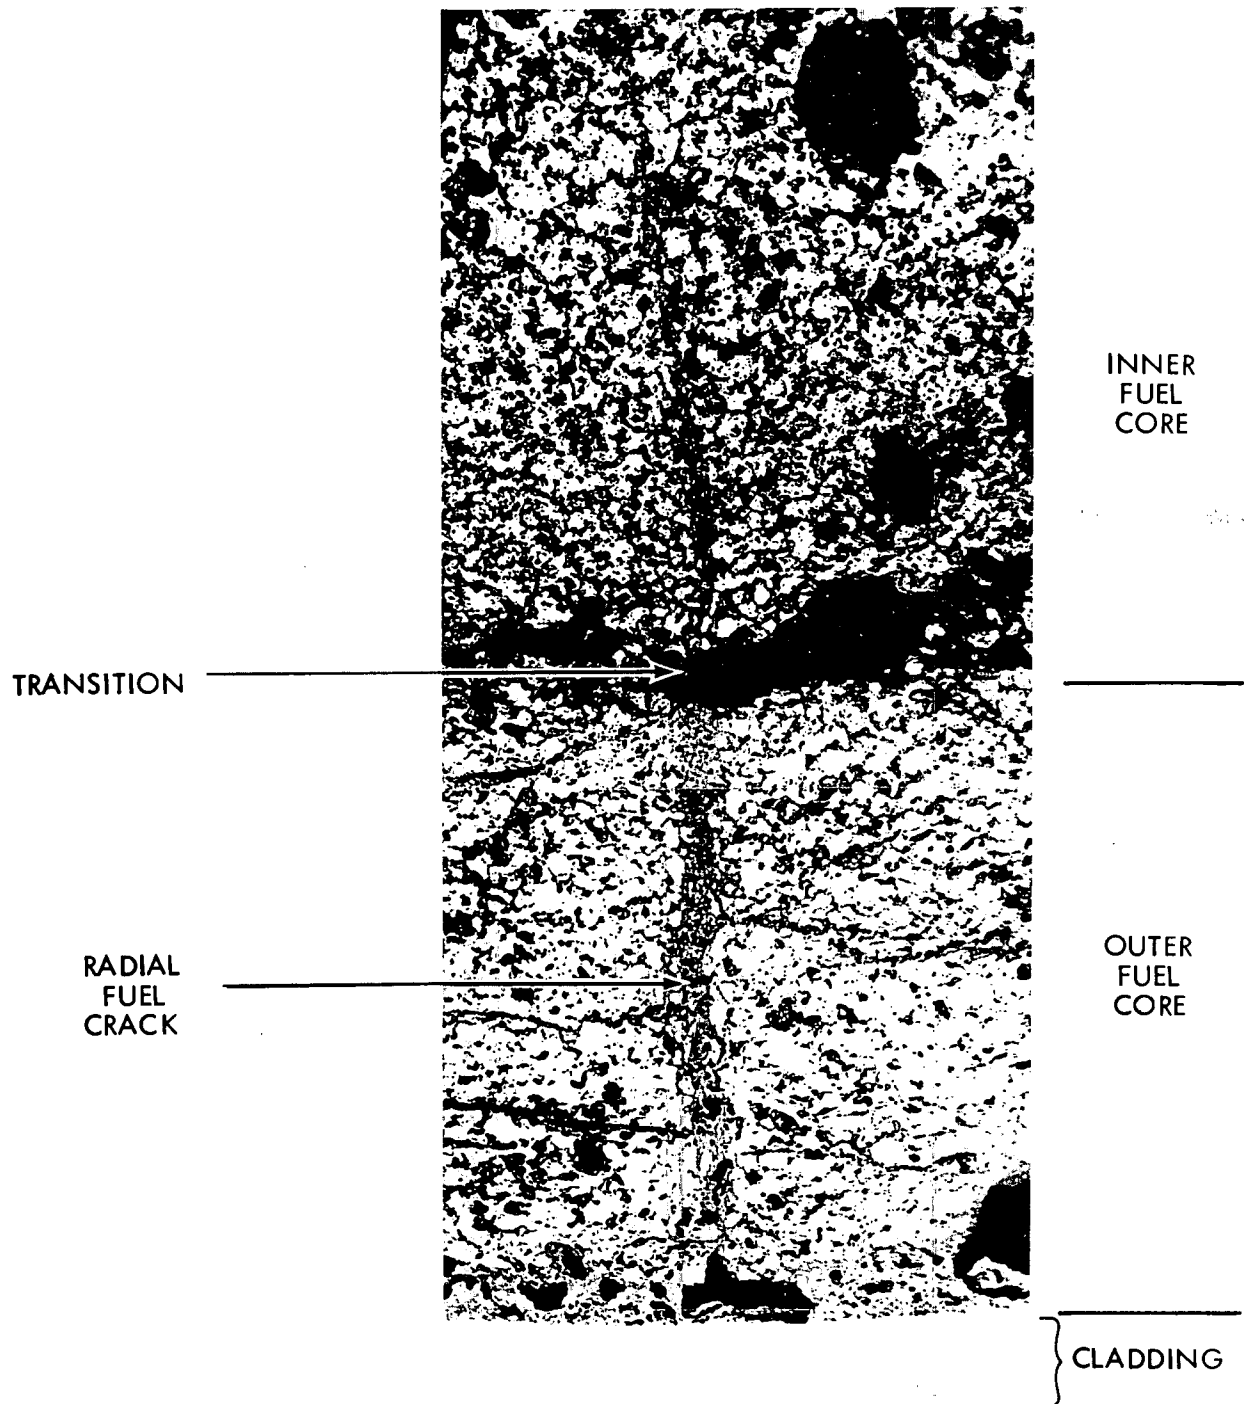
HEDL 7908-020.6

FIGURE 29. Transition Zone in the Fuel from ZP-5-42 Sample H Showing Transition in Fuel Structure and Morphology of Sodium-Fuel Reaction Product Along a Radial Fuel Crack.

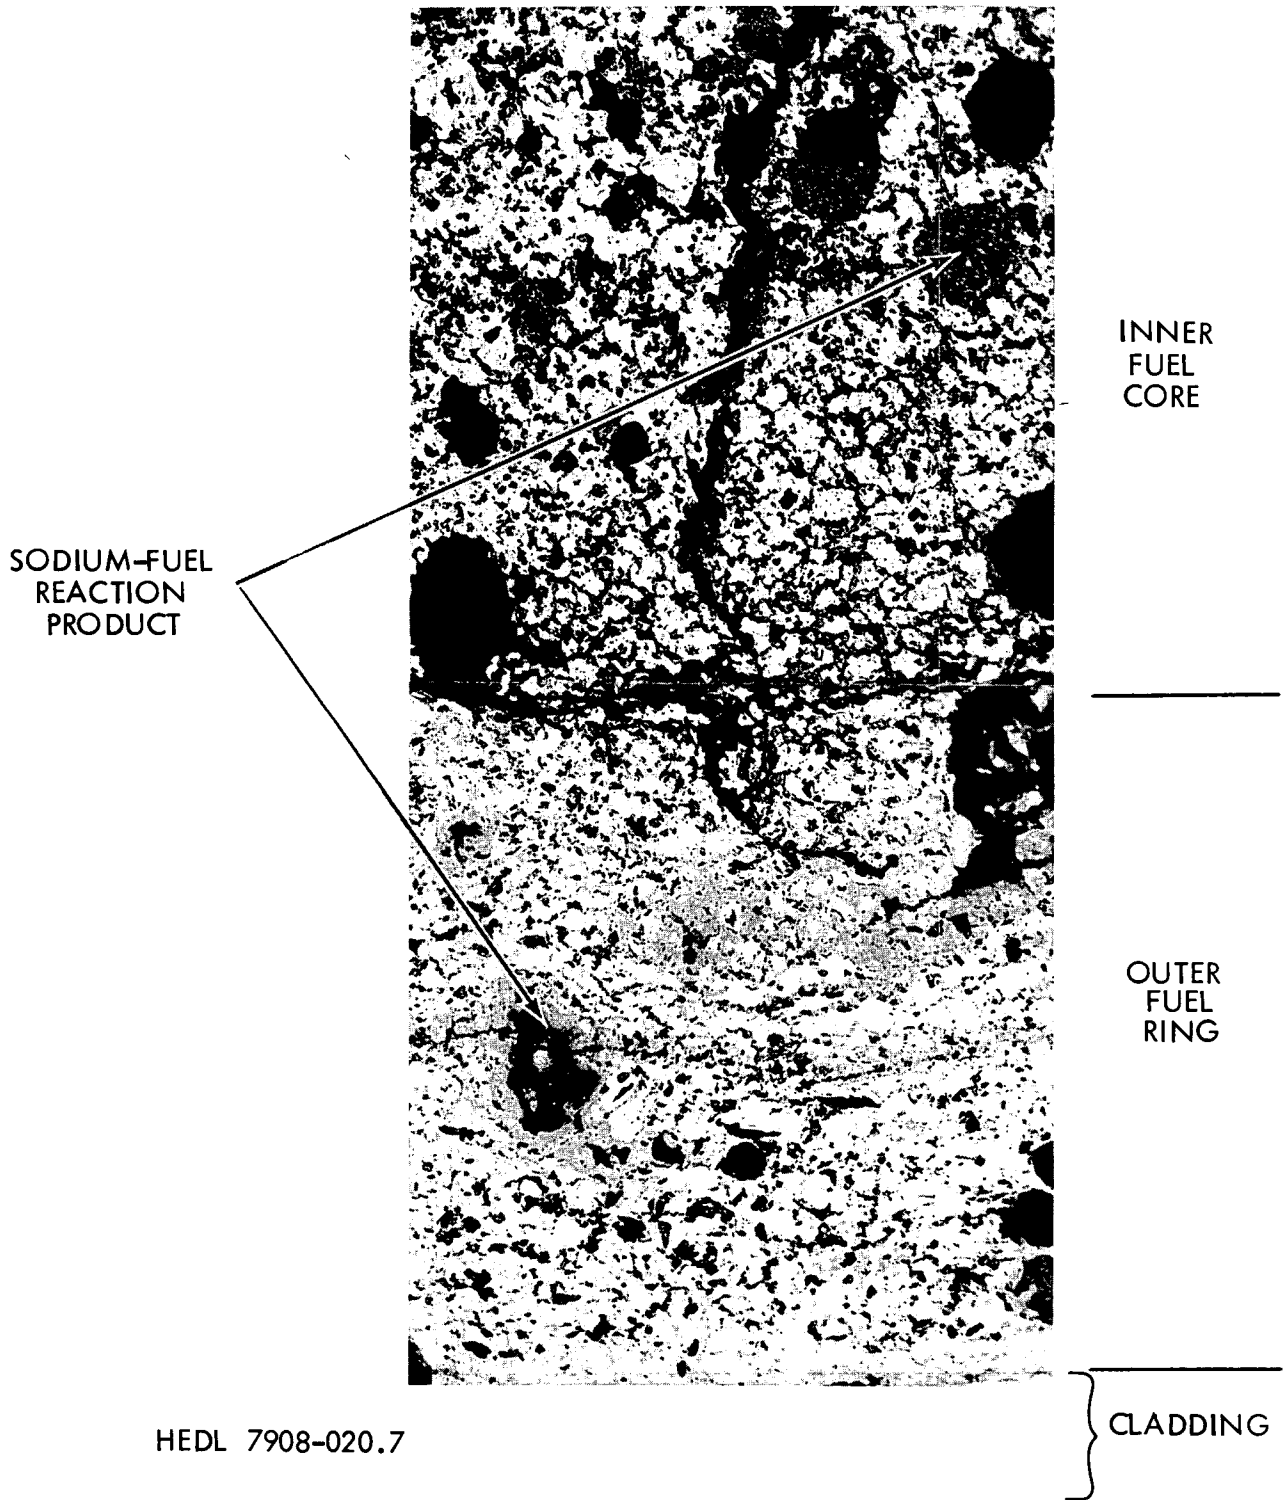
HEDL 7908-020.7

FIGURE 30. Sodium-Fuel Reaction Product Morphology Around Pores in the Dense Outer Fuel Ring and Inner Fuel Core Areas of ZP-5-42 Sample H. Some intergranular reaction product is evident only in the outer fuel ring.
