RECENT HYDROFRACTURE OPERATIONS AT OAK RIDGE NATIONAL LABORATORY

H. O. Weeren, E. W. McDaniel, and L. C. Lasher

Waste Management '85 Meeting

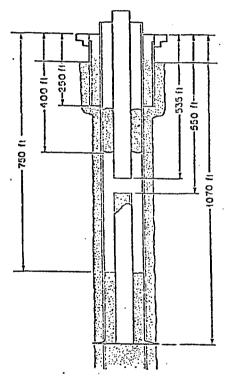
Fig. 6. Well Configuration After Failure.

The injection tubing had parted and fallen 6 m (20 ft). The upper part of the tubing string was cemented to the casing with radioactive grout and the bottom half of the tubing string was both plugged and comented to the casing by the grout plug that had been pumped down the well to seal the existing fracture. In addition, the upper part of the tubing string was found to be leaking at several points.

The immediate cause of the failure of the tubing string was leaks that had developed in the tubing joints at some time during the previous injections. During the injections, grout would have been pumped through these leaks and would have enlarged them by erosion until joint failure resulted. The cause of the leaks is loss clear. No such leaks had developed during 25 injections at the test facility and the occurrence at the new facility was entirely unanticipated. It was finally concluded that any or all of several factors may have contributed:

- 1) improper makeup of the tubing string,
- a lower quality joint design than was used in the test facility, or
- the considerable deviation of the injection well at the new facility.

Recovery of the injection well required several sequential steps:

- a wash-out operation to drill out the tubing string to the bottom of the well.
- a wash-over operation to drill the annulus between the tubing string and the well casing and to remove the free sections of tubing,
- 3) insertion of a new tubing string,
- cementing of the new tubing string in the injection well, and
- slotting the new tubing string at the selected depth.

All of these operations were made more difficult by the contamination and by the deviation of the injection well. The washover operation in particular required more time and was more difficult than initially anticipated. Recovery of the well was, however, completed in three months and the facility was returned to operations. (6)
