LA-10232-SR
Status Report

General-Purpose Heat Source Development: Safety Test Program

Postimpact Evaluation, Design Iteration Test 5

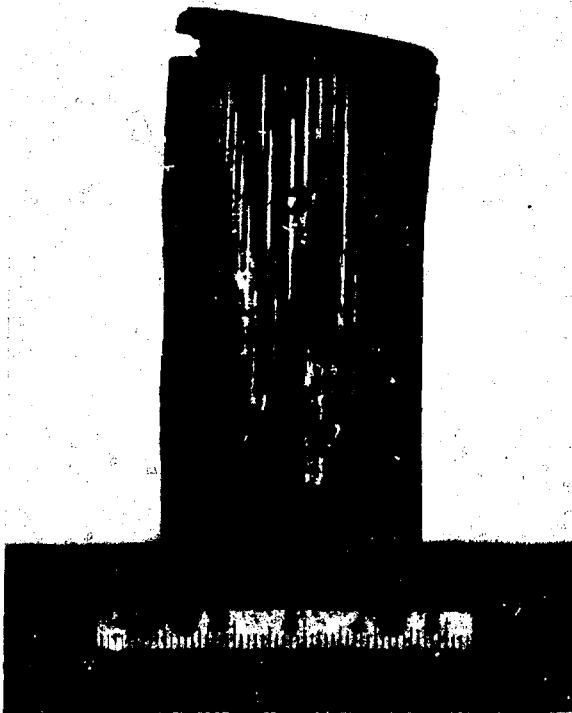
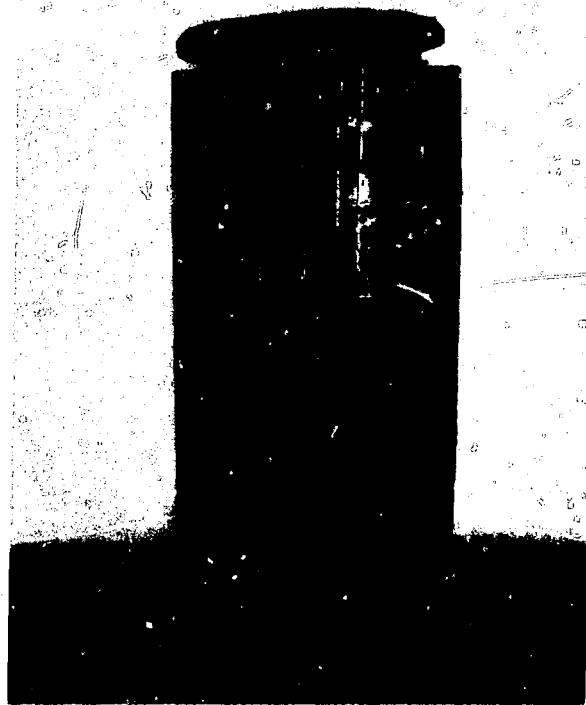
Aeroshell damage was moderate (Fig. 4). A corner of the aeroshell had broken off, and the aeroshell cap had been removed, but the GIS remained in place. The impact shell sustained significant damage (Fig. 5). The GIS cap was partially removed, and numerous longitudinal cracks extended the length of the impact face (Fig. 5a). The trailing face of the GIS contained several short longitudinal cracks and a long horizontal crack that appeared to follow the closure threads (Fig. 5c). The GIS exhibited the same bowed profile (Fig. 5b) observed in impact shells used in previous DIT tests.

Fig. 5. The DIT-5 impact shell sustained a significant amount of damage. (a) Impact face, (b) profile, and (c) trailing face. All at 1X.

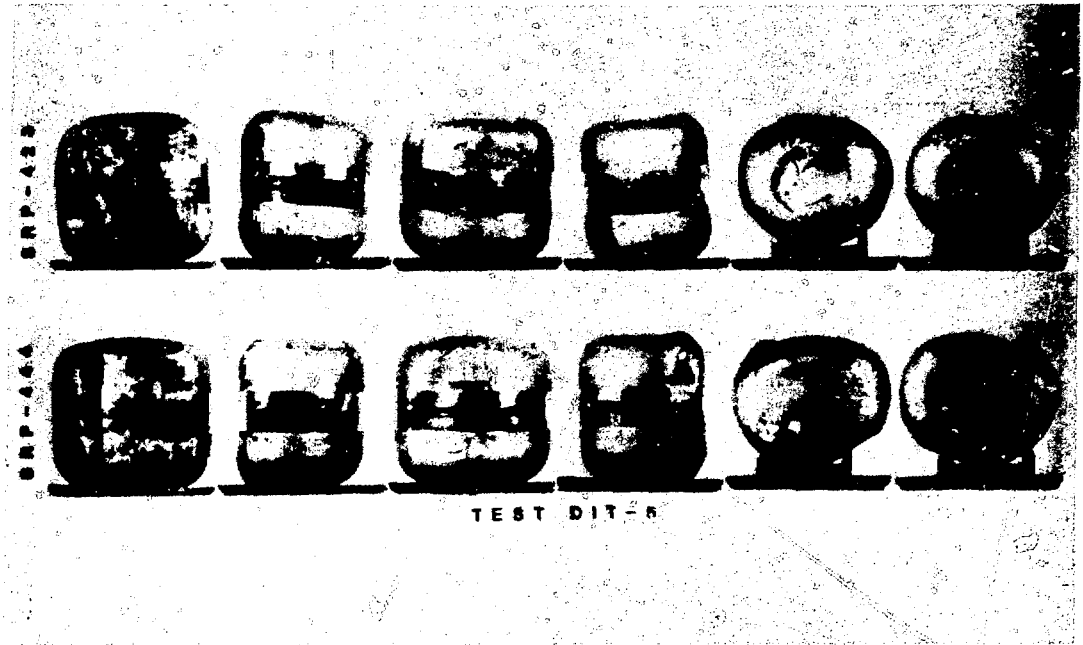
The fuel capsules were extracted from the remains of the impact shell, macroscopically examined, photographed, and measured. Side and end views of each capsule are shown in Fig. 6. Capsule SRP-423 was breached by a narrow crack (approximately 0.1×10.0 mm) on the impact face of the vent cup (Fig. 7). SRP-444 was severely cracked on the impact face: a wide longitudinal crack (~ 2.0 mm wide) extended the length of the capsule and into the cup radii (Fig. 8). A second crack (0.2×10.0 mm), parallel to the main fracture, was observed on the SRP-444 vent cup.

Fig. 6. The capsule deformations were consistent with the clad deformations observed in other flat-on impacts. 1X.

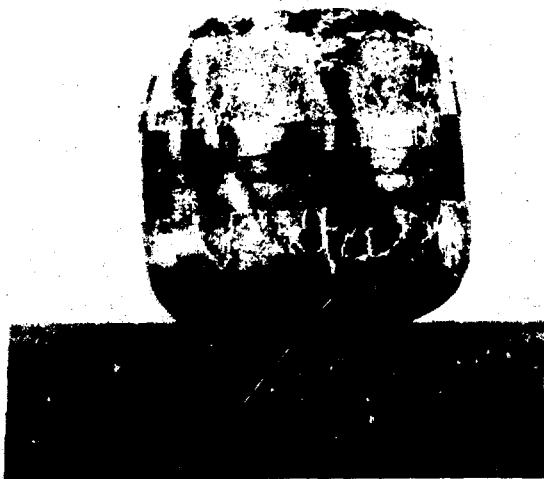
Fig. 7. Capsule SRP-423 was breached by a narrow crack on the impact face of the vent cup; the crack is at the left of the impact face. 1.5X.

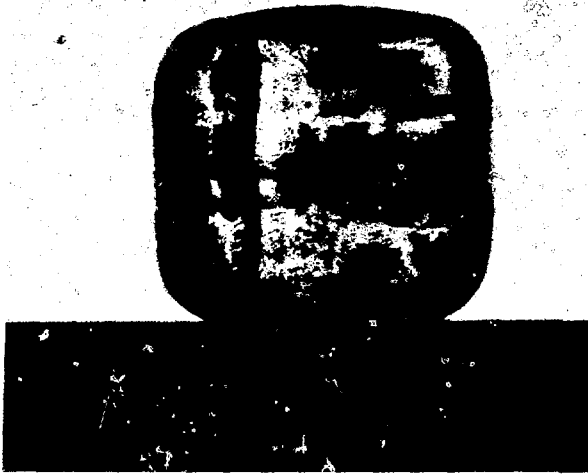
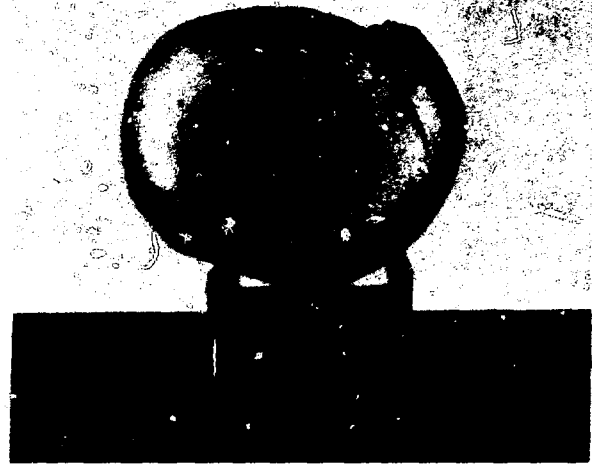
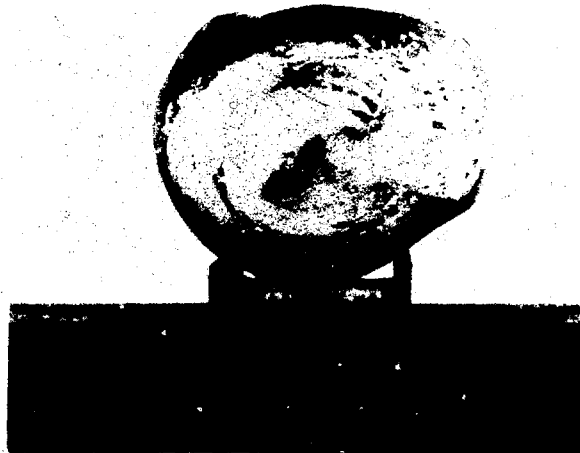
Both capsule failures apparently resulted from the differential displacement of large fuel fragments. The SRP-444 fuel pellet fractured along an axial plane (Fig. 41) and pushed through the clad in a line running the length of the impact face (Fig. 8). Because the SRP-423 pellet fractured in a more random manner (Fig. 40), the clad damage was less extensive (Fig. 7). Clad failure apparently becomes probable whenever the fuel breakup and external capsule support permit large fuel fragments to move across one another. The iridium is in effect only a membrane and cannot prevent the displacement of large fuel fragments or follow the resulting contours. Capsule survivability appears to improve

Fig. 8. The impact face of capsule SRP-444 was divided by a wide crack that extended into the vent cup radii. (a) Impact face, (b) vent end, and (c) blind end. All at 1.5X.

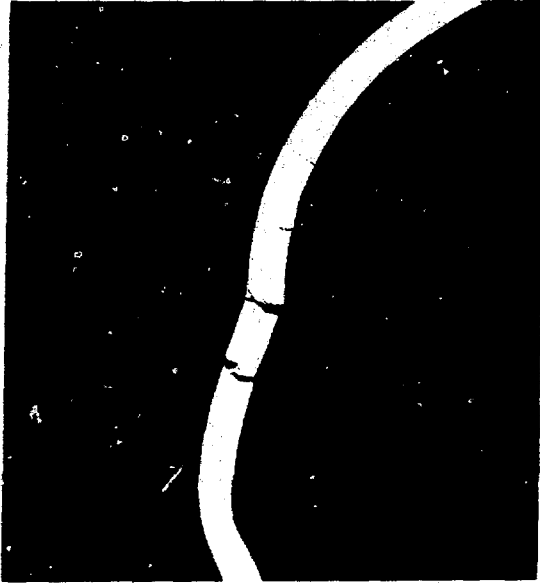
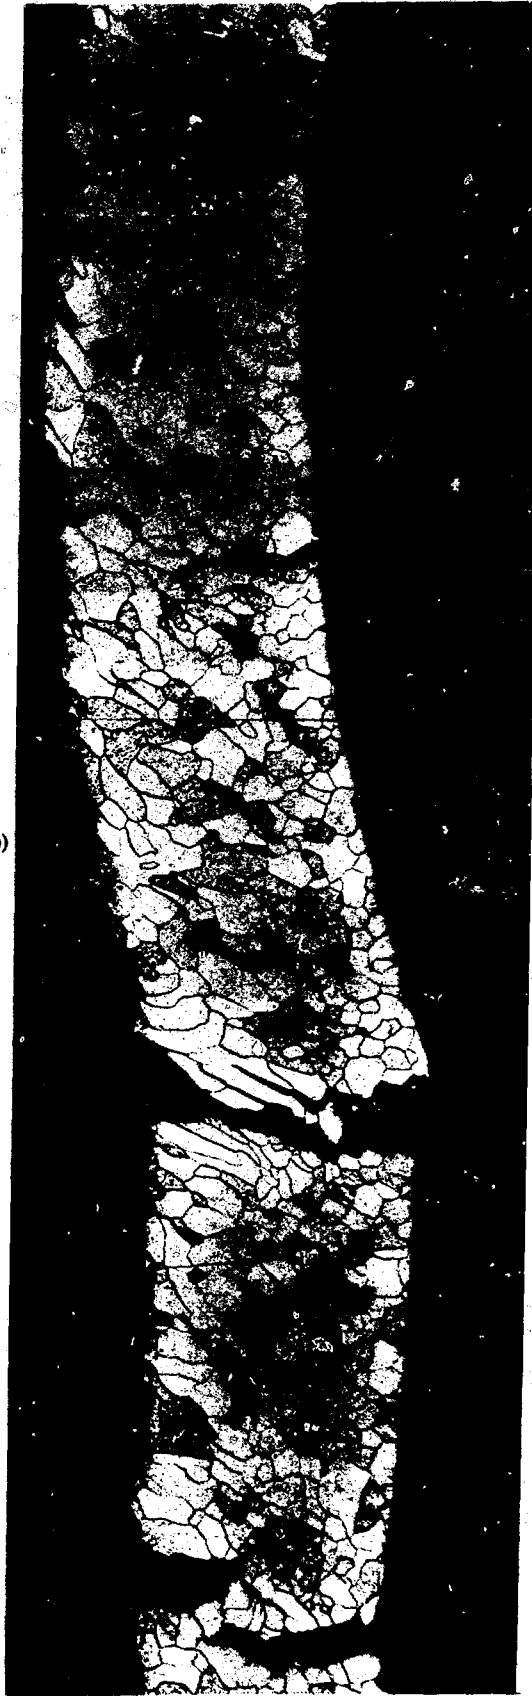
1. SRP-423 (two-pole arc oscillator). The internal surface of the overlap weld is shown in Fig. 9; two small cracks are visible just beyond the weld submergence. Deep weld cracks were observed in a reverse bend on the impact face (Fig. 10). Although the large crack was recognized as a portion of the breach, metallographic examination revealed that one of the other cracks also penetrated the capsule wall (Fig. 11). The single-pass weld specimen (Fig. 12) did not contain any cracks and

Fig. 11. Two cracks in the SRP-423 closure weld penetrated the capsule wall. (a) As polished, 7X, and (b) as etched, 50X.

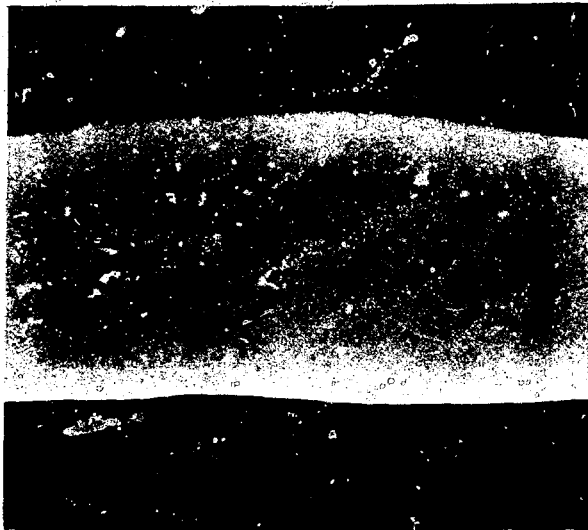
Fig. 12. The SRP-423 single-pass weld was free of defects. (a) As polished and (b) as etched. Both at 50X.

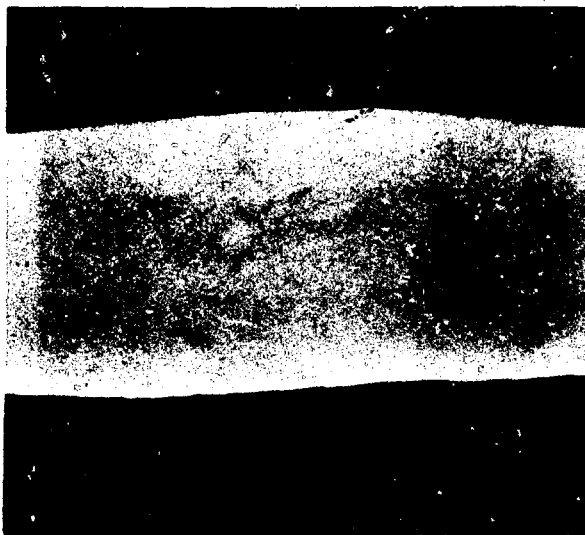
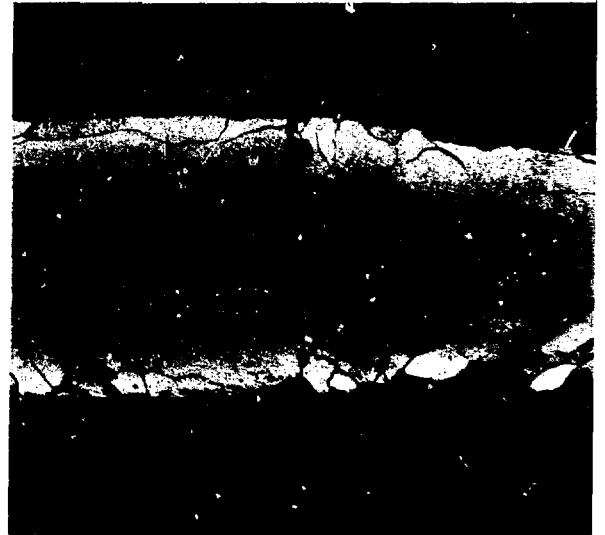
was essentially free of porosity. The overlap specimen, however, contained a significant amount of porosity and had a somewhat coarse microstructure (Fig. 13). The face-on weld specimen was typical (Fig. 14).

Examination of the DIT-5 closure welds revealed that the SRP-444 (four-pole) weld had a somewhat more refined microstructure than the SRP-423 (two-pole) weld had. Sections of both welds contained significant porosity (Figs. 13 and 18). Although the SRP-444 closure weld contained a segment of incomplete weld penetration (Fig. 20), there was no indication that this defect had affected the capsule response. Numerous small cracks were observed on the interior surfaces of both closure welds (Figs. 10 and 15). All of the cracks were intergranular (Figs. 11 and 16) and apparently resulted from the severe capsule deformations. Two small cracks observed near the SRP-423 weld submergence (Fig. 9) were located in a section that experienced little deformation; the cracks probably predated the impact.

Fig. 13. The SRP-423 overlap specimen contained a significant amount of porosity and had a coarse microstructure. (a) As polished and (b) as etched. Both at 50X.

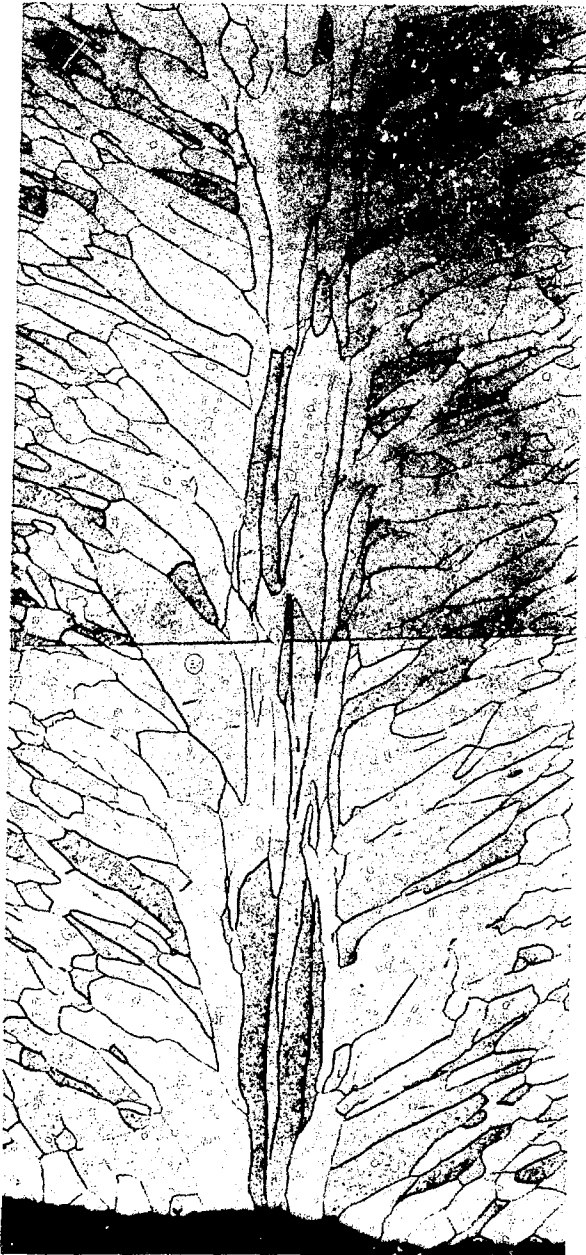
Fig. 14. The SRP-423 face-on weld microstructure was typical. 50X.

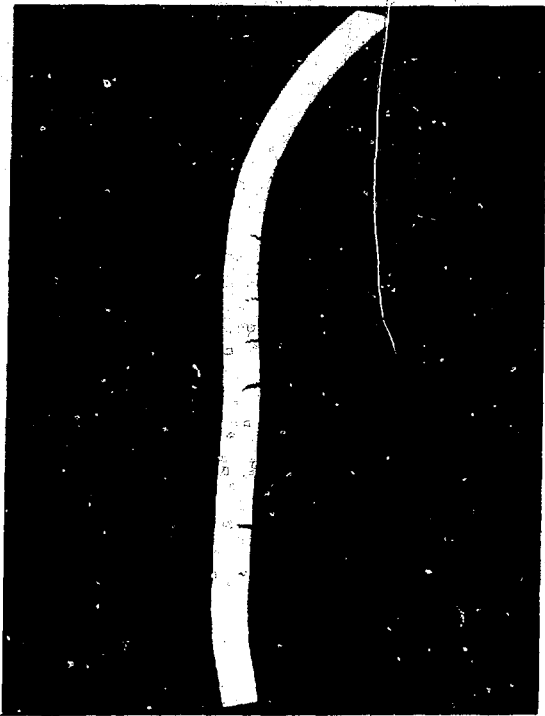
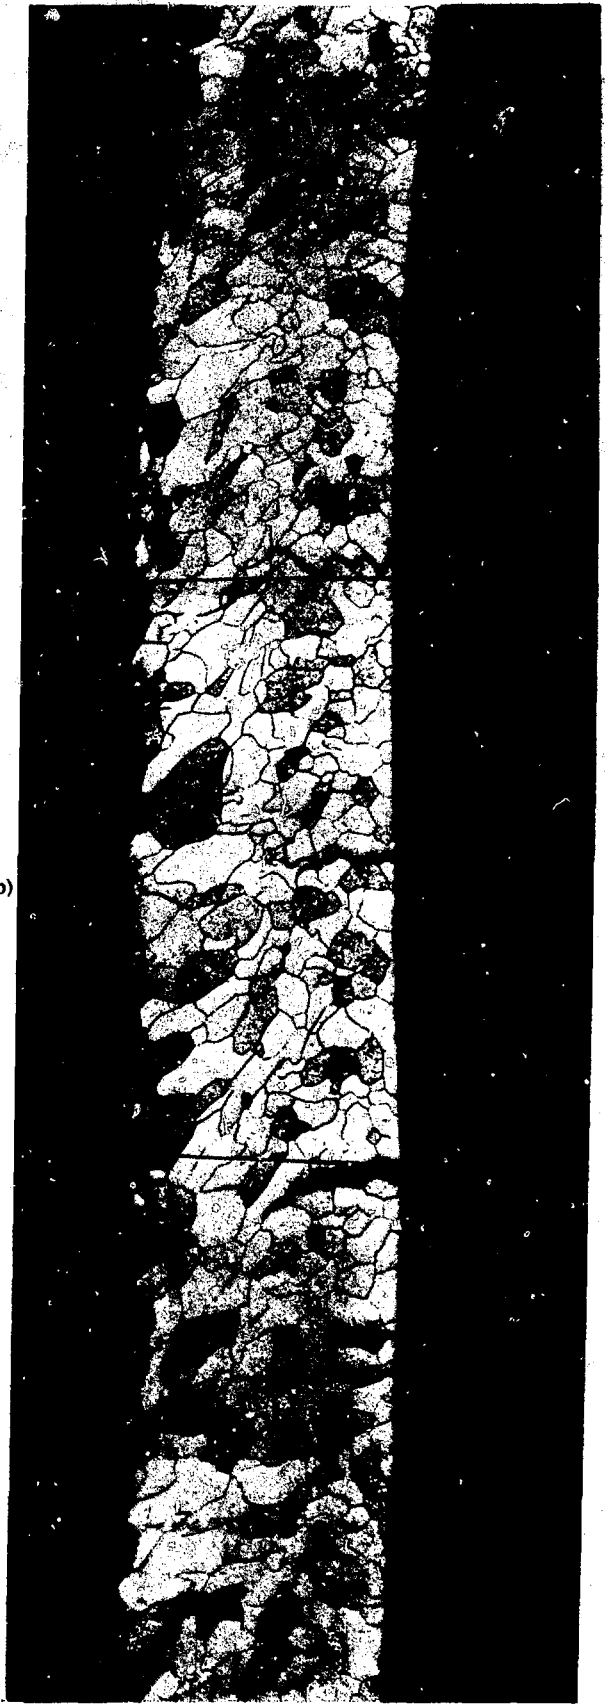
2. SRP-444 (four-pole arc oscillator). Examination of the clad interior revealed a long section of incomplete weld penetration; the cup edges were clearly visible over a 120° arc of closure weld. In addition, numerous transverse weld cracks were observed in a reverse bend on the impact face (Fig. 15). All of the cracks were intergranular (Fig. 16), and the deepest crack penetrated more than 50% of the capsule wall. The section of closure weld containing the point of weld submergence was free of defects (Fig. 17). Microscopic examination of the overlap weld revealed an unusual amount of porosity (Fig. 18a) and an otherwise typical microstructure (Fig. 18b). Examination of single-pass weld specimens from regions of complete (Fig. 19) and incomplete (Fig. 20) weld penetration revealed only slight microstructural differences. The microstructure of the face-on weld specimen (Fig. 21) was acceptable.

Fig. 16. Weld cracks on the SRP-444 impact face penetrated more than 50% of the wall thickness. (a) As polished, 7X, and (b) as etched, 50X.

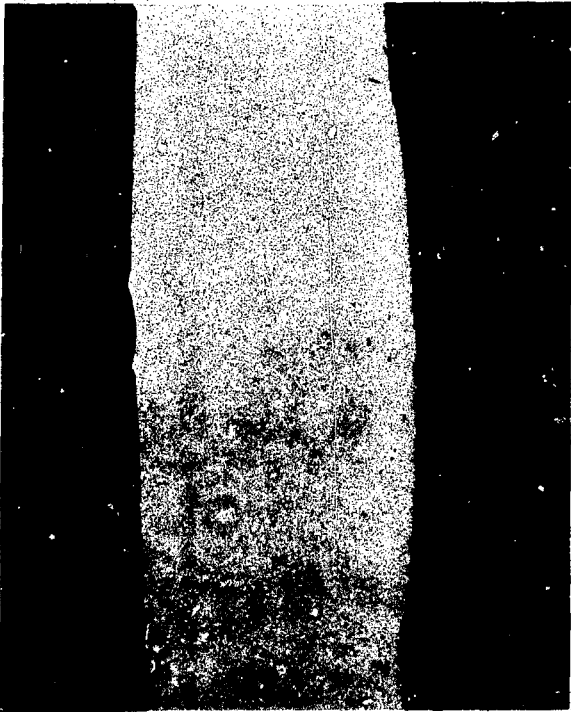
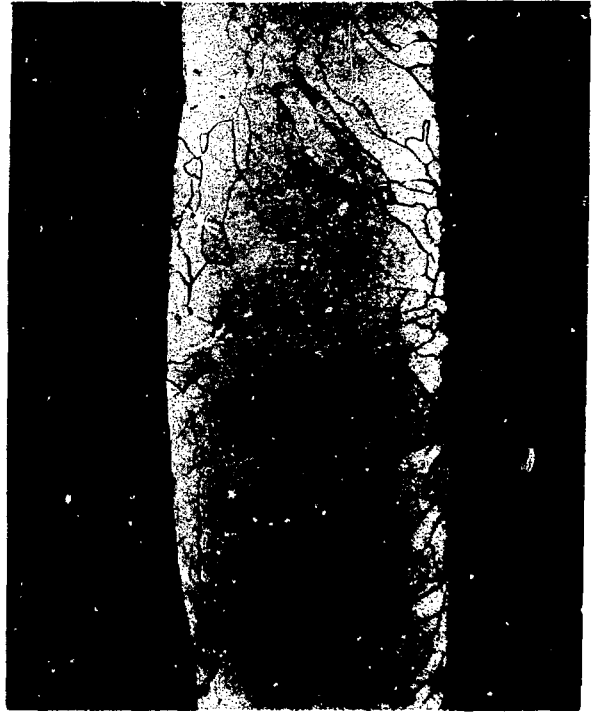
Fig. 18. The overlap region of the SRP-444 weld contained an unusual amount of porosity. (a) As polished and (b) as etched. Both at 50X.

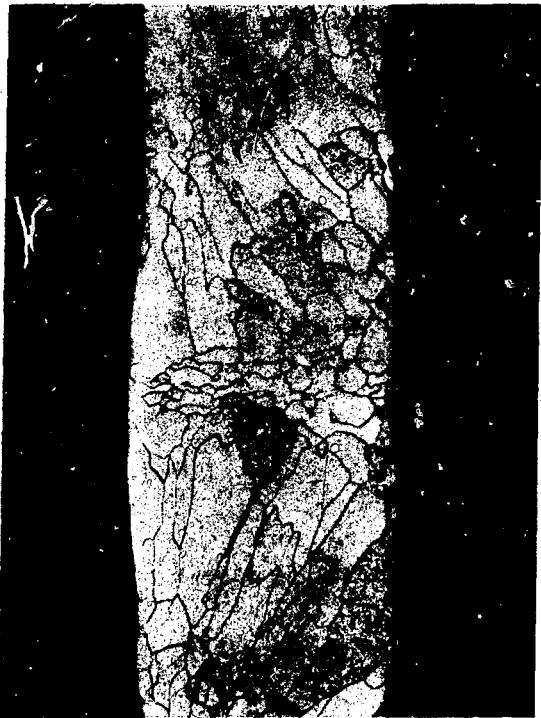
Fig. 19. In sections of complete penetration, the SRP-444 closure weld had a typical single-pass microstructure. Etched, 50X.

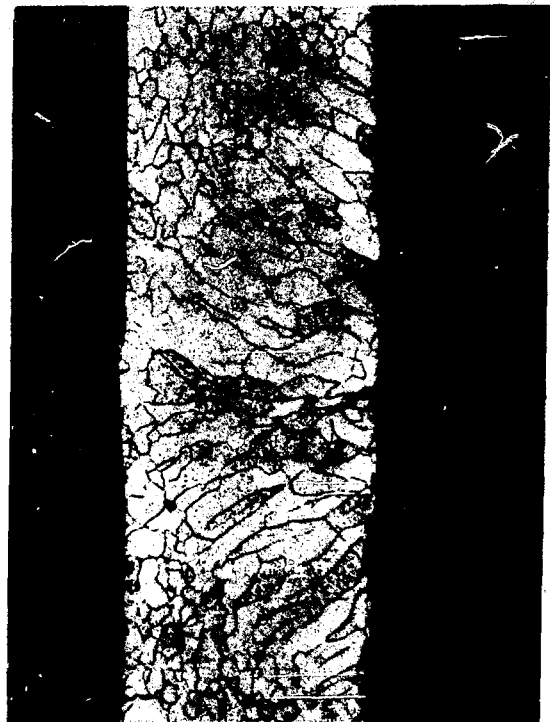
Fig. 20. The SRP-444 single-pass microstructure was only slightly abnormal in the sections of incomplete weld penetration. Etched, 50X.

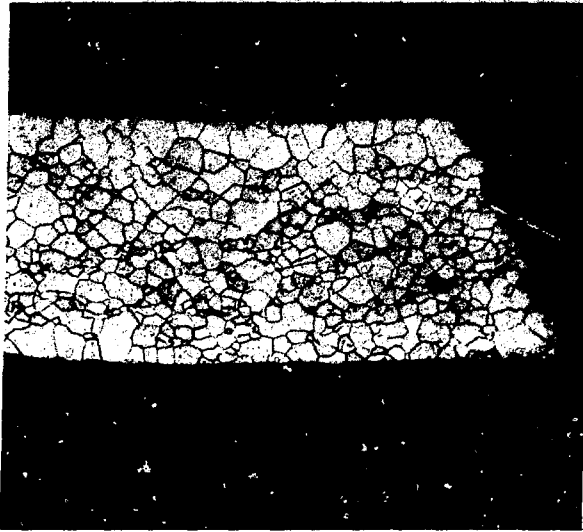
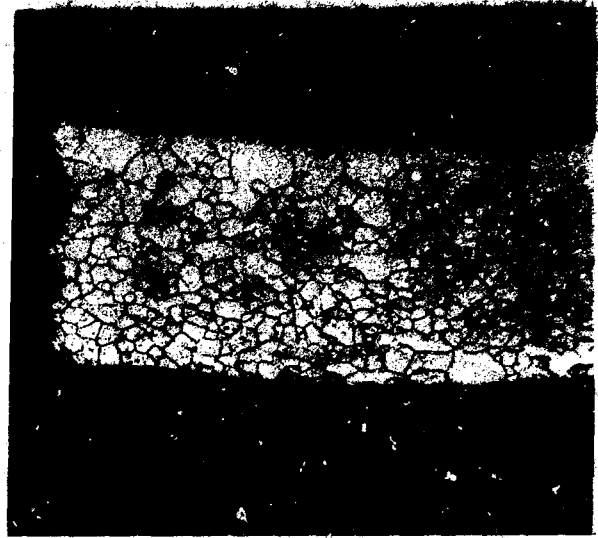
1. **SRP-423 (two-pole arc oscillator).** Examination of a vent cup section containing the breaching crack (Fig. 22) revealed the same intergranular crack morphology observed in previous clad failures. Although wall material adjacent to the breach was relatively fine grained (~16 grains/0.635-mm wall thickness), there was little evidence of plastic deformation. Interestingly, vent cup sections removed from reverse bends near the breaching crack demonstrated a surprising amount of ductility (Figs. 23 and 24). The wall material in a sharp bend only 4 mm from the breach (Fig. 23) was particularly ductile, displaying a significant amount of grain elongation.

Metallographic examination of the clad failures did not reveal any unexpected features. All of the breaching cracks had a brittle, intergranular appearance (Figs. 22, 29, and 30). Although the breach in capsule SRP-444 intersected the weld, there was no evidence of direct weld involvement. The ductility of wall material in a reverse bend only 4 mm from the SRP-423 breach (Fig. 23) illustrates the importance of strain state in determining the failure of DOP-26 iridium.

Fig. 22. The breach in capsule SRP-423 displayed the same intergranular morphology observed in previous clad failures. (a) Left side of impact face and (b) right side. Both at 50X.

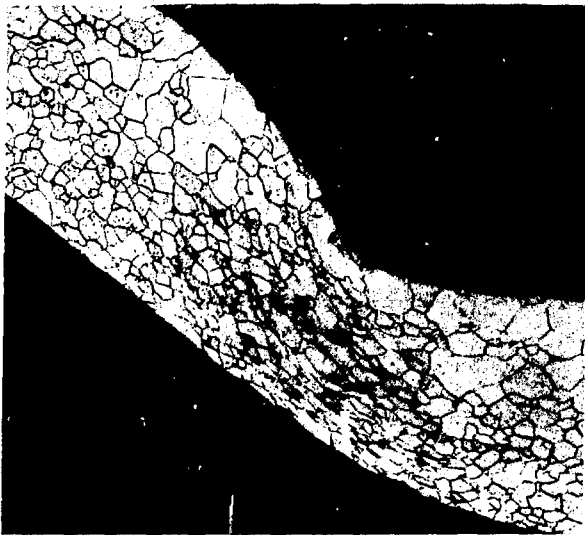
Fig. 23. A significant amount of grain elongation was observed in a reverse bend on the SRP-423 impact face. 50X.

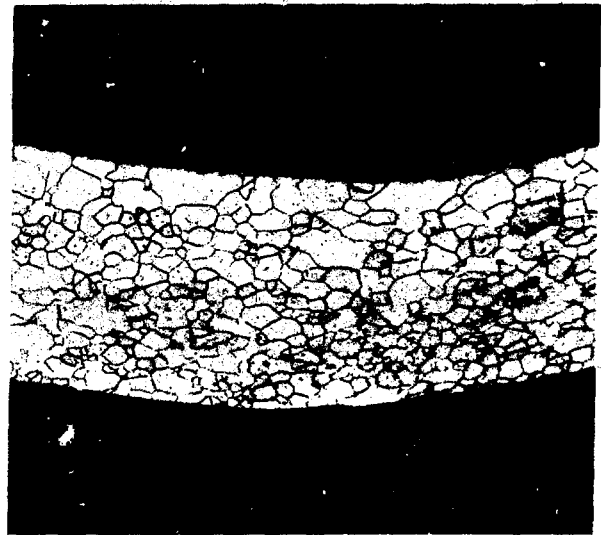
Fig. 24. There was no evidence of cracking in a sharp bend on the SRP-423 impact face. 50X.

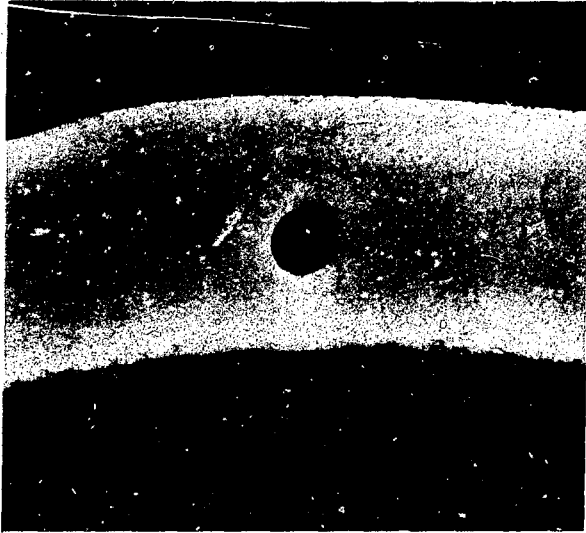
Examination of a transverse section removed from the SRP-423 vent cup revealed a large pore (Fig. 25) with an apparent diameter equivalent to 25% of the total wall thickness. The pore was located nearly 3 mm from the weld centerline and would not be expected to have been within the fusion or heat-affected zones.

The void observed in a transverse section of the SRP-423 vent cup (Fig. 25) is interesting because of its size and location. The void was nearly 3 mm above the weld centerline and had a diameter equivalent to 25% of the total wall thickness. Although a similar defect was observed in a DIT-4 capsule weld,⁴ the SRP-423 void was outside the fusion zone and probably near the border of the heat-affected zone.

Fig. 25. A large void was observed in a transverse section removed from the SRP-423 impact face. 50X.

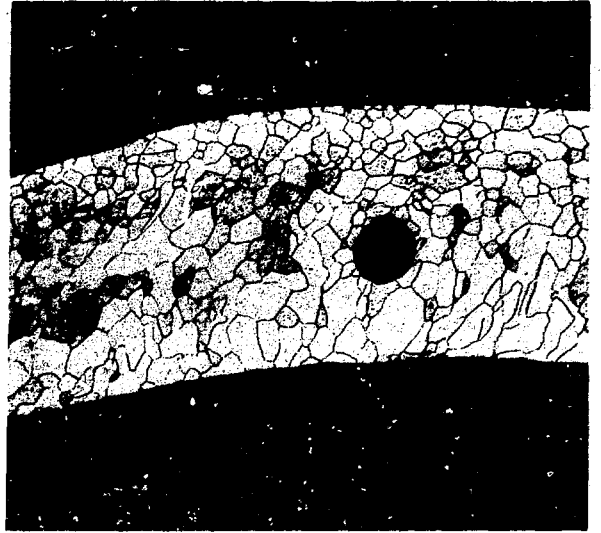
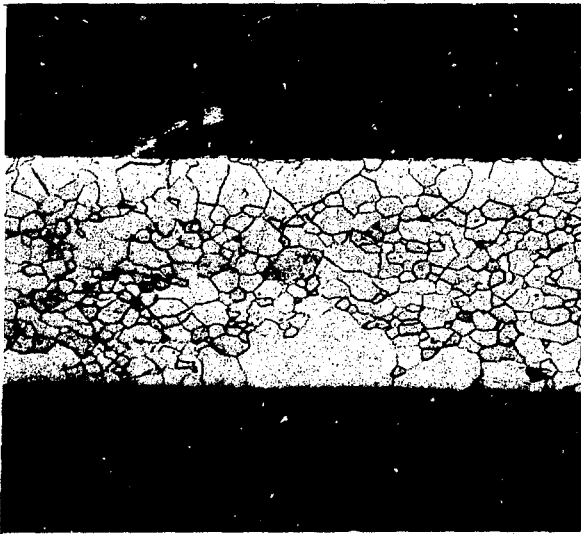
The iridium grain size in the SRP-423 cups ranged from 15 to 22 grains/0.635-mm nominal wall thickness. Although isolated areas of grain growth were observed in the vent cup (Fig. 26), the microstructure was generally fine grained (Fig. 27). The shield cup also had a fine-grained microstructure (Fig. 28).

Fig. 26. Isolated areas of slight grain growth were observed in the SRP-423 vent cup. 50X.

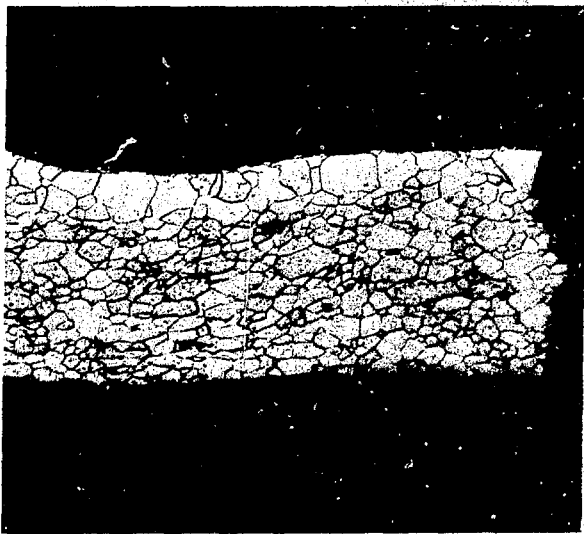
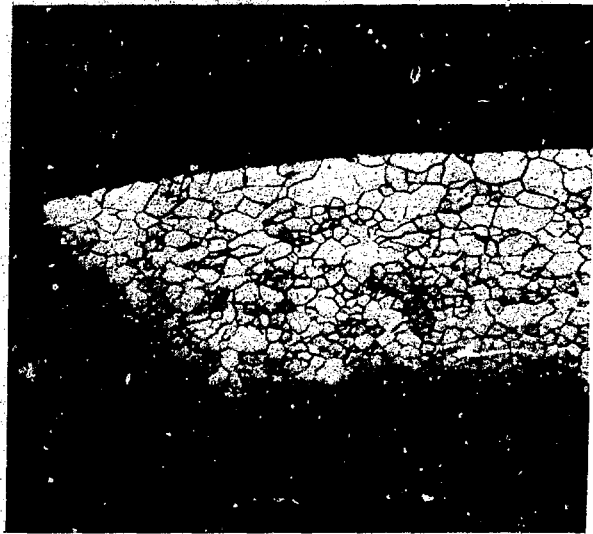
2. **SRP-444 (four-pole arc oscillator).** Examination of a shield cup section containing the main breach (Fig. 29) revealed an intergranular fracture with no evidence of plastic deformation. The secondary breach (Fig. 30) had a similar crack morphology. The wall material adjacent to both breaching cracks was relatively fine grained. Wall sections on both sides of the main breach had an average of 17 grains/thickness, and sections adjacent to the secondary breach averaged 18 grains/thickness. Because capsule SRP-444 breached extensively, no sharp bends were visible on the transverse cross sections.

Fig. 29. The main breach in capsule SRP-444 was intergranular. (a) Left side of impact face and (b) right side. Both at 50X, etched, 50X.

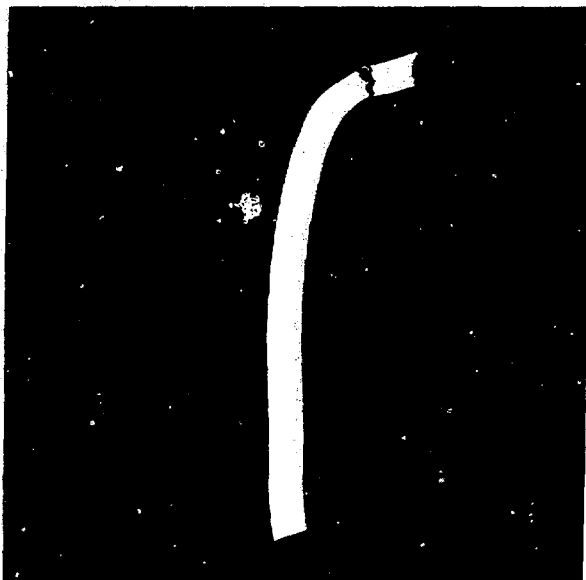
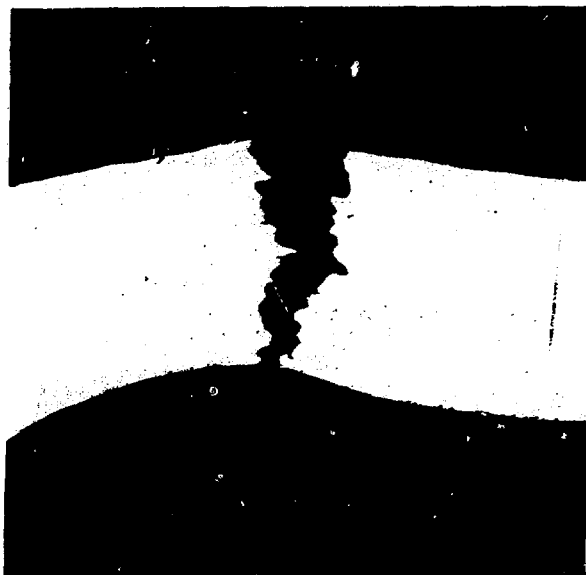
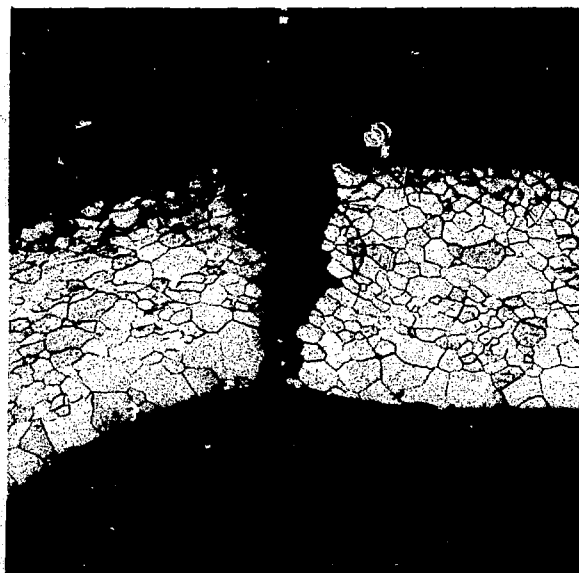
Fig. 30. The secondary breach in SRP-444 also had a brittle, intergranular appearance. (a) As polished, 7X; (b) as polished, 50X; and (c) as etched, 50X.

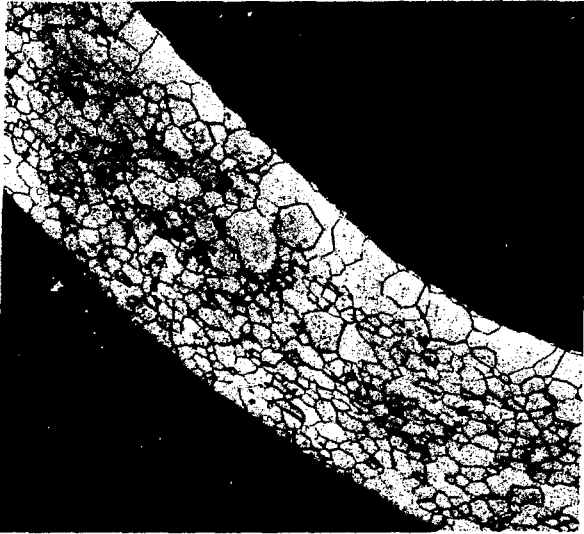
Although a minor amount of grain coarsening was observed on the interior of the shield cup (Fig. 31), the

Fig. 31. A minor amount of grain coarsening was observed on the interior of the SRP-444 weld-shield cup. 50X.

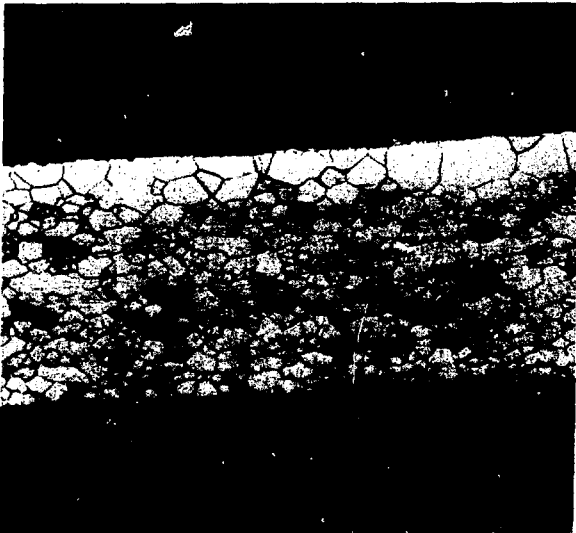
cup microstructure was generally fine grained (Fig. 32). Slight grain coarsening was also observed on the vent cup interior (Fig. 33).

Fig. 33. Slight grain coarsening was also observed on the interior of the SRP-423 vent cup. 50X.

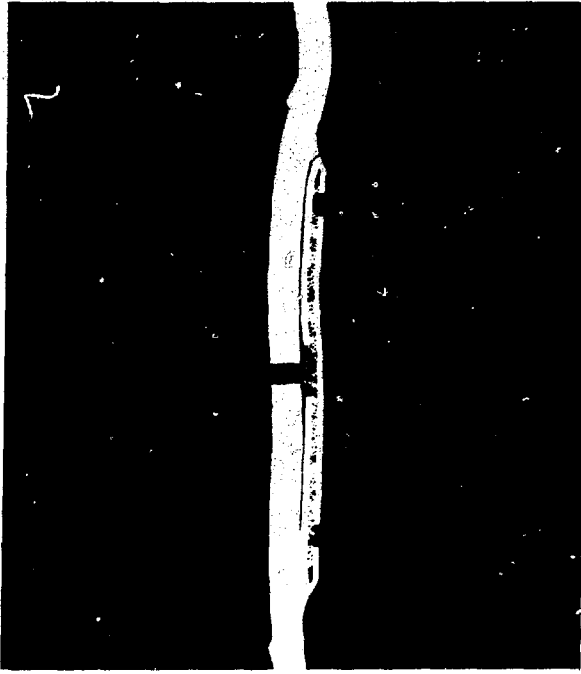
Fig. 34. The vent on capsule SRP-423 survived impact with only minor deformation. 7X.

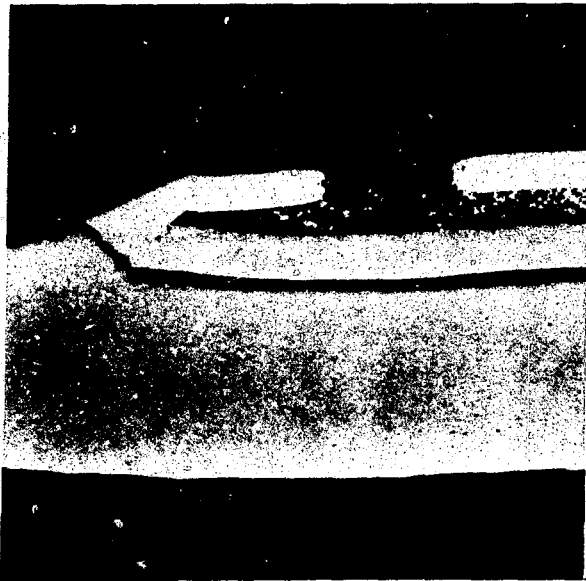
Fig. 36. A small crack was observed in the SRP-423 vent assembly weld. As polished, 40X.

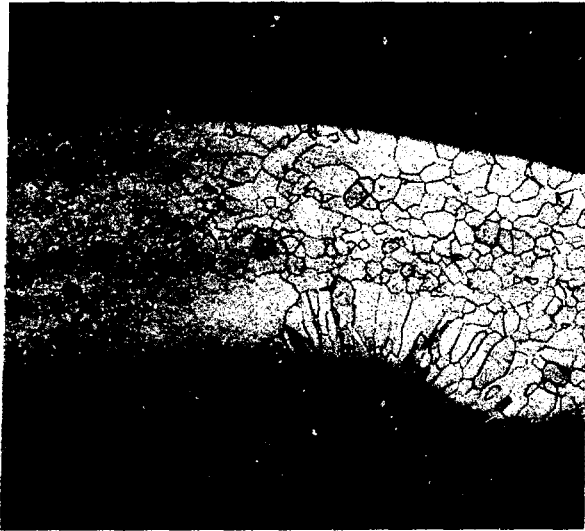
The capsule vents were carefully examined to determine the effects of the preimpact heat treatment (30 days at 1310°C) and to further define the impact response of the vent structure. Macroscopic examination revealed that both vents survived impact with only minor deformation (Figs. 34 and 35). No mechanical defects were observed in either vent, and both vent frits were uniform and properly aligned. A small crack was, however, observed in the SRP-423 vent assembly weld (Fig. 36). The crack was generally intergranular (Fig. 37) but did split a small grain near the inner surface. In addition, unusual amounts of grain growth were observed in wall sections adjacent to the vent cover welds in both capsules (Figs. 38 and 39).

Fig. 38. Wall sections adjacent to the SRP-423 vent cover weld were unusually coarse grained. (a) Impact face side, and (b) opposite face. Both at 50X.

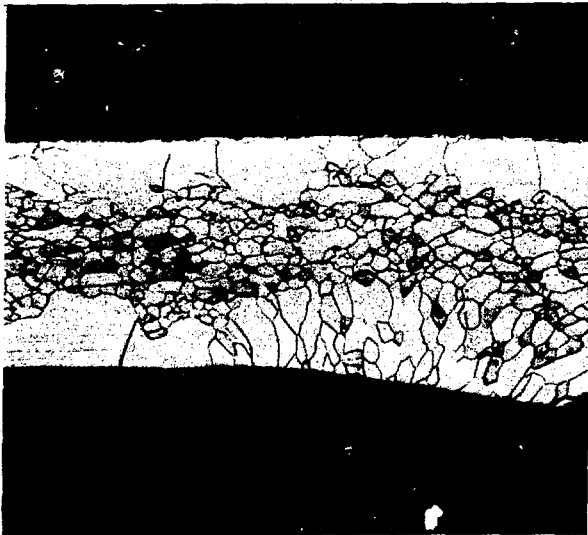
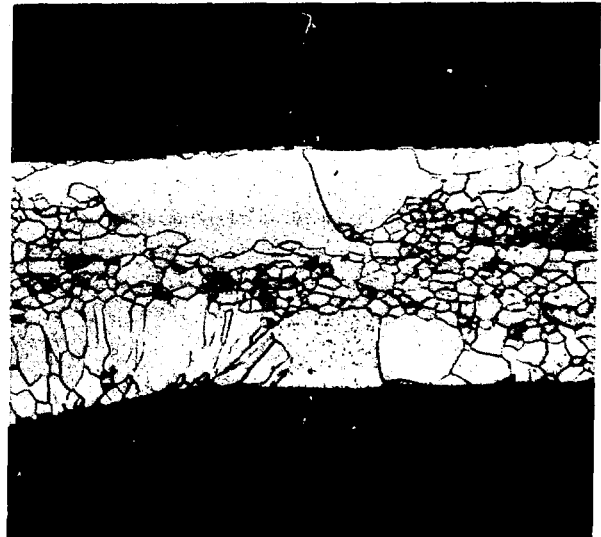
Fig. 39. Abnormal grain growth was also observed near the SRP-444 vent cover weld. (a) Impact face side and (b) opposite face. Both at 50X.

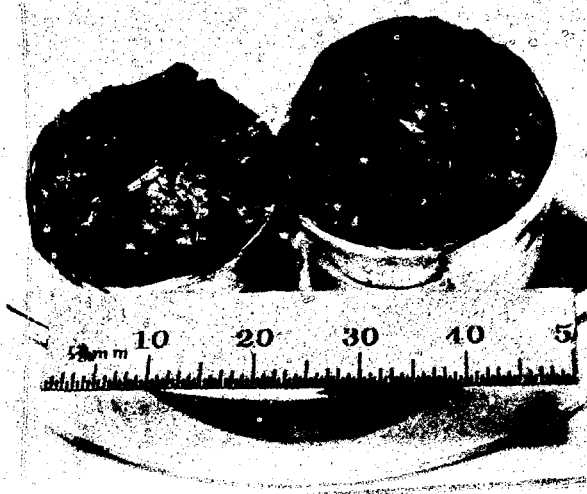
Radiographic examination indicated that both fuel pellets were severely cracked before testing (Figs. 1 and 2); although it is not apparent in the radiographs, pellet HF-444 was reported to be nonintegral at loading (two pieces). Postimpact examination of the as-opened fuel capsules (Figs. 40 and 41) revealed that both pellets were badly fragmented. The fuel in capsule SRP-444 fractured cleanly along an axial plane (Fig. 41) and pushed through the clad in a line running the length of the impact face (Fig. 8). Pellet HF-423 fractured in a more random manner (Fig. 40) and produced less clad damage.

Fig. 40. The fuel in capsule SRP-423 fractured in a brittle manner. 1.5X.
