**LA-10012-SR
Status Report**

General-Purpose Heat Source Development: Safety Test Program

Postimpact Evaluation, Design Iteration Test 2

F. W. Schonfeld
T. G. George

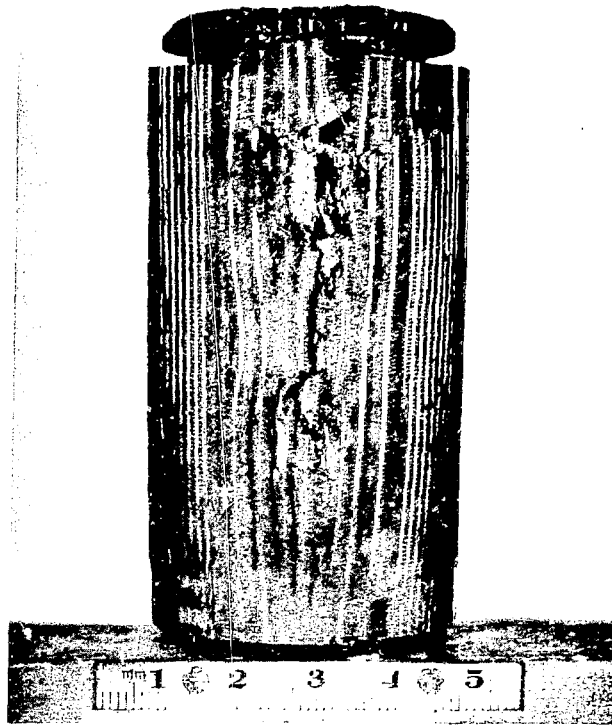
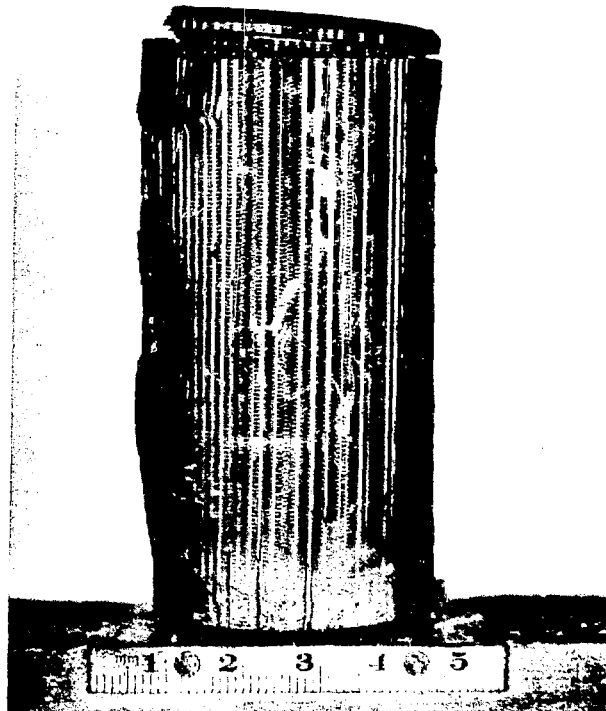
Experience with DIT-1 speeded postimpact disassembly. The catch tube was opened without difficulty; no contamination was found on the samples or lid. The inner nickel can (a radiation shield assembly) was extracted with tongs, and the can/aeroshell/heat source assembly was placed on a bed of solid CO₂. The CO₂ cooled the assembly rapidly, and in a few seconds the temperature had dropped far enough to eliminate the possibility of graphite combustion. The aeroshell was fractured but not as severely as the aeroshell used in DIT-1. Although the damaged aeroshell (Fig. 3) was deformed in a uniform manner, when the GISs were extracted, GIS-2 was noticeably more broken than was GIS-1. GIS-1 and GIS-2 are shown in Figs. 4 and 5.

Fig. 4. GIS-1, containing fueled clads SR-107 and SR-110. (a) Impact face and (b) side view with impact face to the left.

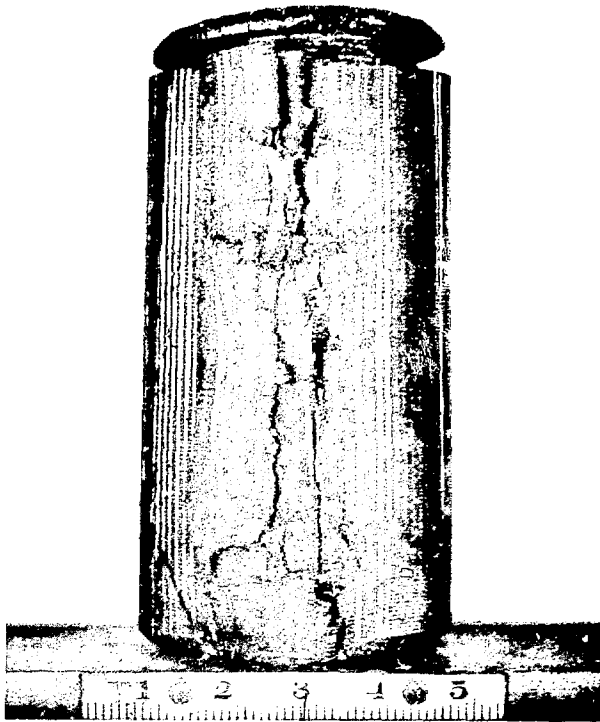
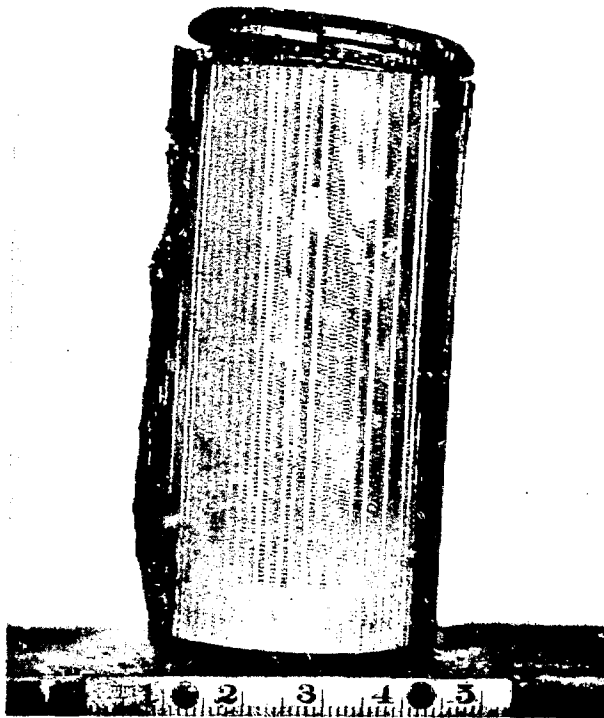
Fig. 5. GIS-2, containing fueled clads SR-105 and SR-106. (a) Impact face and (b) side view.

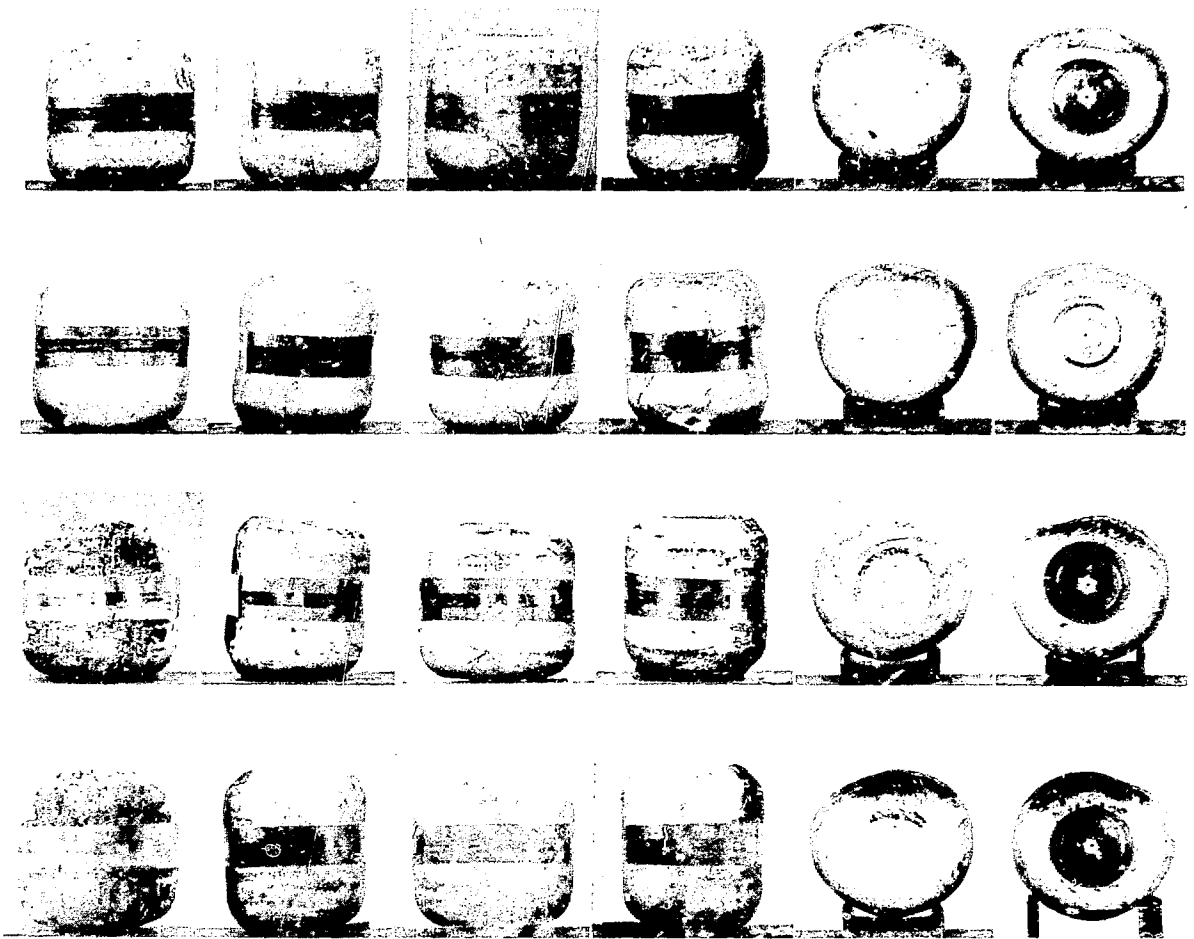
Capsules SR-107 and SR-110 exhibited the same deformation mode observed in the DIT-1 capsules: the capsules were flattened on the impact side and had protrusions at a position corresponding to the unsupported side of the GIS. The capsules removed from GIS-2 were more symmetrical. Side and end views of all four capsules may be seen in Fig. 6. Although the cracks are barely visible in Fig. 6, SR-107 and SR-110 were breached on the leading side of the radius on the vent ends.

Fig. 6. The DIT-2 fueled clads after impact at 58 m/s and 930°C. The impact face is at the left of each row, and the clad is rotated 90° in each succeeding view. The vented and blind ends complete the rows. All 0.7X.

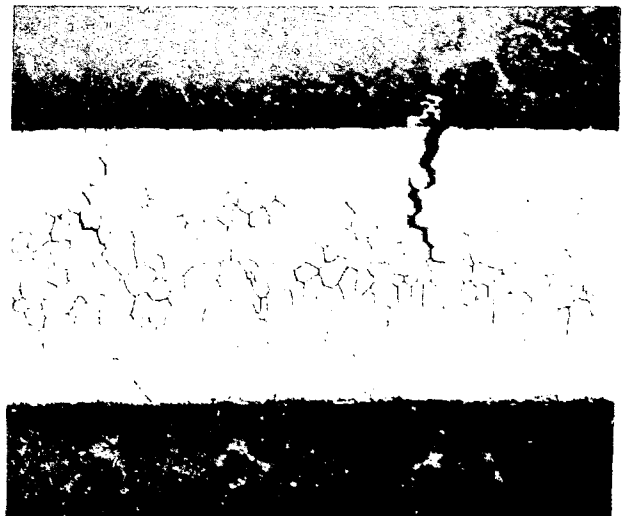
Fig. 8. Cracks in the wall of capsule SR-105 adjacent to the weld bead. 50 X.

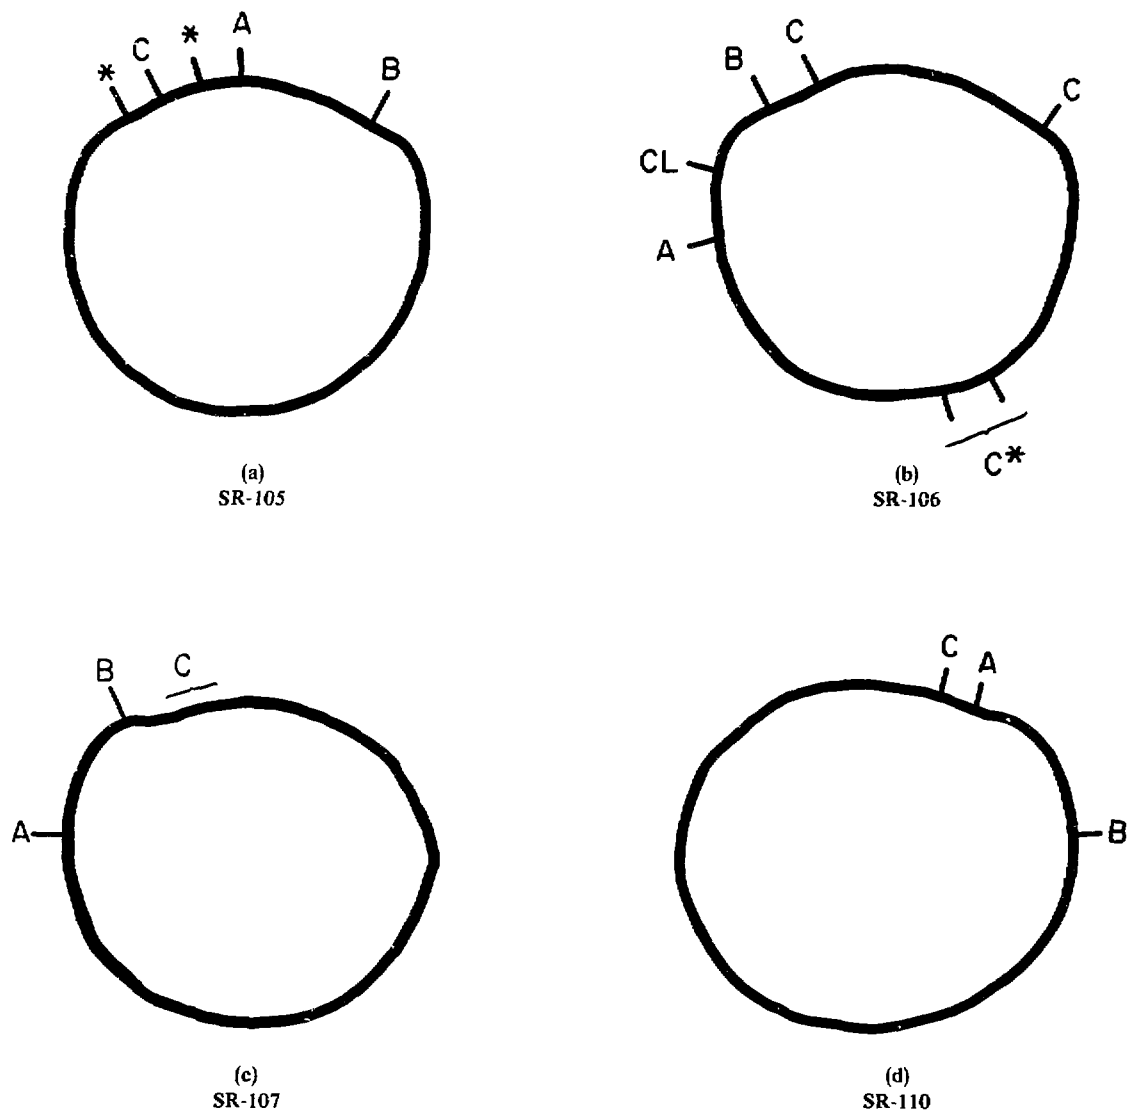
Fig. 9. Features of the impacted DIT-2 capsule welds. The locations of the weld submergence, terminus, and cracking were determined by macroscopic inspection; ultrasonic indication of defects was provided by the Savannah River Plant.

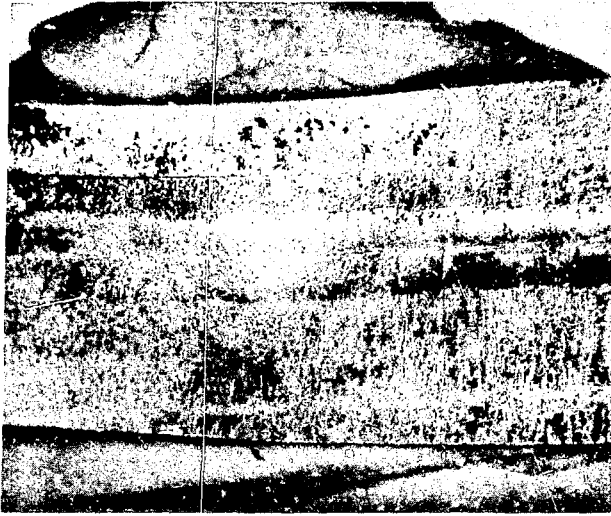
Capsule SR-106 contained more weld cracks than any other DIT-2 capsule. Inspection revealed three crack families (Fig. 10) that apparently were generated by bending. Figure 11 describes the microstructures of these cracks and the associated alloy; Fig. 9 shows the crack locations.

Fig. 10. Three crack families were observed on the interior of capsule SR-106. (a) In the reverse-bend region nearest the weld overlap; (b) on the second reverse bend; and (c) on the capsule back. All 6X.

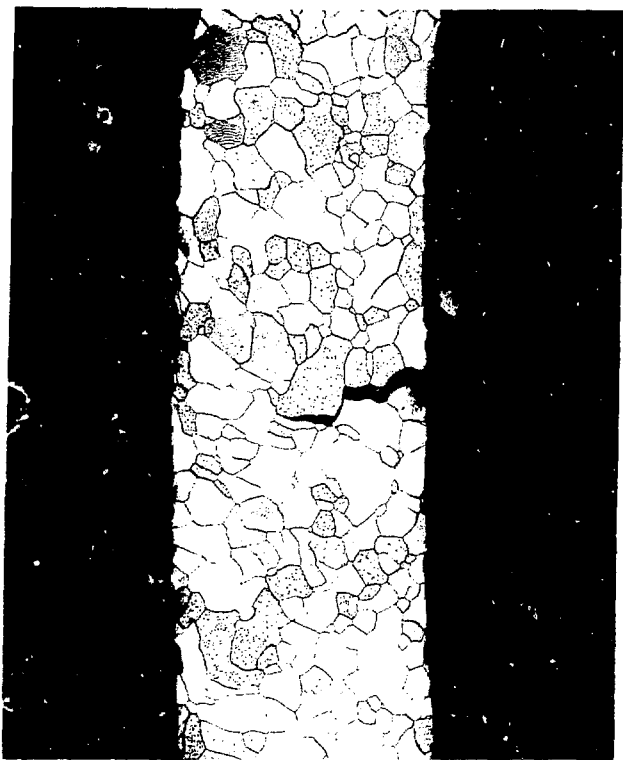
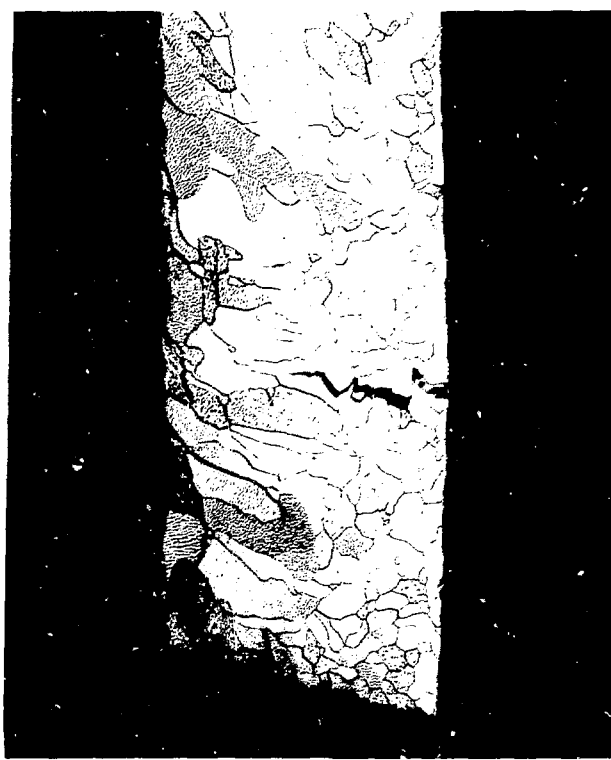
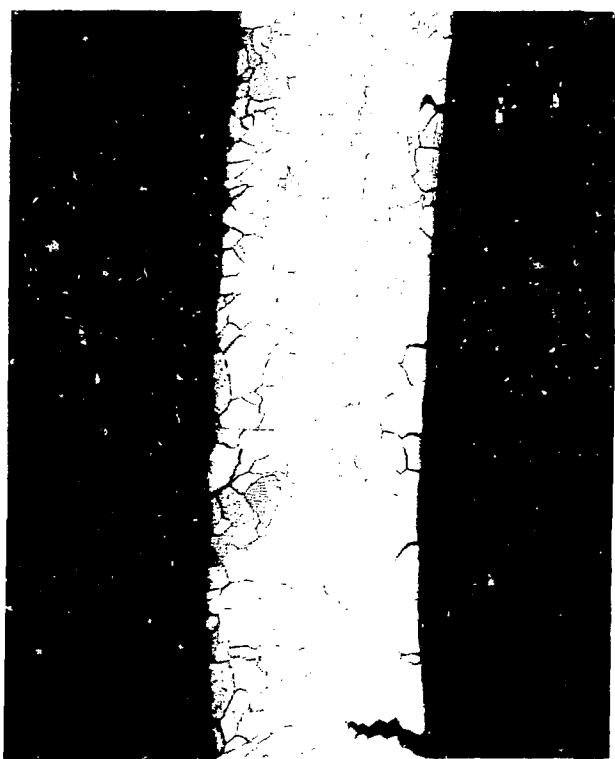
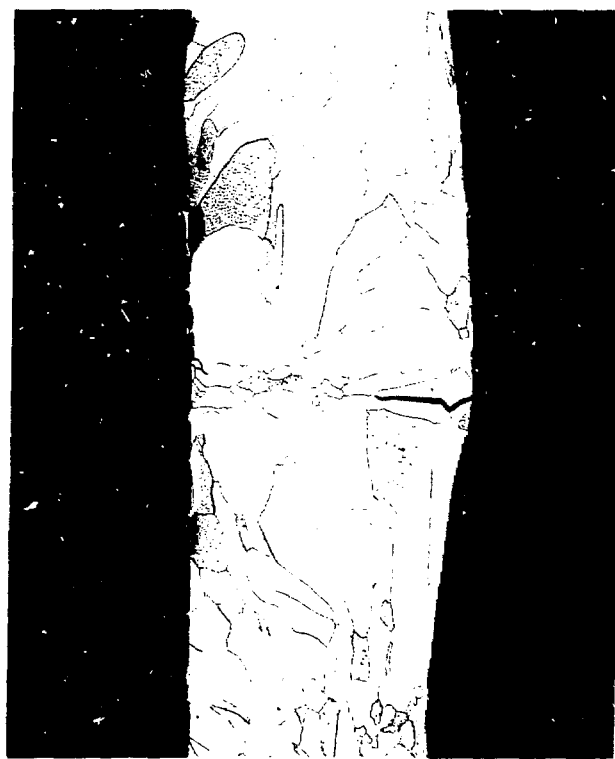
Fig. 11. Microstructural features of the cracks seen in Fig. 10. (a) Largest weld bead crack at the first reverse bend, (b) largest crack at the second reverse bend, (c) trailing face of the SR-106 capsule, and (d) centerline crack at the weld overlap. All 50X.

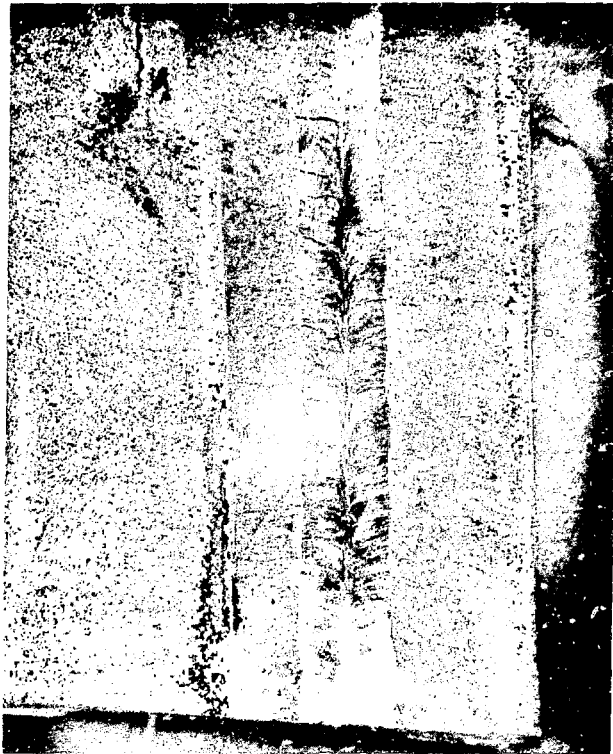
The interior surface of capsule SR-107 had numerous cracks where reverse bending occurred. This area contained at least 9 cracks in the weld bead and 12 cracks in the capsule wall (Figs. 12 and 13). The locations of these cracks are shown in Fig. 9. Some cracks were limited to the weld bead, whereas others were restricted to the base metal; several cracks traversed both the weld and capsule wall. The appearance of these cracks suggests that susceptibility to cracking during bending is slightly greater in the weld bead than in the unaltered wall. This relatively small difference would appear to reflect slight differences in grain morphology rather than a change in basic character.

Fig. 12. Severe internal cracking present at the reverse bend in capsule SR-107, 6X.

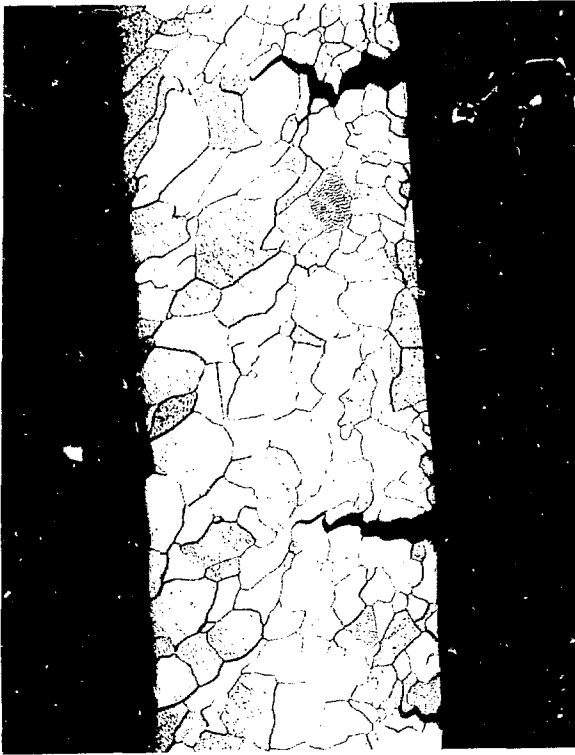
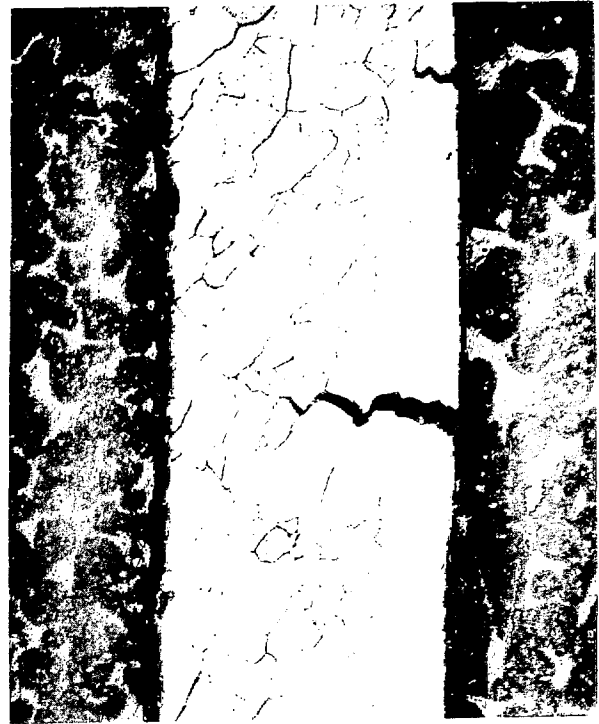
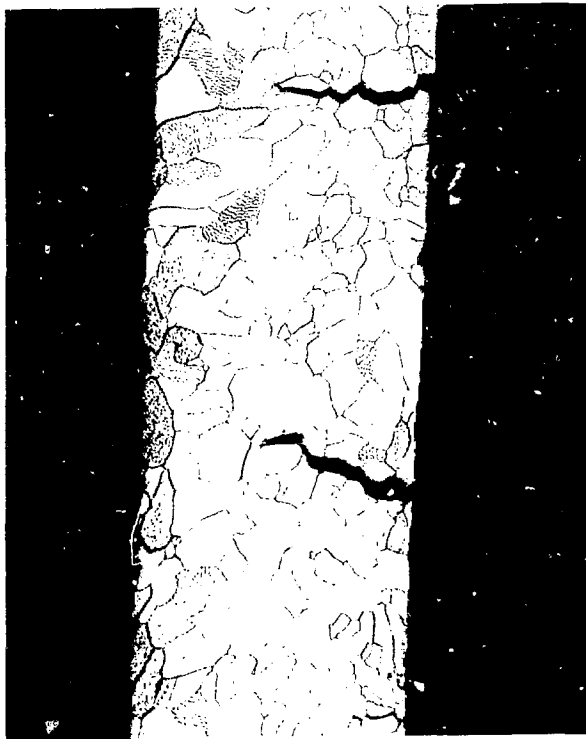
Fig. 13. Cross section containing the cracks seen in Fig. 12. 50X.

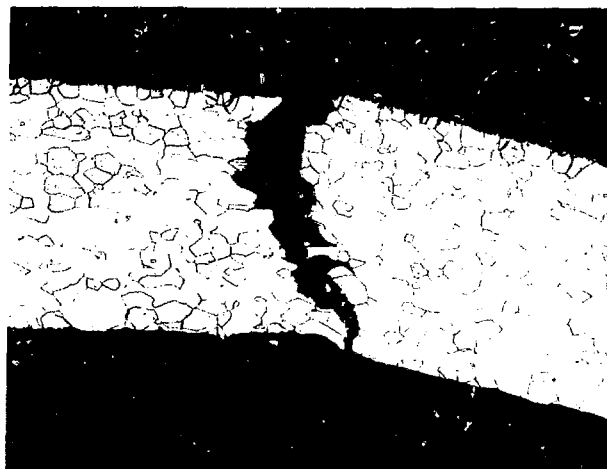
Figure 14 shows the breach in the vent-end radius of capsule SR-107. A two-stage bending action seems to have produced the crack; it appears that the capsule bent inward during the first stage of impact, then outward as the bulk density of the fuel and internal volume of the capsule decreased. Microhardness testing revealed that the alloy adjacent to the crack was significantly harder than was material that had not been deformed. The wall section adjacent to the crack had an average Vickers hardness greater than 400; the Vickers hardness of undeformed wall sections averaged 330. (The results of Vickers microhardness tests conducted on selected sections of all four iridium-alloy capsules are presented in Table VI.) The crack location was apparently influenced

Fig. 14. Breach in the vent-end radius of capsule SR-107. (a) External surface, 6X; (b) internal surface, 6X; and (c) micrograph of a section perpendicular to the crack, 50X.

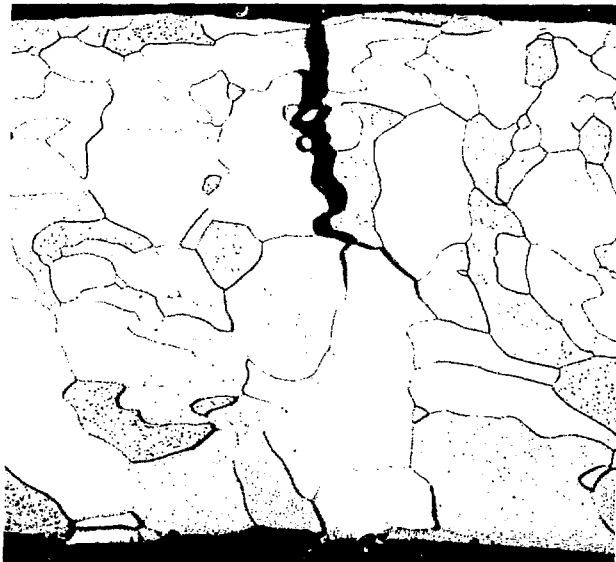
Capsule SR-110 deformation mirrored that of SR-107, including the crack which breached the wall in the radiused portion of the vent end. However, note that the crack in SR-110 was slightly higher and closer to the vent. Internal cracking of the weld bead in SR-110 was not nearly as extensive as that found in capsule SR-107. We observed only one set of cracks in the SR-110 weld bead (Fig. 15). Figure 9 shows the location of these cracks relative to the weld submergence and end. The breaching crack is shown in Fig. 10.

Fig. 15. (a) Only a few internal cracks were observed in the reverse bend region of capsule SR-110, 6X. (b) The deepest weld crack penetrated over 50% of the wall thickness, 100X.

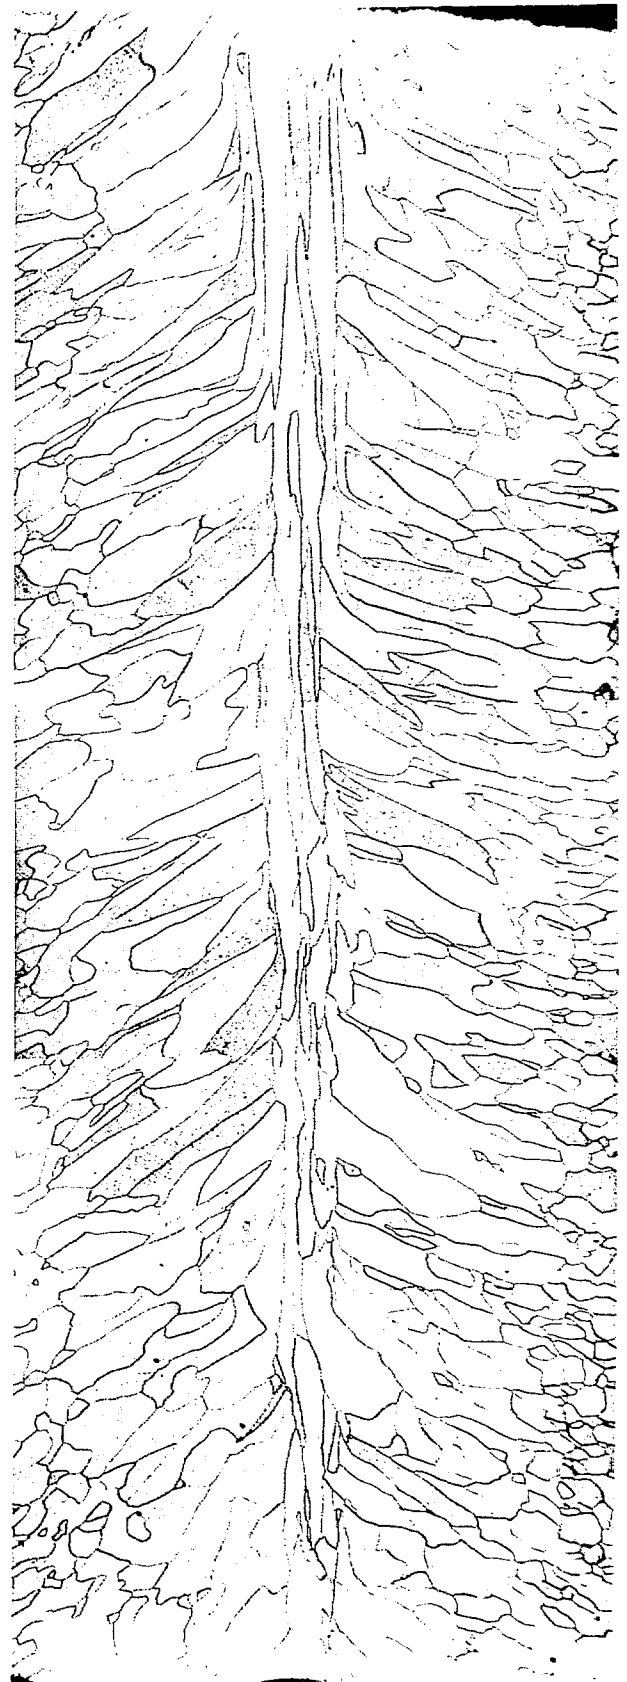
The equatorial weld of capsule SR-105 was sampled in cross sections taken from the single-pass, overlap, and face-on weld areas in accordance with SRP procedure DPSOL 235-F-PuFF. The microstructures of the three samples (Figs. 17a-c) are typical with no observed defects.

Fig. 17. The microstructures of the closure weld in capsule SR-105 were typical of Savannah River welds. (a) Single-pass region, 50X; (b) overlap region, 40X; and (c) face-on section, 40X.

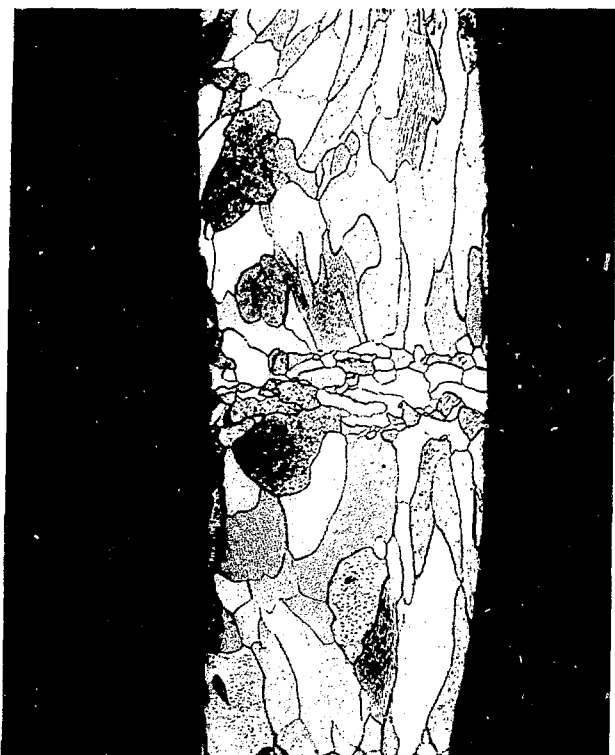
Fig. 18. Typical microstructure observed in the single-pass weld section removed from capsule SR-106, 50X.

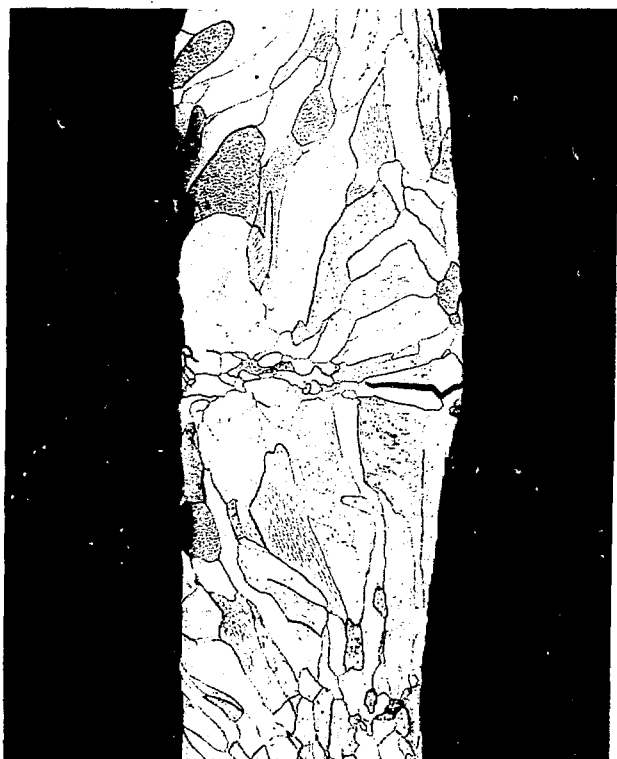
Fig. 19. The centerline crack observed in the overlap region of SR-106 penetrated over 30% of the wall thickness, 50X.

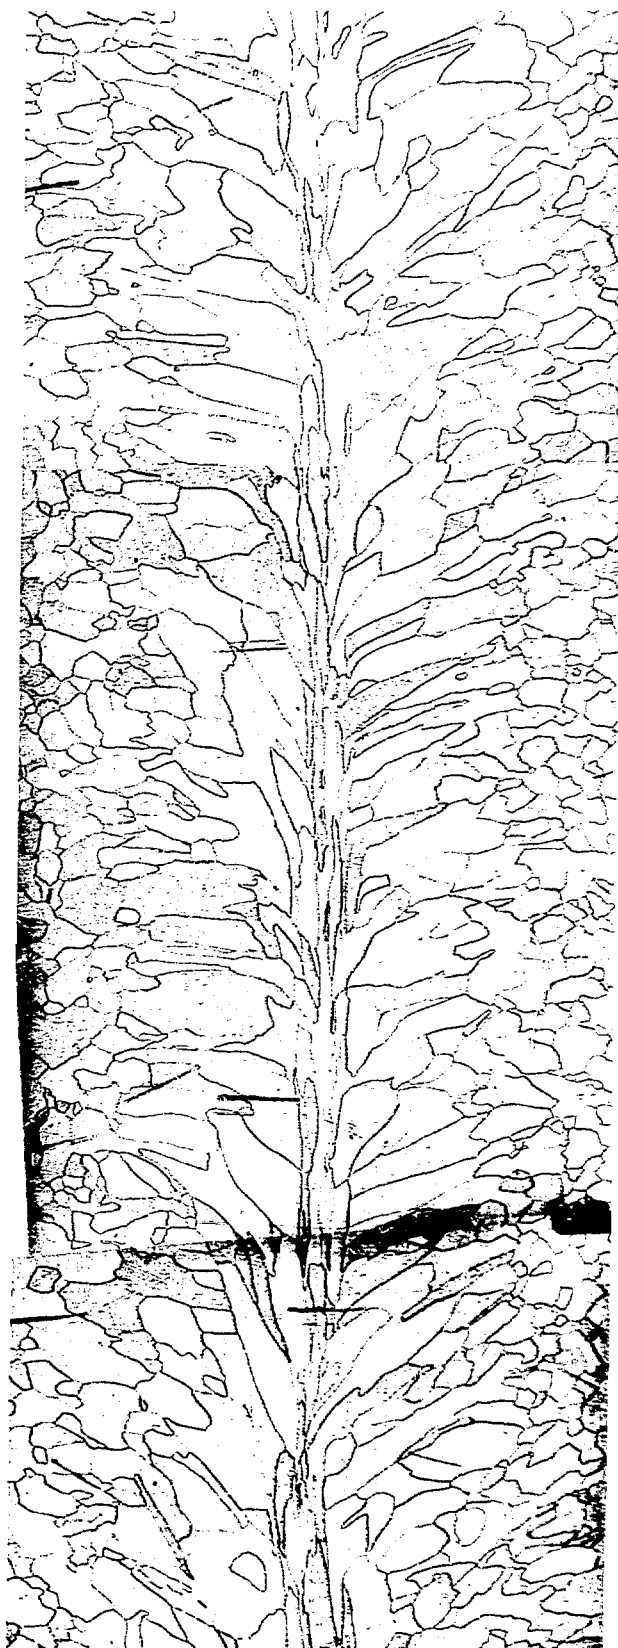
Fig. 20. The closure weld of capsule SR-106 exhibited the expected microstructure in the face-on region, 40X.

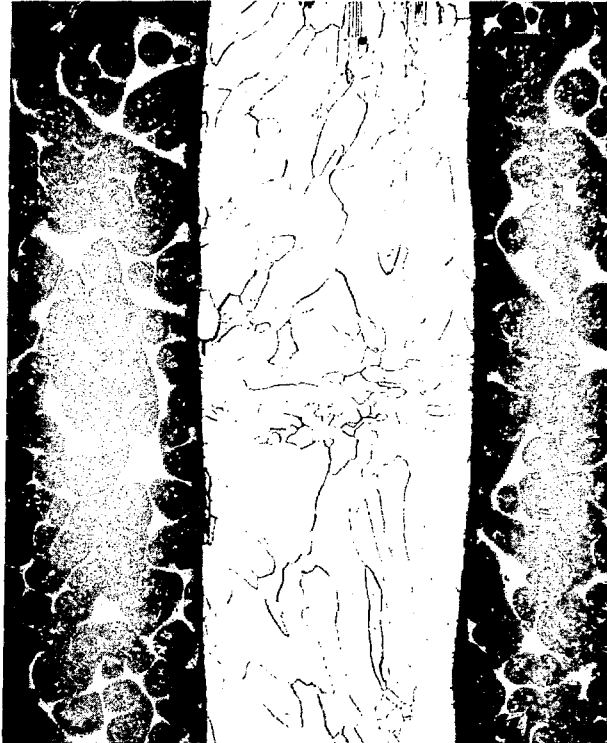
The single-pass weld section of capsule SR-107, shown in Fig. 21, appeared to be sound and contained no unusual microstructural features. The overlap cross section was quite porous (Fig. 22a). This porosity was largely confined to the grain boundaries of the remnant first-pass weld metal (Fig. 22b). Figure 22c verifies this observation within the central portion of the weld bead; Fig. 22d shows that the same phenomenon is present at the root of the weld bead.

Fig. 21. The microstructure of the single-pass weld specimen taken from capsule SR-107 was normal, 50X.

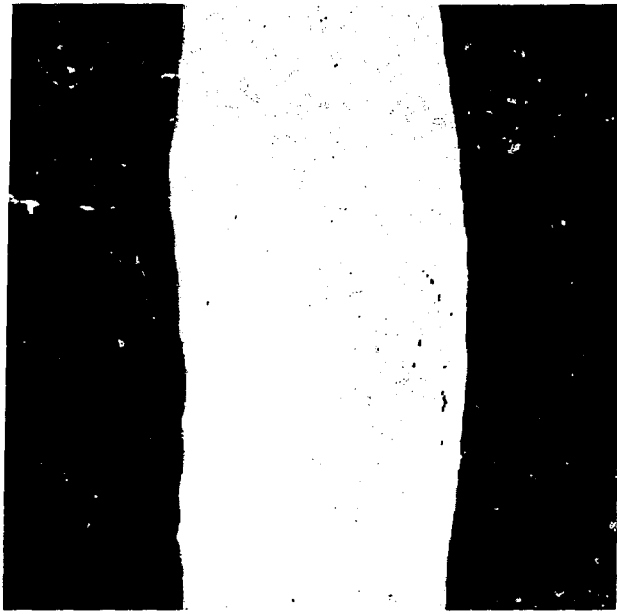
The welds on all four of the DIT-2 capsules were generally of acceptable quality and contained no significant defects. The weld in capsule SR-107, however, was quite porous in the overlap region (Fig. 22). Similar porosity was observed in a wall section removed from capsule SR-105 (Fig. 23). Apparently, reheating the iridium alloy to temperatures approaching the melting point caused grain-boundary porosity in both capsules. Because such porosity appears to be a characteristic response of iridium alloy exposed to temperatures near the melting point, grain-boundary porosity is a possibility in any overlap weld.

Fig. 22. Porosity was present in the overlap region of the SR-107 weld. (a) As-polished, 50X; (b) same area, etched, 50X; (c) SEM photograph of porosity in the central portion of the weld bead, 700X; and (d) SEM photograph of porosity at the root of the weld bead, 700X.

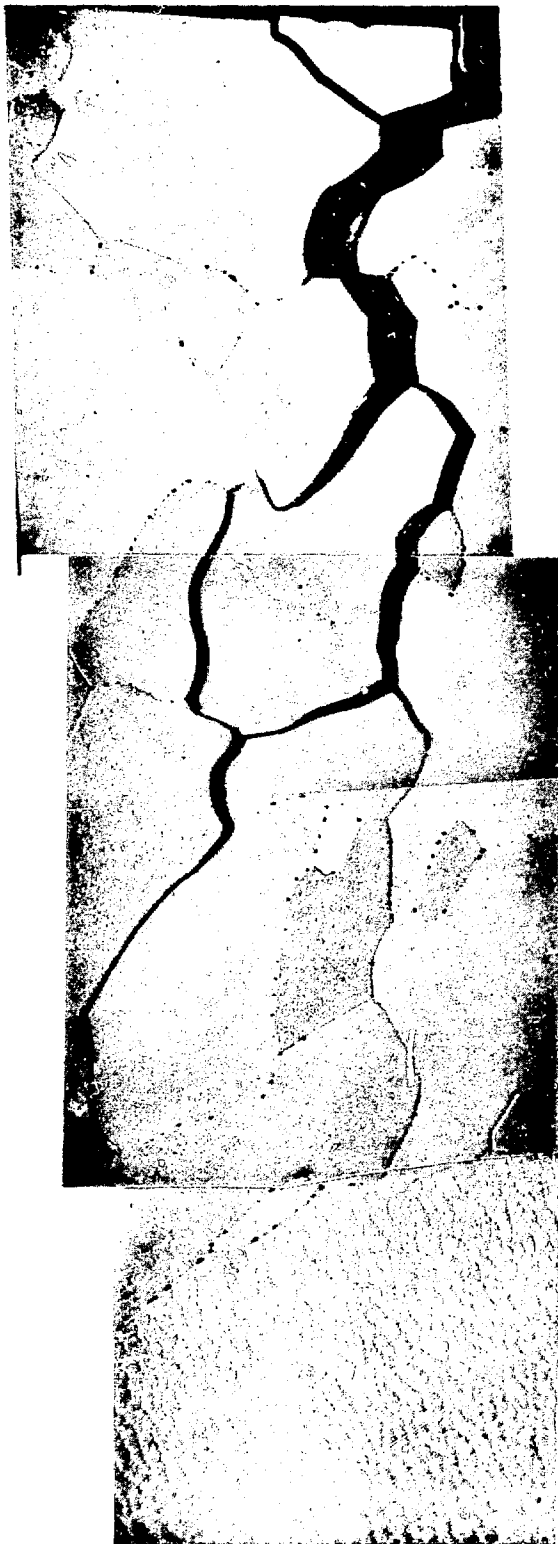
Figures 22c and d clearly indicate that gas evolution can take place at grain boundaries in the weld metal when it is reheated to temperatures approaching the melting point. Figure 23 (SR-105) demonstrates that this type of porosity can be produced in wrought as well as cast (weld bead) iridium alloy. The section shown in Fig. 23 was cut parallel to the weld direction and slightly above the centerline and includes both unmelted wall and weld bead. Reverse bending on impact seems to have produced the crack that originated on the inside surface, and grain-boundary porosity obviously contributed to the failure. Whether the gas evolution that causes grain-boundary porosity is independent of or part of the "hot short" weld cracking problem, which we observed previously, is unclear; however, some degree of interaction is likely.

Fig. 23. The base metal adjacent to the weld in capsule SR-105 contained grain-boundary porosity, 300X.

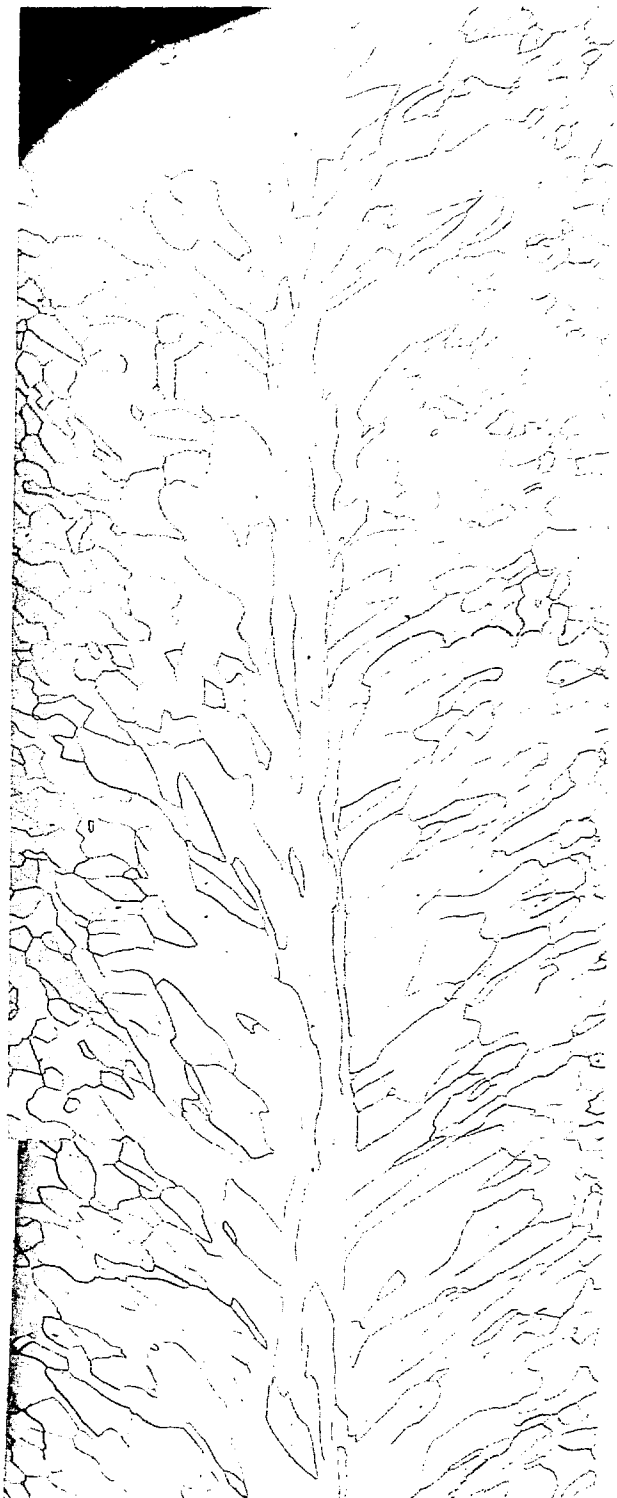
The face-on section of the single-pass weld in capsule SR-107, shown in Fig. 24, revealed typical structure and contained no observable defects.

Fig. 24. Face-on section of the single-pass weld in capsule SR-107, 40X.

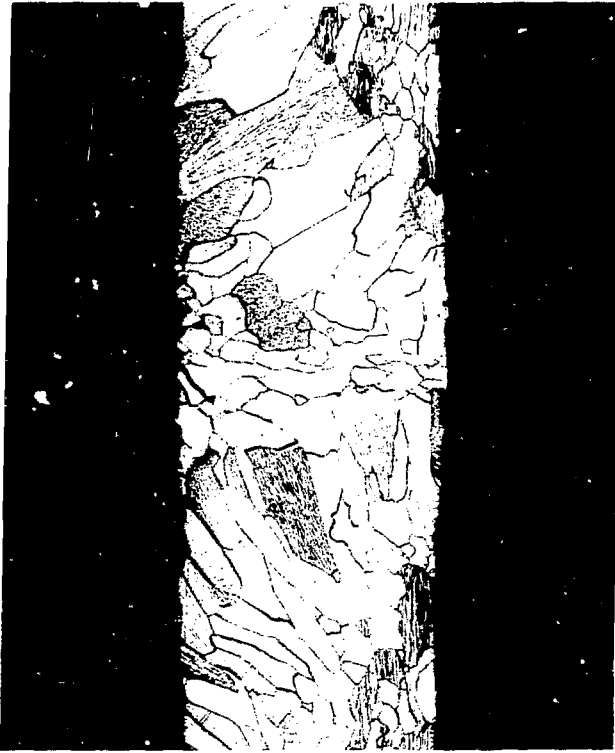
Fig. 25. The single-pass specimen removed from capsule SR-110 was normal, 50X.

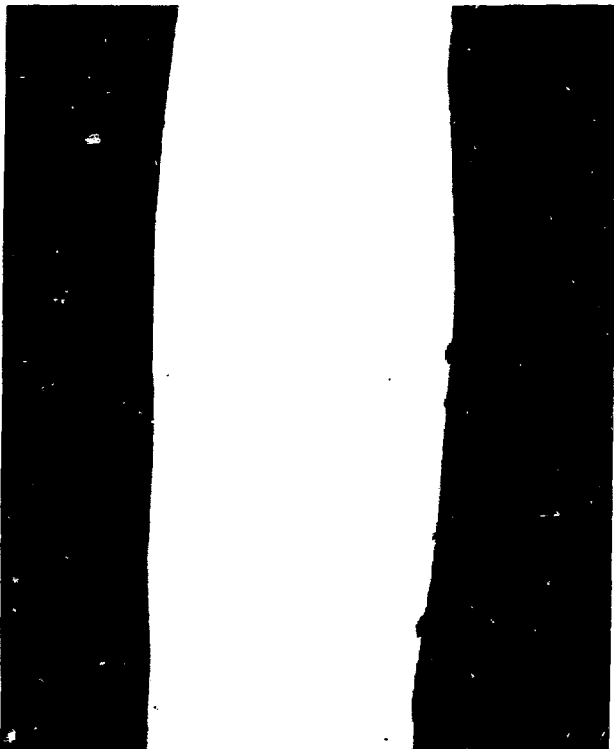
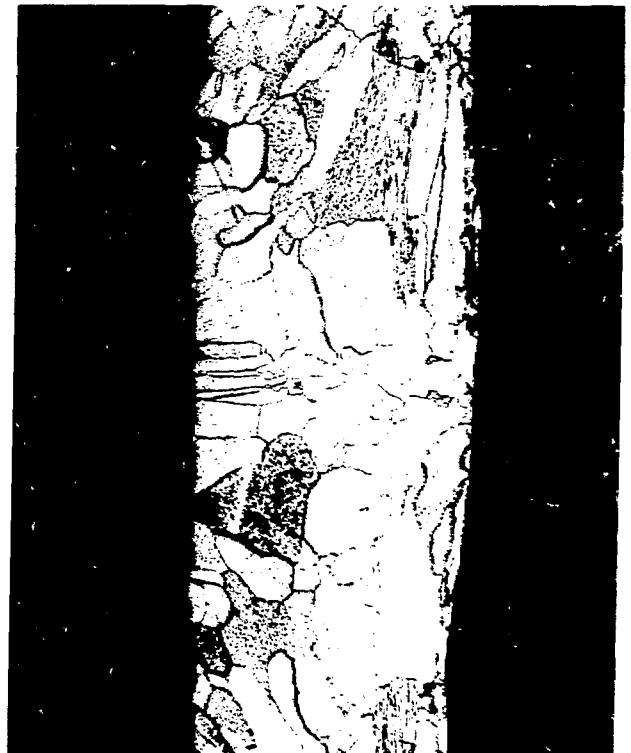
The three weld sections (single-pass, overlap, and face-on) removed from capsule SR-110 contained no significant defects. The single-pass sample was sound and had a typical microstructure (Fig. 25). The weld bead in the overlap section contained a few small pores (Fig. 26a); otherwise, microstructure was typical (Fig. 26b). Figure 27 illustrates typical face-on weld structure.

Fig. 26. A few small pores were observed in the overlap weld sample taken from capsule SR-110; otherwise, the section exhibited typical microstructure. (a) As-polished and (b) etched. Both 50X.

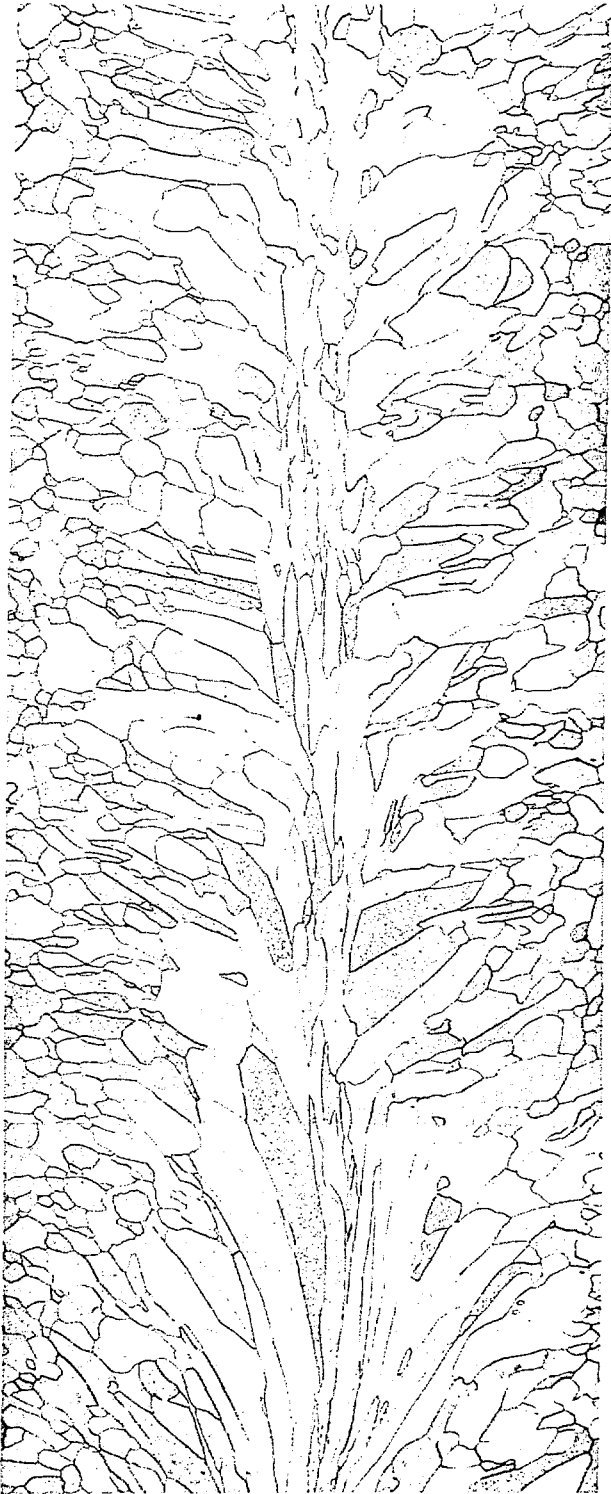
Fig. 27. The face-on weld section removed from SR-110 had a typical microstructure, 40X.

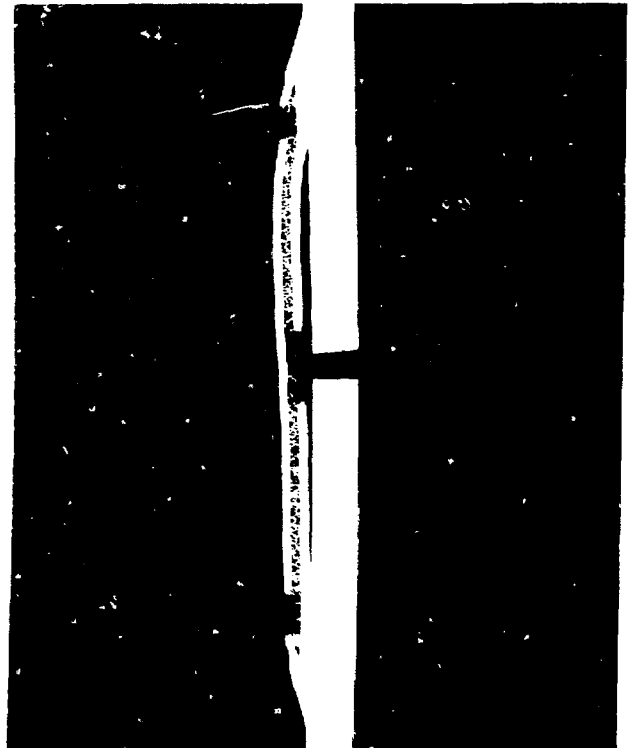
Fig. 29. The capsule SR-106 vent exhibited a small amount of plastic strain, 10X.

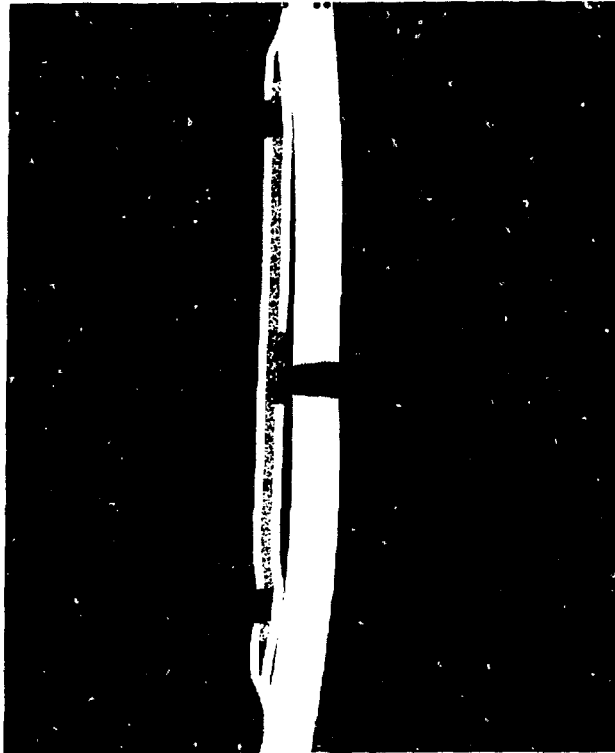
Fig. 30. The capsule SR-107 vent exhibited the same type of deformation as that in the SR-106 vent, 10X.

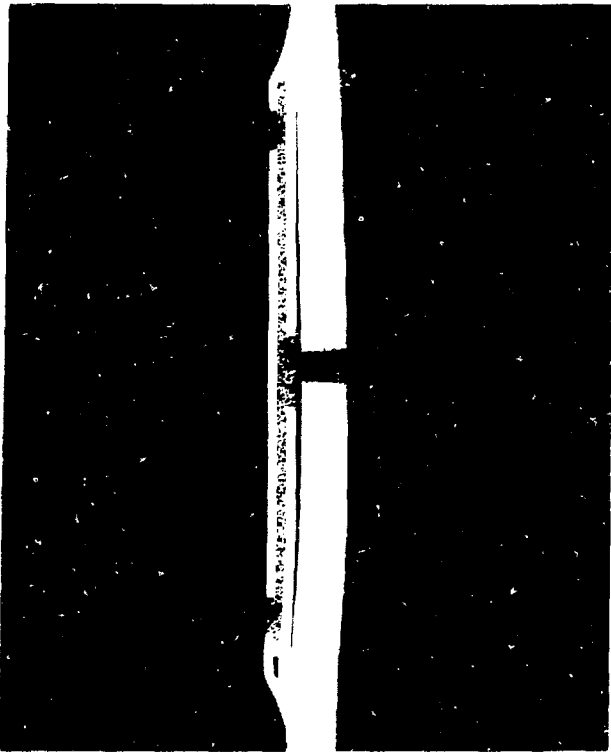
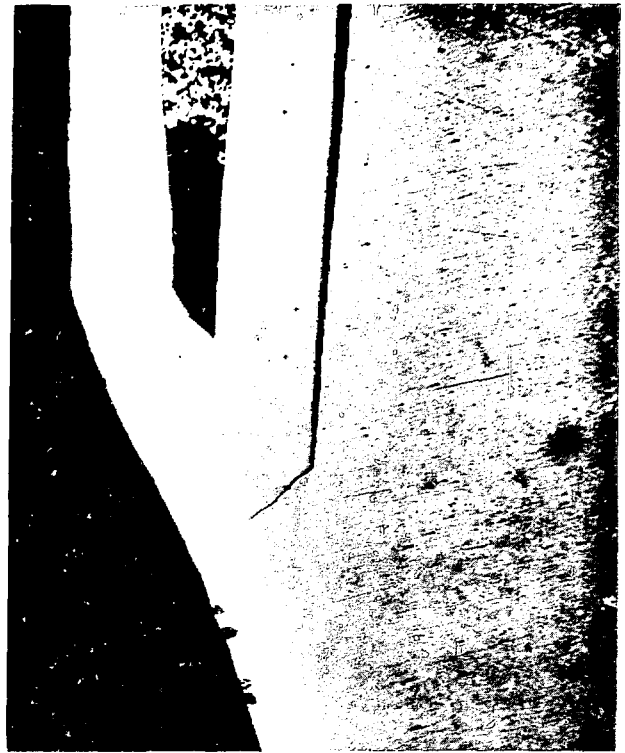
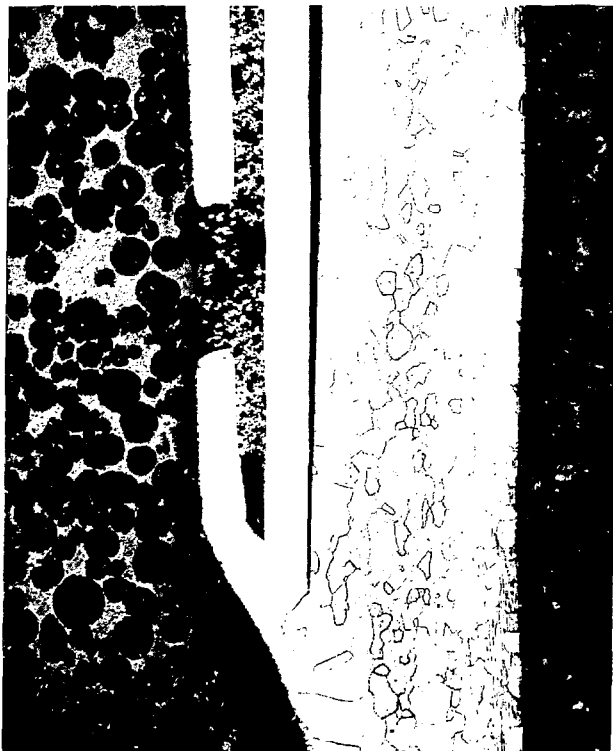
Fig. 31. A small crack was present in the capsule SR-110 vent-assembly weld. (a) As-polished, 10X; (b) as-polished, 100X; and (c) etched, 40X.
