**LA-10012-SR
Status Report**

General-Purpose Heat Source Development: Safety Test Program

Postimpact Evaluation, Design Iteration Test 2

F. W. Schonfeld
T. G. George

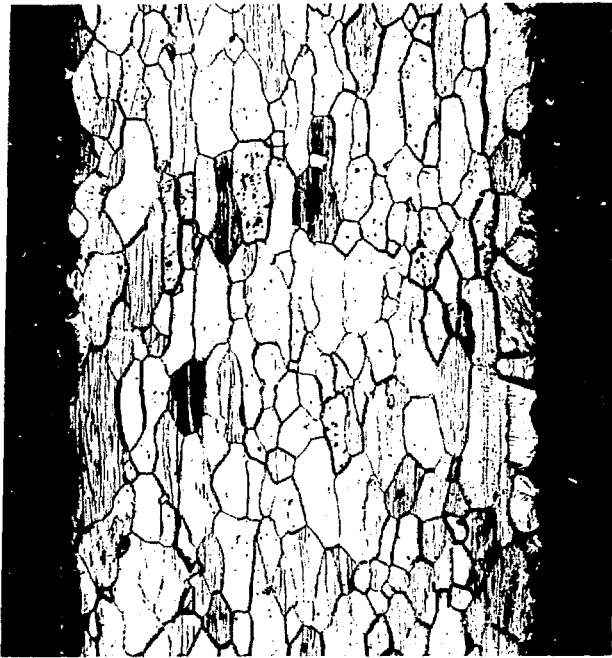
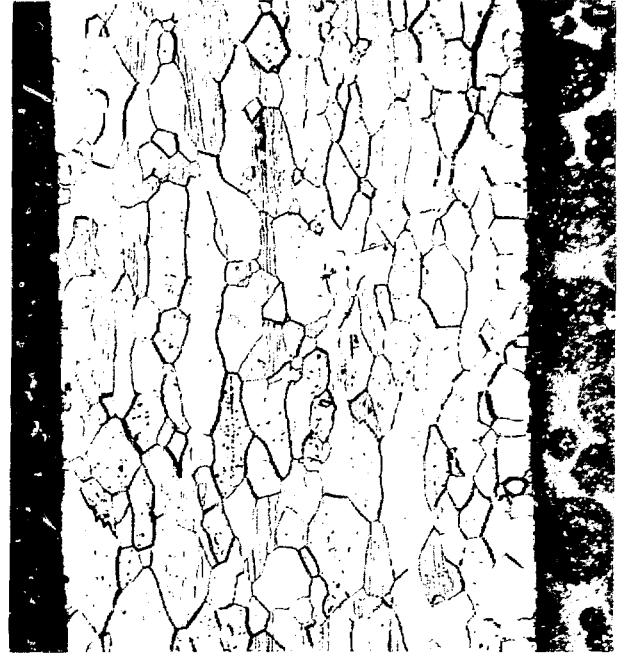
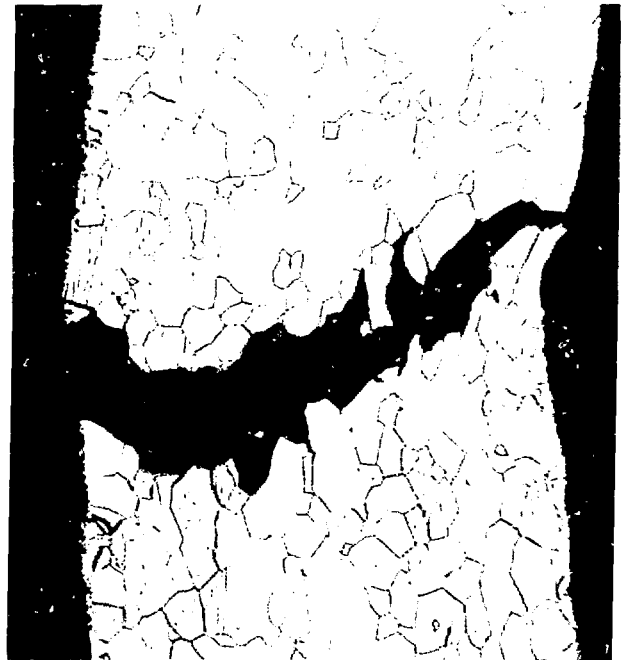
Fig. 34. Microstructures of wall samples removed from capsule SR-107. Polished and etched. (a) Weld-shield cup, (b) vent cup, (c) deformed portion of vent cup wall, and (d) vent cup section containing the breaching crack. All 100X.

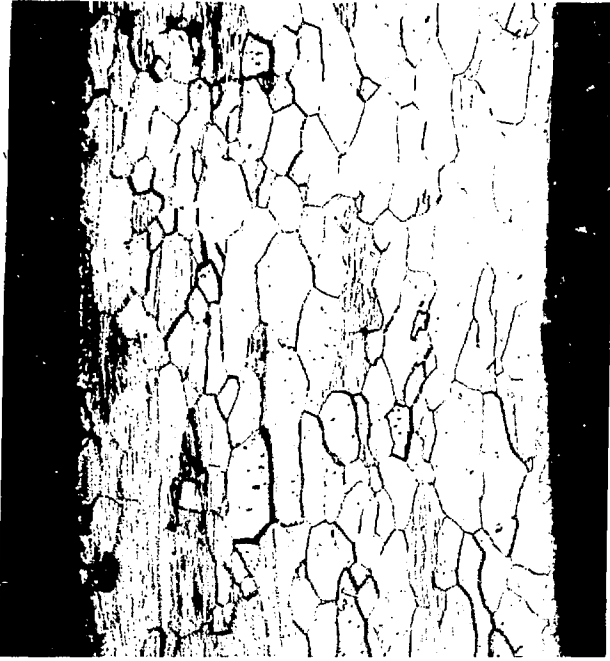
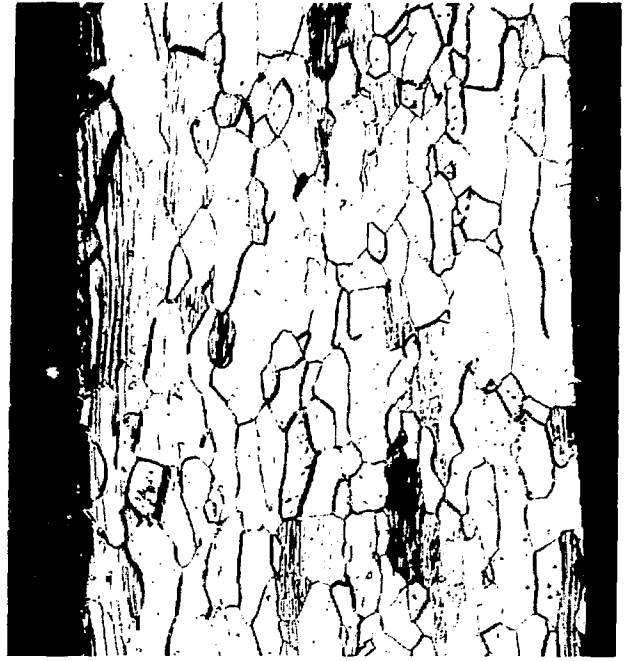
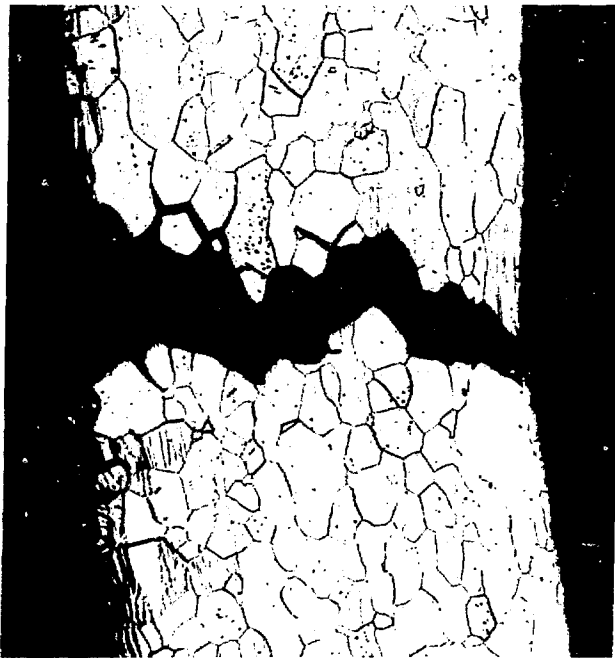
Fig. 35. Microstructures of wall samples removed from SR-110. Polished and etched. (a) Weld-shield cup, (b) vent cup, and (c) vent cup section containing the breaching crack. All 100X.
