Assessment of Thermal Damage to Polymeric Materials by Hydrogen  
Deflagration in the Three Mile Island Unit 2 Reactor Building\*

N. J. Alvares\*\*  
Lawrence Livermore National Laboratory

UCRL--92721

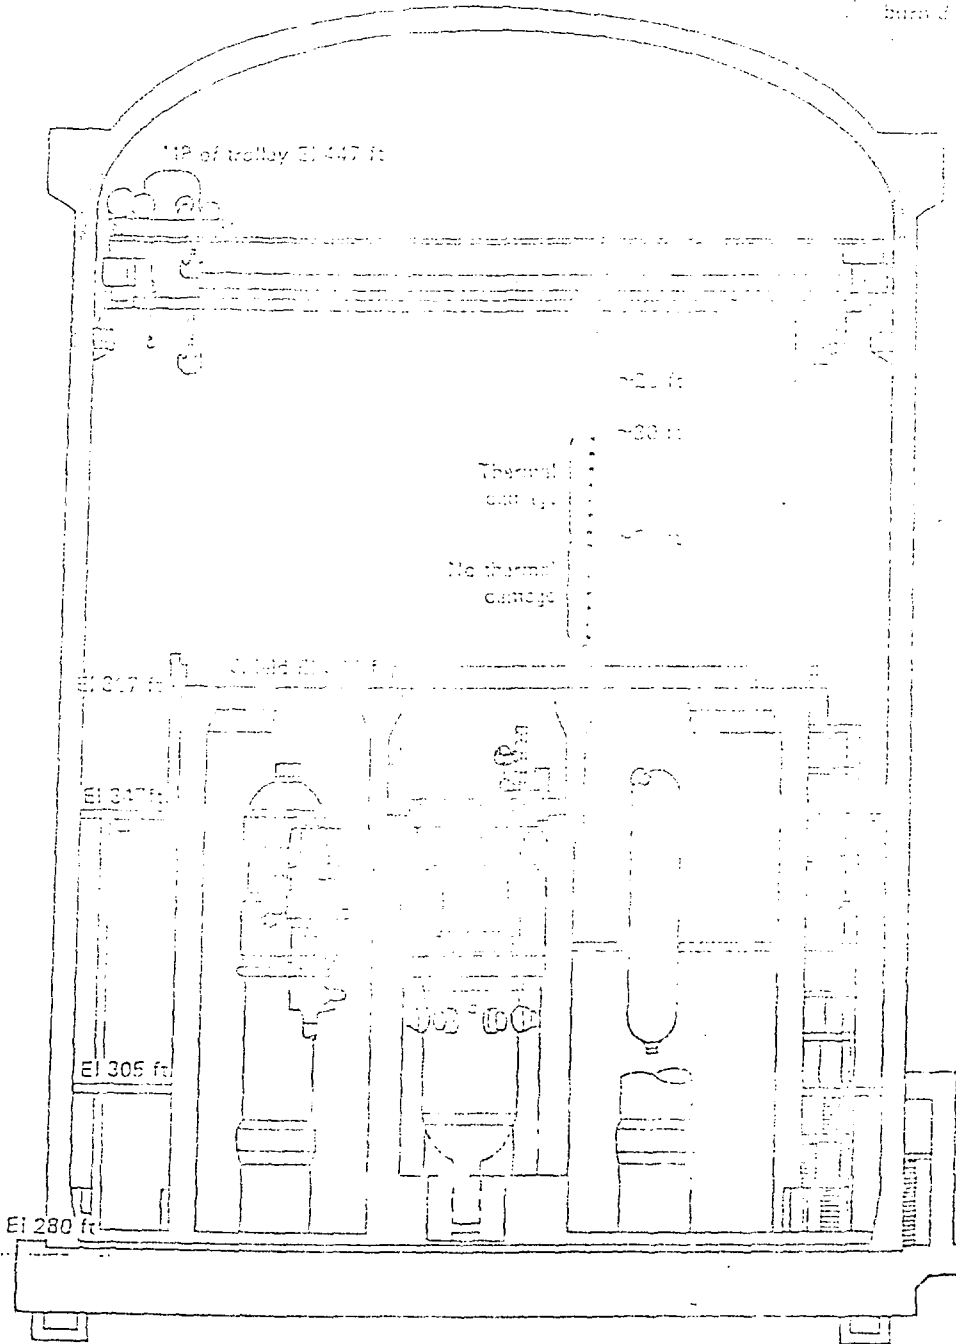
Fig. 9

A cross section of the reactor building (Figure 9) and plan view of the main (347-ft) operations level (Figure 10) show the regions of thermal and burn damage. Given that few operational ignition sources were available in the reactor building above the 305-ft level, the time delay to achieve peak overpressure is consistent with an ignition location in the basement. Potential electrical shorting of electrical control systems caused by basement water spillage and the frequency of steam and hydrogen release from the reactor coolant drain-tank pressure-release system supports this assumption.

Figure 9. Cross section of TMI-2 reactor containment building (7).

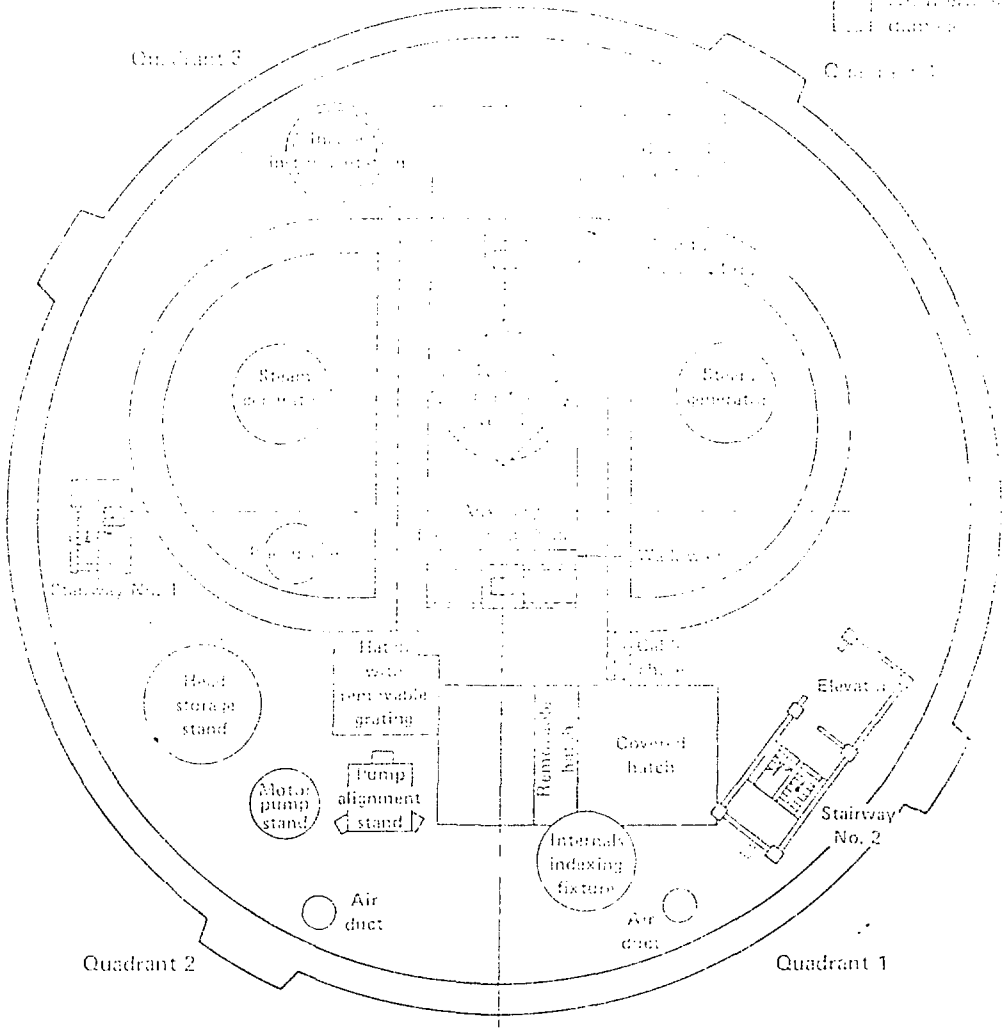
Figure 10. Thermal and burn damage and potential overpressure on the 347-ft level (7-8).

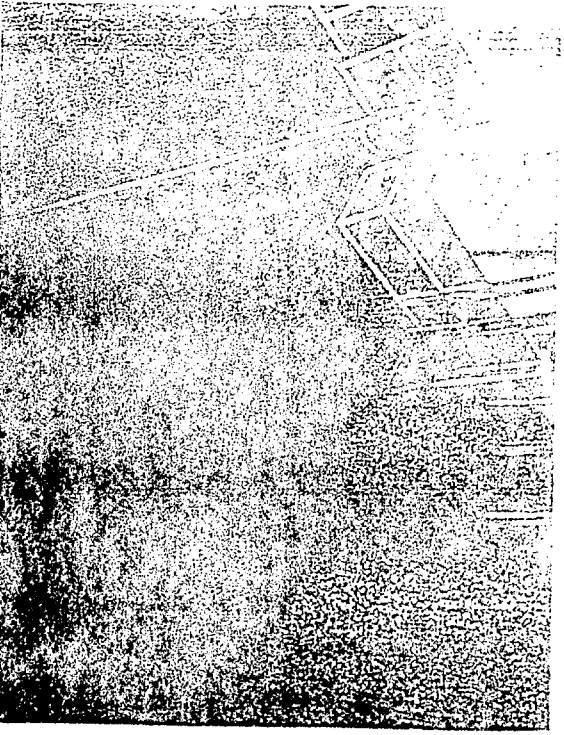
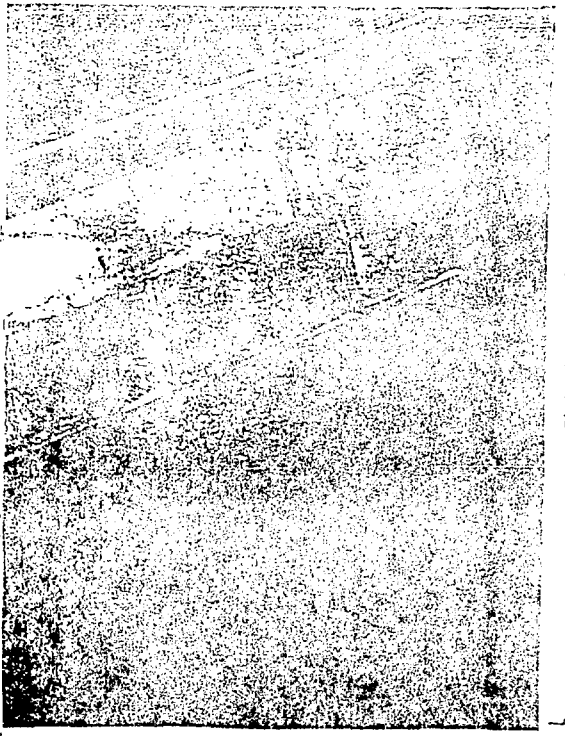
Fig. 15

The pendant and festoon for the polar crane possibly received the most intense energy exposure. The covering of this cable is Du Pont Hypalon and ethylene propylene rubber. Figures 15(a) and 15(b) show the lower polar crane pendant, and upper polar crane pendant and festoon along the "A" girder of the crane. Figures 15(c) and 15(d) show the relative thermal damage of cable sections extracted from the reactor building. (This examination was conducted at Sandia Laboratories, Albuquerque, in cooperation with Mr. Ralph Trujillo, Project Manager for the cable integrity project for TMI-2 reactor building electrical circuits.(10)) A detailed description of thermal damage on each section is contained in Figure 16, along with a curve showing  $\beta/\gamma$  activity along the pendant cable. Figures 15 and 16 show that all sections received thermal exposure, including those coiled on the D-ring catwalk. The degree of thermal degradation decreased from the polar-crane level to the D-ring top, and, in fact, was only apparent on the bottom pieces where cuts in insulation projected free surfaces of poor heat transfer. Thermal degradation is also apparent on light lenses of the pendant control box.

Maximum thermal damage occurs in the region from 6 to 10 ft below the polar crane girder (from about the 440-ft level down to about the 406-ft level). This region shows locally high  $\beta/\gamma$  activity, which may correlate to physical absorption by porous, charred insulation. Thermal damage is severe and circumferentially equal in this region. Char depth on the polymer surface averages 1 to 2 mm.

From the 406-ft level to the top of the D-ring (the 367-ft level), thermal damage is progressively less and becomes more directional, i.e., half of the insulation circumference exhibited a heavier degree of damage, ranging from char at the 406-ft level to no perceptible insulation degradation just above the D-ring plane. The pattern of asymmetric thermal damage along the pendant below the 406-ft level (a distance approximately 14 ft below polar crane girder bottom) indicates exposure from a westerly direction.(10) The extent of thermal damage to other available polymers at about the 347-ft level indicates intense thermal exposure in southerly areas of the reactor building. Moreover, since all containment gases above the 347-ft level were convected to the air-cooler intake plenums in the southern sector just below the 347-ft level, some preferential ventilation pattern may have influenced fire propagation path. However, because of fewer thermally susceptible materials in the north reactor building regions, we cannot confidently compare the south and north experience to define sources of non-uniform heat flux. Had there been either minimal thermal experience or other patterns in susceptible polymers in any other region, we may have had better opportunity to define fire geometry. One cause for asymmetry of the burn pattern below the 406-ft level can be conjectured: the cable at this height was

exposed to radiation and convection resulting from hydrogen combustion originating from one side (logically the southwest side) of the reactor building. The exposed surface would sustain thermal damage more readily than the shadowed surface, thus producing the observed pattern.

Figure 15. In-containment views and sectional pieces of the polar crane pendant: (a) Job crane; D-ring A is in lower right; (b) Girder A of the polar crane; (c) North side of cable is ash; plastic tape is charred all around; no degradation under the tape; (d) Half of circumference is ash, half char (ash is gray; char, black).

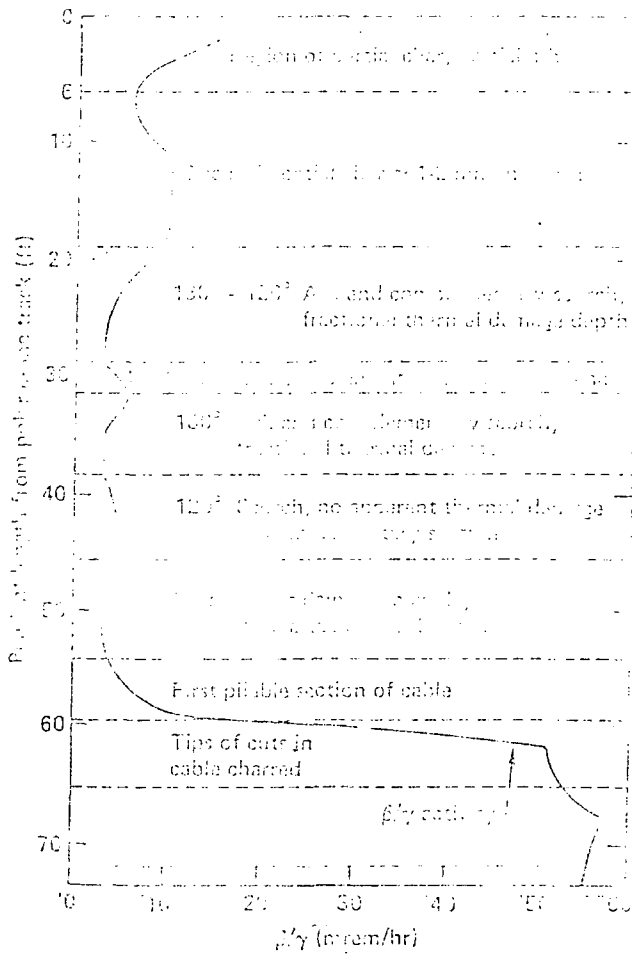
Fig. 16

Figure 16. Thermal damage pattern and  $\beta/\gamma$  activity along the Du Pont Hypalon and ethylene propylene covered polar crane pendant.
