Lawrence Livermore Laboratory

SEISMIC ANALYSIS OF THE MIRROR FUSION TEST FACILITY BUILDING

D. W. Coats

September 1, 1978

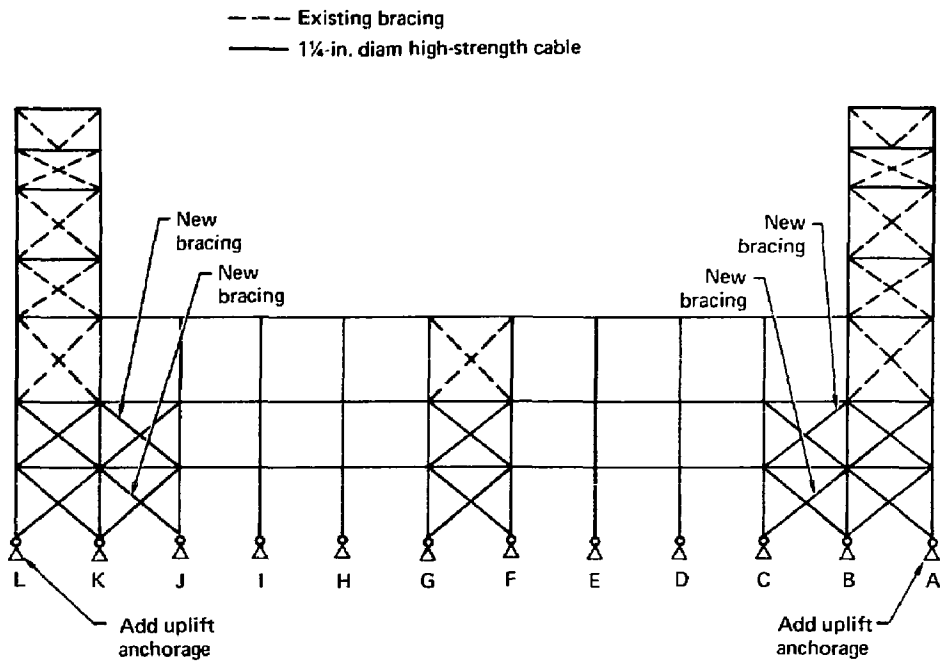
FIG. C-1. Column line 15 modifications.

The results shown in the tables are based on the use of the generalized floor loadings. As can be seen, the current structure is not adequate to survive the postulated DBE.

SOUTH SIDE OF STRUCTURE (See Fig. C-1)

Replace existing diagonal bracing on exterior wall (column line 15) with 1-1/4-in. o.d. high-strength cable. Add two additional bays of bracing with 1-1/4-in. o.d. high-strength cables.

Same modifications as first story.

Upgrade connection details of bracing on exterior wall by replacing existing rivets with high-strength bolts.
