GENERAL ELECTRIC COMPANY

November 3, 1954

SLUG RUPTURE OUTBREAK AT H PILE

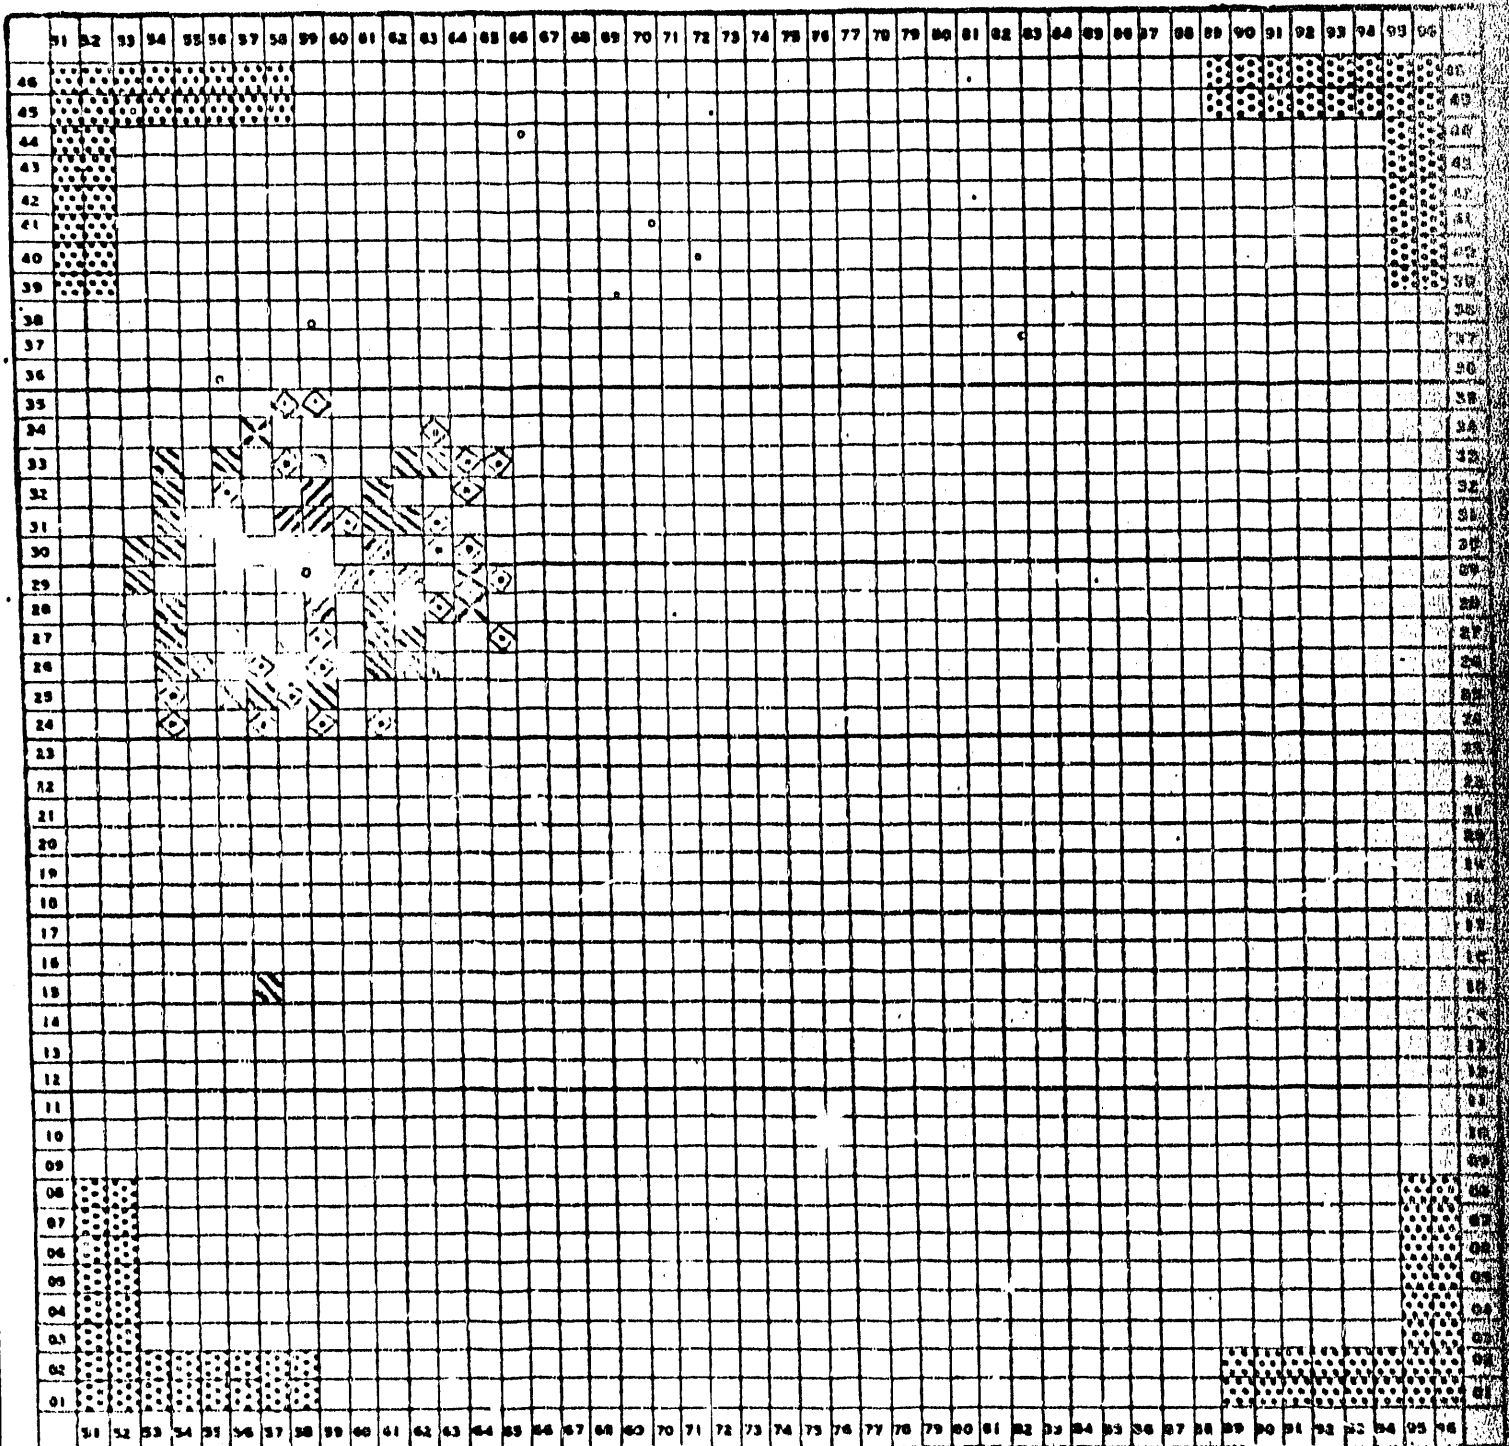
FIGURE 1: Distribution of failures and discharges at H Pile, October 1954

The pattern of failure occurrence, beginning in a small area and later extending outward from this area in all directions, as shown in Figure 1, indicates the possibility of some detrimental condition in the region where the failures began, that decreased in severity with distance from the spot. This could have been a "hot spot" during non-equilibrium operation, in which metal at the center of the "rupture area" operated at powers far above normal for some period of time, and the powers decreased along a smooth curve with distance from this point. It has been noted that this area is the "hottest" in the pile, frequently during scram recoveries and occasionally during poison column startups.

On October 4, 1954, slug ruptures occurred in tubes 3057 and 3058, on October 8, a slug rupture occurred in tube 2958 and, on October 12, ruptures occurred in tubes 3156, 2956, 3056, 3155, 3059, and 2862.

From October 15 to October 17, ruptures were discharged from tubes 2758, 2756, 3257, and 2954. At this time, all charges over 400 MWD/T exposure from row 26 to 33 and column 54 to 63 inclusive were discharged. Tubes 1557 and 2953 were also discharged for inspection in the hope of detecting a tendency for the failures to spread to these regions. Inspection of the metal from non-rupture tube 3359 disclosed two near ruptures. Six near ruptures were discovered in the metal discharged from non-rupture tube 2656. Metal from all other non-rupture tubes discharged at this time appeared to be in good condition.

On October 23, a rupture occurred in tube 2864, on October 25, ruptures occurred in tubes 3457 and 2964, and on October 28, a rupture occurred in tube 2556. During the shutdown for the latter rupture, twenty-five additional tubes were discharged.

3. To prevent further ruptures in the region, tubes have been discharged as knowledge of the extent of the damaged region has been obtained by (a) location of the ruptures, and (b) examination of metal discharged from tubes.

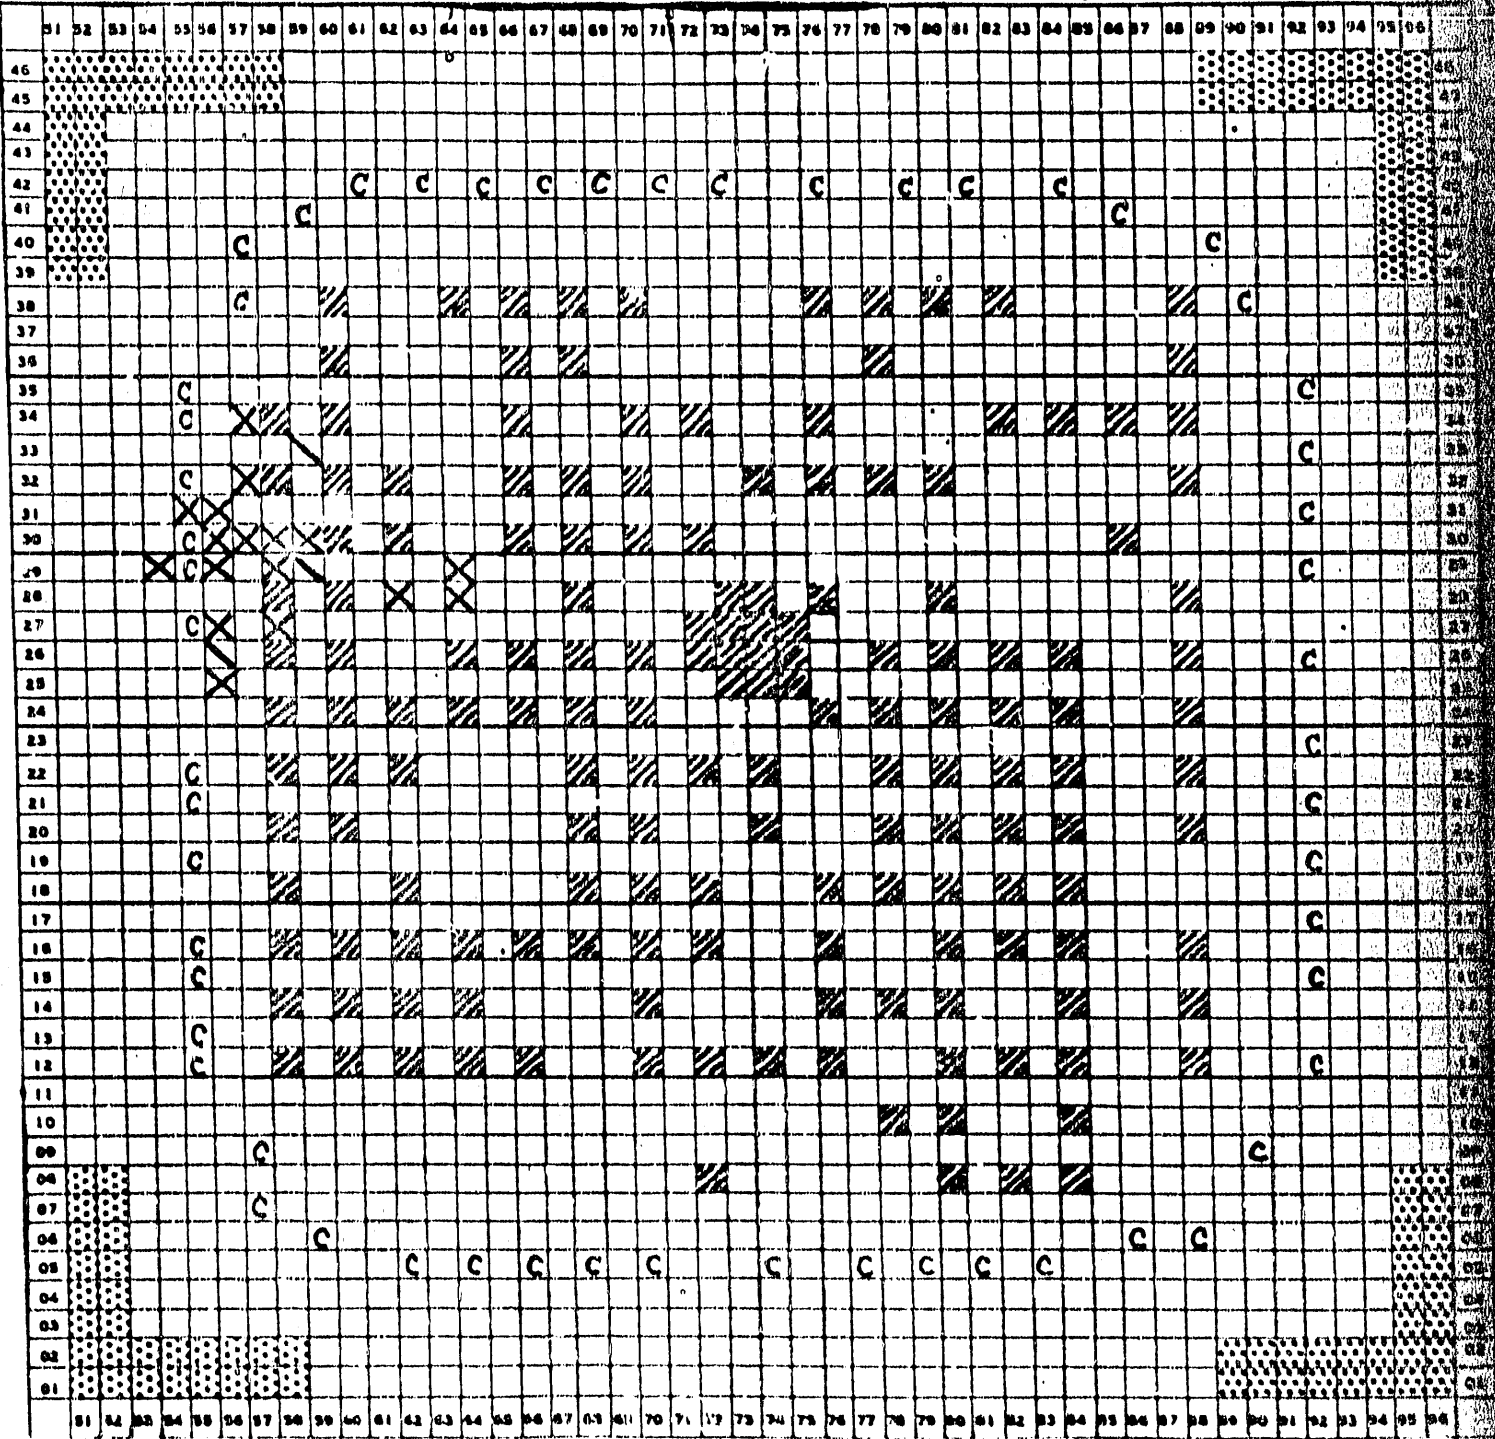
FIGURE 2: Distribution of October 1954 failures at H Pile with respect to enrichment columns.

When the first of these failures occurred, the proximity of several relatively fresh enrichment charges, "C" metal columns and "J-Q" columns, was suspected as a possible cause. It was thought that possible flux distortions caused by the enrichment pattern might cause part of the length of the normal uranium columns in adjacent tubes to run abnormally hot. However, if this were the case, ruptures should occur in other regions of the pile where similar metal, at comparable exposures, is operating in essentially the same position relative to enrichment columns. Figure 2 shows the positions of rupture tubes along with the position of the enrichment columns in H Pile. As yet, there has been no indication of failures extending to these other regions. It is possible, if some flux distortion due to an operating condition were responsible, that the presence of the enrichment columns would increase the distortion.

Wensel readings of a column of solid aluminum dummies which had been in tube 2760, between two "J-Q" columns, during two days of operation showed no abnormal flux distribution along the tube.
