SAND78-2176
Unlimited Release

A Study of the Application of Quality Assurance Human Factors and Reliability Principles to the Prevention of Major Environment, Safety and Health Incidents

Sandia Laboratories

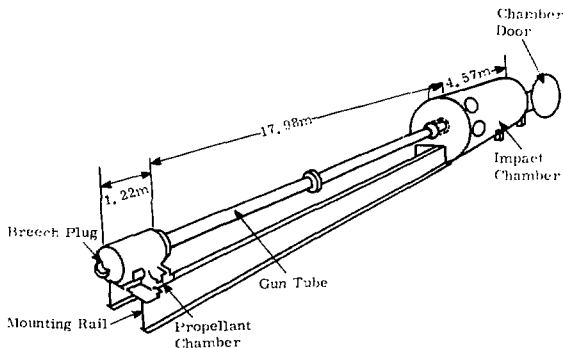
Figure 4. A High-Velocity Propellant Gun System. In the accident discussed, energetic gases escaped from the impact chamber at the right.

The result was that the nearly 2400-kg rear door of the chamber was blown open with sufficient force to rupture the approximately 13-cm-thick steel hinge brackets. The angular momentum of the door caused severe misalignment of the whole, massive system, and the overpressure released into the building housing the gun caused wall and roof sections to be blown out damaging the equipment in the area. Total damage was estimated at \$133,000. No personnel were injured because, as required by safe operating procedures, they were in a blockhouse located externally to the gun facility at the time of firing.

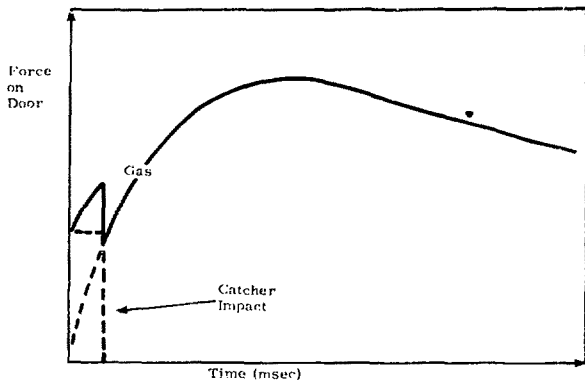
Figure 5. Force Exerted on Chamber Door After Firing, When the Catcher is Mounted on the Door

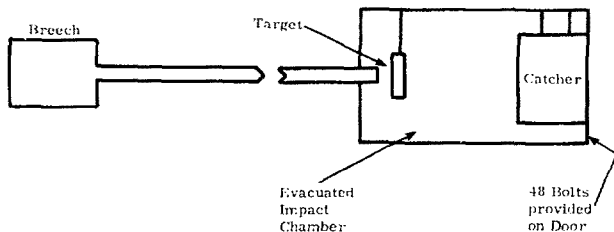
The design configuration of the impact chamber is shown in simplified form in Figure 6. Over about 15 years, experimenters gradually reduced the number of bolts used from 48 to 7. During the same period, instrumentation grew more sophisticated and hand torquing rather than pneumatic torquing of the bolts was instituted to avoid disturbing the alignment of the instrumentation. Safe operating procedures made no mention of the use of fewer than the 48 bolts that the design intended, and the relationship between over-pressure and charge was never examined.

Figure 6. Schematic of Gun Assembly in Original Design Configuration

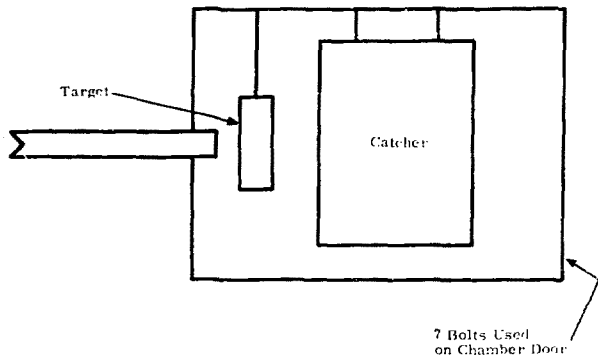
In 1977 a design change moved the catcher forward from its location against the rear door to a position just behind the target (Figure 7). This change was made to help confine the products of impact to the target area for a longer time. When the gun was fired with a nearly maximum charge, the catcher, upon impact of the target, was torn loose and impacted in the rear door. The force pulse from this impact occurred later in the time sequence than it ordinarily had done when the lighter target was propelled into the catcher fastened to the door (Figure 5). Figure 8 is a schematic of the resulting force-curve for the rear door compared to the theoretical ability of the door to withstand that force when held with 7 bolts.

Figure 7. Impact Chamber Condition at Shot Time Shown Schematically.

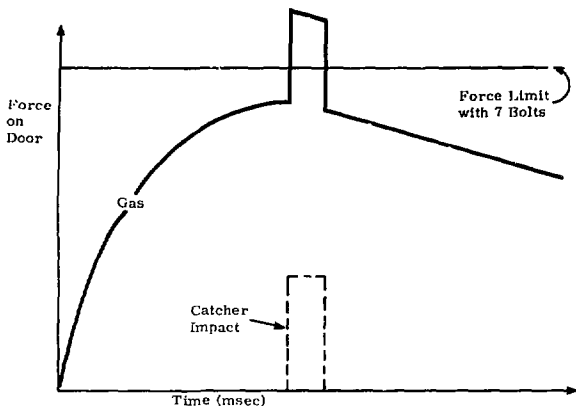
Figure 8. Force on Chamber Door in Design Change Configuration

- The design configuration actually used (as a result of the decreased number of bolts and the change in location of the catcher) was clearly inadequate. The probability of failure was equal to "one" (Figure 8).

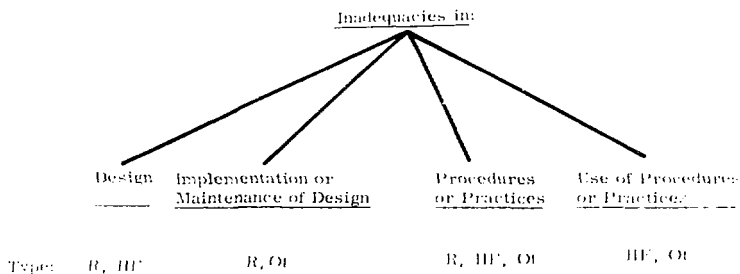
Discussion -- In this example, inadequacies in design, its maintenance, safe operating procedures and practices, and the use of safe practices are observed. The original "inadequacy" of design was an HF problem. Lack of maintenance of the design was due to HF considerations (tendency to use fewer than the maximum number of bolts), to HF "inadequacies" in pressure-failure analysis would have uncovered the inadequacies) and to other administrative factors relating to training. The inadequacies in safe operating procedures arose primarily because of the bolt issues (HF, B) and because design changes were permissible without adequate review (administrative and operational factors). Fundamentally, the safe operating procedures were not based on an adequate failure analysis for the design changes -- a "reliability" related question. The inadequacies in the use of safe operating practices stemmed from a lack of adequate recognition on the part of relatively new personnel that the system should have been treated as a pressure system (an administrative or operational problem). This lack of appreciation of the system as a pressure system led to failure to perform proper analyses and to update operating procedures to reflect their results (change the number of bolts, or don't change the nut and position). Finally, assurance of adequate design and procedures, through review, and of their use, through audits, was clearly not present. All of these inadequacies are summarized in Figure 9.

Figure 9. Summary of Inadequacies in Example 1.

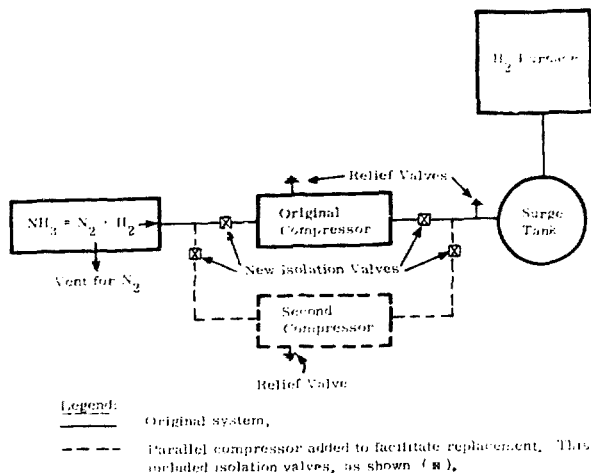
Figure 10. Simplified Schematic of a Hydrogen Furnace Facility

When the compressor failed one night the first person to arrive at work recognized the problem. Following safe operating procedures, he first shut off the system, then closed isolation valves at each end of the failed compressor (Figure 10). He then tried to open the isolation valves (gate valves with threaded stems) on either side of the parallel compressor. When he couldn't turn these latter isolation valves counter-clockwise, the employee assumed that they were open and energized the compressor. Both valves, however, were stuck shut. Returning later, he found the hydrogen furnace again cold and once more tried to turn the isolation valves on either side of the second compressor--which he left running. Unfortunately, he managed to free the stuck valve on the intake side of the running compressor first. The second stage of the compressor rapidly built up internal pressure. The pressure relief valve on the first stage of the compressor failed to function, and the pressure relief valve on the output side of the compressor was still isolated from the compressor by the stuck isolation valve. A section of the compressor head blew off, scattering shrapnel around the area. The compressor noise prior to this "explosion" alerted the individual, causing him to start running from the room just as the compressor "blew."

1. There were "inadequacies" in the design. The original design was adequate, but the change, as indicated by the dashed lines and legend of Figure 10, was judged inadequate from several points of view. First, gate valves, whose open/closed position was not immediately discernible by the operator, were used. In potentially critical systems, lack of a clear on/off indication is a typical human engineering deficiency. Had two-position ball valves, visually verifiable as either open or closed, been used, the accident could not have occurred. In addition, the second design change appears not to have been adequately documented. A handwritten design is inadequate and presents an administrative problem. Because the system was labeled in an area best described as a "plumber's signature", visual inspection of the system was difficult without, at least, a schematic as a guide. Thus, operational factors (relating to the operational configuration or characteristics) were important in this incident. Under the circumstances, labeling of the pipes would have been desirable also, as a part of the design requirements (a human engineering input). In addition, the second design should have called for the replacement of the pressure relief valve on the input side of the surge tank (see Figure 10) with two such valves (one each compressor and the isolation valve on its output side). Also, standard over-pressure, cut-off switches should have been a part of the system design. A simple failure modes and effects analysis (a reliability technique) or even a close look at a schematic diagram should have indicated possible problems. Finally, a "panic button" by the exit that shut off the entire system would probably have been of value (a human factors consideration).

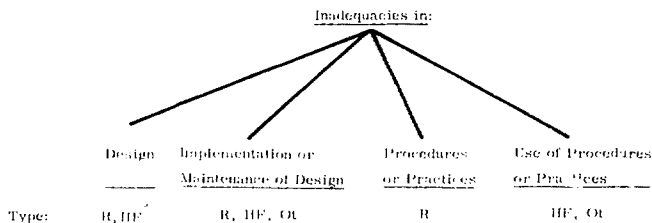
Here is just one example of the lack of completeness of the audits for "use"; there was no requirement to send the old pressure relief valves to the institution's pressure safety laboratory, nor a suitable fielder system to verify their receipt. Such a simple system could have drawn attention to the situation and prevented the accident. All of the inadequacies illustrated by this example are summarized in Figure 11.

Figure 11. Summary of Inadequacies in Example 2.
