# Lawrence Berkeley Laboratory

### GROUND-PLANE INSULATION FAILURE IN THE FIRST TPC SUPERCONDUCTING COIL

March 1981

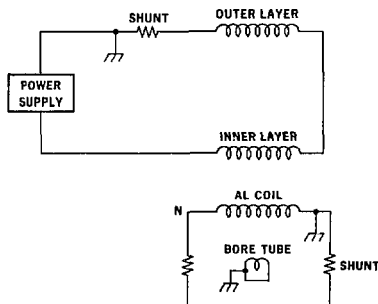
Fig. 2. Circuit diagram for the TPC magnet coil, ultra pure aluminum circuit, and bore tube. before the failure.

An analysis of the electrical data suggests the magnet behaved normally for the first 0.19 s, when a short appeared between either the UPA circuit and the bore tube or the UPA circuit and the coil. The short occurred at a point near the north end of the magnet. (Indicated by the point W in Fig. 2.) Either kind of short would cause the current in the UPA circuit to bypass the shunt and the 0.1 ohm resistor across the leads. A reconstruction of the current in the UPA circuit was made using the measured transfer functions and the  $d\phi/dt$  signal from the pickup coils [1].

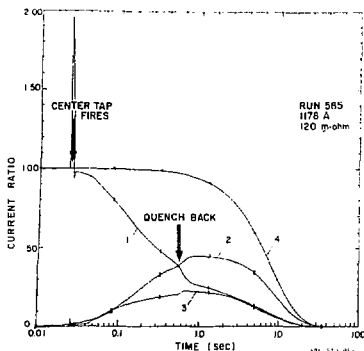
a. 1175 A quench before failure

The highest quench current prior to the failure was 1178 A. During the induced quench at this current, the UPA circuit carried up to 20 percent of the initial magnet ampere turns, and the bore tube carried up to 48 percent. (See Fig. 3a.) The coil went completely normal though quench-back after 0.6 s. The coil failed during an induced quench at 1258 A. The quench appeared to be normal for the first 0.19 s. The quench protection circuit fired after 30 ms, and the current currents evolved as in the 1178 A case.

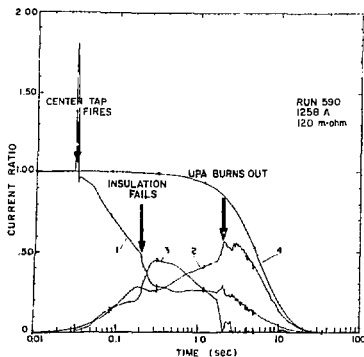
b. 1258 A quench when the insulation failed.

to increase from 19 to 41 percent of the total current. (See Fig. 3b.) The higher current in the UPA circuit persisted for about 2 seconds. Then the current in the UPA circuit was extinguished. At the start of the failure, the bore tube carried about 30 percent of the total current. This was reduced to about 25 percent until the UPA current was cut off; then the bore tube current rose to around 50 percent of the magnet starting current.
