Corrosion Monitoring in the UF₆ Cylinder Yards at the Oak Ridge K-25 Site: FY 1994 Report

Prepared by
Mukund Rao
Midwest Technical Inc.
Oak Ridge, Tennessee 37831
under subcontract 1BK-02268C with
Martin Marietta Energy Systems, Inc.

Ron Adamski
Jeff Broders
Alvin Ellis
David Freels
Don Kelley
Bonnie Phillips
K-25 Site Technical Division
OAK RIDGE K-25 SITE
Oak Ridge, Tennessee 37831

October 1994

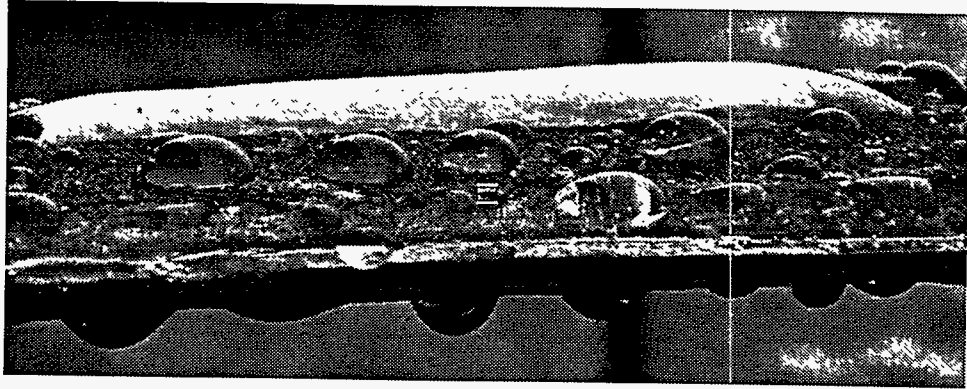
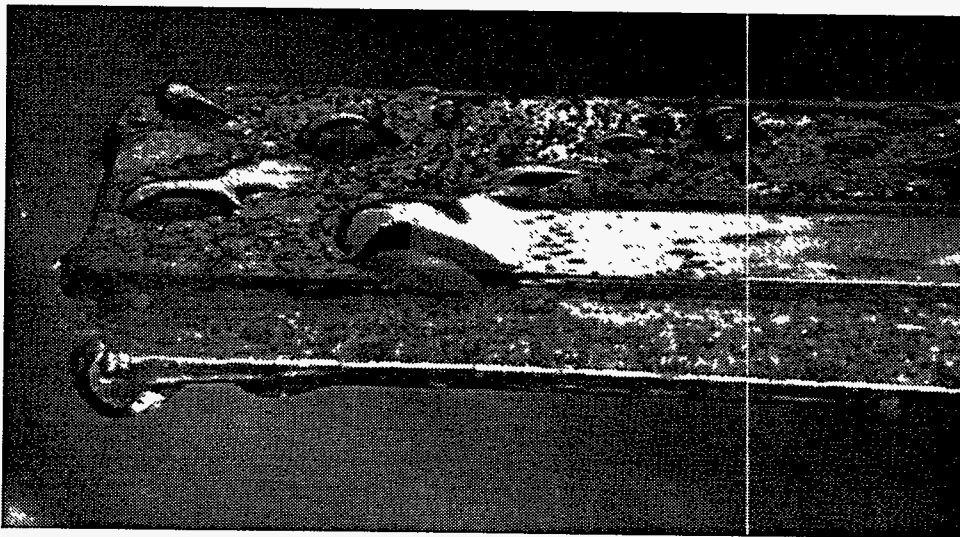
Visual inspections showed that Probe 54 quickly developed a rust layer on its surface (completely rust covered within 7 days) whereas Probe 55 had large rust-free areas even after 40 days of exposure. Probe 56 showed intermediate behavior while developing a thinner, darker, more adherent corrosion product. During rain events, Probes 54 and 56 were quickly wetted whereas Probe 55 stayed mostly dry, with occasional wetting from wicking action of water beads forming on the edges of the covering surface. Furthermore, Probe 54 stayed wet for significant periods (often on the order of 1 day) after rain ended, whereas Probe 56, inclined at 45°, dried off within a couple of hours. Figure 15 shows photographs of the two top facing probes following a rainfall event. The beads of water seen on the probes were typical of observation even after short periods of rain. The water drops overhanging the edge of Probe 54 occasionally wicked onto the surface of Probe 55 directly underneath, initiating corrosion.

Fig. 15. Photographs of (a) Probe 54 (mounted facing up horizontally) and (b) Probe 56 (mounted facing up inclined at 45°) after a period of rain. Probe 55, which is not visible, is mounted directly beneath Probe 54.
