TEMPERATURE-HUMIDITY-BIAS AGING TECHNIQUE TO IDENTIFY DEFECTIVE SURFACE MOUNT CAPACITORS

Rajen Chanchani
Multichip Module Applications Department
Sandia National Laboratories
Albuquerque, New Mexico 87185
Tel: (505) 844-3482
FAX: (505)844-8480

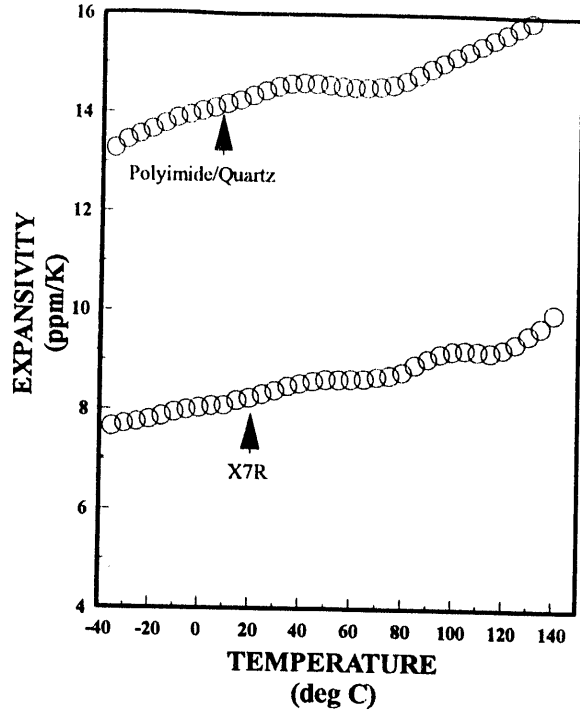
Figure 2 Thermal expansivity of the board and capacitor dielectric.

For each solder process, there is no significant effect of 100 thermal cycles on the capacitor failure rate. Thermal expansivity of polyimide/quartz board is about 5 ppm/°K higher than that of the capacitor dielectric as shown in Figure 2. The result indicates that thermal expansion mismatch is not large enough to cause fatigue cracking, either in the capacitor or in the solder joint.

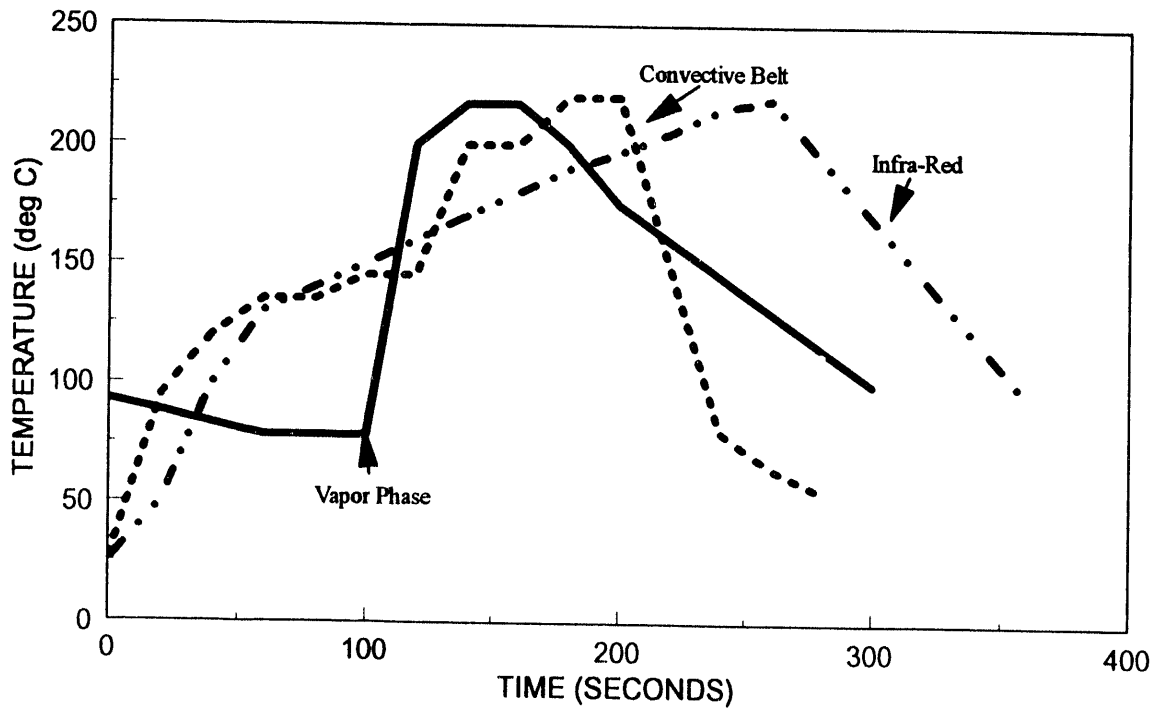
Figure 3 Temperature profiles of different solder processes.

Vapor phase solder processes yielded 6.3% cracked capacitors compared to only 1.25% obtained with infra-red and belt processes. Higher failure rates with vapor phase soldered batch can be explained by comparing the temperature profiles of all three solder processes shown in Figure 3. The cool down rate is the least steep in vapor phase soldering, and thus it cannot account for the higher failure rate of vapor phase soldered parts. This also implies that thermal stress due to thermal expansivity mismatch is not a major contributing factor in causing the capacitor failure because capacitor to substrate attachment occurs only at the on-set of cool down. Surface cracks are probably caused by thermal shocks that a capacitor undergoes during the solder process. Vapor phase has the steepest heating rate. Majority of the cracks were seen near the bottom half of the end terminations of the capacitors (refer to Figure 6). During a rapid heating in vapor phase oven, the solder material because of its higher heat capacity will heat up before either the ceramic or the organic board. Thus, the bottom half of end terminations of the capacitors will see higher thermal gradients and more cracking. Although majority of the cracks were seen as described above, a few were seen on the top surface and a few that run through the center of capacitor. Probably these cracks could have been initiated at a weak site caused by a defect already present in the capacitor before the assembly.

In our study, we have demonstrated the use of the THB aging technique to compare the effect of different surface mount process on the component reliability. Based on the results, the process engineers may take appropriate actions such as altering the temperature profile of the vapor phase process, switching to IR or convection belt soldering, or for a longer term solution developing dielectric and electrode materials that are more tolerant to thermal shocks⁴.

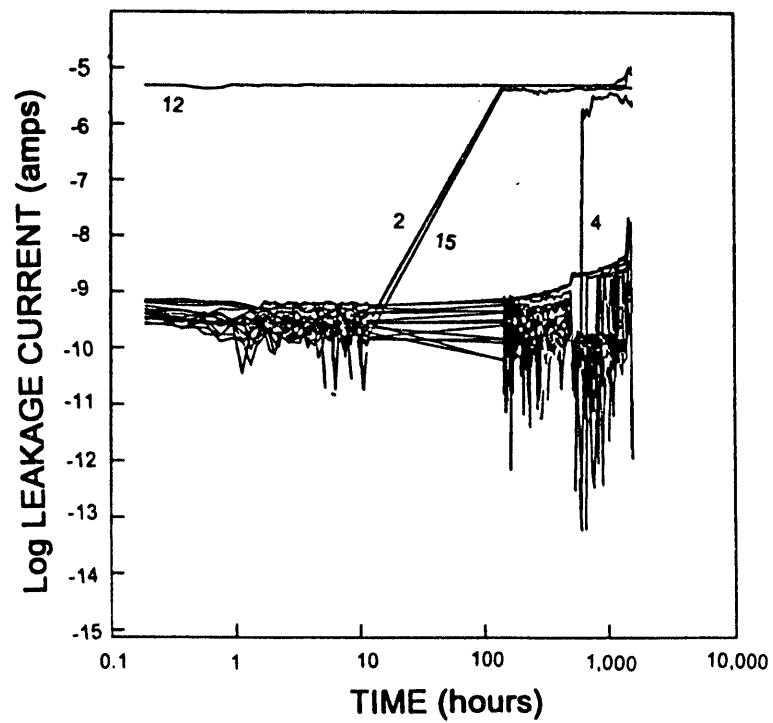
Figure 5 Plot of THB data for board 011.

The assembled boards were aged at 85°C, 85% relative humidity with 50 volt bias for 1500 hours. The examples of the outputs of the THB test set, plotted on log-log scale as leakage current versus time, are shown in Figure 5 for board 011. Board 011, which was thermal shocked, had several shorted capacitors. The capacitor on site 12 started short, capacitor at sites 2 and 15 shorted after 10 hours, and capacitor at site 4 shorted after 600 hours. The summary of the data from all four assembled boards is shown in Table 1.
