## LIFE TESTING OF A LOW VOLTAGE AIR CIRCUIT BREAKER\*

Mano Subudhi  
Department of Nuclear Energy  
Brookhaven National Laboratory  
Upton, New York 11973

BNL-NUREG--47471

Satish Aggarwal  
U.S. Nuclear Regulatory Commission  
Washington, D.C. 20555

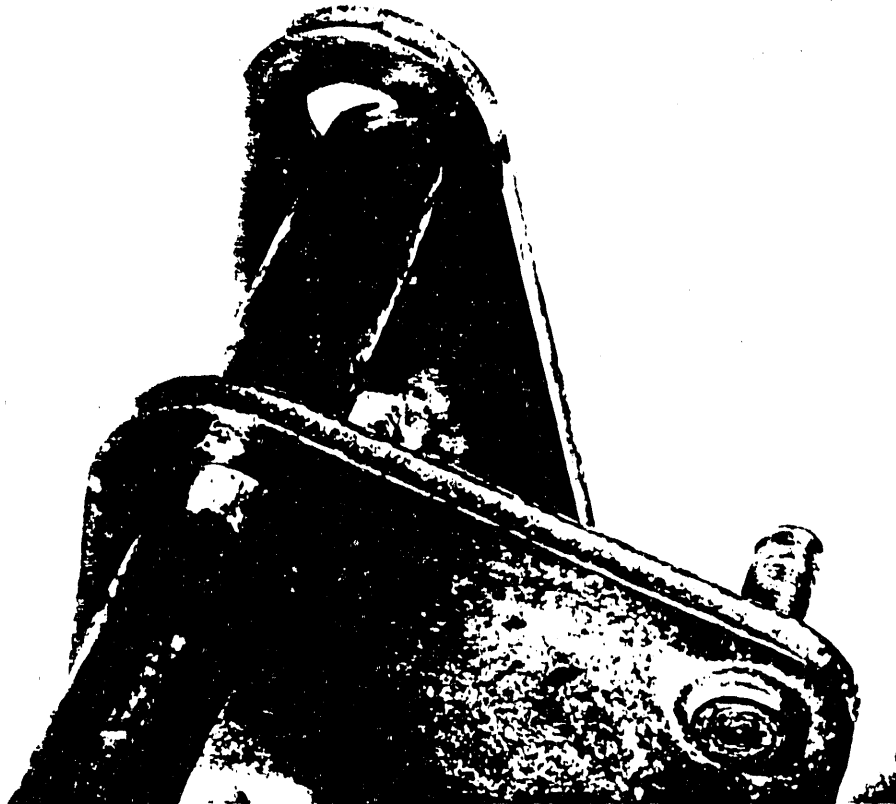
For the second and third shafts, where the weld lengths were larger, cracks were found to develop in both the #3 and #1 pole lever welds simultaneously. On the second shaft, both cracks grew at almost the same rate. After reaching a size of one-fourth their original weld length, misalignment between the five levers connecting to the three poles occurred, as illustrated

in Figure 8. This misalignment later caused the phase A pole pin to fracture. Other problems included failure of the first mechanism and burning of the charging motor. Similar symptoms were noted in the third shaft. However, in this case the cracks never grew large enough to cause misalignment problems. Nevertheless, both these shafts functioned satisfactorily for the first 10,000 test cycles.

Figure 8. Pole lever misalignment

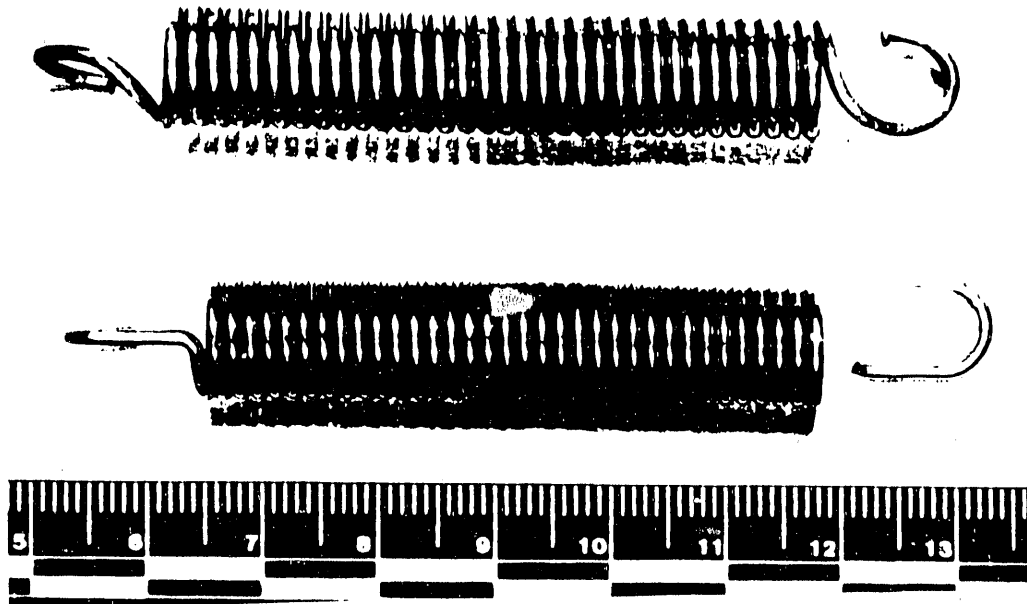
Each time the charging motor is energized, the oscillator pawl reset spring goes through a number of expansions and contractions. The original unit had a smooth transition bend in the neck of the end hooks, while that of a newly procured unit did not (see Figure 10). The new spring, with a sharper bend, failed after 2286 test cycles, while the original unit never failed even after experiencing over 10,000 cycles.

Figure 10. Oscillator pawl reset springs

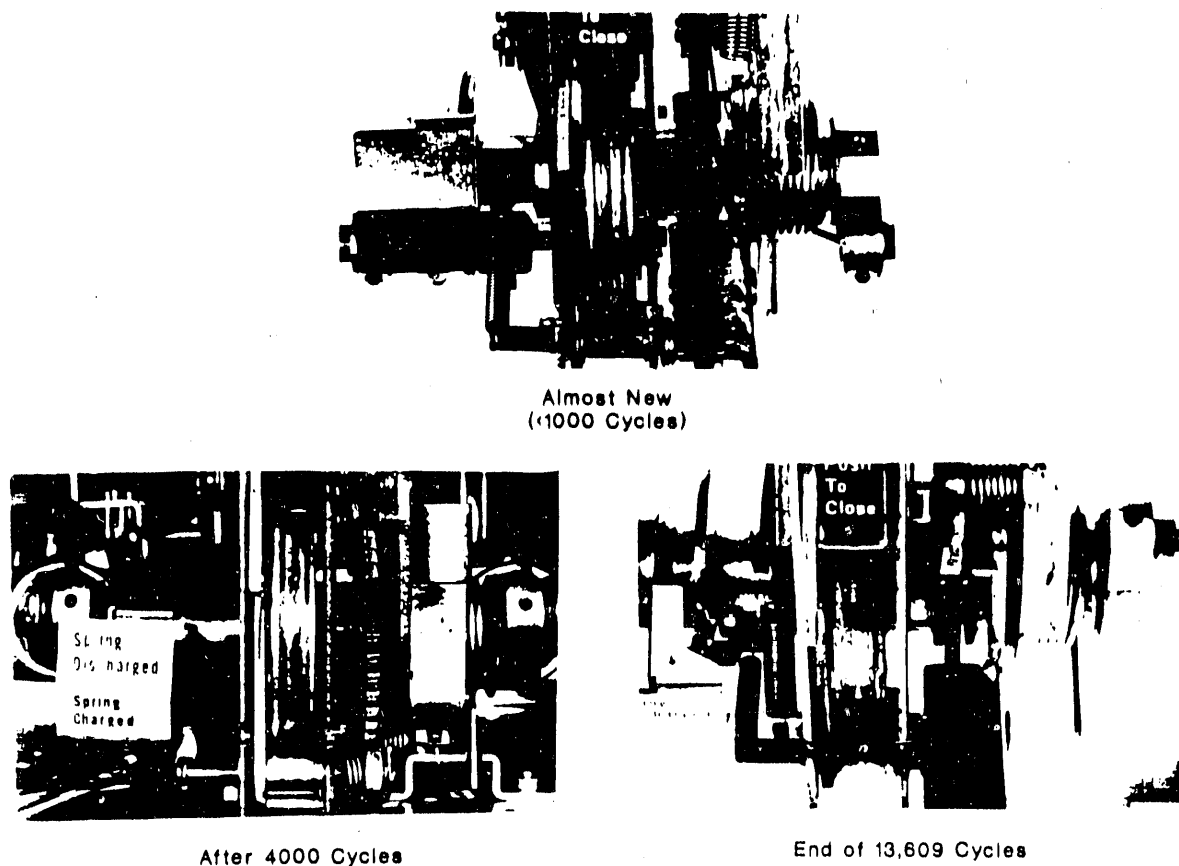
Figure 11 shows the severity of aging as the first mechanism underwent test cycles: the wear on the four cam segments increased with the number of cycles. In addition, the cam assembly loosened and developed a little play within the housing. Grooving in the stop roller and on the cam itself were also evident after disassembling the unit, as illustrated in Figure 12. Further, the inner two cam segments were worn more than the two outer plates.

Figure 11. Wear on cam assembly

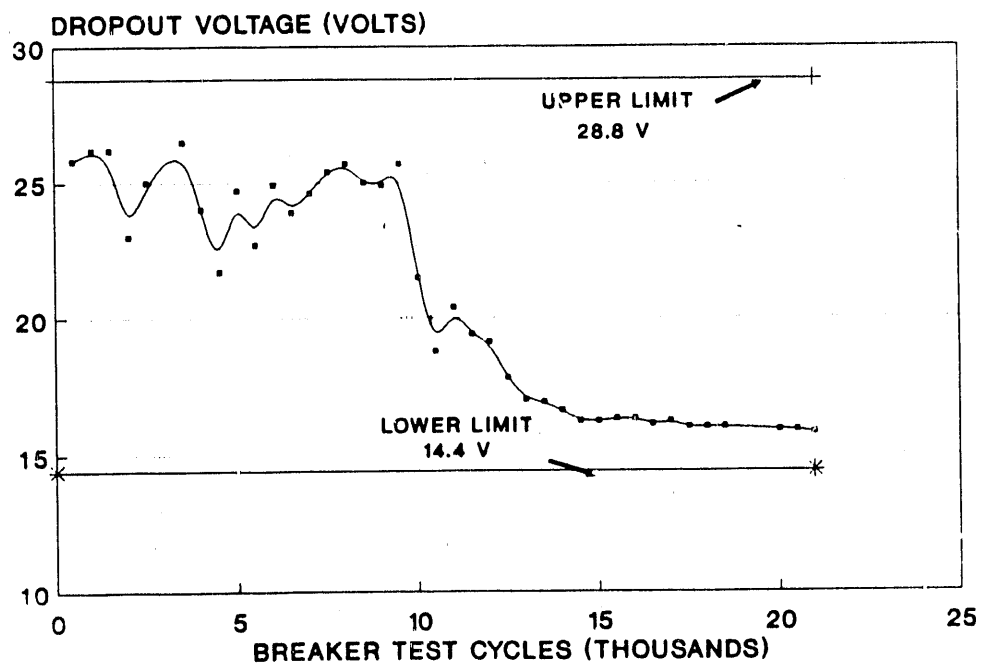
The trip bar, trip latch, and roller constraining link are connected to tripping devices, such as the shunt trip attachment (STA) and/or under-voltage trip attachment. There was no indication of burn out or malfunction of these attachments during the test. Temperature rise, insulation resistance, and threshold voltage (STA was tested for pick up at a voltage of 55% of the rated value and the UVTA was tested for drop out voltage) tests indicated no significant change warranting replacement. However, for the first 10,000 cycles the dropout voltage for the UVTA was closer to the upper limit of 28.8 volts,

while for the remaining life it was closer to the lower limit of 14.4 volts (see Figure 13).

Figure 13. Dropout voltage test on UVTA

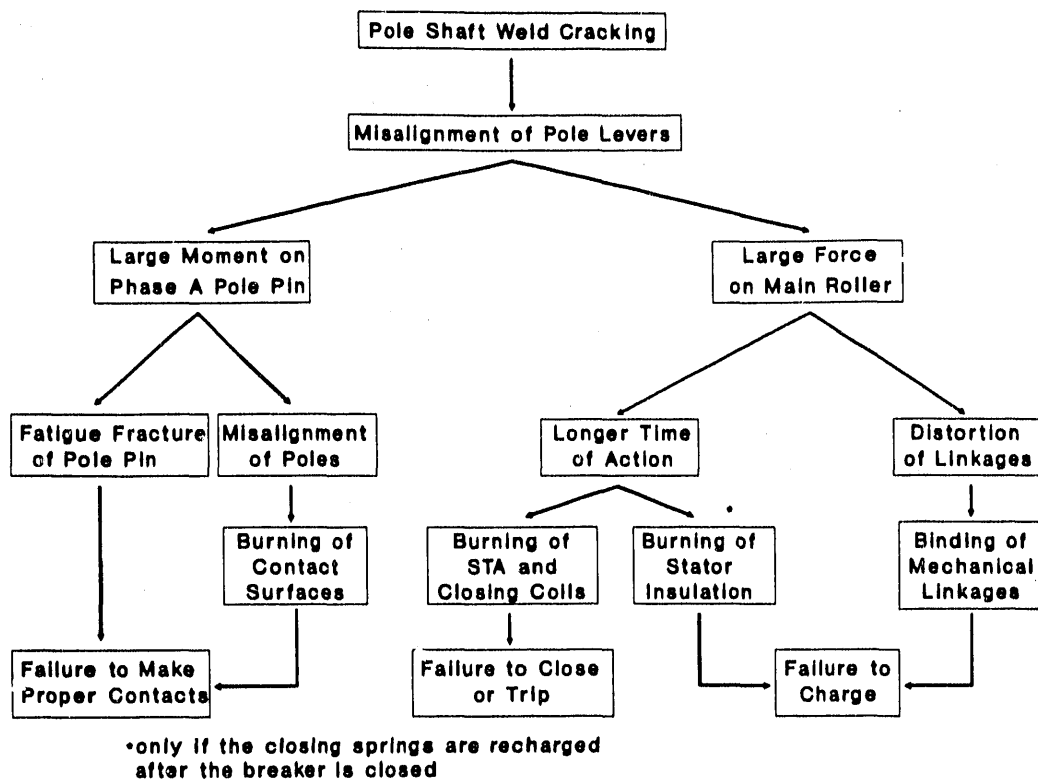
The failure of the pole shaft weld, which recently received a great deal of attention, is analyzed separately. The strain-gage plots suggest that the peak torques experienced by the pole shaft and the tripping time spans change with the age of the breaker. The torque signatures are influenced both by the pole lever weld cracks and aging of various parts within the operating mechanism assembly. Analyzing the test results for the three test shafts, the following two failure modes are associated with pole shaft failures:

- (1) If the quality of the weld in the lever #3 is very bad (i.e., an effective weld size less than 90 degrees, or the presence of cleavages or slugs in the weld), complete separation of lever will occur.
- (2) If the quality of the weld in the lever #3 is normal (i.e., an effective weld size is at least 90 degrees with some level of imperfection such as porosity), cracks in the #1 and #3 welds will develop.

Figure 14. Cause and effect analysis of failure of pole shaft weld

Provided the welds on the pole shaft are good (as designed or passed NRC Bulletin 88-01 requirements), the life of the pole shaft can be well over 12,000 mechanical cycles. Thus, after complying with the NRC Bulletin inspection programs cracking in the pole shaft weld should not be a concern for safety. However, monitoring for possible cracks in the welds #1 and #3 during a breaker overhaul or maintenance would be a good practice.

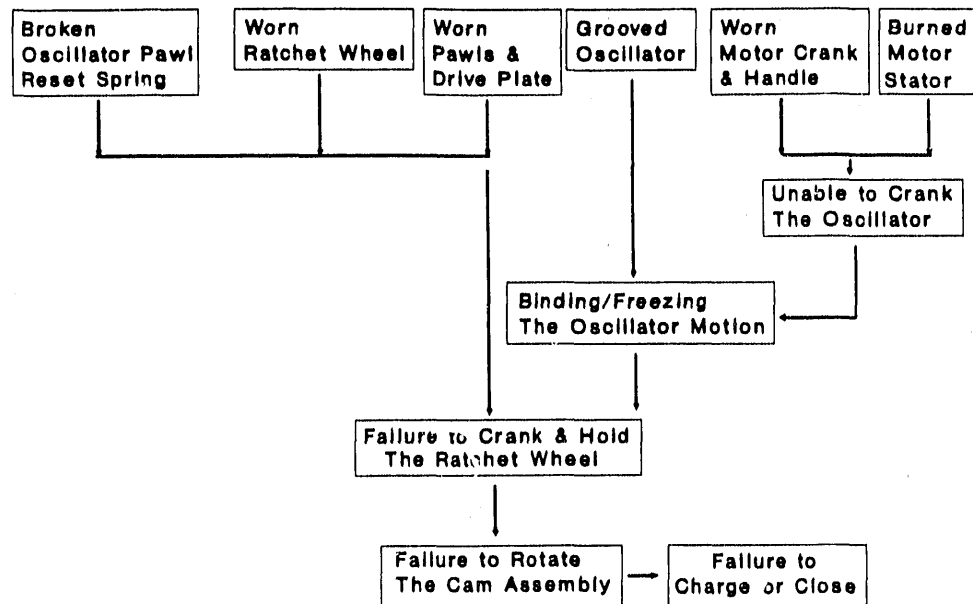
Excessive wear of the teeth in the ratchet wheel and the rounding of pawl and the drive plate edges caused the ratcheting action to slip when the

electric motor began to crank. Furthermore, the grooving on the oscillator surface and wearing of the motor crank and handle caused irregular motion of the crank shaft. Finally, deterioration of insulation in the motor stator windings was a factor in the loss of motive power to the charging components. As a result of these aging problems, the breaker failed either to crank or to hold the ratchet wheel at its proper positions. thus, eventually the breaker failed to rotate the cam assembly to appropriate positions. Figure 15 illustrates the root-cause analysis of parts associated with components responsible for charging the breaker.

Figure 15. Cause and effect analysis of parts responsible for charging the breaker

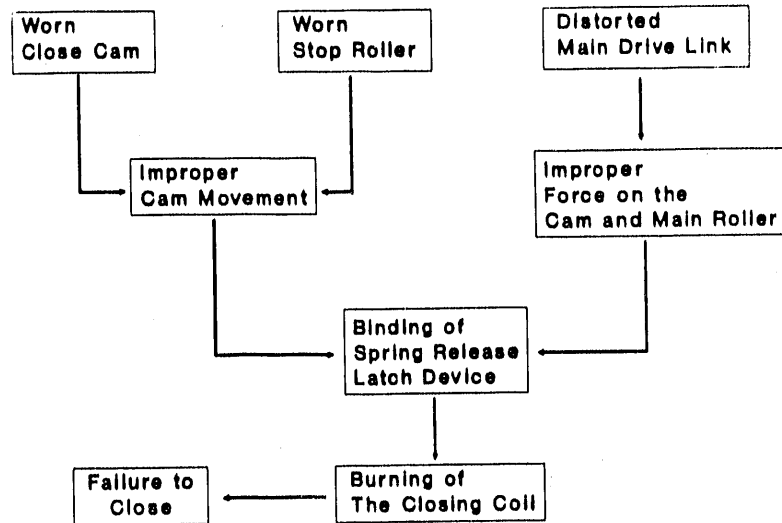
For the parts within the operating mechanism, wear in the cam assembly and the stop roller reduced the ability of the cam to transfer appropriate control to the main drive link. The constant rolling action of the main roller over the cam surfaces, which can be further accentuated by the redistribution of forces on the main drive link by either failure of the pole shaft weld or misalignment, is primarily responsible for wear on the cam. The main roller attached to the main drive link showed some wear and distortion. Aging in all these components often leads to a binding force on the spring release latch which, in turn, leads to burning of the closing coil. Figure 16 shows the cause and effects analysis for this group of components.

Figure 16. Cause and effect analysis of parts in the operating mechanism

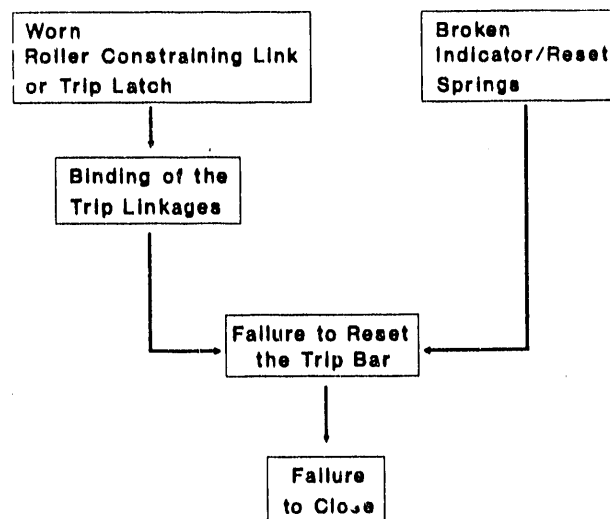
Finally, among all parts within the tripping assembly, the roller constraining link or the trip latch indicated some wear. In addition, there are two small springs, one attached to the left end of the trip shaft, and the other linked to the "trip" indicator plate. Both springs are used to reset the trip bar. Metallurgical examination of the fractured surfaces of the broken trip indicator spring revealed that because of the sharp bend at the ends, a high

stress probably initiated the crack, which grew under cyclic action of this spring. Under these conditions, the trip shaft failed to reset the breaker. Although this never happened in this test program, dwelling of the trip shaft in one position could lead to burning of the STA coils. Figure 17 shows the root cause analysis for this group of breaker components.

Figure 17. Cause and effect analysis of parts in the tripping assembly
