Proof of Product Defect (Metallurgical Case)

Advertised-Product Liability: Proof of Product Defect (Metallurgical Case)

Ellis B. Brannon* (on law and practice)
Robert F. Hehemann** (on engineering aspects)
Keith E. Weigle, Jr., M. D.*** (on medical aspects)

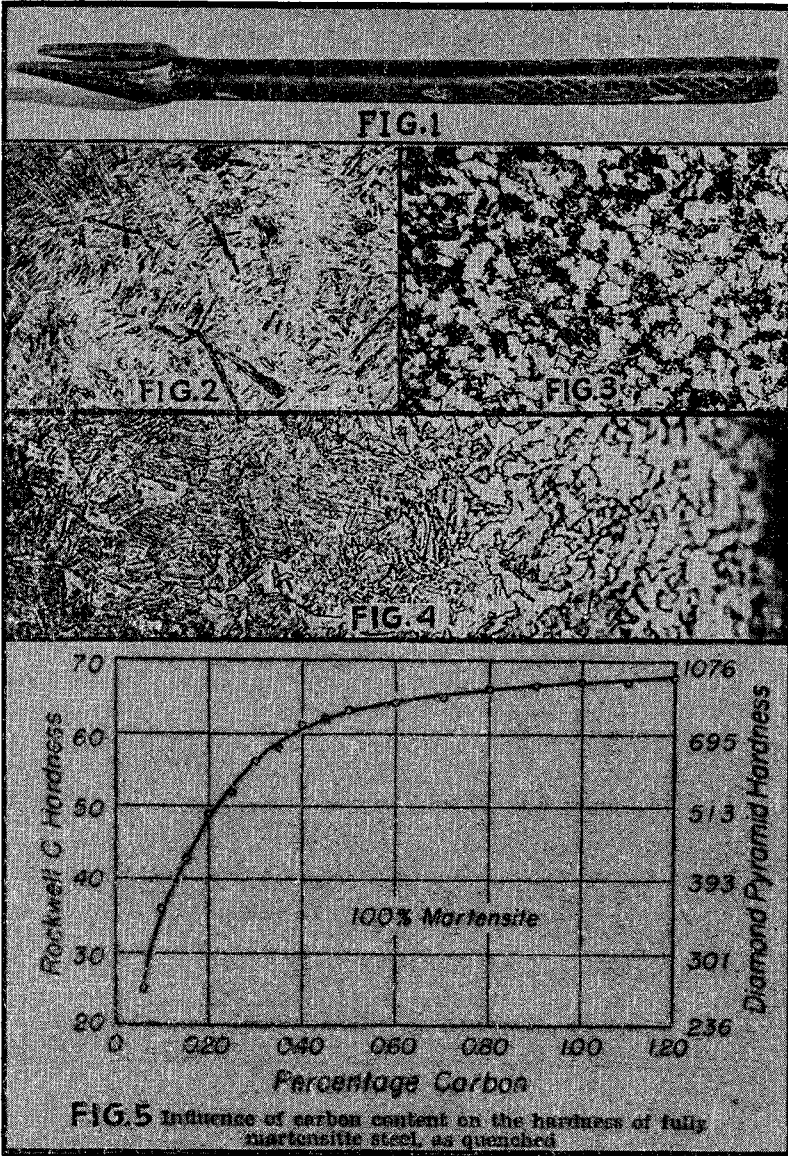
ILLUSTRATION A

In the instant case, the mechanic McCaul did not dress the tool prior to using it. The tool had not been dressed during the 4¼ years of its use. His judgment, whether good or bad, was a question of fact to be decided by a jury. And, in the same tone, a stronger case against contributory negligence would be stated if the accident occurred in the home, where the tool might be used by one not familiar with the reason for dressing the tool. Ill. A, Fig. 1.

Visual examination revealed that a number of chips had spalled from the hammered end of the tool (III. C, Fig. 1 and III. A, Fig. 1). The nature of this spalling suggested that the tool had failed in a brittle fashion. Such failures may result for a number of reasons, for example, inadequate quality of the steel, improper heat-treatment, or other reasons associated with fabricating procedures. Thus, it was important to establish clearly the reason for the brittle failure of this particular tool.

The microstructures of the tool in question and of the new tool are shown in Ill. A, Figs. 2, 3, and 4. Figure 2 in Ill. A was taken at approximately $\frac{1}{4}$ " below the surface of the tool in question and shows that the micro-structure is typical of that for a martensitic structure tempered at a very low temperature. However, the surface of the tool was decarburized⁸ severely, as demonstrated by the structural gradations illustrated in Ill. A, Fig. 4.

The structure of the new tool (ferrite plus pearlite, as shown in Ill. A, Fig. 3) indicates that this tool had not been quenched properly from an adequate hardening temperature (such as 1550° F.)

Data in the literature⁹ indicates that, for section sizes smaller than 1.4" in diameter, 8640 steel will be hardened throughout when oil quenched from 1550° F. while 4140 will harden throughout in section sizes up to 2.0" in diameter when quenched under the same conditions. Thus, since these tools are less than 1" in diameter, the hardening treatment specified by the manufacturer (oil quench from 1550° F.) would produce hardening (produce a martensitic structure) over the entire cross section of the tool. This was the case for the tool in question (see Ill. A, Fig. 2) but

was not true for the tools of recent manufacture. The hammered ends of the new tools either were never heated above about 1350° F. or else they were cooled so slowly from a higher temperature (such as 1550° F.) that they failed to harden (see Ill. A, Fig. 3).

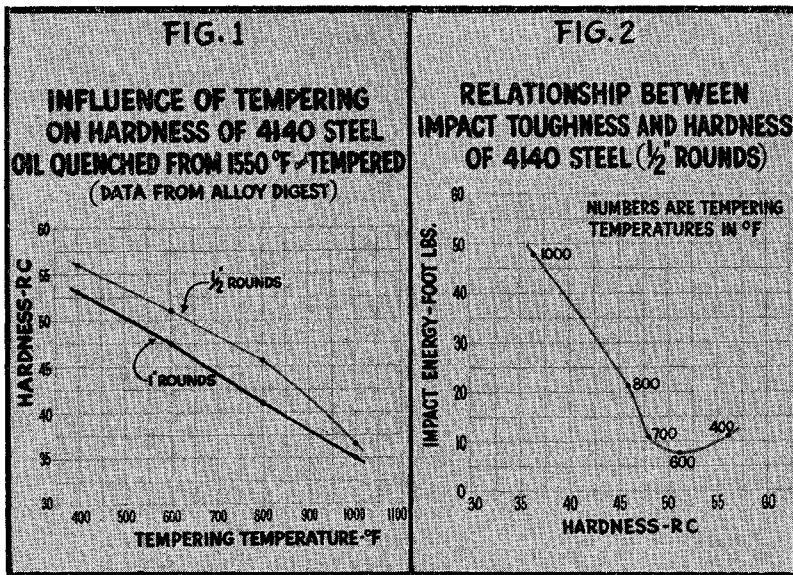
ILLUSTRATION B

Toughness is measured qualitatively by determining the energy required to break a sample in an impact test. Illustration B, Fig. 2 shows the influence of hardness on the toughness of 4140 steel.¹¹ Note that the toughness increases rapidly as the hardness is lowered (by increasing tempering temperature). Thus, it is apparent that hardness and toughness are essentially reciprocal properties, i.e., a hard steel has low toughness and consequently will break in a brittle fashion.

The practical significance of these observations in the present problem is that at a high hardness (56 Rc), a quenched and tempered steel is brittle. Thus, it takes little energy to break the steel so that it will chip or spall cataclysmically under a single blow. At lower hardness (higher toughness), the steel will deform gradually under repeated blows (called mushrooming) and thus give adequate forewarning of impending failure.

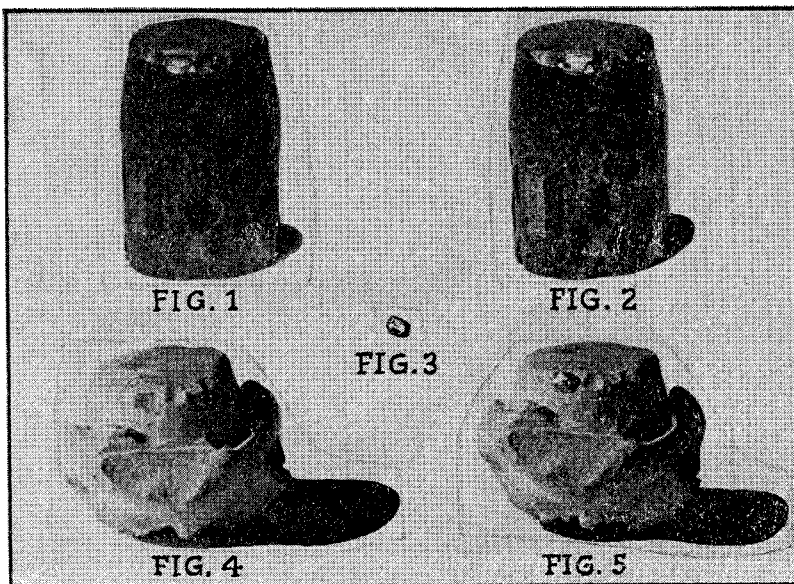
ILLUSTRATION C

For safety it is better that shock tools, some of which can be dressed frequently, be a little soft rather than too hard, because a chip may fly from an excessively hard tool without warning when the tool is struck with a hammer or sledge¹² (Ill. C, Figs. 1 and 3).

The wedge tool was presented to a dentist with instructions to make a gold inlay, reduplicating the fragment from a specific defect in the tool as closely as possible. The defect in the blunt end of the tool is shown in Illustration C, Fig. 1. The inlay was made using a direct technique which consisted of filling the cavity with wax to contour, then casting the wax impression in gold using a dental procedure known as the "Lost Wax Technique." The gold inlay representing the fragment is seen in Illustration C, Fig. 3. A perfect fit was obtained when the gold inlay was placed in the defect around the radius of the blunt end of the tool (Ill. C, Fig. 2). To polish the gold inlay to as near perfect a fit as possible, another procedure was carried out which allowed the inlay to be polished without disrupting in any way the edges or the contour of the defect in question on the wedge tool. This procedure consisted of making an impression of the blunt end of the tool in a dental impression material (in this instance an irreversible alginate). Dental stone was poured into this impression resulting in a model of the blunt end (Ill. C, Fig. 4). The gold inlay then was finished and given its final form by being polished while it was situated in the defect of the model (Ill. C, Fig. 5). The next step was to obtain radiographs of the artificially created gold fragment, approximating as closely as possible the same conditions prevailing when films of the patient's orbit were obtained. When this was carried out, using standard techniques, direct comparison of the profile of the gold inlay (Ill. D, Fig. 2) to the profile of the metallic foreign body seen in the patient's right orbit (Ill. D, Fig. 1) showed a striking similarity relative to both size and configuration. Fortunately, the fragment presented several features relative to its configuration that made comparison, and hence identification quite certain. For further clarification, radiographic magnification techniques¹⁴ were carried out, and this allowed further comparison of the magnified views of the patient's orbit containing the metal fragment (Ill. E, Fig. 1) with the magnified views of the gold inlay (Ill. E, Fig. 2). The results of this investigation seemed to show quite conclusively that the metallic foreign body in the patient's right orbit matches

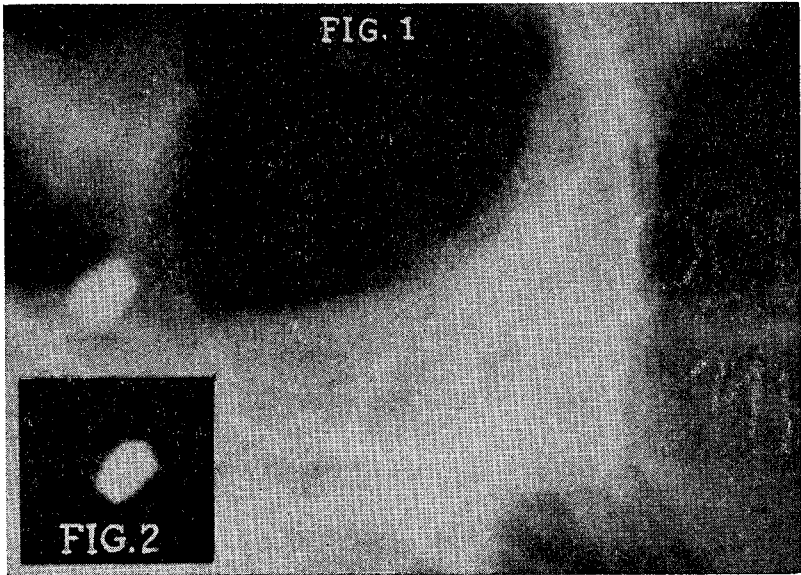
ILLUSTRATION E

the gold inlay created from the defect in the blunt end of the tool, both as to size and configuration. There was little doubt that the source of the metal fragment imbedded in plaintiff McCaul's right orbit had been established.
