Collapse of 2000 Commonwealth Avenue: Punching Shear Case Study

Suzanne King, S.M.ASCE,¹ and Norbert J. Delatte, M.ASCE²

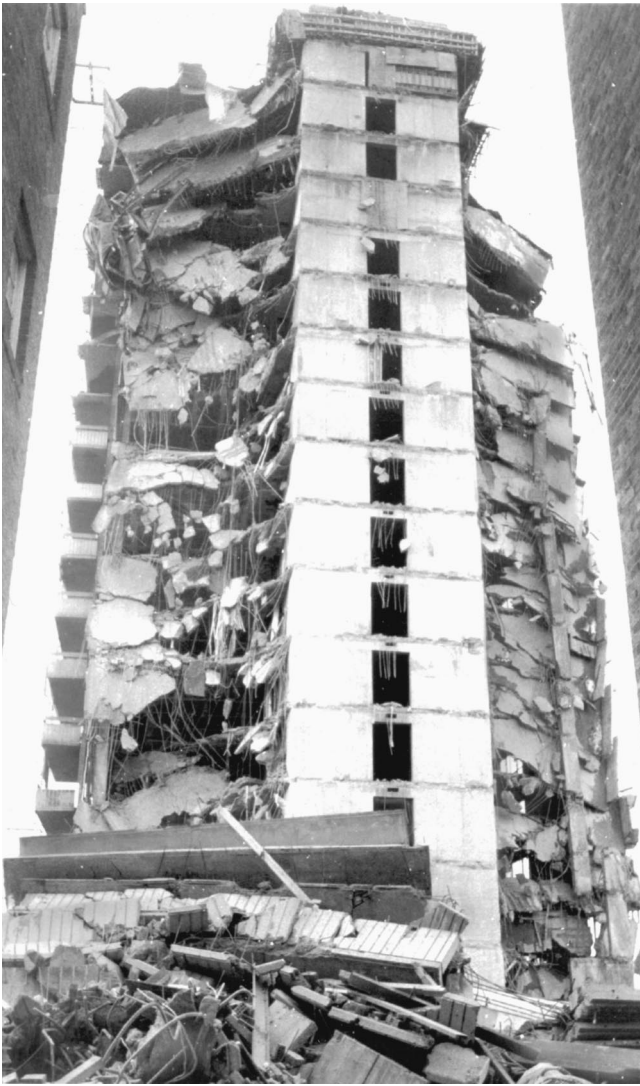
Fig. 2. Building collapse; four men missing and three injured when apartment under construction collapsed in Brighton [from *Boston Globe*, January 26, 1971; republished with permission]

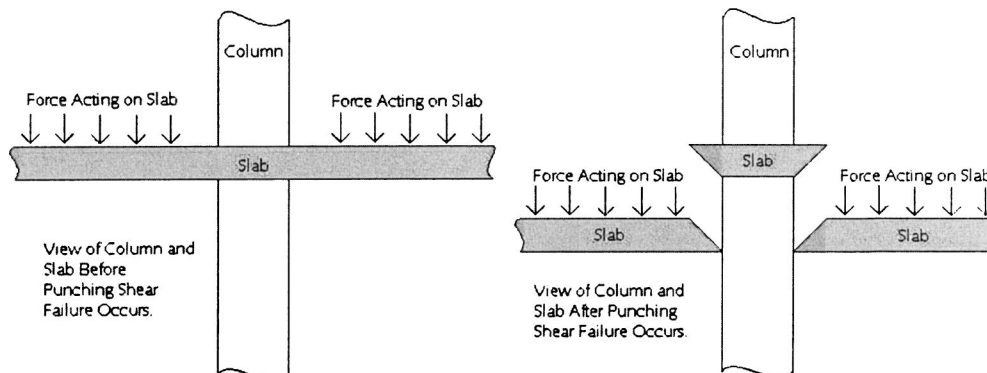
Fig. 5. Punching shear mechanism

Punching shear is usually the critical failure mechanism for flat slab reinforced concrete structures. This mechanism is illustrated in Fig. 5. With this type of failure, the column and part of the slab punch through the slab as it moves downward.

The force acting on the slab around a column overcomes the resistance and the slab falls down around the column. A portion of the slab is left around the column, but the remainder of the slab falls to the next floor. If the lower slab is unable to hold up both floors, then a progressive collapse will begin.
