INVESTIGATING PERFORMANCE OF BONDED CONCRETE OVERLAYS

By Norbert J. Delatte Jr.,¹ Member, ASCE, David W. Fowler,² Fellow, ASCE,
B. Frank McCullough,³ Member, ASCE, and Stefan F. Gräter⁴

ABSTRACT: A bonded concrete overlay (BCO) is a concrete pavement rehabilitation method used to extend the life of an existing concrete pavement. The BCO should bond fully with the existing concrete, leading to a thicker composite pavement section, a much stiffer pavement, and a considerable decrease in pavement stresses. For one project, cost estimates for a BCO were half as much as for full-depth replacement of a pavement. In some cases BCOs have delaminated shortly after construction. This paper proposes a framework for identifying the causes of early age delamination in BCOs. The early age behavior of newly constructed BCOs is examined. The factors affecting the long-term performance of the BCO are the quality of the surface preparation, the materials used in the BCO, and the curing of the BCO. Weather monitoring during BCO construction is recommended. Methods of detecting and mapping delaminations are discussed. Several BCO delamination case studies are analyzed using this framework. The model

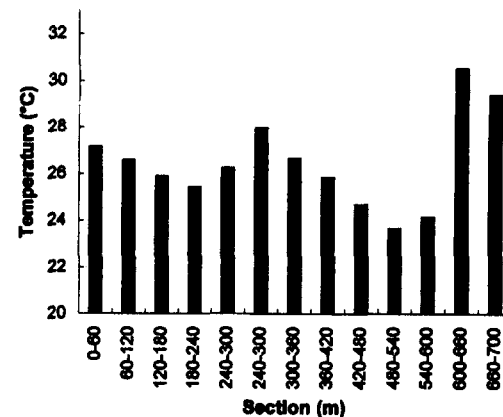
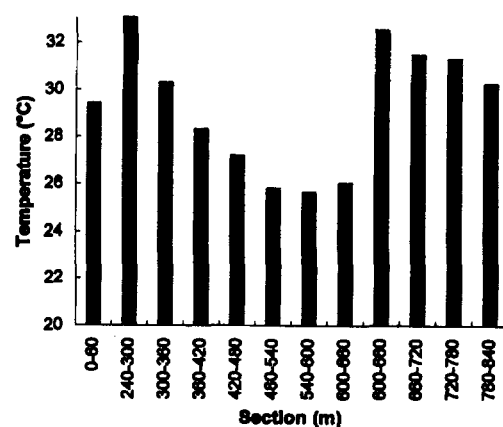
In order to find possible causes for the delamination, the weather station data gathered during the placement of the overlays were analyzed, as well as the concrete mix moisture content. Ambient temperatures and water evaporation rates were studied for the periods that concrete was placed. Information was provided by correlating the time of placement and the section placed. Figs. 9 and 10 present the average temperatures during the construction period for the eastbound and westbound lanes, respectively. The most critical temperatures occurred while the westbound lanes were overlaid, especially the 240–400 m section, which includes the only unbonded section in that direction, where the average temperature was 33°C. In the eastbound direction, the temperatures were not as high, but the two sections with highest temperature recordings (between 600 and 700 m) had unbonded segments.

FIG. 9. Average Ambient Temperatures during Eastbound Lane Construction

FIG. 10. Average Ambient Temperatures during Westbound Lane Construction

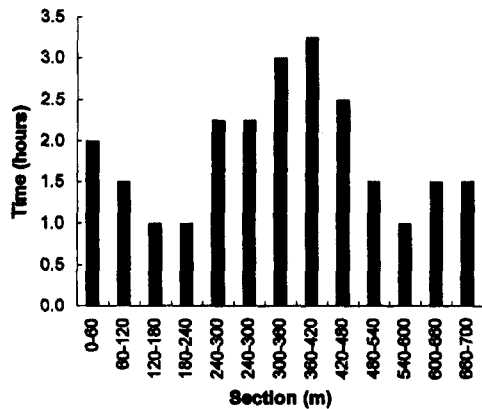
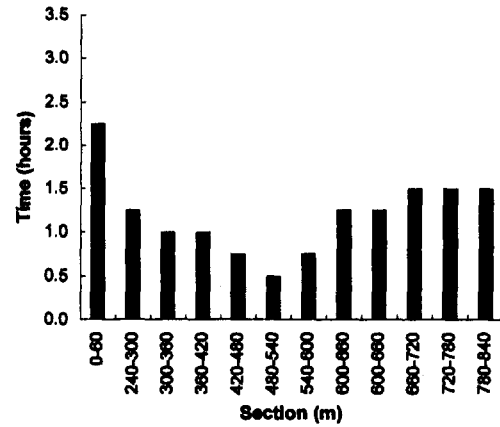
FIG. 13. Time between Concrete Placement and Application of Curing Compound on Eastbound Lane

that was dry to start with in order to satisfy the strength requirement may have lost critical water required for adequate adhesion. Figs. 13 and 14 illustrate the time after overlay construction until curing, for the eastbound and westbound lanes, respectively. In some cases, the surface of the overlay for the eastbound lanes lost moisture for about three hours before the curing process started. Limiting water loss to evaporation is an important construction aspect that should be carefully followed up to avoid delaminations in the future.

FIG. 14. Time between Concrete Placement and Application of Curing Compound on Westbound Lane
