Analysis of Uncontrolled Concrete Bridge Parapet Cracking

ANALYSIS OF UNCONTROLLED CONCRETE BRIDGE PARAPET CRACKING

The Ohio Department of Transportation has recently identified the problem of wide-spread premature cracking of concrete bridge parapets throughout its District 12 region (Northeast Ohio). Many of the bridge decks that contain these prematurely cracked parapets are of relatively recent construction. In severe cases, replacement of the parapet may be required before replacement of the bridge deck itself. This incurs a sunk cost upon the bridge owner, as the parapets will again be replaced during the regularly scheduled replacement of the bridge deck. In a recent instance, the replacement of a cracked parapet (without replacing the deck) cost District 12 approximately \$140,000. In addition, parapet walls are a crucial safety feature of roadway bridge construction, and severe deterioration of these barriers could introduce a significant safety hazard.

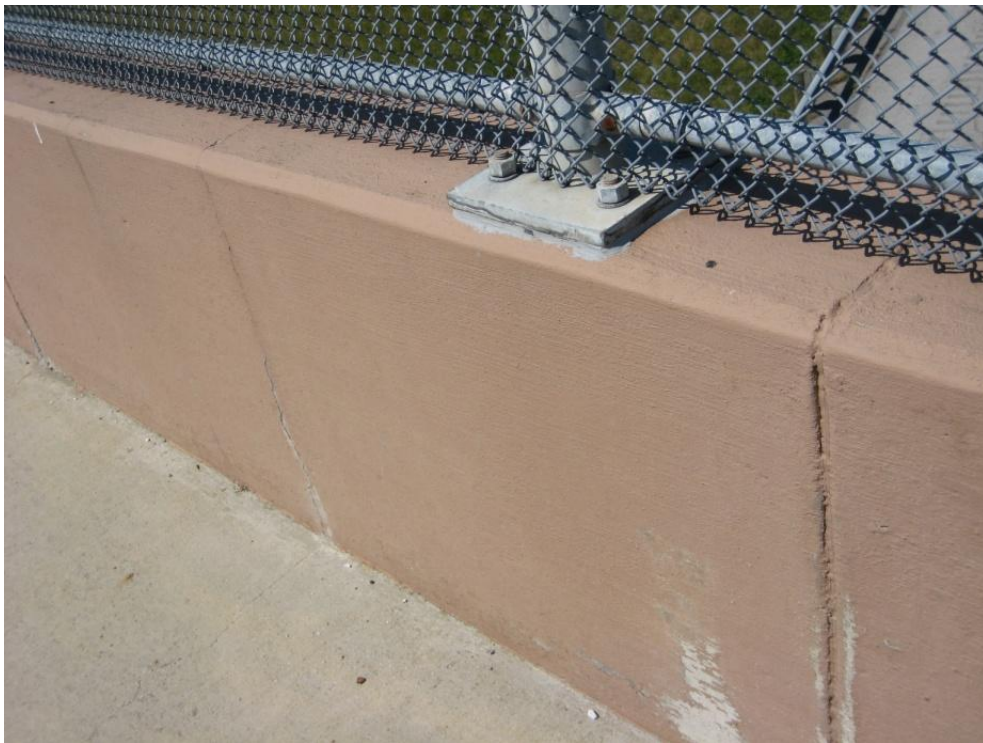
cracks located a few inches below the top of the parapets, vertical cracks located approximately midway between control joints, and vertical cracks located near or directly below the vandal protection fence post base plates. The widespread nature of these crack types implies that there may be an inherent flaw in the design and/or construction specifications of certain aspects which contributes to premature cracking of the parapet at these locations. Examples of cracks are shown in Figures 9 through 15.

Figure 9: Vertical crack midway between control joints, Canterbury Road

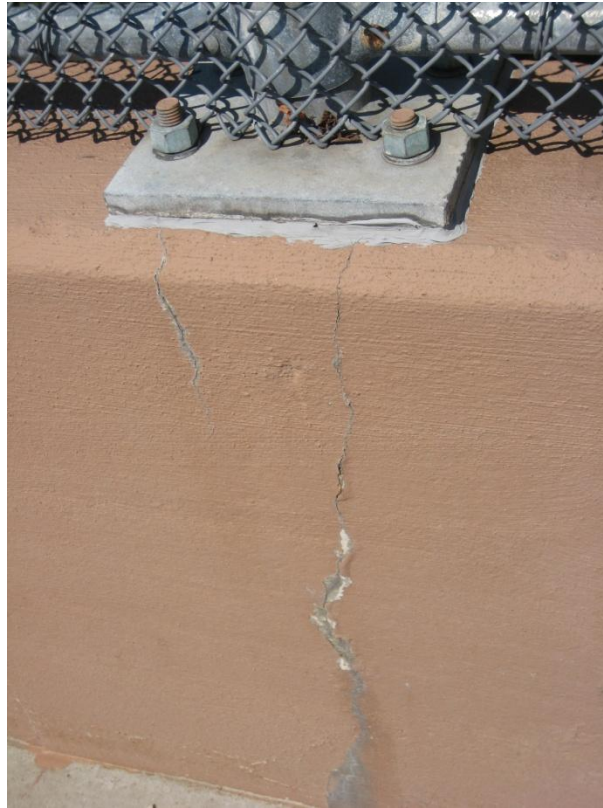
Figure 10: Crack below VPF base plate, Canterbury Road

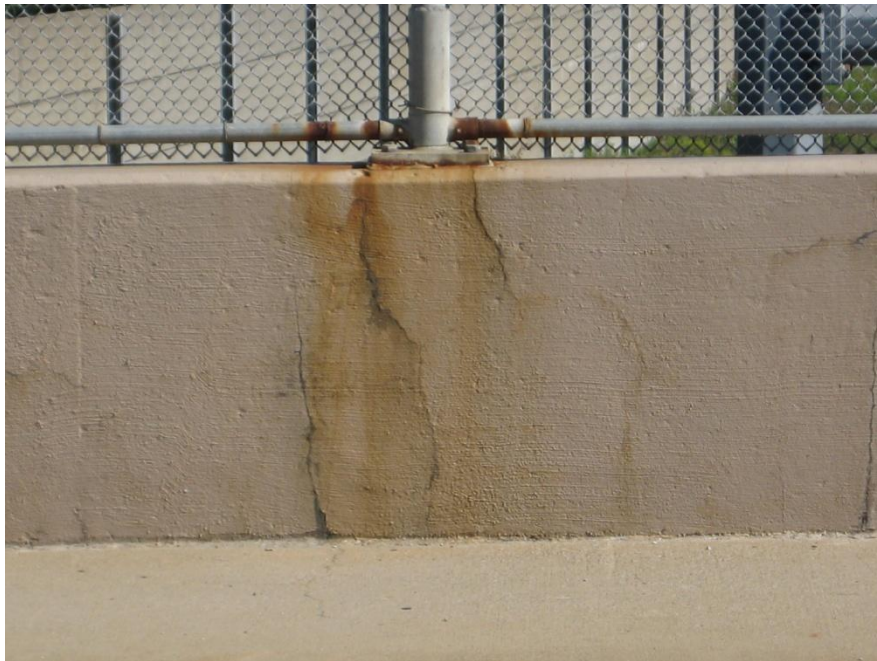
Figure 11: Crack below VPF base plate, Sheldon Road

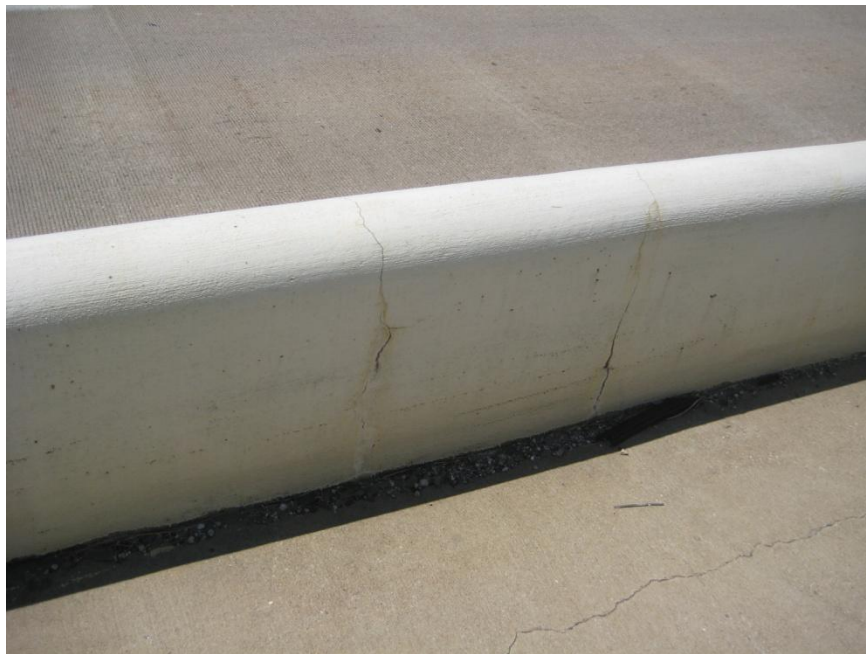
Figure 12: Vertical cracks on inner parapet midway between control joints, Spring Road

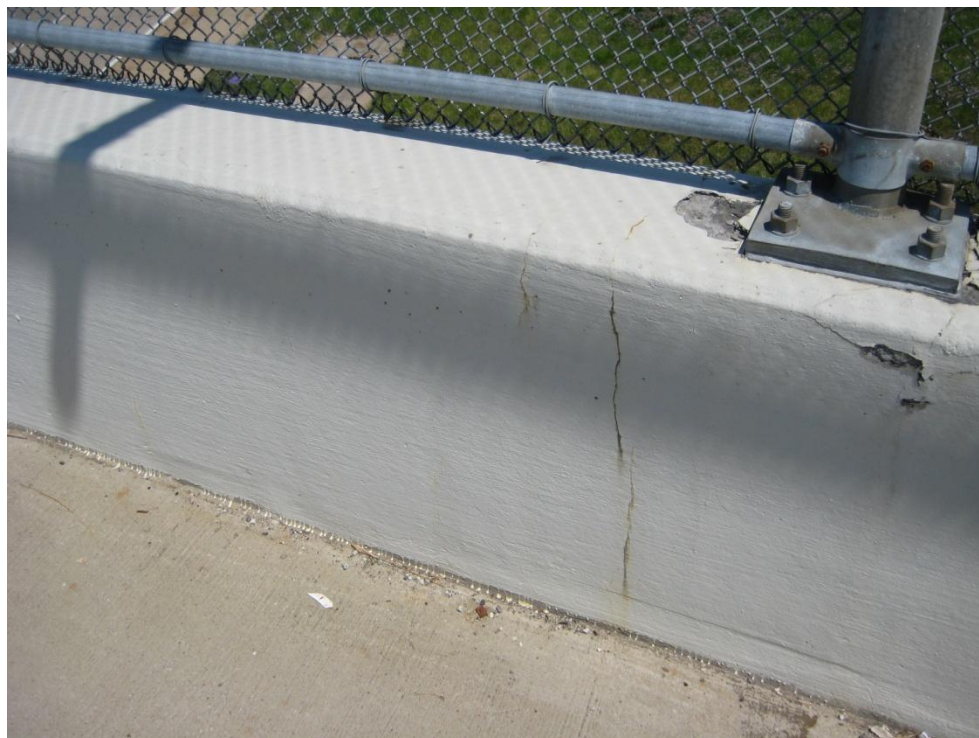
Figure 13: Cracking and flaking below VPF base plate, Spring Road

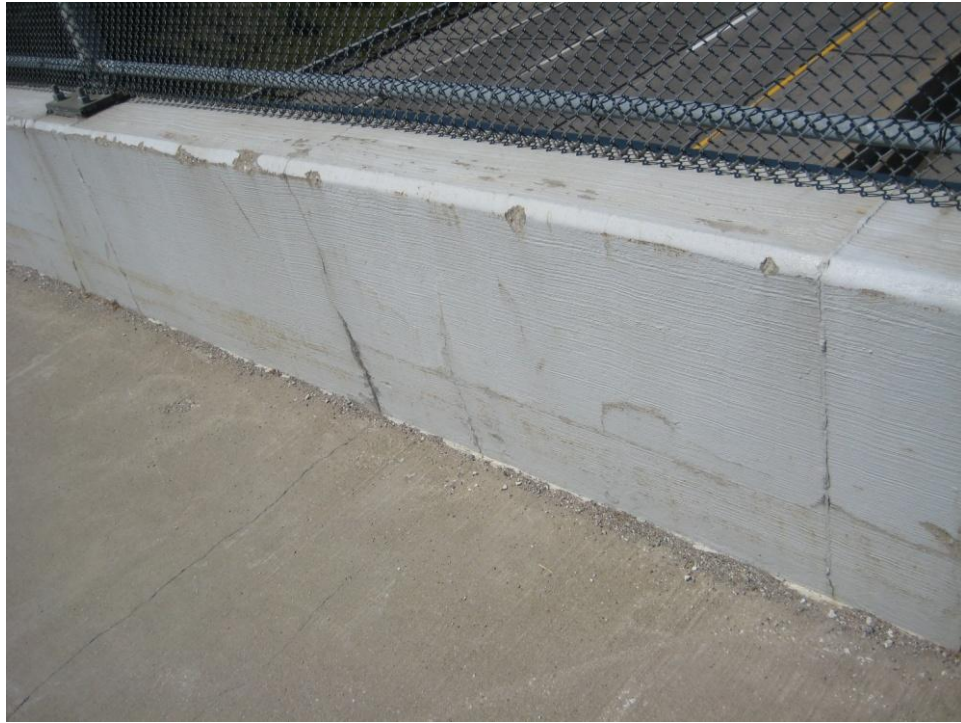
Figure 14: Vertical crack midway between control joints, Wagar Road

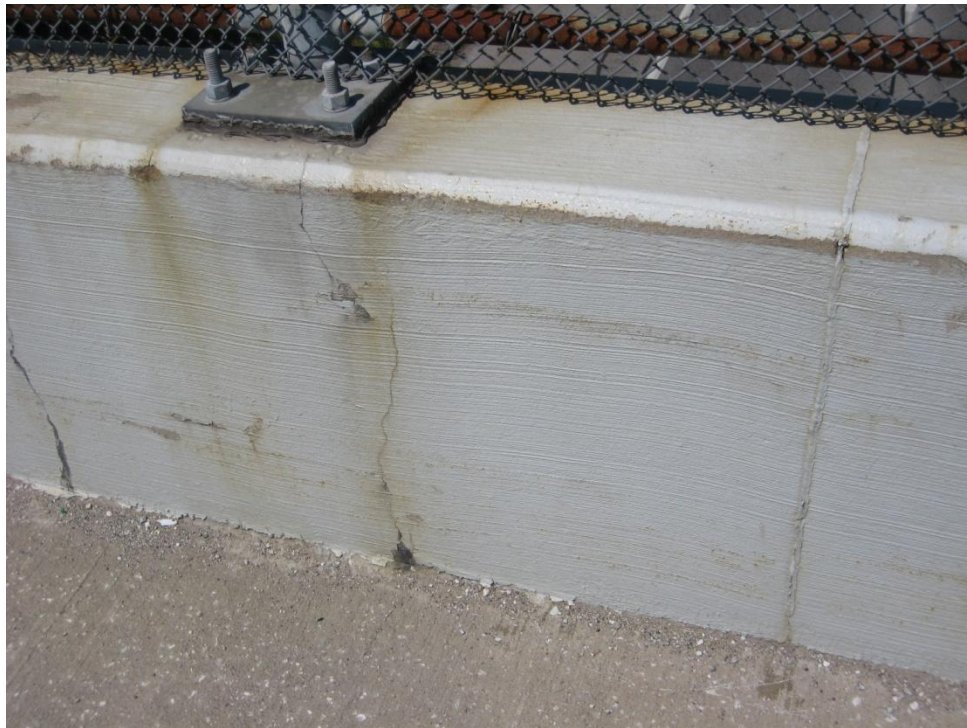
Figure 15: Crack below VPF base plate, Wagar Road

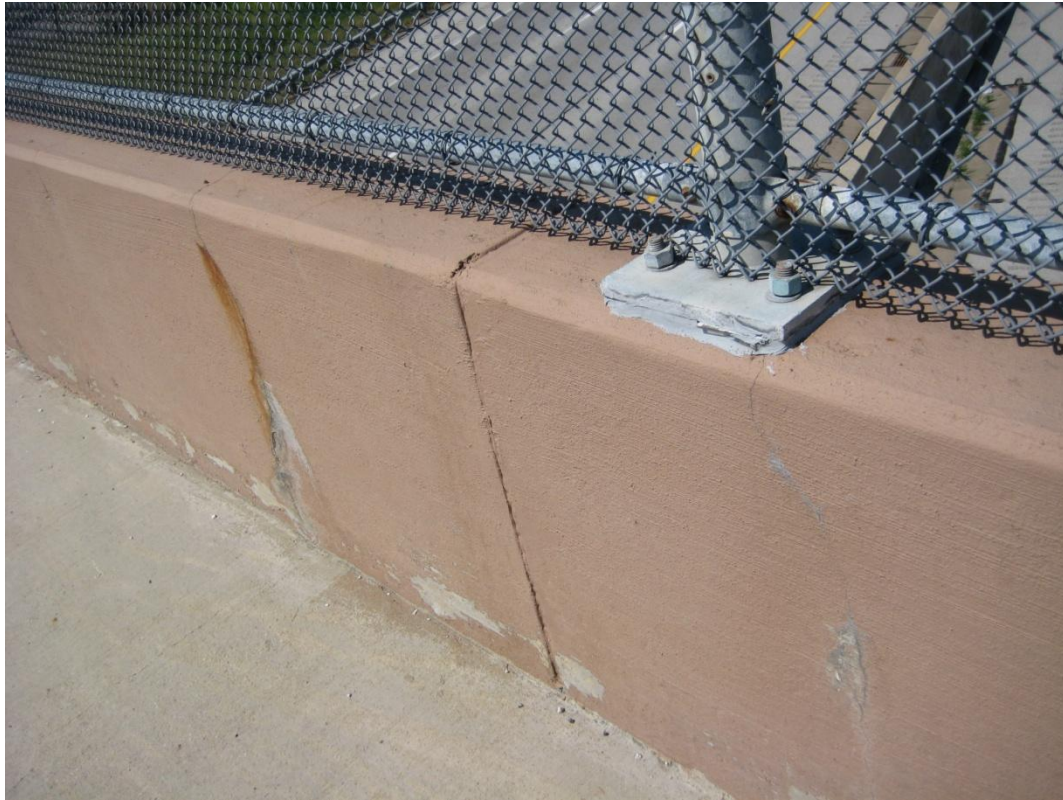
Another major observation is that many of the control joints in the parapets are improperly or poorly constructed. Specifications typically call for a ¼ inch (6 mm) wide, 1 ¼ inch (32 mm) deep sawcut joint, spaced in the range of six to ten feet (1.8 to 3.0 m). The sawcut should extend through the full height of the parapet on both sides and is to be filled with a sealant material all the way around the sawcut, except for the bottom two inches at the base of the parapet to allow moisture to drain out. However, the majority of control joints observed in the field contained at least one and sometimes several of the following discrepancies: sawcuts less than 1 ¼ inches (32 mm) deep (often measured to be around ½ inch (13 mm)), poor quality application or complete absence of the joint sealant, joints that are completely sealed to the bottom and do not allow for moisture drainage, sawcuts that terminate several inches above the base of the parapet, and joints located too close to a VPF base plate. These are shown in Figures 16 through 19.

Figure 16: Completely sealed control joint, Canterbury Road

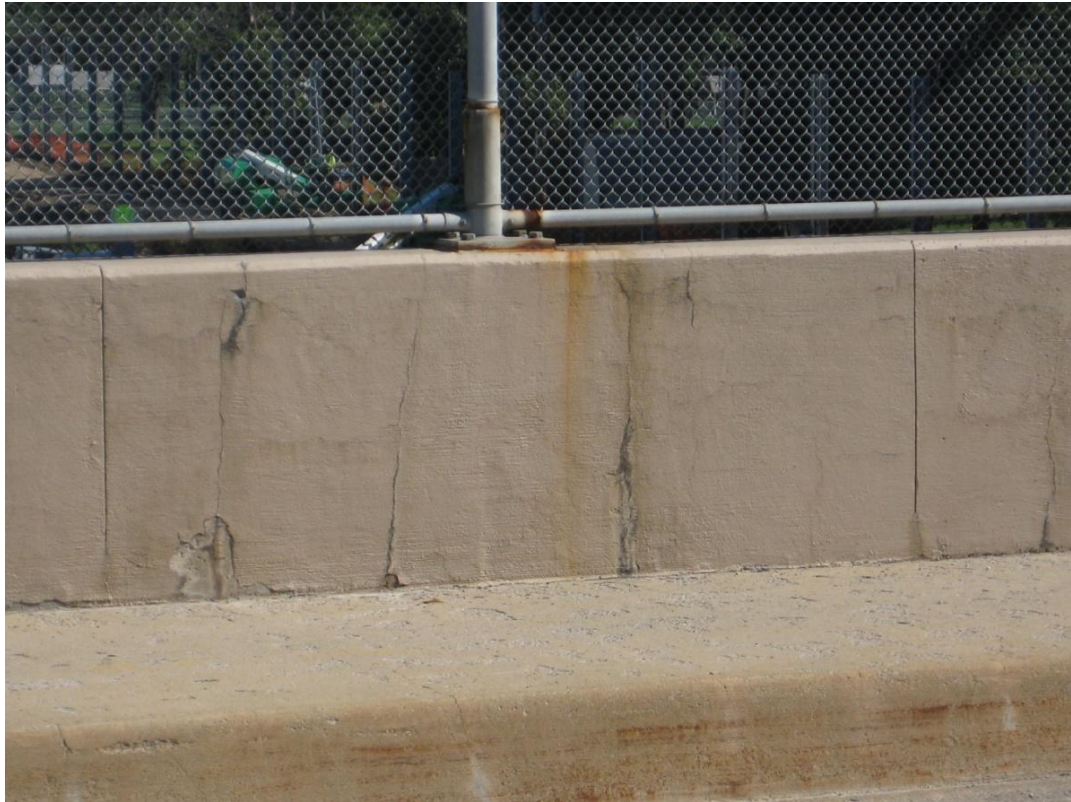
Figure 17: Unsealed control joints with incomplete sawcuts, Sheldon Road

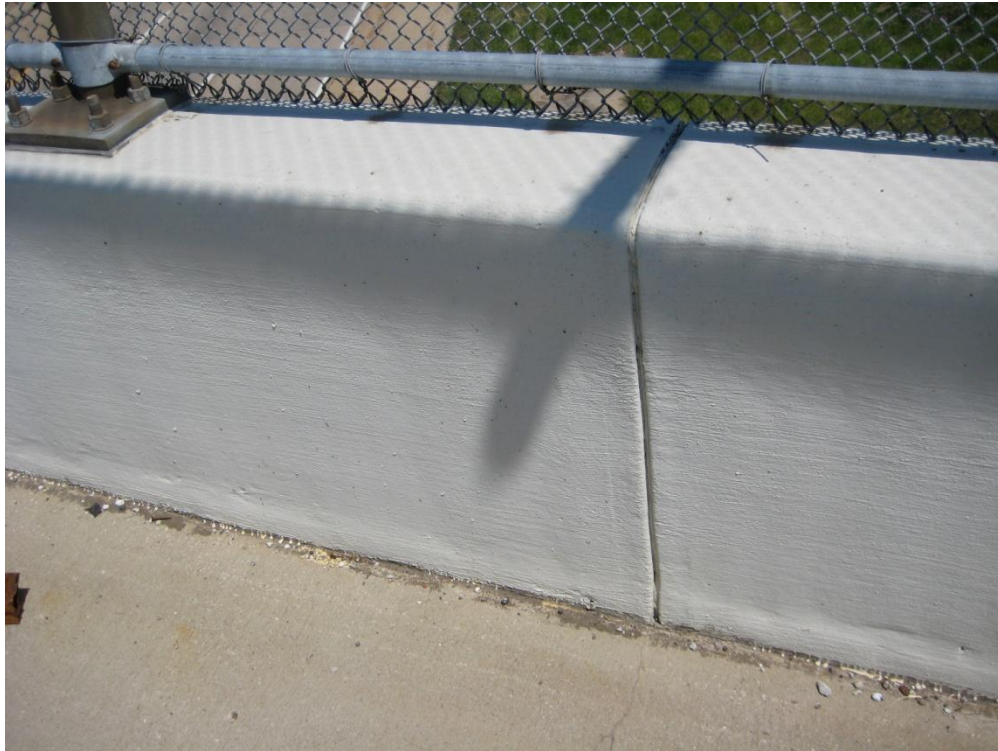
Figure 18: Completely sealed control joint, Spring Road

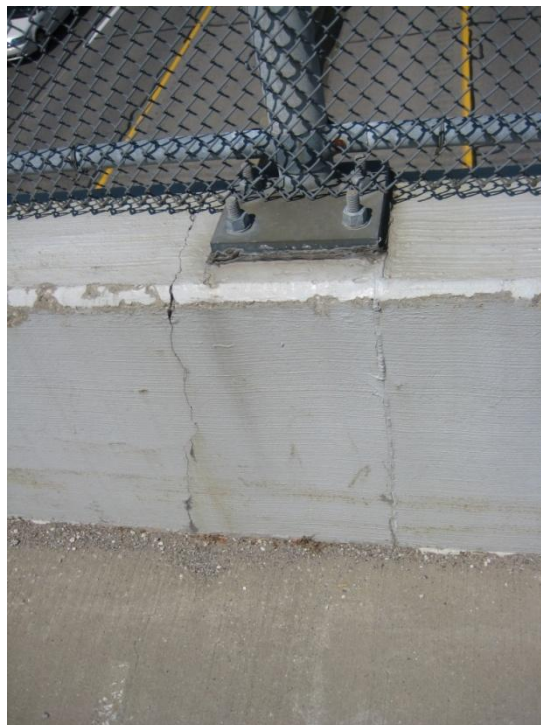
Figure 19: Completely sealed joint located directly below VPF base plate, Wagar Road

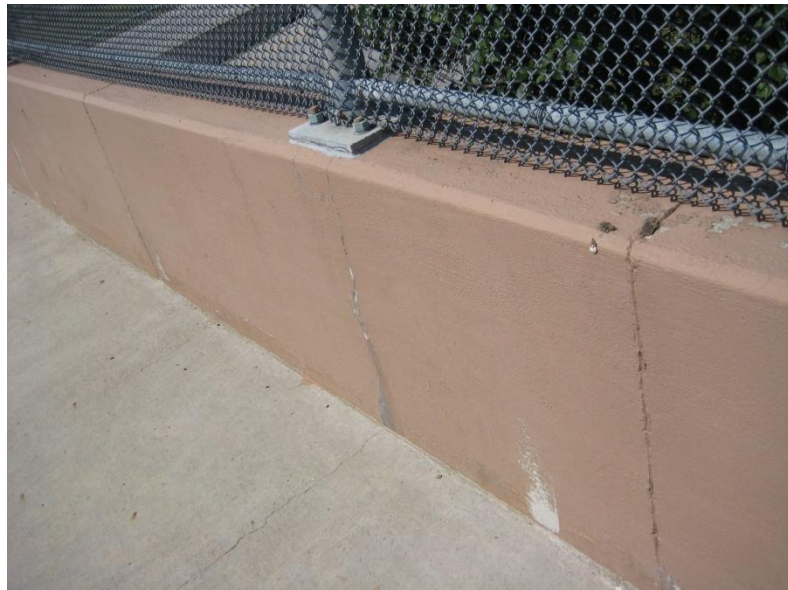
Another major observation is that many of the vertical parapet cracks continue through the sidewalks and bridge deck. These are visible as a completely continuous transverse crack through the concrete deck and superstructure. This phenomenon implies that a high degree of continuity is present between the bridge deck and sidewalk and between the sidewalk and parapets,. High continuity between components subsequently creates a higher degree of composite structural action, as tensile stresses are shared among the components. These are shown in Figures 20 through 22.

Figure 20: Continuous crack through sidewalk, Canterbury Road

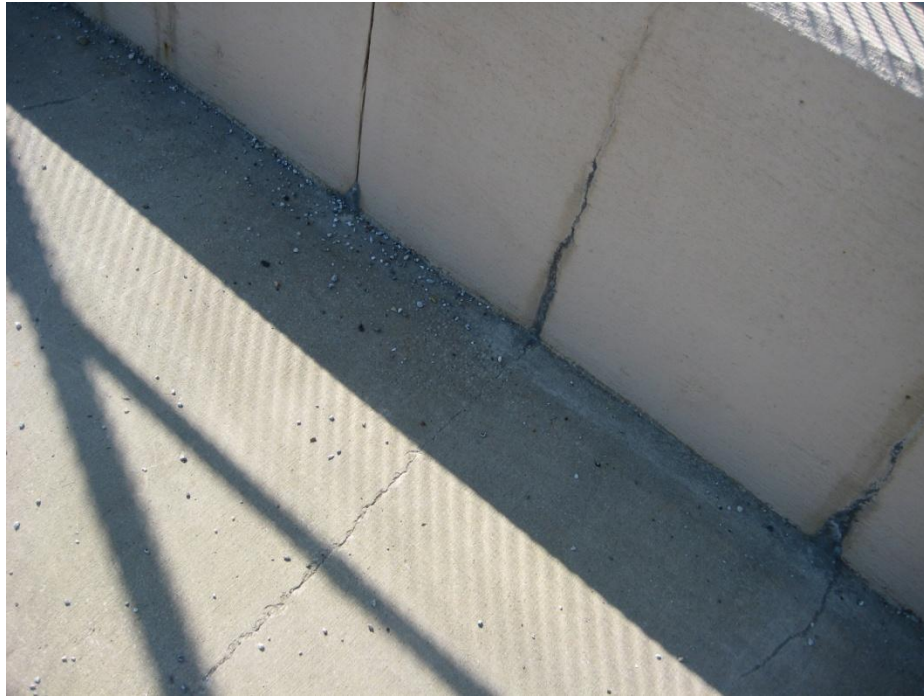
Figure 21: Continuous crack through sidewalk, Sheldon Road

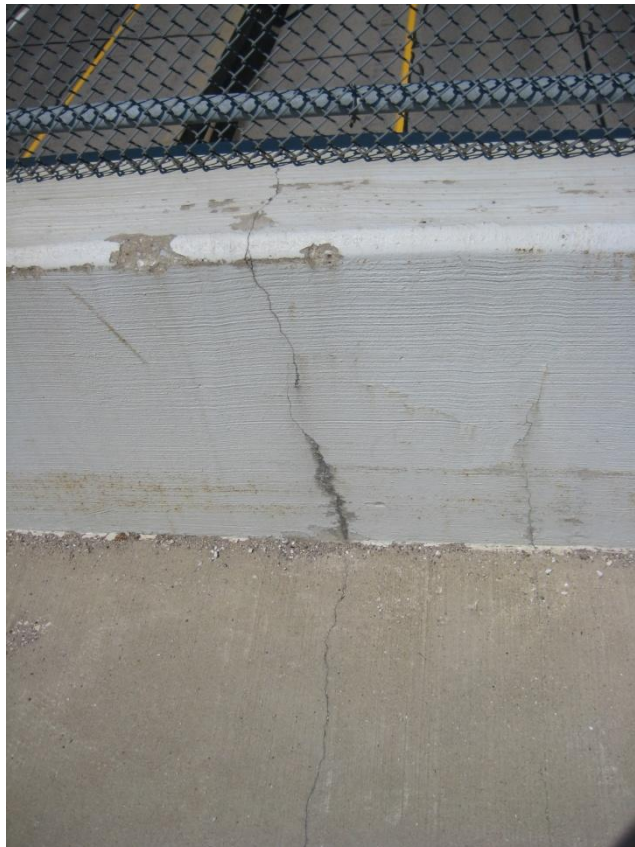
Figure 22: Continuous crack through sidewalk, Wagar Road
