Evaluation of bridge decks using non-destructive evaluation (NDE) at near highway speeds for effective asset management-implementation for routine inspection (Phase III)

Evaluation of Bridge Decks Using Non-Destructive Evaluation (NDE) at Near Highway Speeds for Effective Asset Management – Implementation for Routine Inspection (Phase III)

**Element Level Condition State Assessment,
Comparison to Traditional Methods, and Cost and
Time Comparison Analysis mini reports**

October 09, 2018

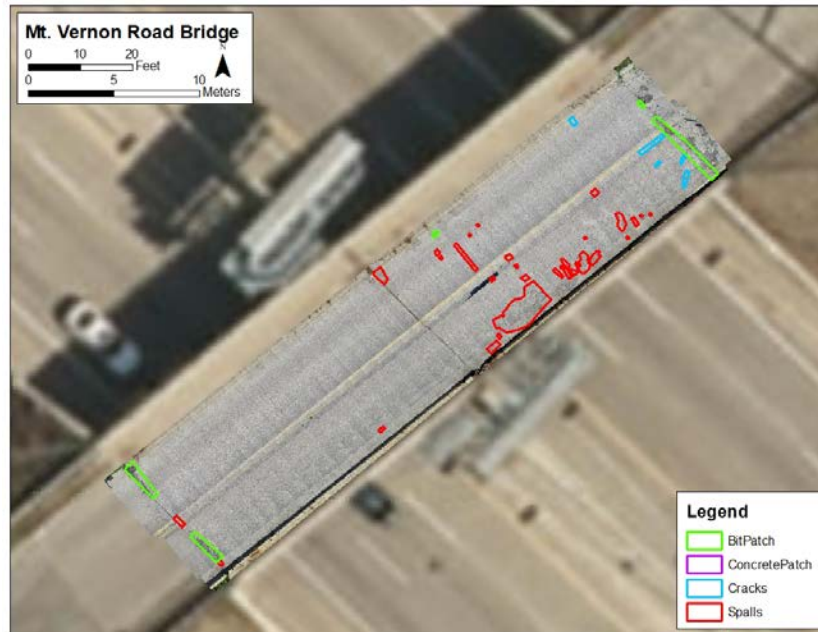
Figure 4. Identified distresses on the Mt. Vernon Road bridge.

The Mt. Vernon bridge (Str 7882) is located in Southfield, Michigan and passes over M-10, the Lodge. The total area of the bridge deck is approximately 4,685 sq. ft. and has two spans. After processing the optical imagery, analysts were able to identify spalls, bitpatch, and cracks (Figure 4). The total area of the distresses are as follows:

- Spalls - 94 sq. ft
- Bitpatch - 51 sq. ft
- Concrete Patching - 0 sq. ft
- Cracks - 9 sq. ft

Table 3 shows the results from processing the distresses through the BDCS algorithm. None of the identified spalls had rebar showing, placing each of the spalls into a “fair” category. All of the bitpatch distresses were classified as “poor” condition. Lastly, the cracks on the deck were all rated as “insignificant”, resulting in a classification of “fair”. Overall, the condition of the bridge deck was rated “Good” at 97%, “Fair” at 2%, and “Poor” at 1%

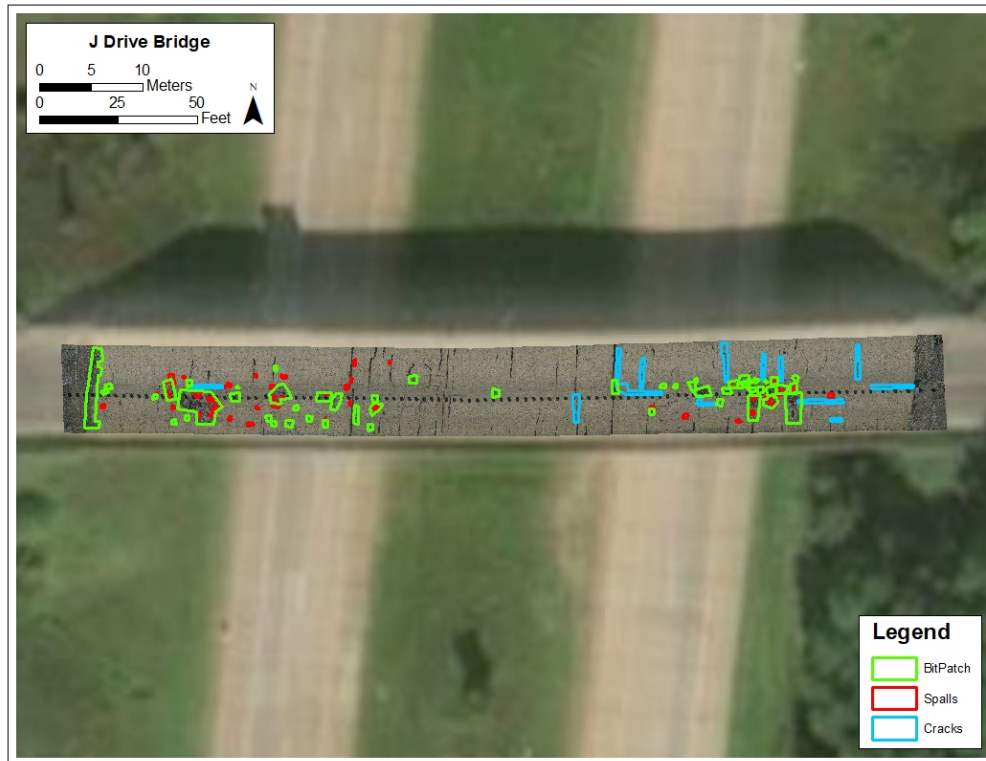
Figure 8. Identified distresses on the J Drive Road bridge.

The J-Drive bridge (Str 1241) is located in Marshall, Michigan and passes over I-69. The total area of the bridge deck is approximately 10,127 sq. ft. and has two spans. After processing the optical imagery, analysts were able to identify spalls and bitpatch (Figure 8). The total area of the distresses are as follows:

- Spalls - 38 sq. ft
- Bitpatch - 500 sq. ft
- Concrete Patching - 0 sq. ft
- Cracks – 146 sq. ft

Table 7 shows the results from processing the distresses through the BDCS algorithm. For Elem. Key 1080 (spalls and bitpatch), the bitpatch areas were all placed into the “poor” category. Four spalls had rebar showing and were therefore placed assigned a “poor” condition. The remaining spalls were assigned a “fair” condition. For Elem. Key 1130 (cracks), most of the cracked areas were determined to be insignificant / in “good” condition. However, some cracks were moderate or heavy, resulting in a “fair” category. Overall, the condition of the bridge deck was rated “Good” at 94%, “Fair” at 1%, and “Poor” at 5%.
