Nondestructive Assessment of Wood Members in a Viewing Tower in Potawatomi State Park, Door County, Wisconsin, USA

Research Note
FPL–RN–0366

December
2018

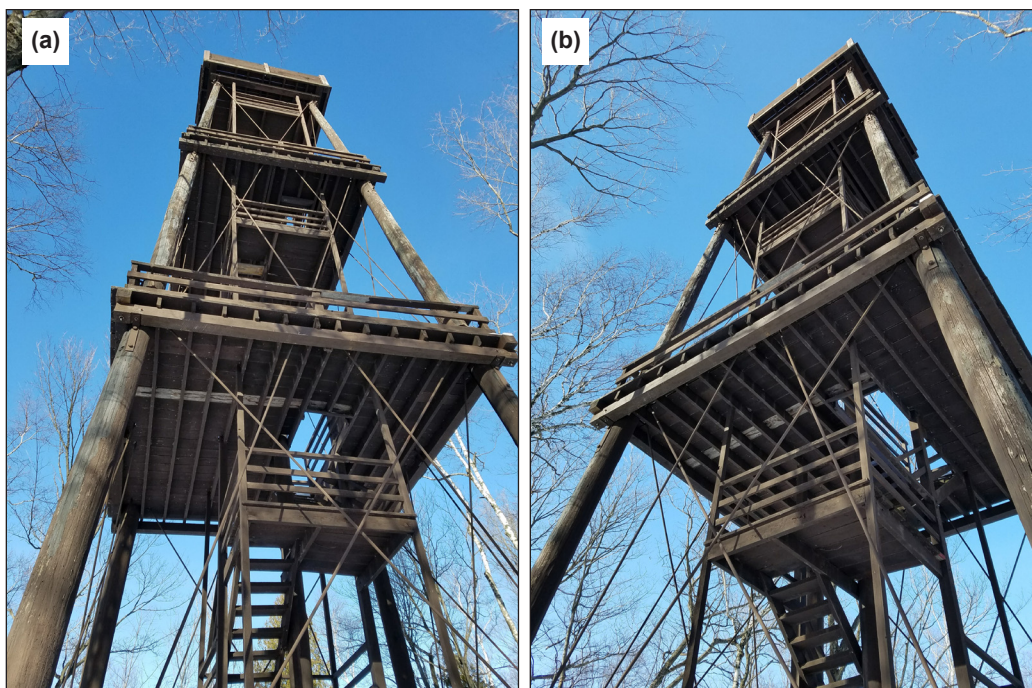
Figure 1. Potawatomi Observation Tower: (a) southwest view; (b) southeast view.

The condition assessment of the Potawatomi Observation Tower was performed on February 6, 2018. Figures 1a and 1b show the tower on the day of the inspection. The assessment began with a visual inspection. Deterioration of structural and nonstructural wood members was evident in the tower. Numerous deep splits and cracks within many of the members, and several deep splits on the main load bearing support columns, were observed. Holes, probably

resulting from nesting activities of birds, were observed. Of concern were splits and deterioration in the vicinity of connections and the evidence of lateral movement of the upper sections of the tower.

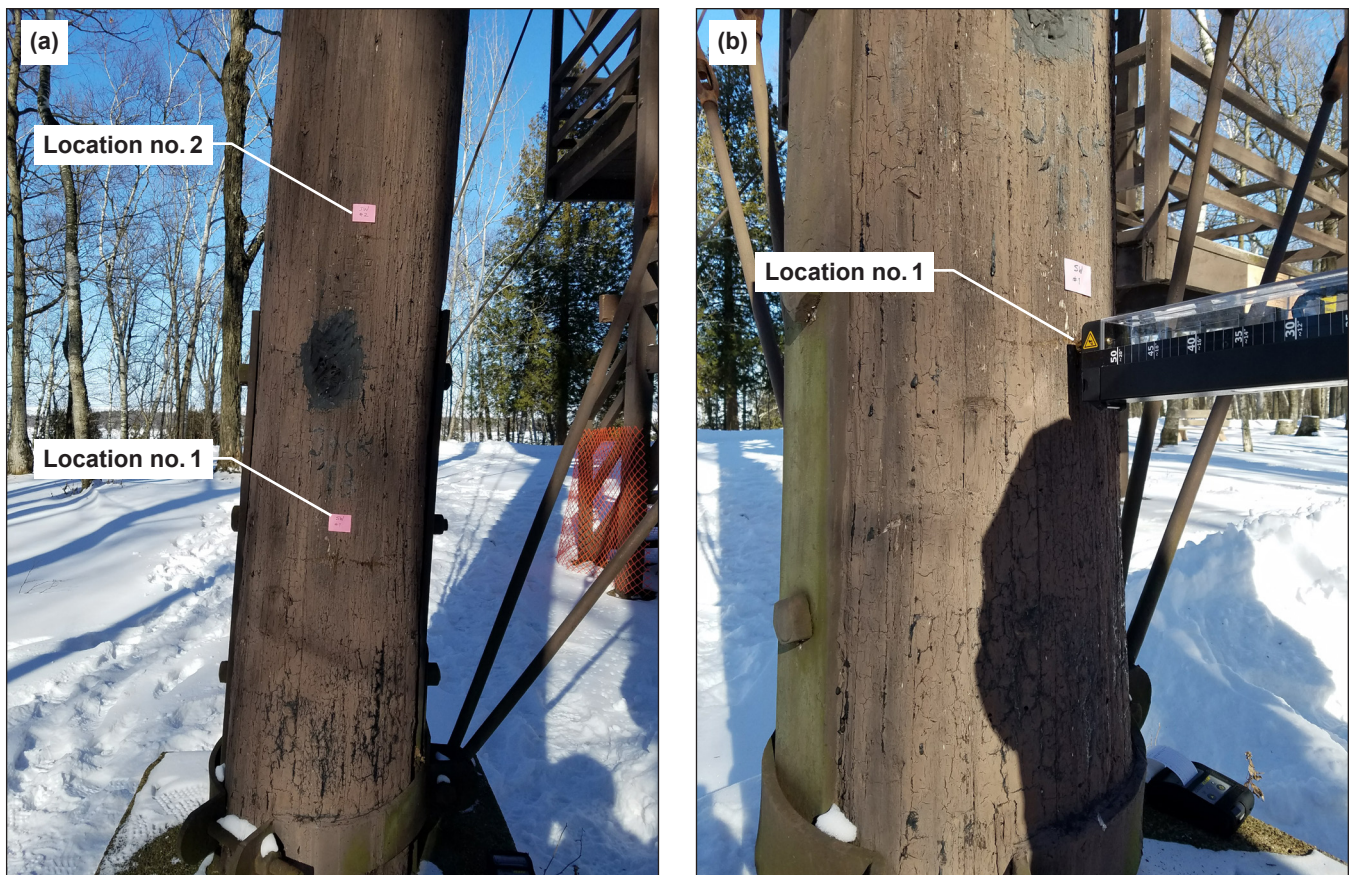
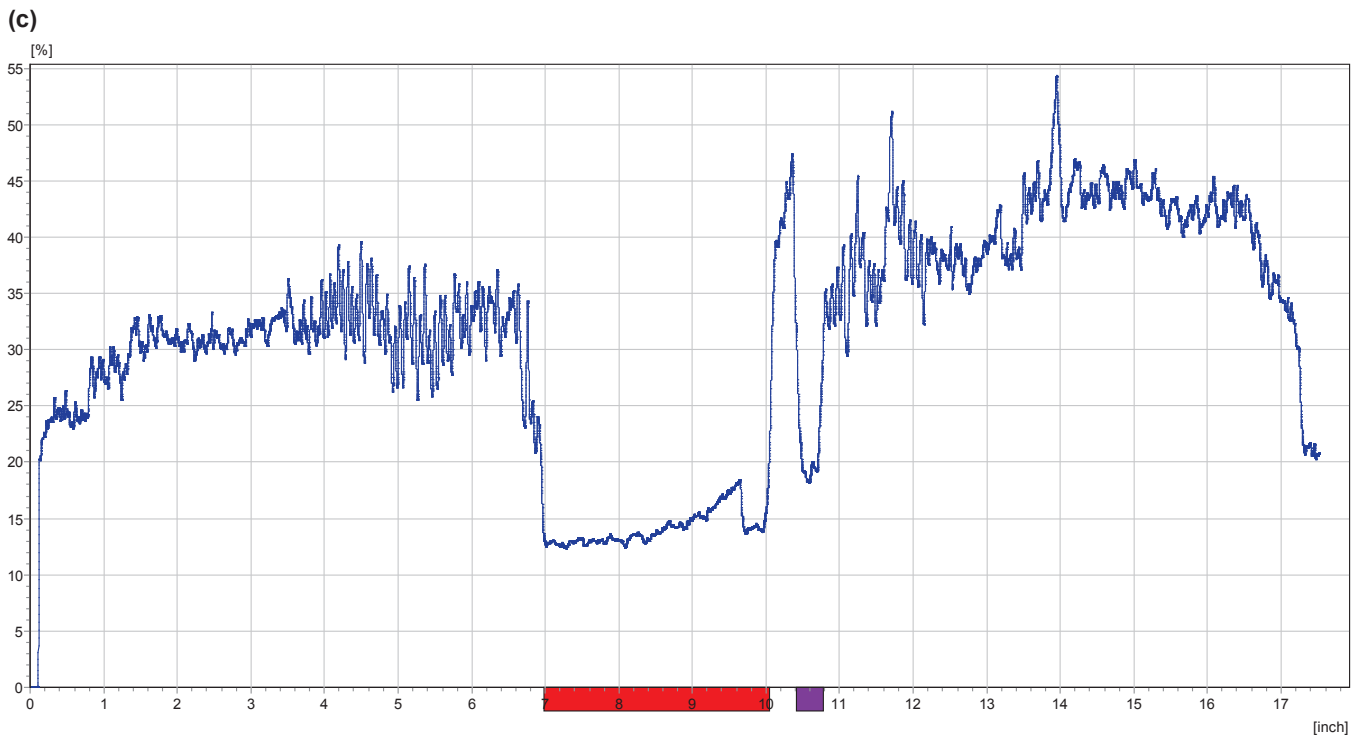
After the visual inspection was completed, sound transmission and micro-resistance drilling tests were performed. Figure 2a shows the southwest tower support pole near ground level. Note the large patched area sealing a previous woodpecker hole. Similar patches were present on all four support legs of the tower. The pink attached notes indicate sites where micro-resistance drilling inspections were performed. Figure 2b shows the resistance drilling tool positioned for use, and Figure 2c shows the results of the inspection. The diameter of the pole at the inspection site was 17 in. The measured resistance noticeably decreases between approximately 7 and 10 in. from the edge. The decrease indicates the presence of interior decay or a void, or both.

Figure 2. Southwest support pole at ground level. (a) View of southern side of support. The attached pink notes indicate locations of micro-resistance drilling test. The black patch is the location of a sealed woodpecker hole. (b) Micro-resistance drilling test at location no. 1, 32 in. above the footing. (c) Resistance profile for location no. 1 reveals a 3- to 4-in. center deterioration, which was likely caused by water entering through the woodpecker hole 1 ft above.

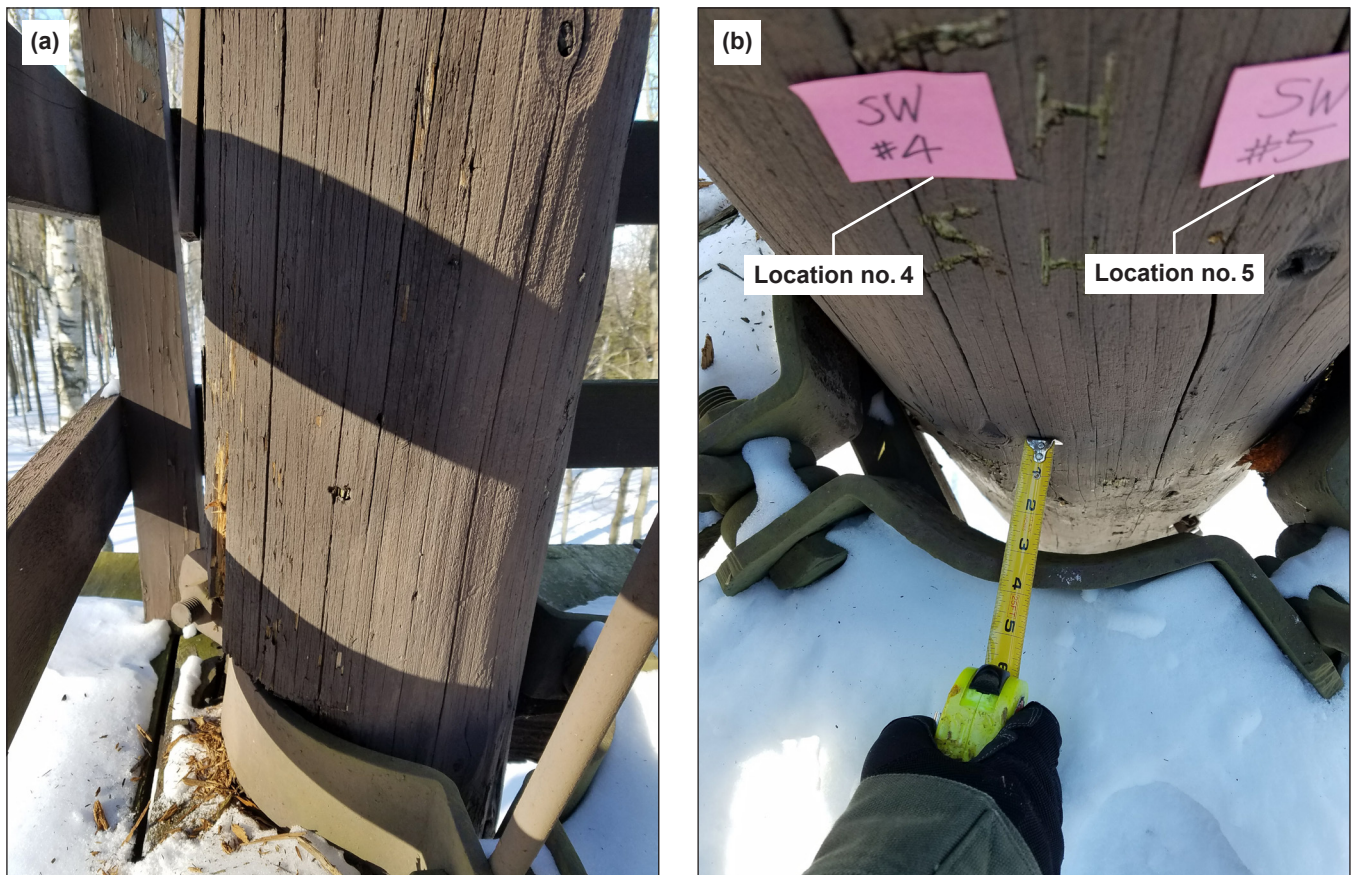
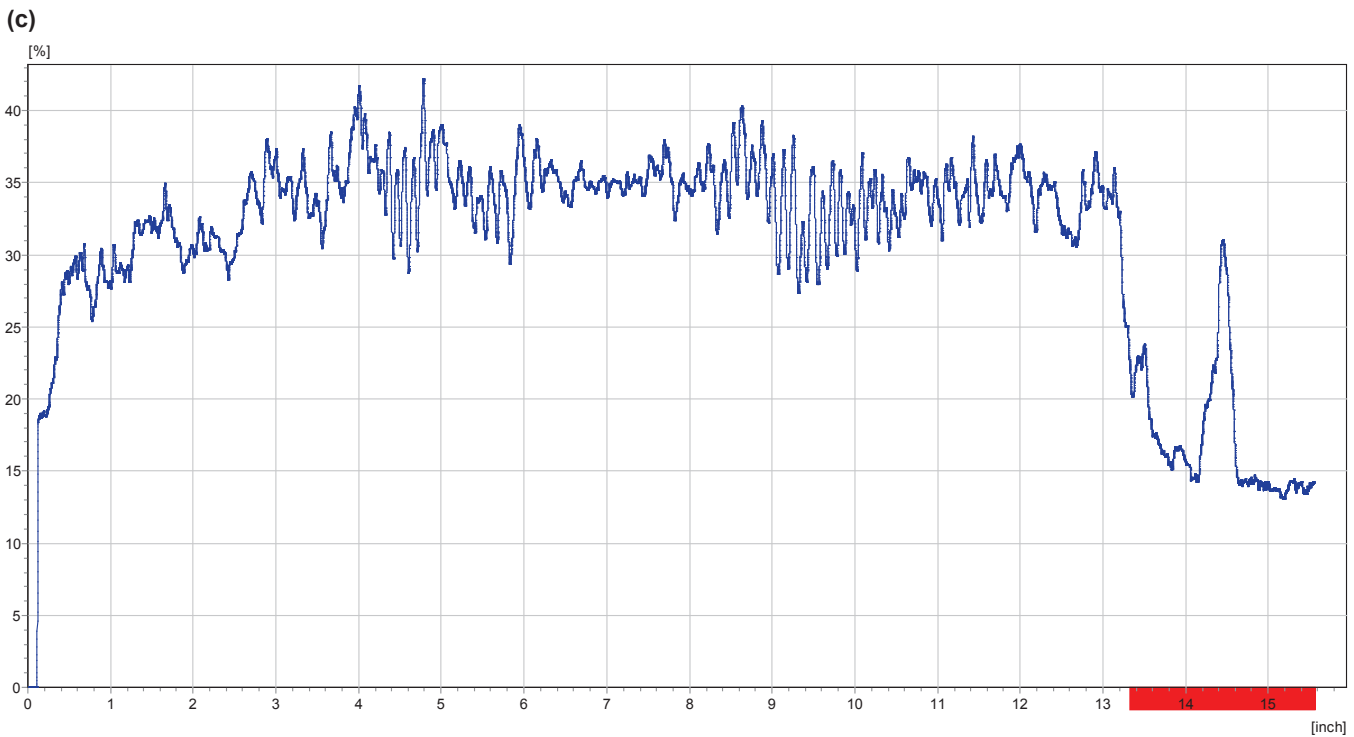
Figure 3a shows the steel collar securing the first platform to the southwest support. The steel collar had displaced relative to the location of the support approximately 3-1/4 in., causing noticeable damage (Fig. 3b). The displacement was sufficiently deep to completely penetrate through the surface preservative treatment. Figure 3a also shows surface deterioration on the south side of the support. The wood at that location was easily penetrated by a probe with minimal effort, indicating the presence of advanced decay. Figure 3c shows the results of the micro-resistance drilling at location no. 5, 10 in. above the steel collar (as shown in Fig. 3b). The resistance profile showed sign of decay for the outer 1-1/2 in. in this location.

Figure 3. Southwest support pole at platform 1. (a) Steel collar securing the first platform to the southwest support. Displacement of the collar has damaged the support and penetrated the surface layer of preservative. Deterioration is apparent where the clamp has damaged the support. (b) Steel clamp has displaced 3-1/4 in. The attached pink notes show micro-resistance drilling locations no. 4 and no. 5, 10 in. above the collar. (c) Resistance profile for location no. 5 shows 1-1/2 in. of surface decay.

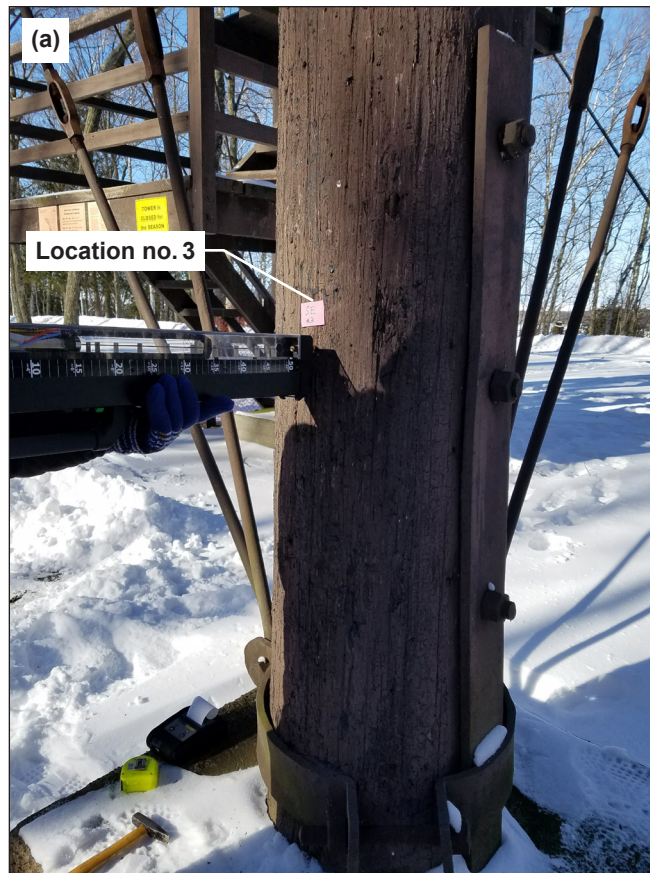
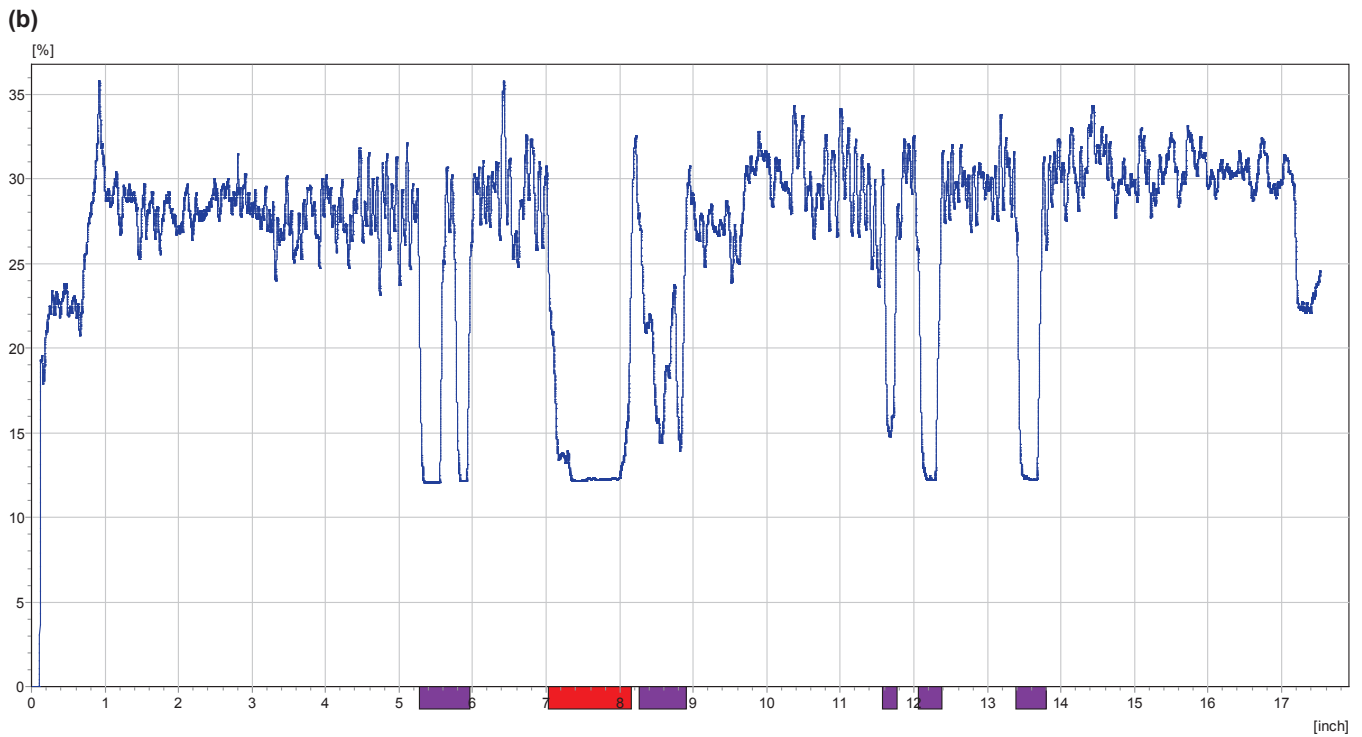
Figure 4a shows the southeast support of the tower. The diameter of the support pole at the location shown is 17 in. Micro-resistance drilling at location no. 3 is 37 in. above the footing. The resistance profile shown in Figure 4b reveals center decay of 1 in. diameter and multiple internal cracks.

Figure 4. Southeast support pole at ground level. (a) Micro-resistance drilling test at location no. 3, 37 in. above the footing. The support diameter is 17 in. at this location. (b) The resistance profile reveals center deterioration (marked red) of 1 in. diameter and multiple internal cracks (marked purple).

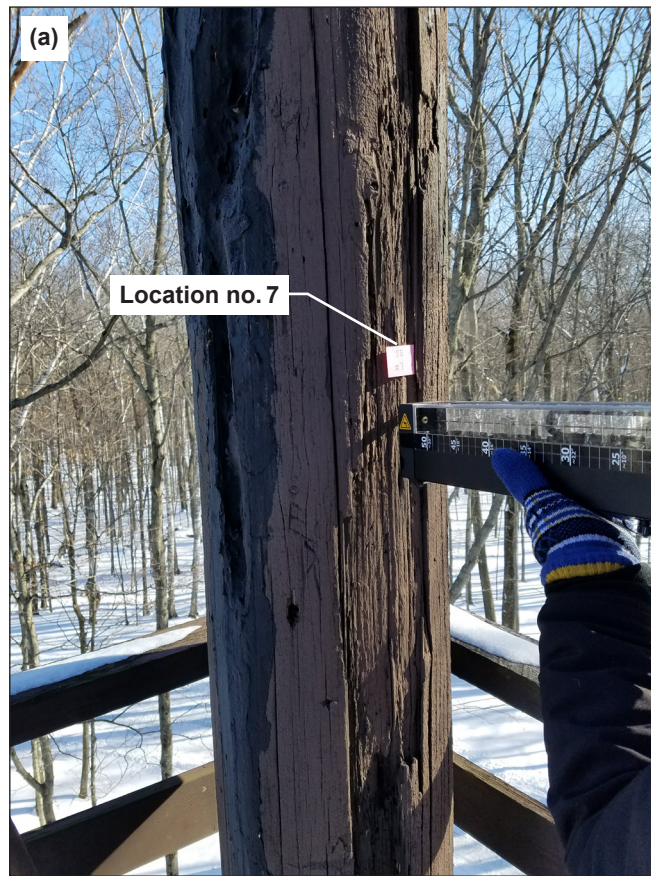
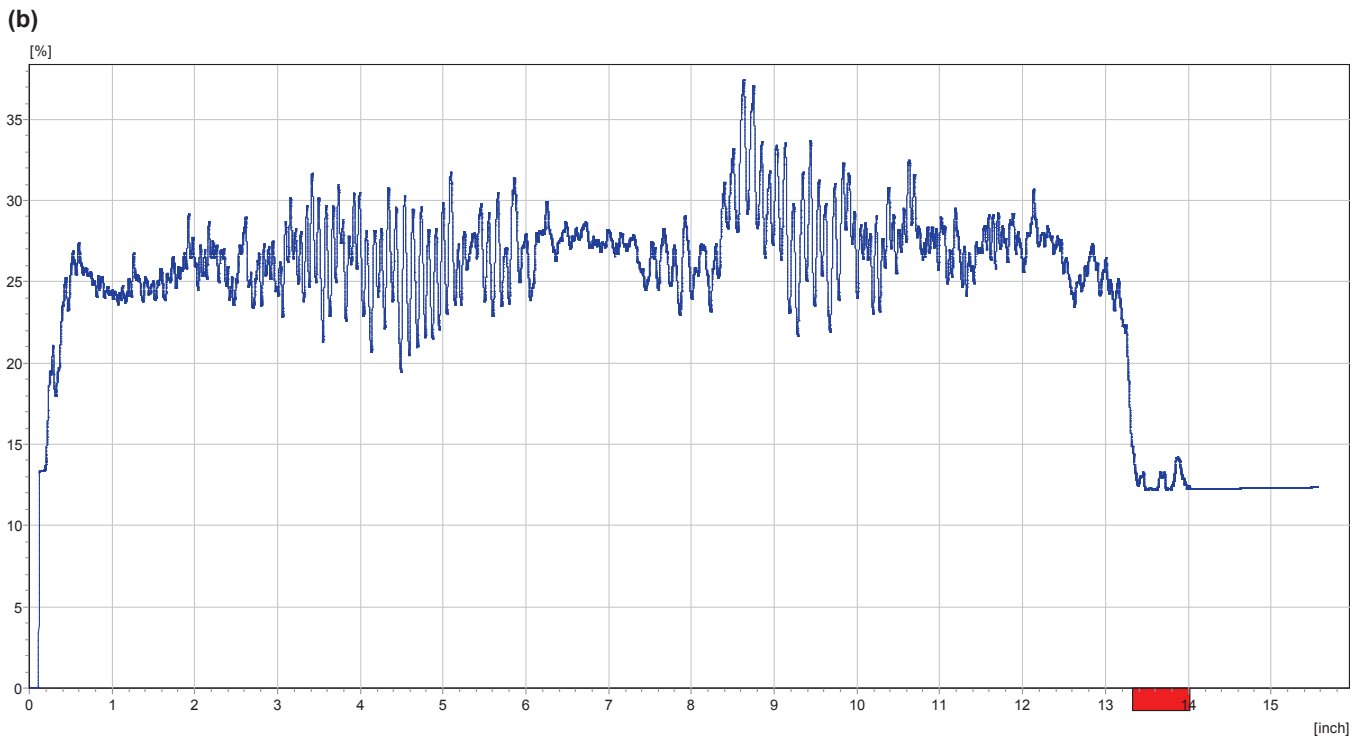
Figure 5a shows the southeast support pole at the first platform. Micro-resistance drilling was performed at location no. 7, 58 in. above the platform, where the diameter of the support pole was 15 in. Large patched cracks of unknown depth are observed on this timber. The resistance profile results shown in Figure 5b reveal an internally sound support with some surface deterioration (marked red in the resistance profile).

Figure 5. Southeast support pole at platform 1. (a) Micro-resistance drilling test at location no. 7, 58 in. above the platform. The support diameter is 15 in. Large patched cracks of unknown depth can be observed on this timber. (b) The resistance profile reveals an internally sound support with surface deterioration.

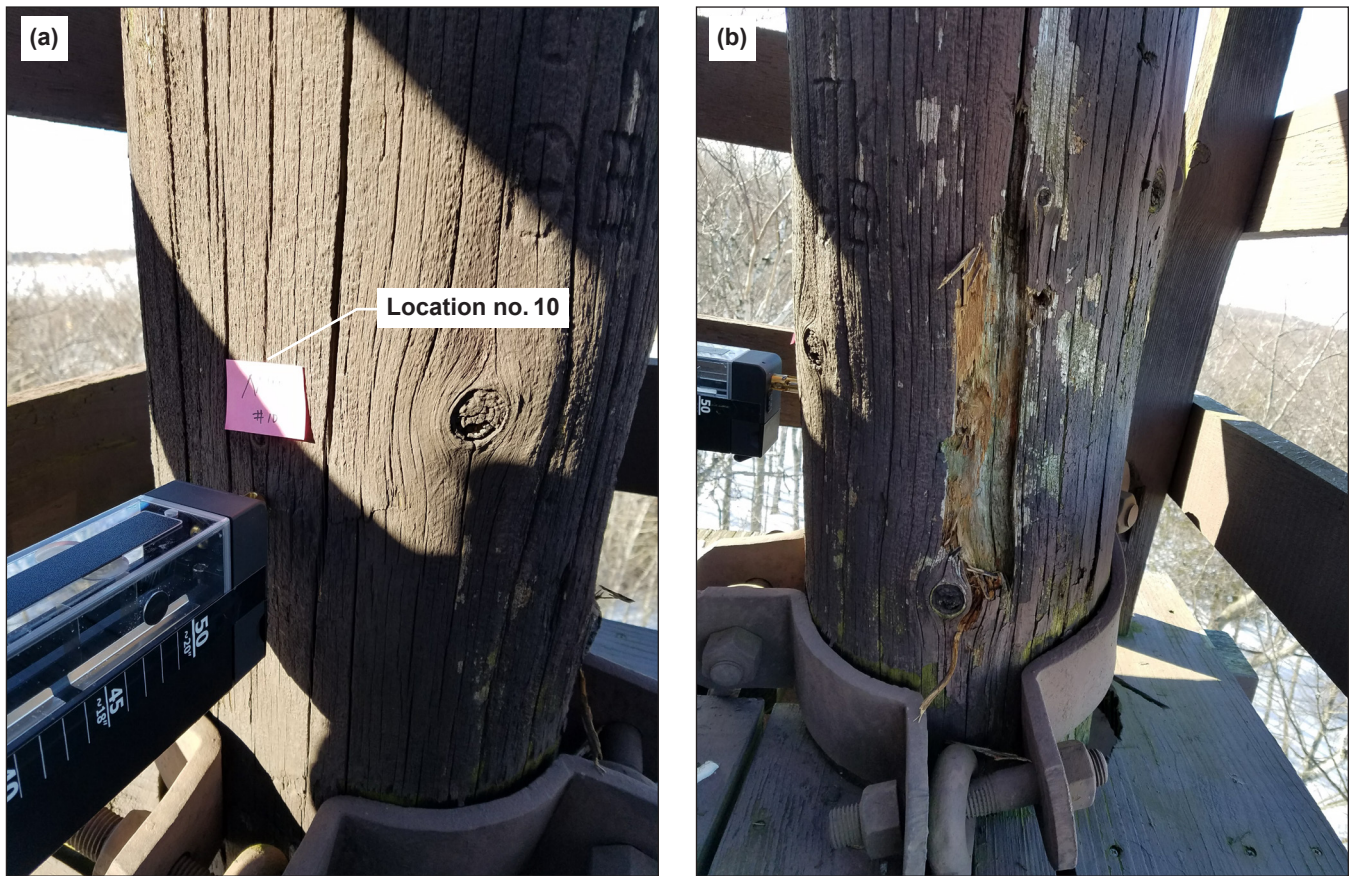
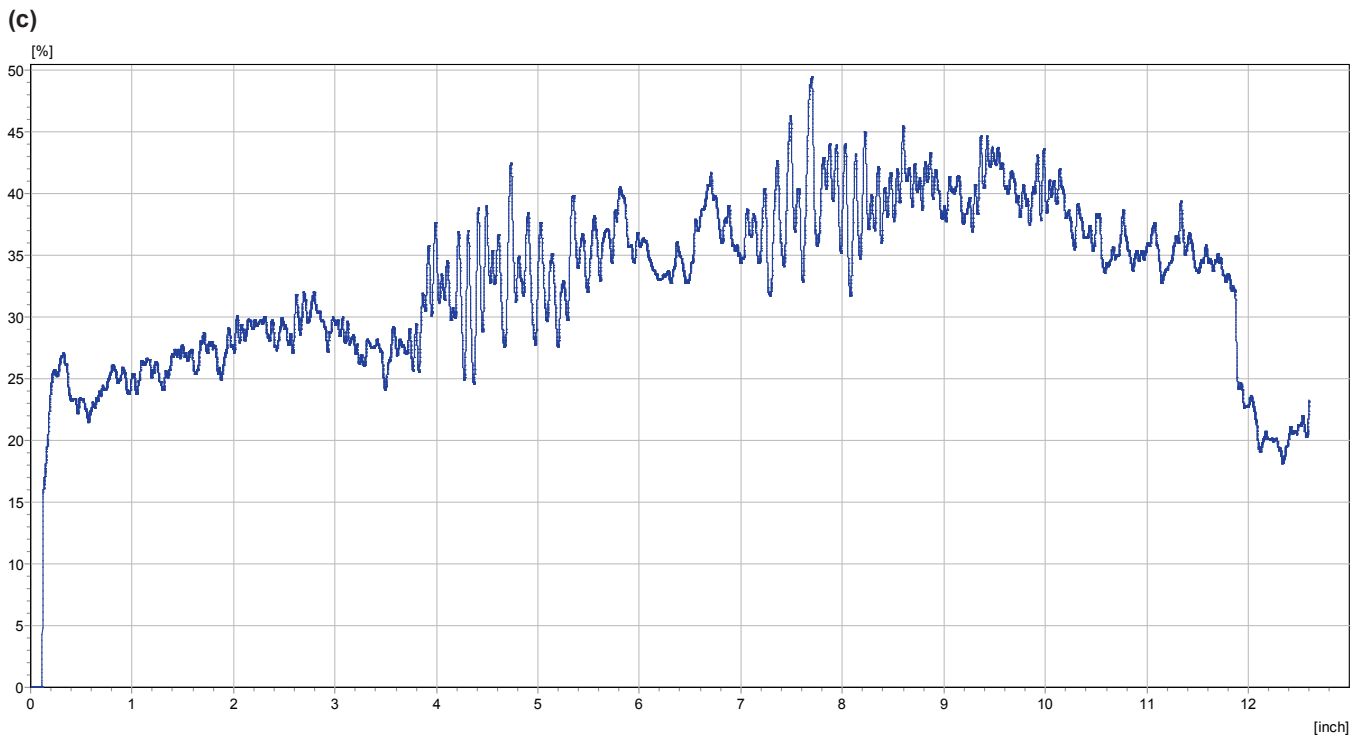
Figure 6a shows the northwest support pole at the second platform. Micro-resistance drilling was performed at location no. 10, where the support pole diameter was 12 in. Figure 6b shows visible surface deterioration on the east side of the support. The resistance profile shown in Figure 6c reveals an internally sound support.

Figure 6. Northwest support pole at platform 2. (a) Micro-resistance drilling test at location no. 10. (b) Visible surface deterioration. (c) Resistance profile reveals an internally sound support.

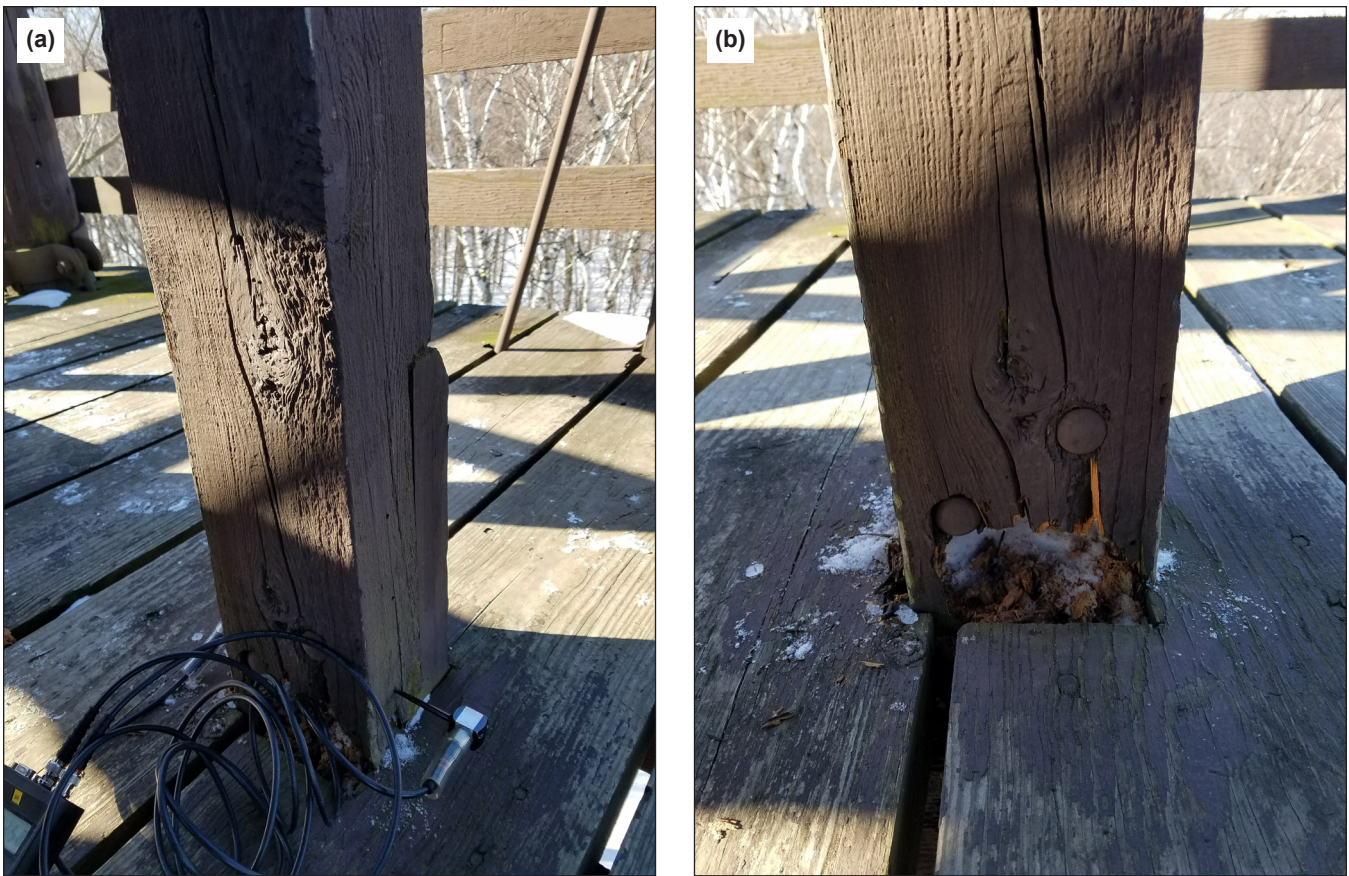
Figure 7 shows the central rectangular timber supporting the staircase at the second platform. The stress wave timing tool is shown in Figure 7a. Results of the stress wave timing

measurement were significantly high. Any measurement of greater than 300 $\mu\text{s}/\text{ft}$ is indicative of internal decay. The measurement across the support was 853 $\mu\text{s}/\text{ft}$, indicating severe decay. In addition, Figure 7b shows visible decay. The extent of the decay on the support was such that the wood could be removed by hand with little to no effort.

Figure 7. Central stairway support at platform 2. (a) Stress wave timing measurement showed significantly high readings (426 μ s, equivalent to 853 μ s/ft), indicating severe decay. (b) Visible deteriorated wood.
