MR400: Assessing Compliance with BMPs on Harvested Sites in Maine: Final Report

Russel D. Briggs

Assessing Compliance with BMPs on Harvested
Sites in Maine: Final Report

Maine Agricultural and Forest Experiment Station

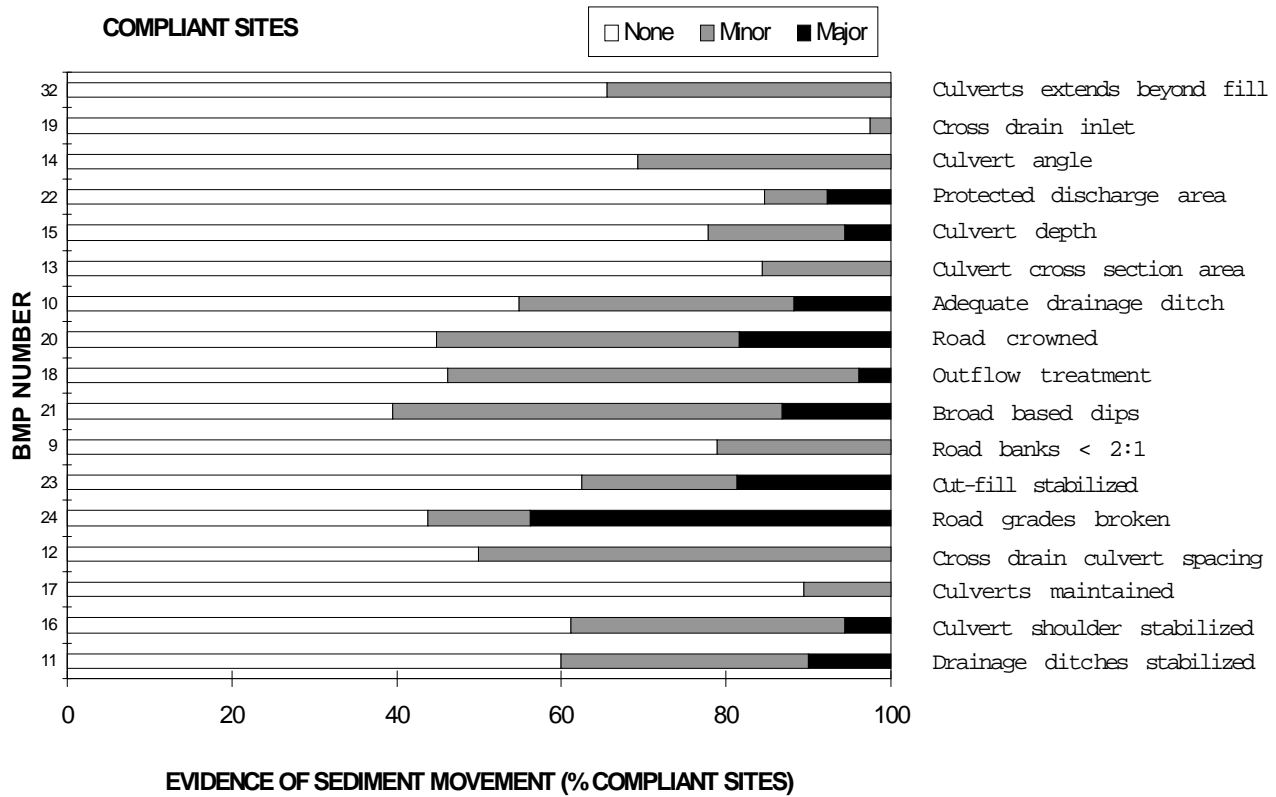
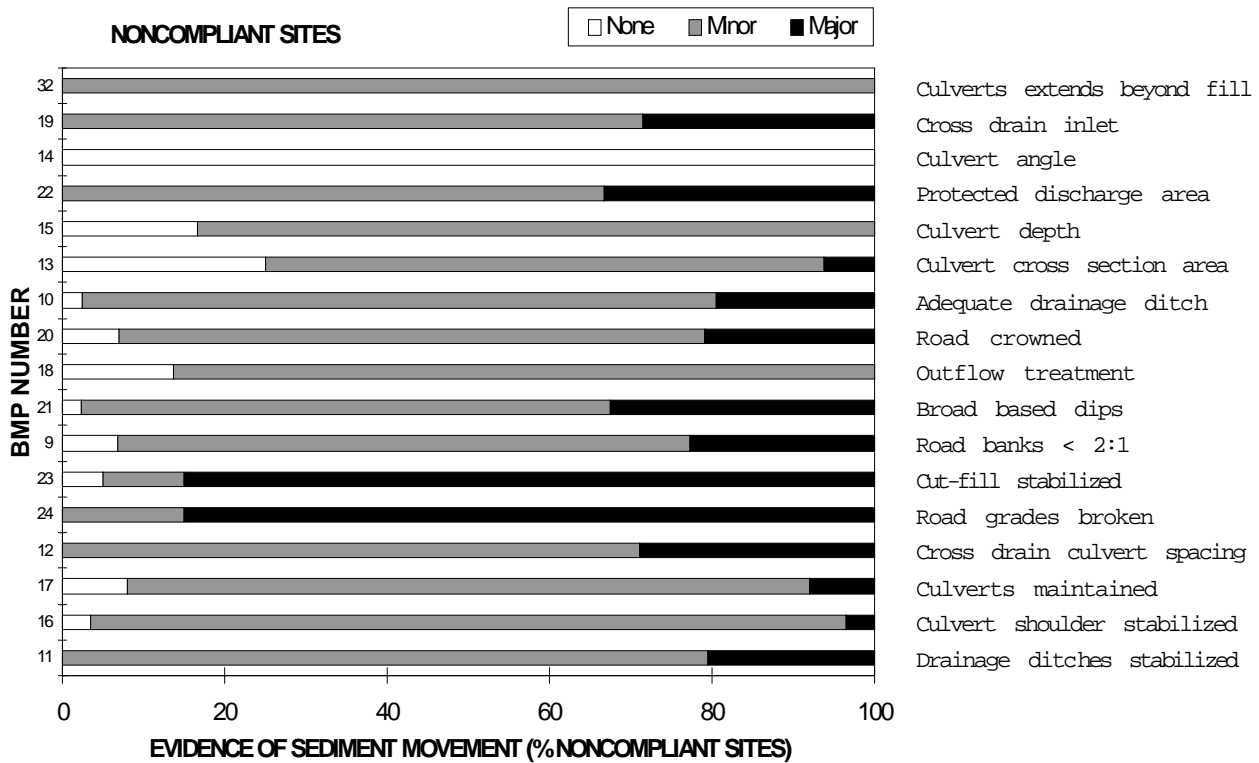
Noncompliance of haul road BMPs tends to be a chronic problem that continues long after harvest operations cease because the roads remain. Eighty-nine percent of the observed cases of sediment movement were judged to be long-term impacts.

Figure 7. Evidence of sediment movement haul road BMP compliant and noncompliant sites. None = no sediment movement, minor = movement and no delivery to surface water, major = delivery to surface water.

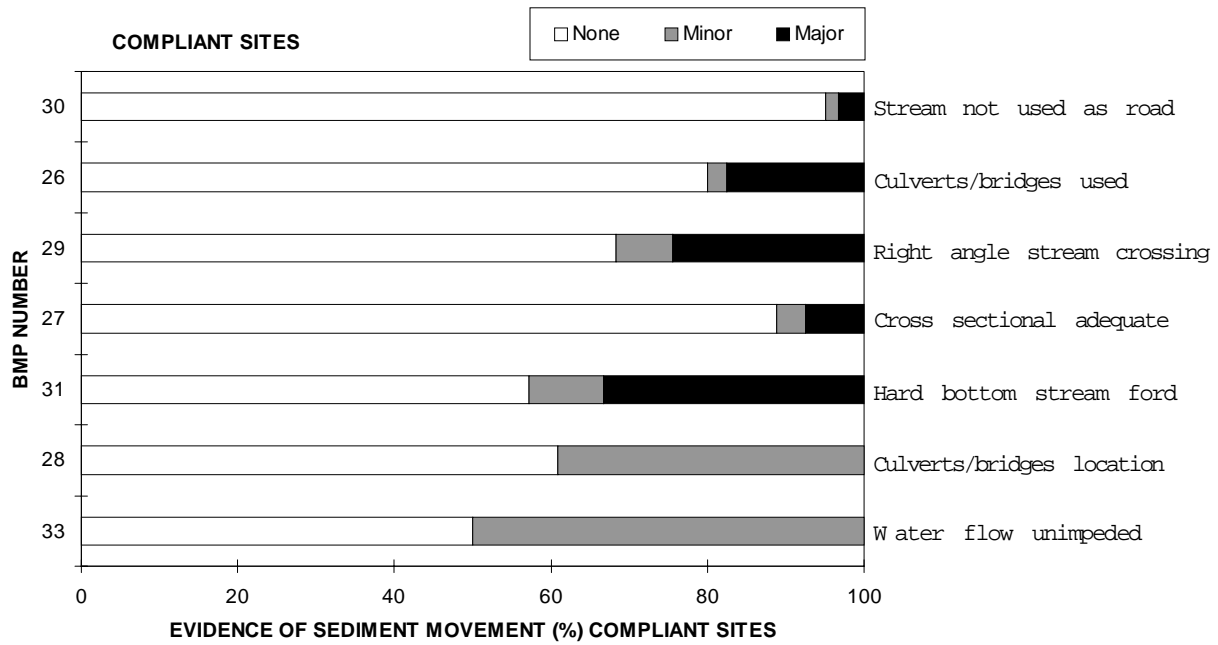
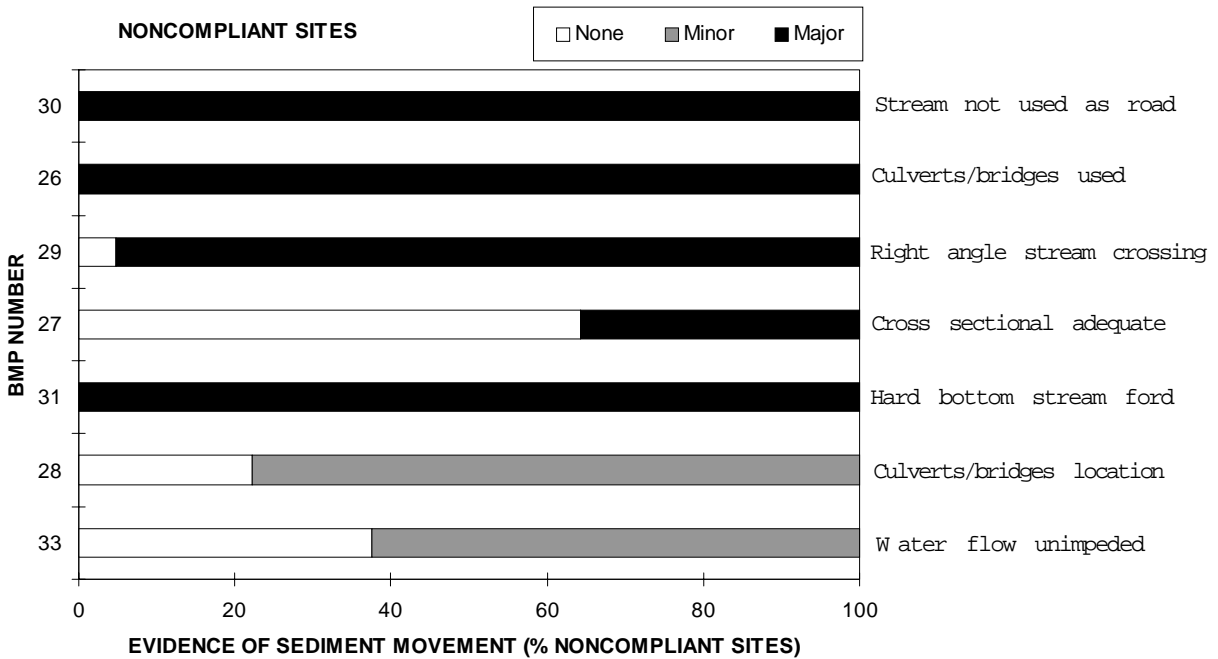
As was the case with haul road cross drains, cross sectional area of culverts used to cross streams was sometimes smaller than the minimum required (15 in). While this may not result in a problem during normal and dry years, there is potential for serious problems in wet years. The single high rainfall events that coincide with spring runoff present a real potential for erosion and sedimentation problems.

Figure 8. Evidence of sediment movement for stream crossing BMP compliant and noncompliant sites. None = no sediment movement, minor = movement and no delivery to surface water, major = delivery to surface water.

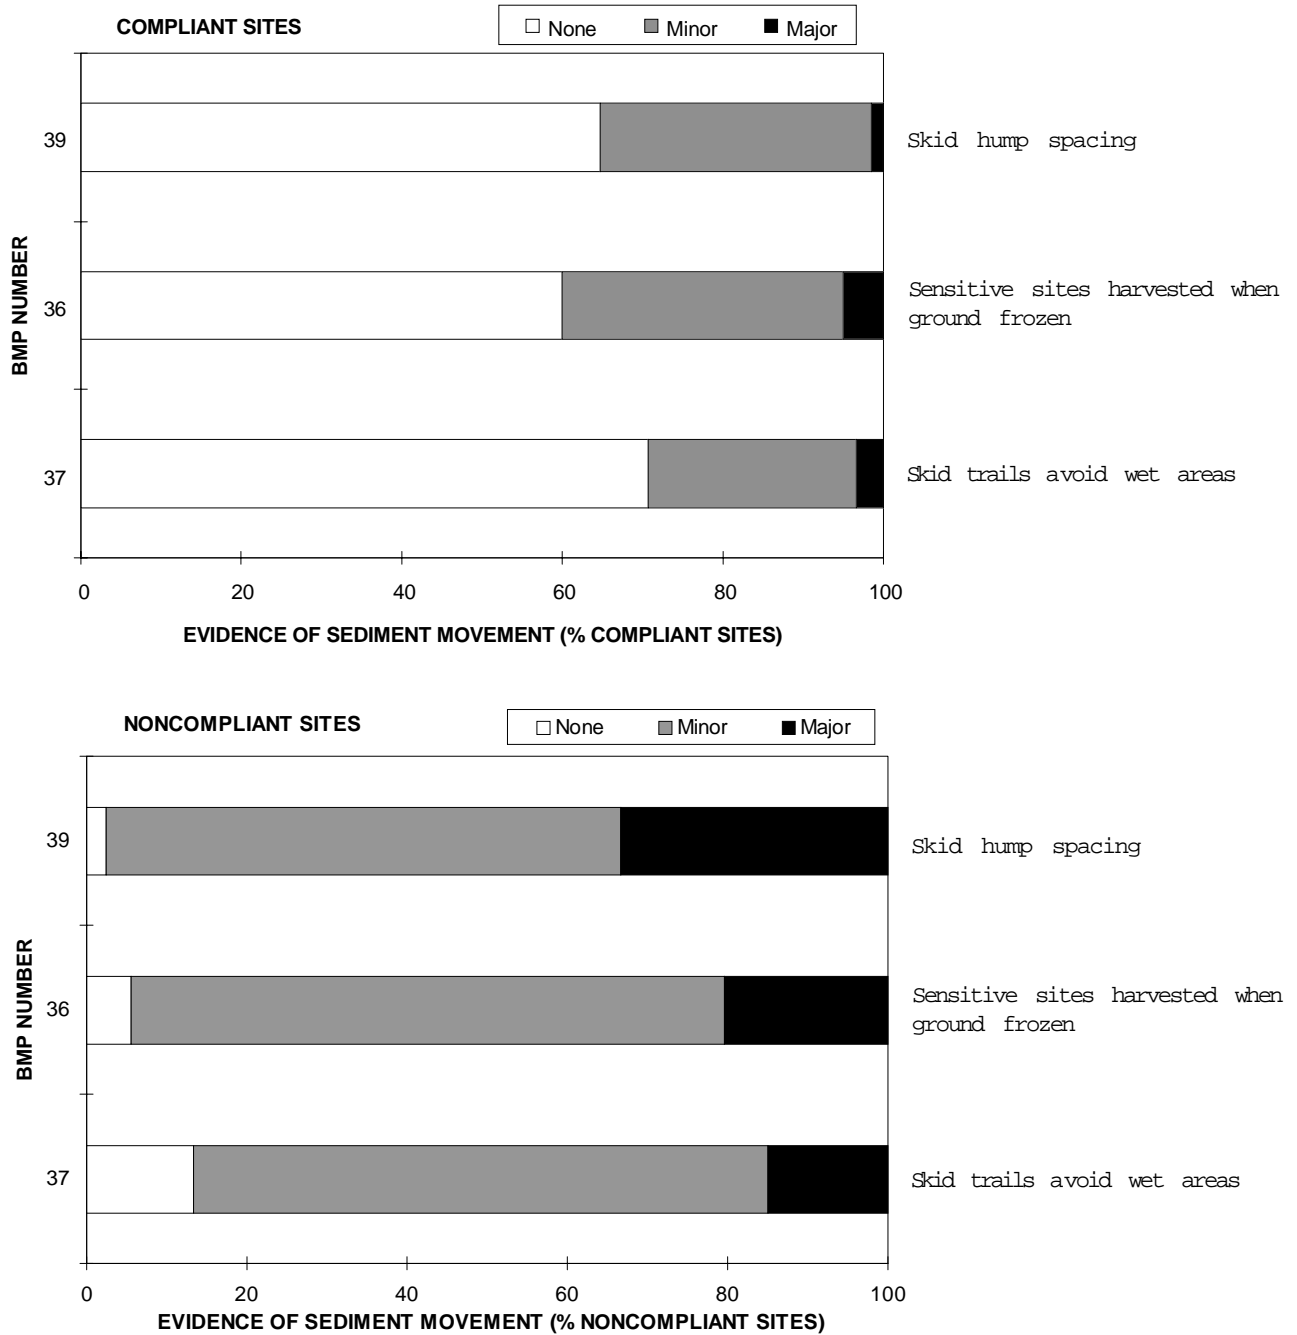
Steep skid trail sections were not stabilized with vegetation or brush on half of the sites where those features occurred (BMP 47). This deficiency, combined with the need for more water bars, provides opportunity for erosion and sedimentation by allowing water to continue a downward path, increasing erosive forces. Recreational use of ATVs on these skid trails, an impact beyond the direct control of the landowner, sometimes was responsible for disturbing water bars and reducing their effectiveness.

Figure 9. Evidence of sediment movement for skid trail BMP compliant and noncompliant sites. None = no sediment movement, minor = movement and no delivery to surface water, major = delivery to surface water.

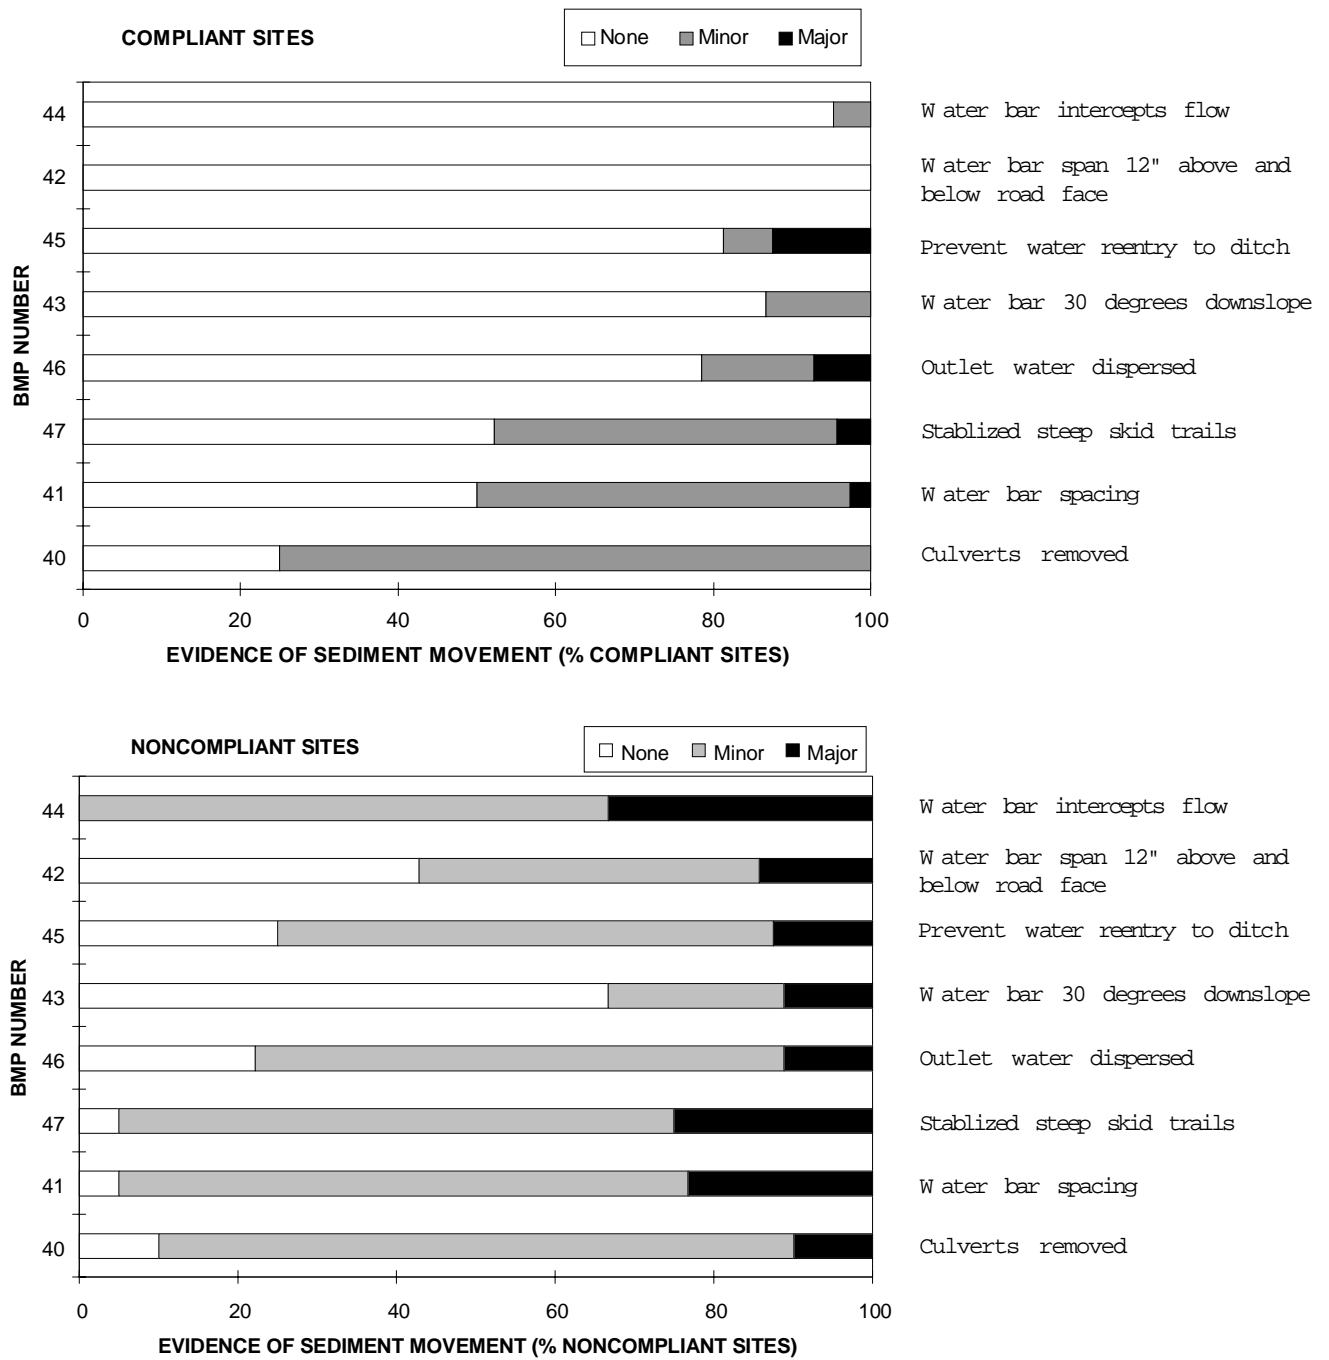
The hypothesis of independence of sediment movement and BMP compliance was rejected for all of the BMPs that could be rated for evidence of sediment movement. Noncompliance resulted in increased occurrence and severity of sediment movement (Table 11; Figure 10). Seventy-six percent of the sediment movement associated with noncompliance was rated as long-term impact.

Figure 10. Evidence of sediment movement for putting to bed BMP compliant and noncompliant sites. None = no sediment movement, minor = movement and no delivery to surface water, major = delivery to surface water.

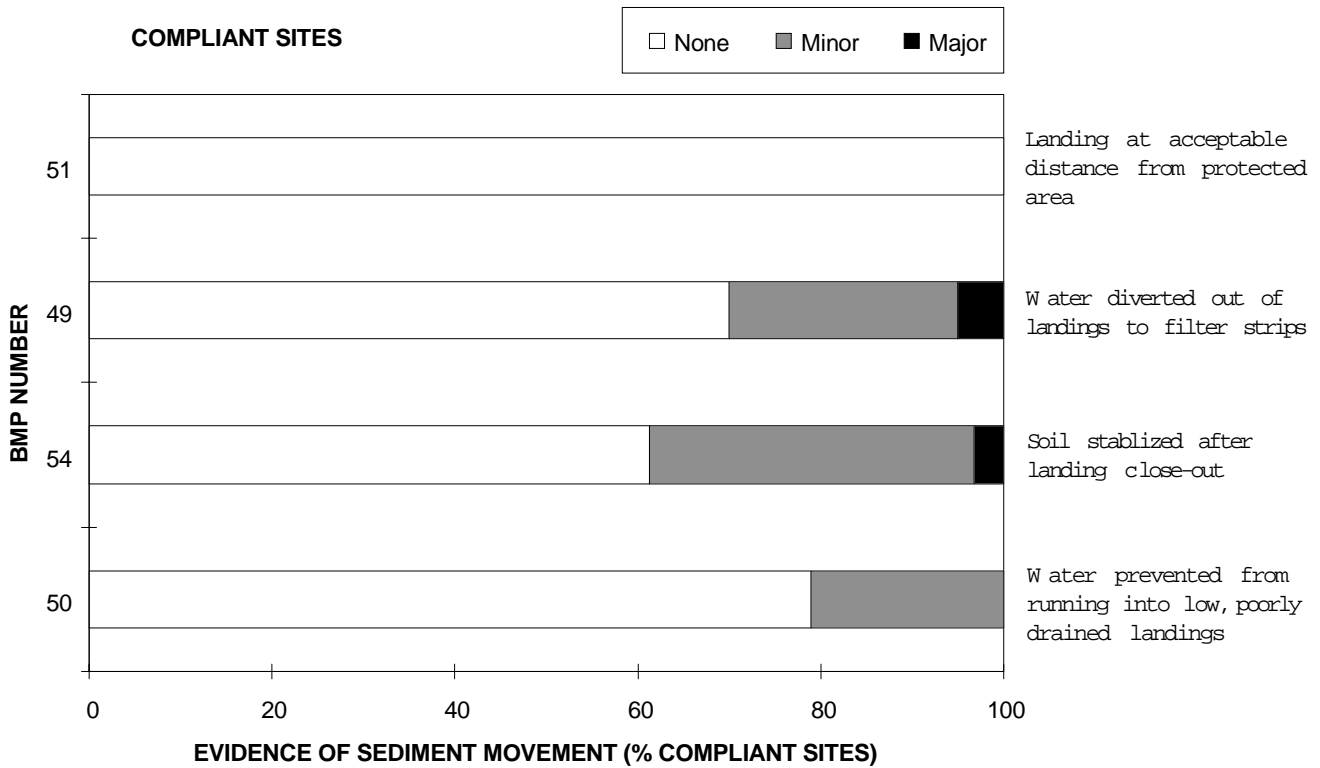
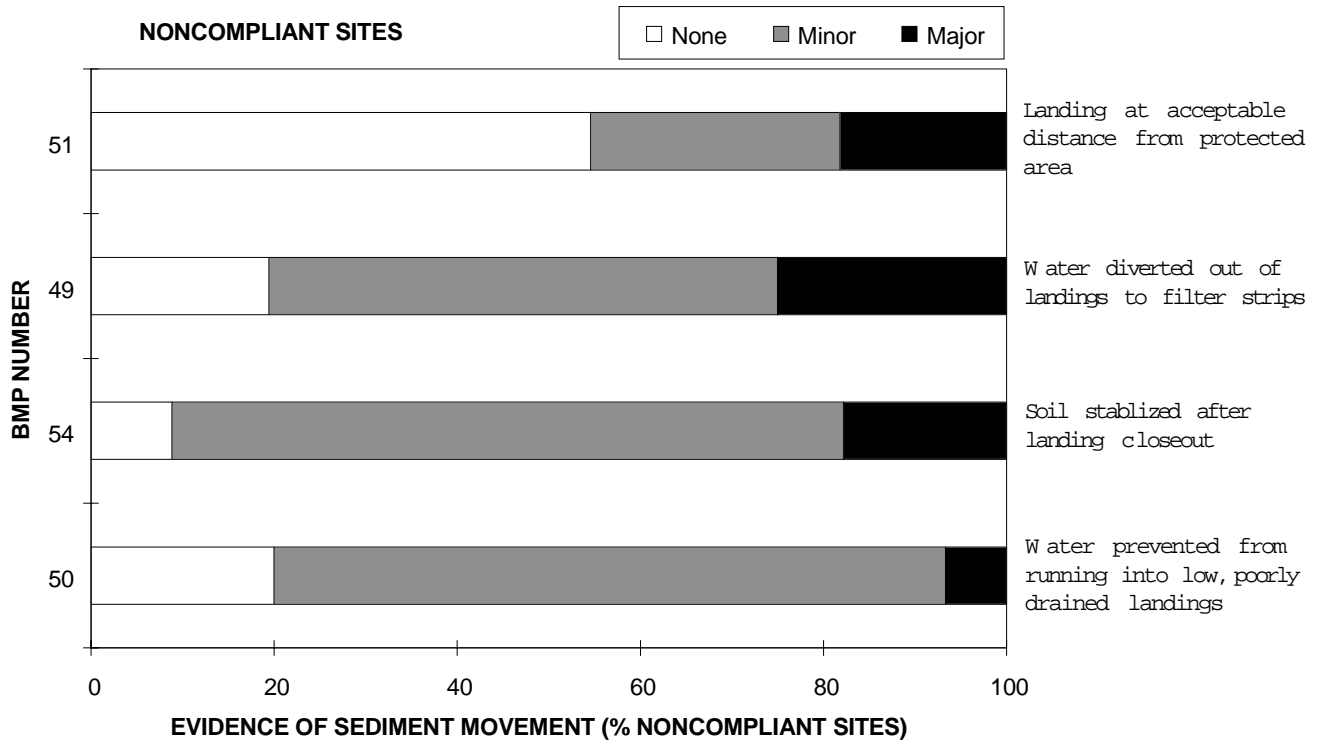
Figure 11. Evidence of sediment movement for landing BMP compliant and noncompliant sites. None = no sediment movement, minor = movement and no delivery to surface water, major = delivery to surface water.

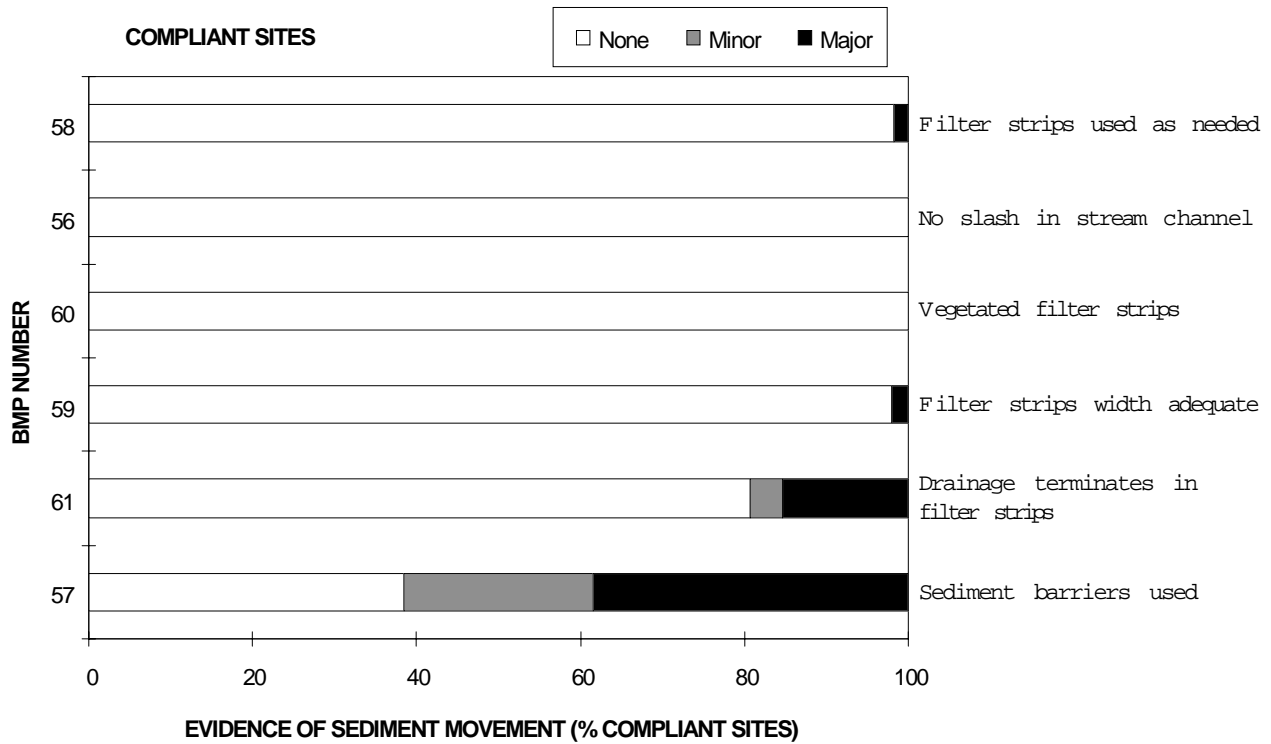
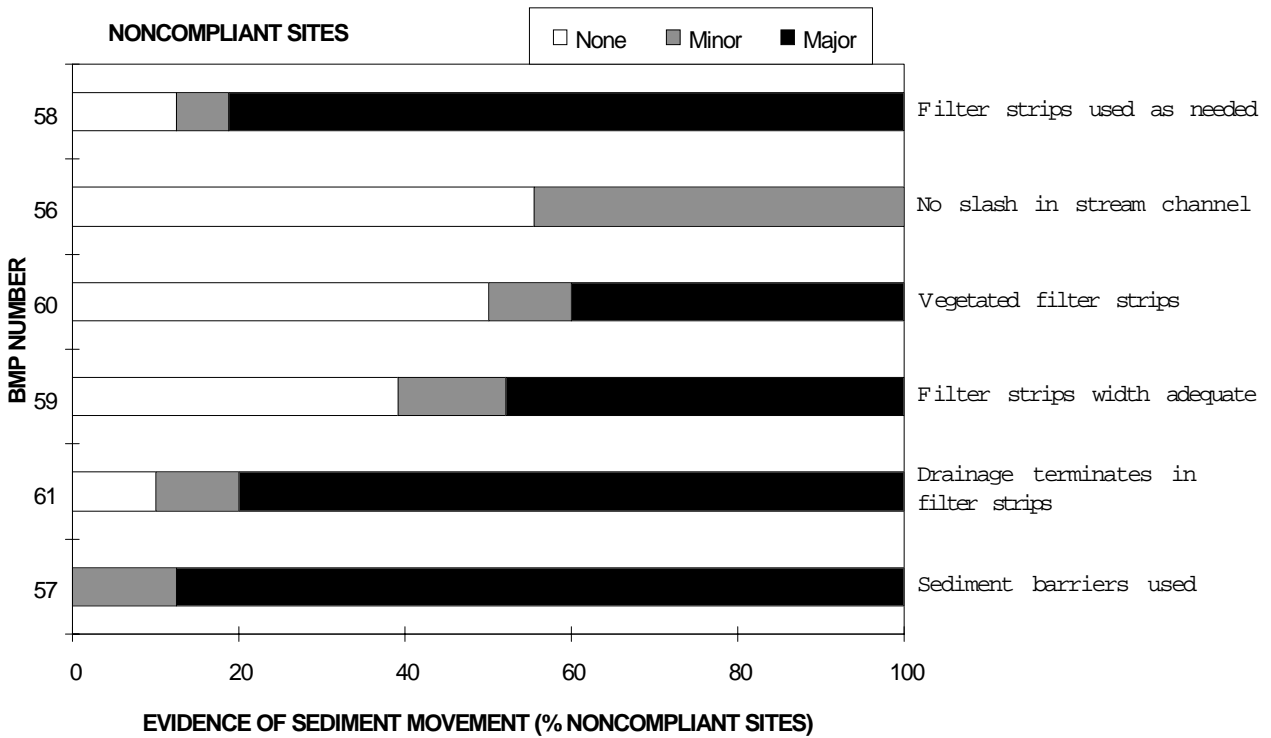
Dealing only with those sites where the BMPs were applicable, the percentage of sites in compliance with the streamside management zone BMPs ranged from 42 to 78%. Where filter strips were used, slash was kept out of stream channels, and adequate shade was retained over perennial streams on approximately three quarters of the sites where water features occurred. Water from drainage ditches found a path to streams on about half of the sites; some of those filter strips were ineffective (not wide enough) or nonexistent. When sediment barriers (silt fences, hay bales) were used to correct problems, they were not sufficient to prevent silt from entering surface waters for more than half of those instances.

Figure 12. Evidence of sediment movement for streamside management zone BMP compliant and noncompliant sites. None = no sediment movement, minor = movement and no delivery to surface water, major = delivery to surface water.
