An application of AcciMap to identify and analyse the causes of the Eastern Star and Sewol casualties

Yanning Jiang

**AN APPLICATION OF ACCIMAP TO IDENTIFY
AND ANALYSE THE CAUSES OF THE EASTERN
STAR AND SEWOL CASUALTIES**

2016

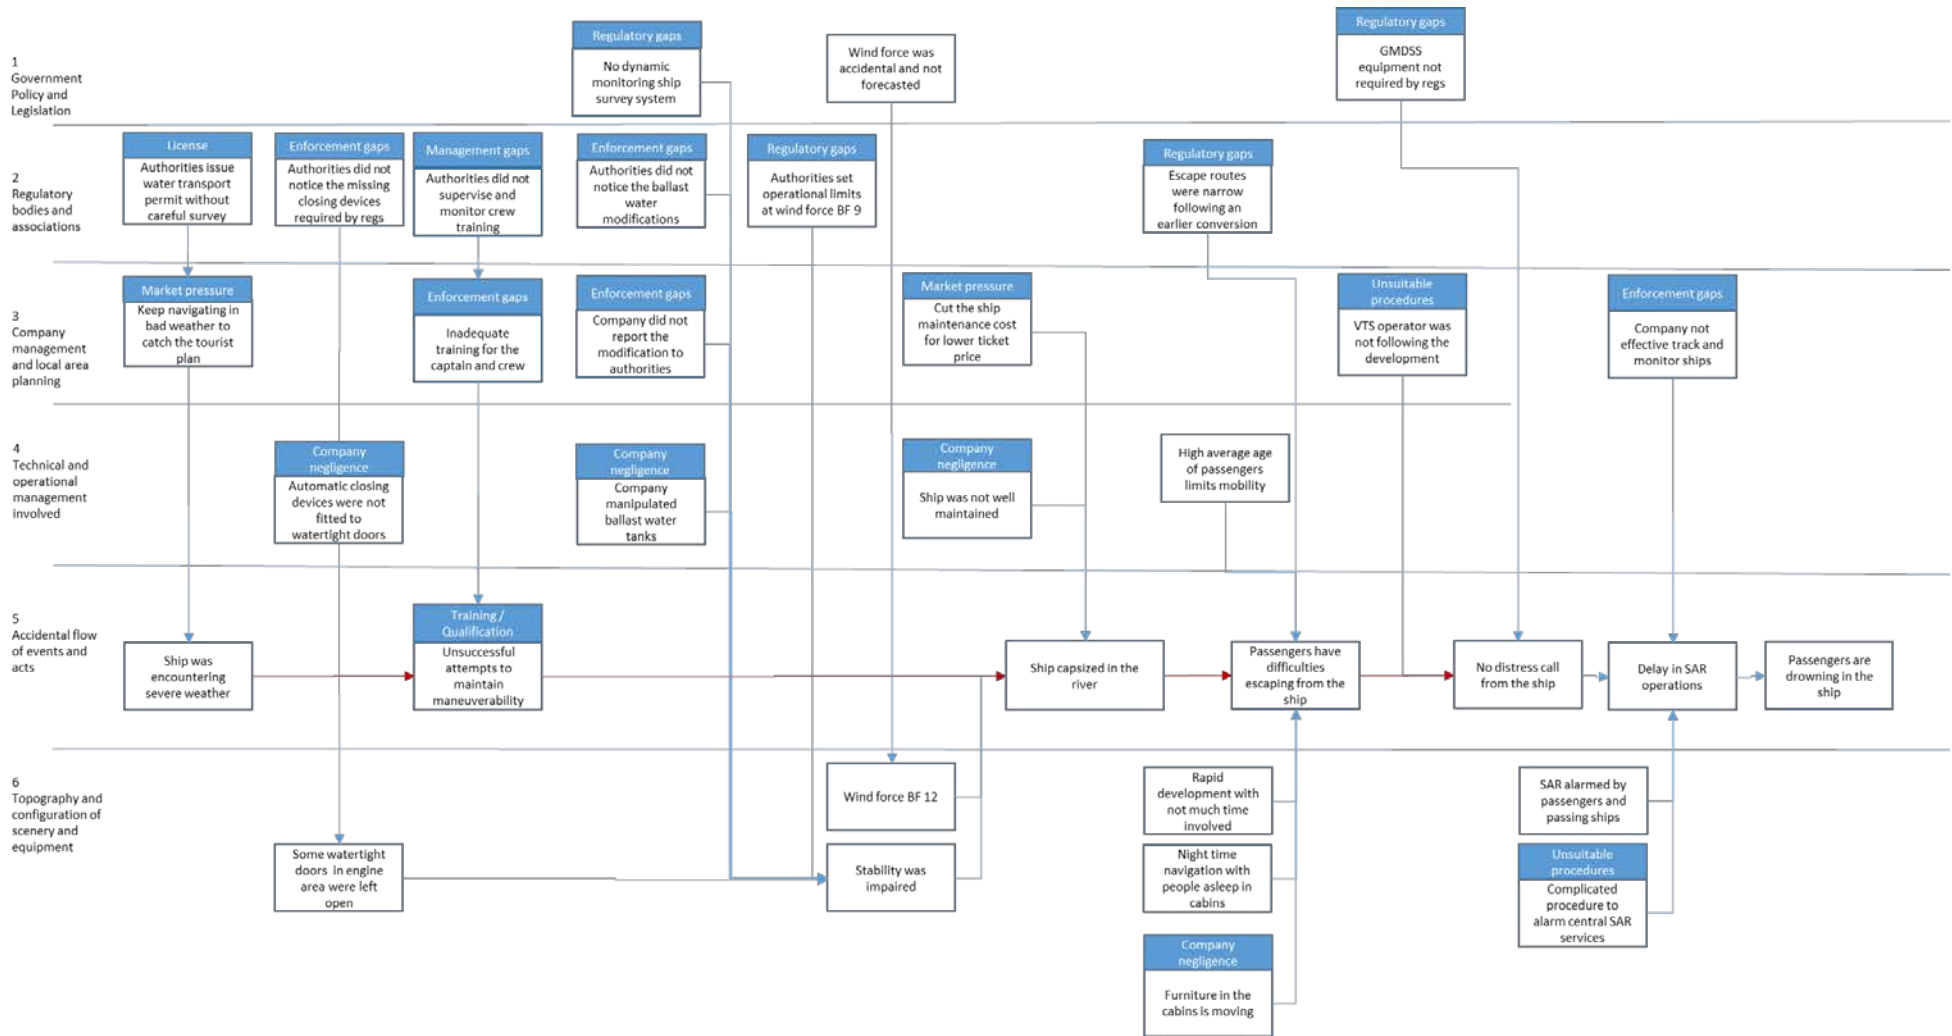
Figure 12. AcciMap of the Eastern Star casualty

Accidental flow of events and acts First, the accident flow of Eastern Star can be outlined with a series of events and acts as level 5 with red arrows. The ship encountered severe weather, which led to an unsuccessful attempt to maintain maneuverability. It capsized into the river immediately and passengers on board had difficulty escaping from the ship. No distress call was sent out. The tragedy caused a total of 442 deaths with only 12 persons surviving.

Topography and configuration of scenery and equipment At the time of the accident, a squall line system appeared above the waters where the Eastern Star navigated, accompanied with downburst, tornadoes, and other short-term local heavy rainfall, as well as severe convective weather. Waters where the ferry capsized suffered strong storms with the maximum wind speed reaching 32-38m/s (Bf 12-13). The unanticipated tornadoes directly caused the capsizing.

The extreme weather conditions encountered by the Eastern Star resulted in the loss of stability. After the initial construction of the ship, it underwent rehabilitation and technical changes on three occasions and the fundamental stability criterion numeral of wind pressure was gradually reduced (see Table 11). Although it is still in line with regulatory requirements, the ship will capsize when encountering 21.5 m/s beam wind (BF 9) or 32.0 m/s maximum instantaneous wind speed (BF 11) with $21.1^{\circ}\sim 156.6^{\circ}$ wind angle according to calculation and experience. The navigational area for the Eastern Star is approved as level B, which means it will lose stability when subjected to 21.52 m / s (Bf 9). However, at the time of the accident, the wind reached Bf 12.

The company adjusted the ballast tanks without applying inspections from local professional institutions. The captain and senior officers on board had not received adequate training, especially for response to extreme weather conditions. When the accident happened, the captain did not recognize the potential risks caused by the severe weather. He did not send out a distress message or sound an alarm to the whole ship. The captain and crew did not organize any kind of evacuation from the ship. The newly hired crew members were not qualified for their positions due to inadequate training and careless assessment. The daily security checks were not thorough enough to identify problems such as lack of closing appliances to prevent water ingress and unfixed beds in cabins. In addition, there were no full-time staffs in charge of ship daily maintenance. The monitoring systems were not under dynamic tracking and the VTS operators were not following the development.

Regulatory bodies and associations At the Regulatory bodies & Associations level, Changjiang River Administration of Navigational Affairs had not effectively implemented the shipping administrative department duties and issued waterway transport licenses without careful survey. Changjiang MSA did not audit the safety management system of the company strictly and failed to identify regulatory loopholes. The crew training was not supervised effectively. The problematic modifications, including ballast water tank adjustments and narrowing of escape routes, were not noticed. The lack of closing devices required by regulations was not detected

during inspections. Yueyang MSA did not implement the requirements from MOT and Changjiang MSA to maintain tracking and monitoring of every passenger ship navigating in Changjiang. The operational limits at wind force BF 9 were not safe enough considering the poor condition of some old ships.

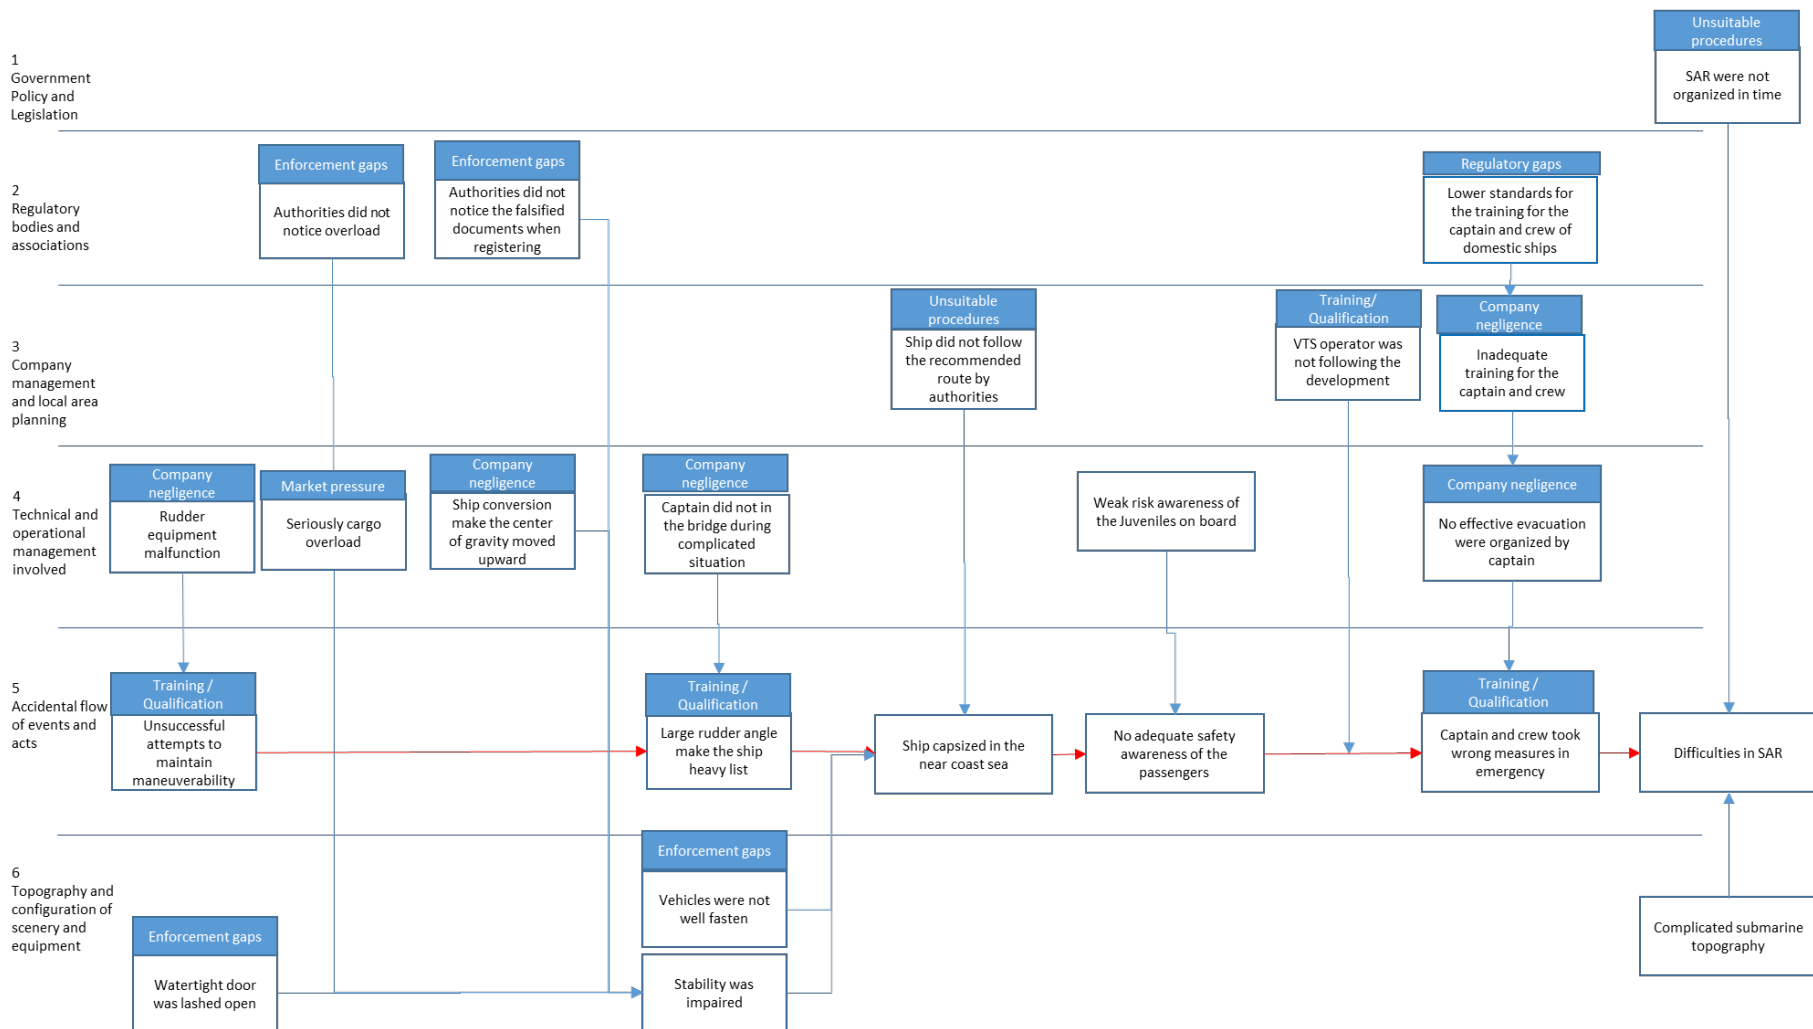
Figure 14 AcciMap of the Sewol casualty

Accidental flow of events and acts Firstly, the Accident flow of Sewol can be concluded in a series of events as shown by the line with red arrows. The accident occurred at 20km north of Screen Island, Ronan County, where the natural conditions are complicated. The inexperienced helmsman felt the rudder angle was significantly larger than normal steering and was unsuccessful in the attempt to maintain maneuverability. The large rudder angle made the ship list heavily and the ship capsized in the near coastal sea. The inadequate awareness of risk of the passengers, the improper actions of the captain and the delay in SAR increased the loss of lives to 304 in the end.

Technical and operational management involved A malfunction in the rudder equipment was identified in the investigation report. The materials for rudder maintenance applied by Sewol were aging due to their long existence. The problematic rudder device caused a significant error when steering. The ship continued rotating until the rudder reached the maximum steering angle so that the ship was out of control. When navigating in the complicated waters, the young helmsman operated the ship improperly with a sharp turn from 135 to 150 degrees. The Sewol began to list to port and tilted towards the water while the captain was not on the bridge. The overall effect was that the ship turned about 45 degrees to the right and rotated 22 degrees on the spot for a span of 20 seconds. The cargo fell to one side of the ship causing the Sewol to lose all of its restoring force and allowing water to flow into the ship through the side door of the cargo-loading bay and the car entrance located at the stern.

during the total 394 voyages between Incheon and Jeju after modifications, the overloading times reached as many as 246 and among them there were 136 times of loading cargo over 2,000t and 13 times of more than 3,000t. On April 16, when the accident occurred, Sewol carried more than 400 passengers, 180 cars, 22 trucks and 34 sets of trucks over 2.5t, with a total weight of 3,608t, which was 3.66 times the full load. This was almost the worst overloading on record. It was easy to capsize in such an overloaded condition, especially when encountering bad weather like wind, rain, snow, or fog.

Interestingly, the Sewol was equipped with enough advanced escaping facilities, but only two among 44 lifeboats were opened and 4 escape ships, which can accommodate over a thousand of persons, were not opened at all in the accident. When in a state of emergency, the captain did not make an effective response. Since the captain misjudged the dangerous situation and lack of capability to deal with emergencies, he failed to organize the crew to take timely measures to help the passengers, including guiding the passengers to evacuate immediately to the place where the lifeboats and life rafts were placed. Even when Jindo control center told the captain to direct the passengers to wear lifejackets as soon as possible for emergency evacuation and escape, the crew did not completely fulfill the corresponding duties. It is the captain and crew's weak risk knowledge and skills that resulted in missing the best time for escaping.
