XVIII SCIENTIFIC - EXPERT CONFERENCE ON RAILWAYS RAILCON '18

METHODOLOGY FOR STATISTICAL ANALYSIS OF SQUAT RAIL DEFECTS

Milica VILOTIJEVIĆ¹
Ljiljana BRAJOVIĆ²
Andrey P. PUSTOVGAR³

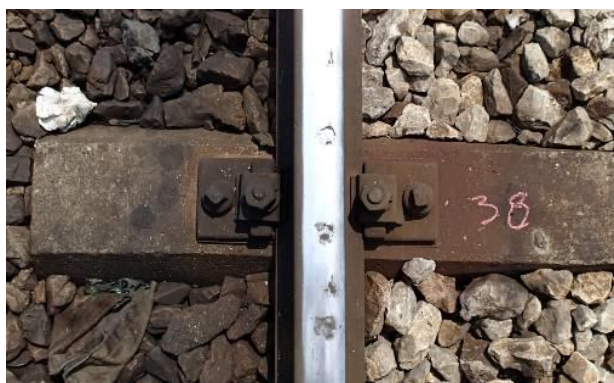
There is a common occurrence of squat rail defects on straight tracks or in large radius curves $R \geq 3000$ m (Figure 2). Since the squat defect occurs in the areas with braking and acceleration of the railway vehicles, the visual inspection of rail defects was performed on

Fig.2. Successive occurrence of squats (left rail, track No. 2, Pančevo Varoš station, 2017)

Due to inadequate railway infrastructure maintenance in Pančevo Varoš station, especially in the inspected zones II and III, where the trains break and accelerate, a successive squat occurrence was observed. Therefore, the statistics of squat rail defects in the station proved that these defects occur in places with higher friction, i.e. on the track sections where greater traction and greater braking are required.

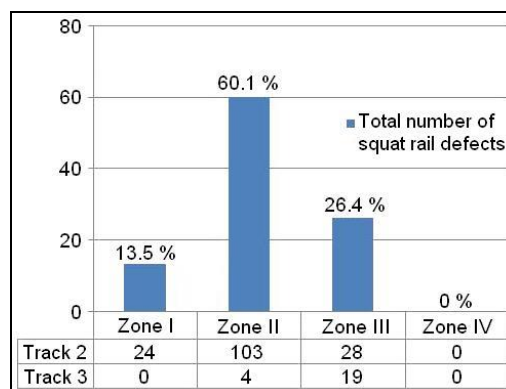
Fig.4. Distribution of squat rail defects per zones

Figure 4 shows the distribution of squat rail defects in zones I-IV. The greatest number of squats was observed in zones II and III on both tracks, in the area where trains break and accelerate (in front of the station building).

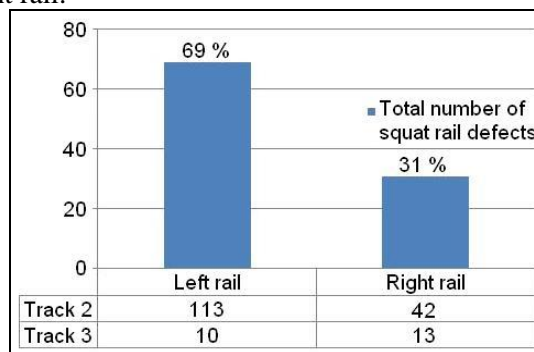
Fig.5. Distribution of squats on rails

The total number of squat rail defects on the left and right rails in the second and third tracks is shown in Figure 5. It was observed that the left rail of the second track is significantly more damaged than the right rail.

It is interesting to note that the left rail is significantly more damaged than the right rail on both tracks. Wooden sleepers are located in the zones of switches at the beginning and at the end of railway station, while the zones II and III contain concrete sleepers. By comparing zones with wooden and concrete sleepers, it can be concluded that the percentage of squat rail defects is significantly higher (more than 3 times) on the rails above the concrete sleepers. This is closely related to the rail support stiffness.

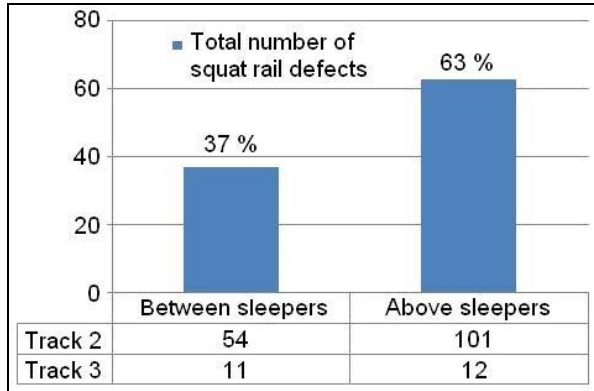
Fig.6. Distribution of squats between and above sleepers

The following statistics refers to the total number of squats that occur above the sleeper and between two sleepers (Figure 6). The zones above and between

Based on the defined zones of defect occurrence (Figure 7), around 63% of all squat rail defects were detected in the zone above the sleeper, while 37% of squat defects were detected in the zone between two sleepers. Thus, the correlation of the defect location and the rail support stiffness was confirmed. In addition, larger number of defects above the sleepers was detected in the case of decreased distance between sleepers ($L < 60$ cm). Therefore, it could be concluded that the distance between sleepers affects the occurrence of squat rail defects. The continuous occurrence of squat rail defects is observed in the zones with smallest sleeper distance (higher vertical stiffness of rail support).

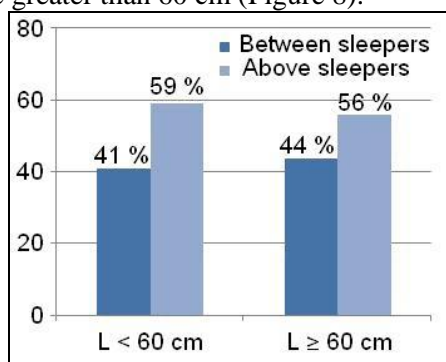
Fig.8. Distribution of squats depending on the sleeper distance

Furthermore, two cases were considered: one with the sleeper distance less than 60 cm and another with distance greater than 60 cm (Figure 8).

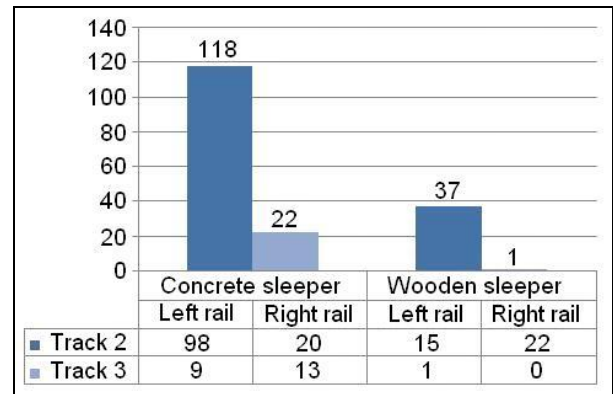
Fig.9. Distribution of squat rail defects in zones with concrete and wooden sleepers

Figure 9 shows statistical data on the total number of squats observed on the tracks No. 2 and No. 3 in zones with wooden and concrete sleepers (zones II and III). According to the total number of detected defects, a significantly greater number of squat defects was observed in zones with concrete sleepers.

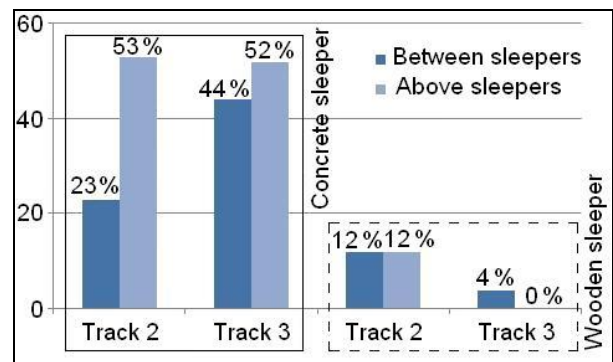
Fig.10. Distribution of squat rail defects occurring between and above concrete and wooden sleepers

The visual inspection showed a higher percentage of squat occurrences in the zones above the concrete sleepers for both tracks (Figure 10).

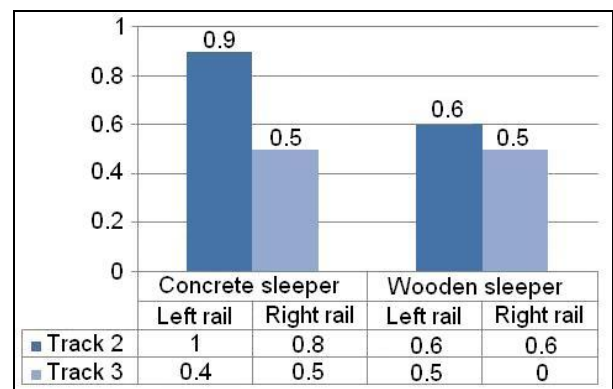
Fig.11. Average depth of squat rail defects [mm]

The depth of squat rail defects is divided into three classes: 0.5 mm, 1 mm and 2 mm. Figure 11 shows the average depth of squat defects per tracks in zones with concrete and wooden sleepers.

The results of the squat depth analysis for the second track show a greater average depth value in the zones with concrete sleepers (0.9 mm) comparing to

the zones with wooden sleepers (0.6 mm). However, the maximum measured depth of squat rail defect was 2 mm (the rails were laid in the track in Pančevo Varoš station in 1992). This could be considered as an alarming situation, since squat depth between 3 and 5 mm leads to the crack propagation downward and transversely, thus causing the rail break [3].
