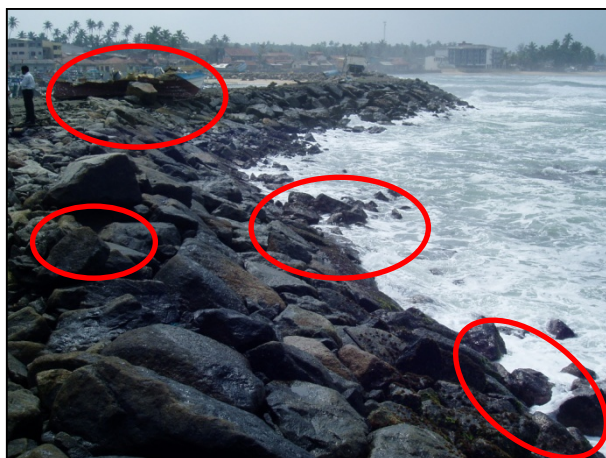
Figure 1. Displaced rock armour at the seaward side of the outer breakwater at Hikkaduwa.

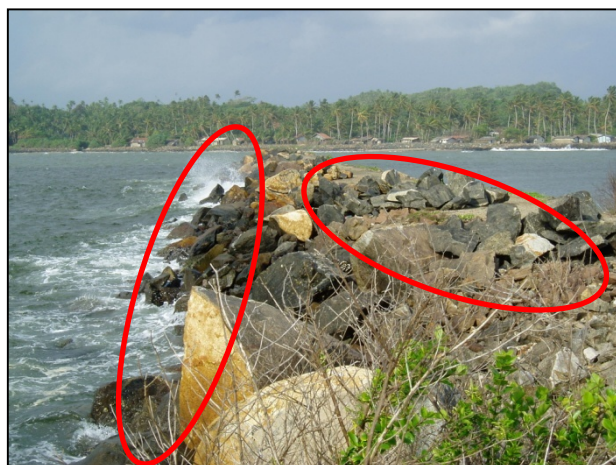
Figure 2. Displaced primary rock armour at the seaward and crest of the main breakwater at Mirissa

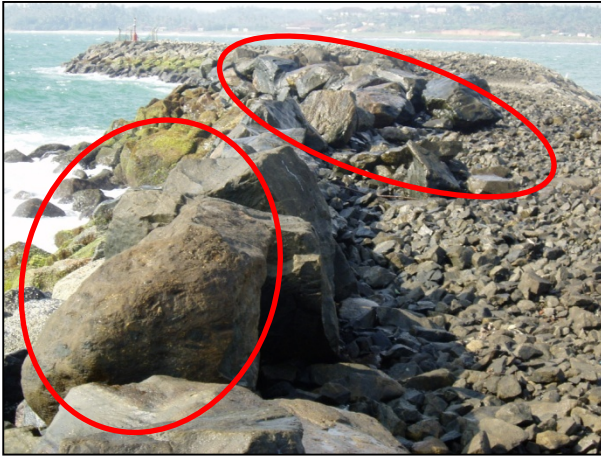
Figure 3. Displaced primary rock armour at seaward and crest of the main breakwater at Puranawella

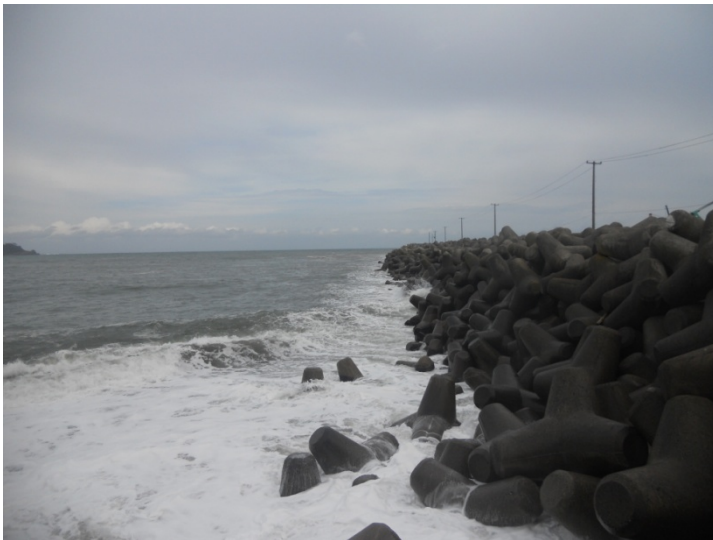
Figure 4. Steep Tetrapod Armour Layer at Kuji Port.

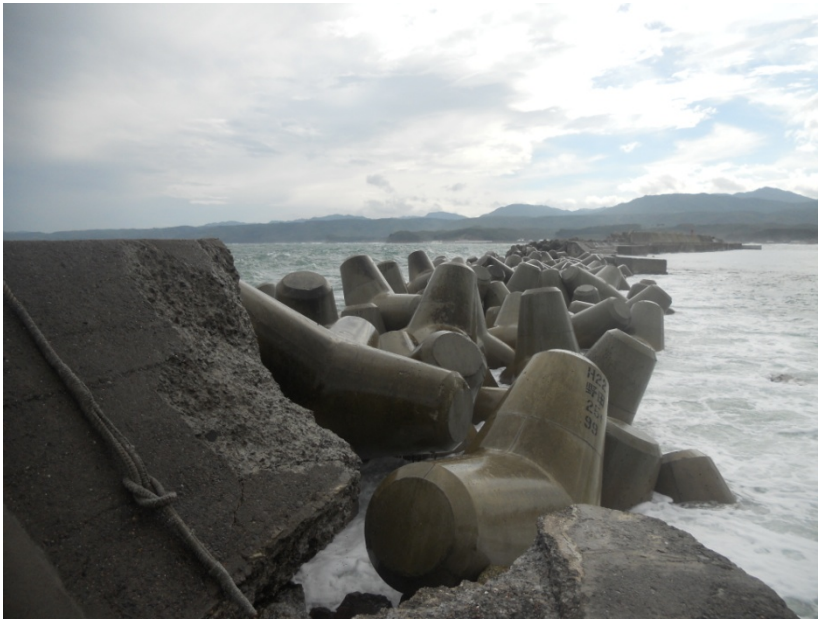
Figure 5. Damaged Breakwater at Noda Port, provisionally repaired using 25 ton tetrapods.

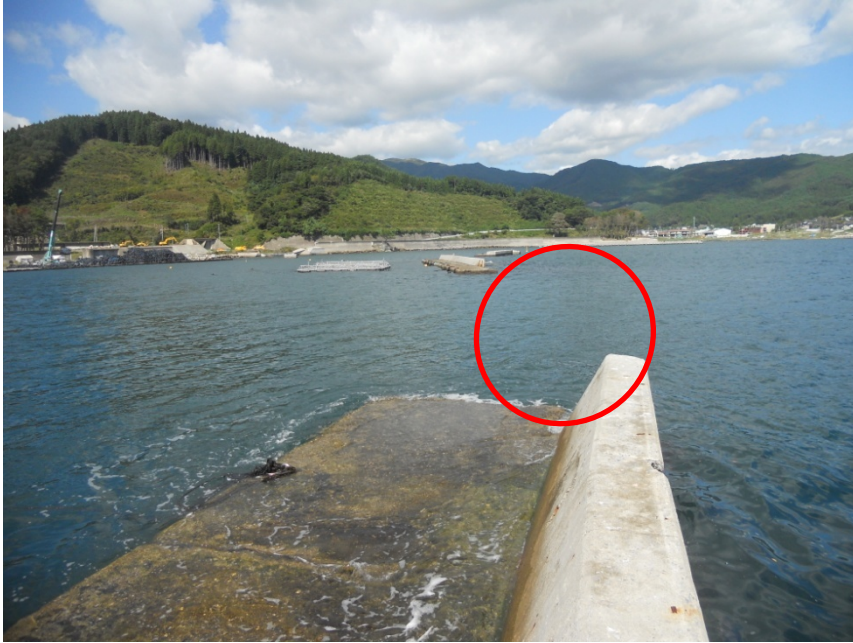
Figure 7. Damaged breakwater at Okirai port, showing missing caisson sections.

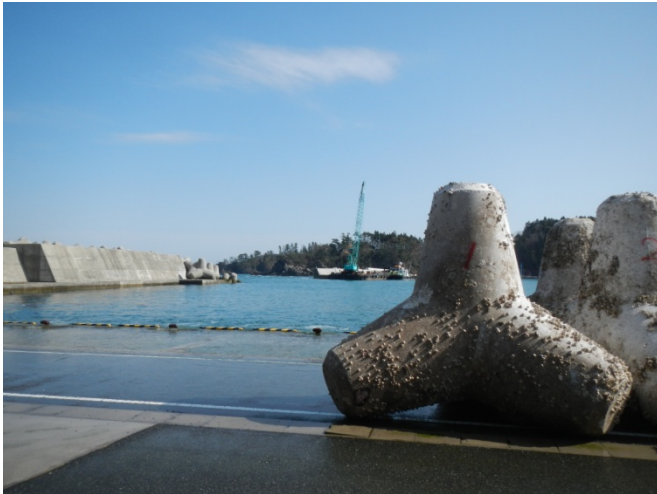
Figure 8. Recovered tetrapod units at Ishimaha port were temporarily stored behind the breakwater before being placed back in their original location

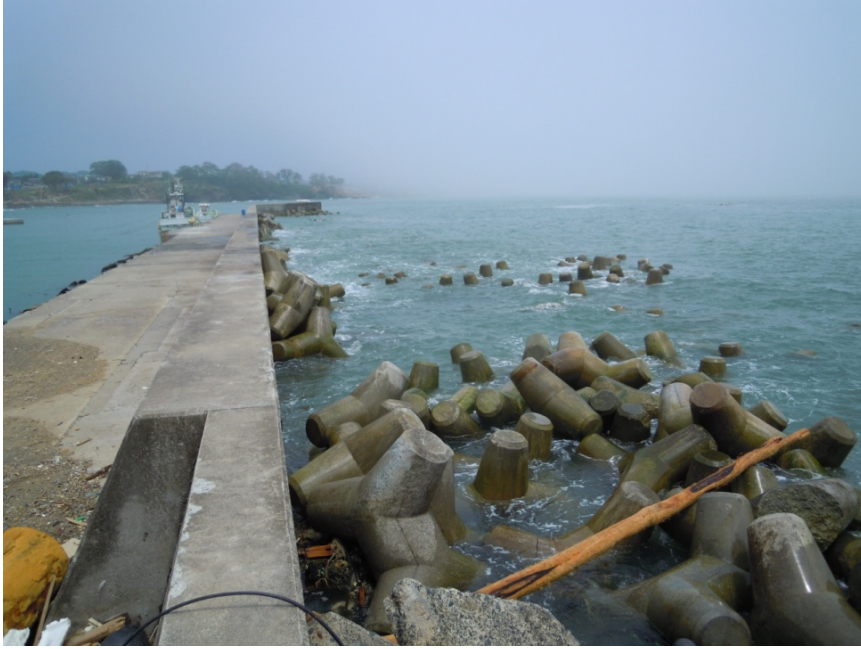
Figure 9. Damaged Sea-Lock Armour Units at Ooya Port.

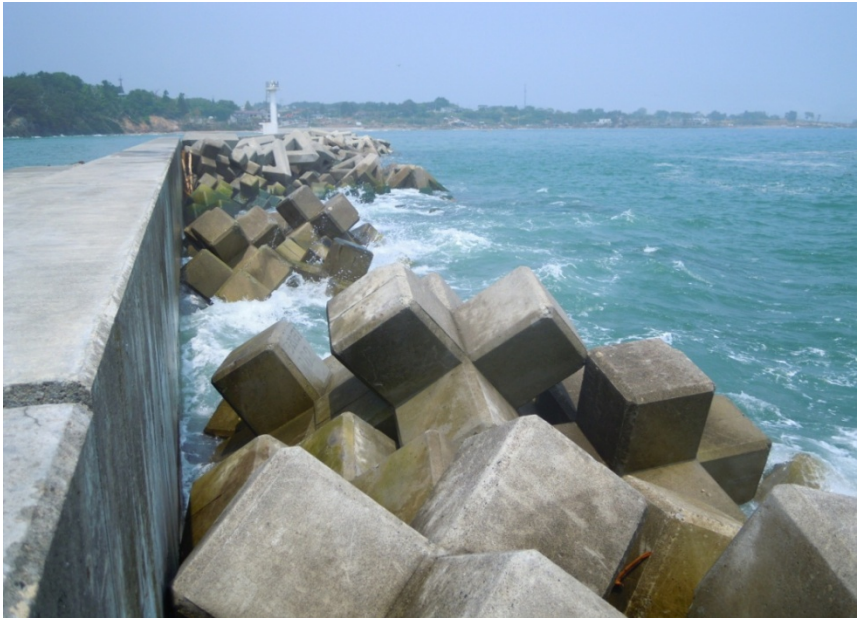
Figure 10. Failed X-Block Armour Units at Hikado Port.
