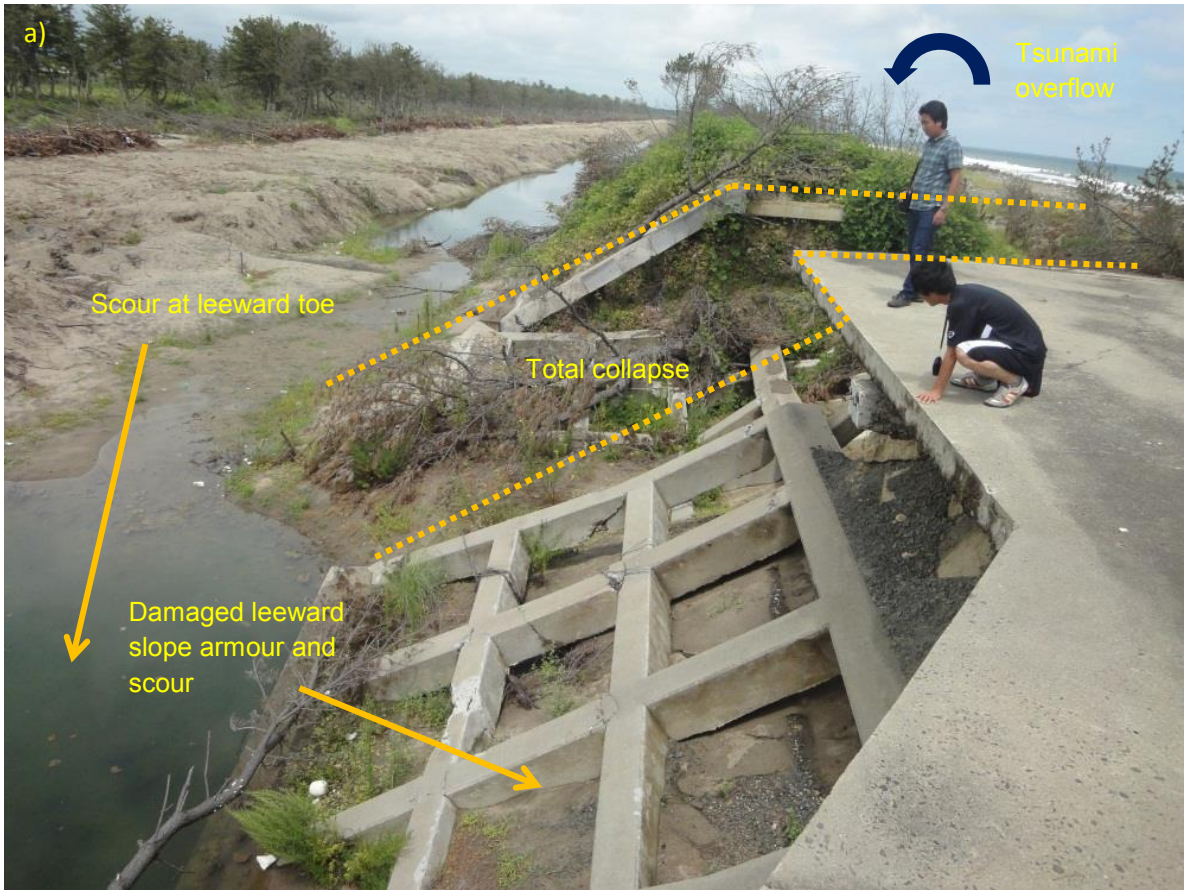
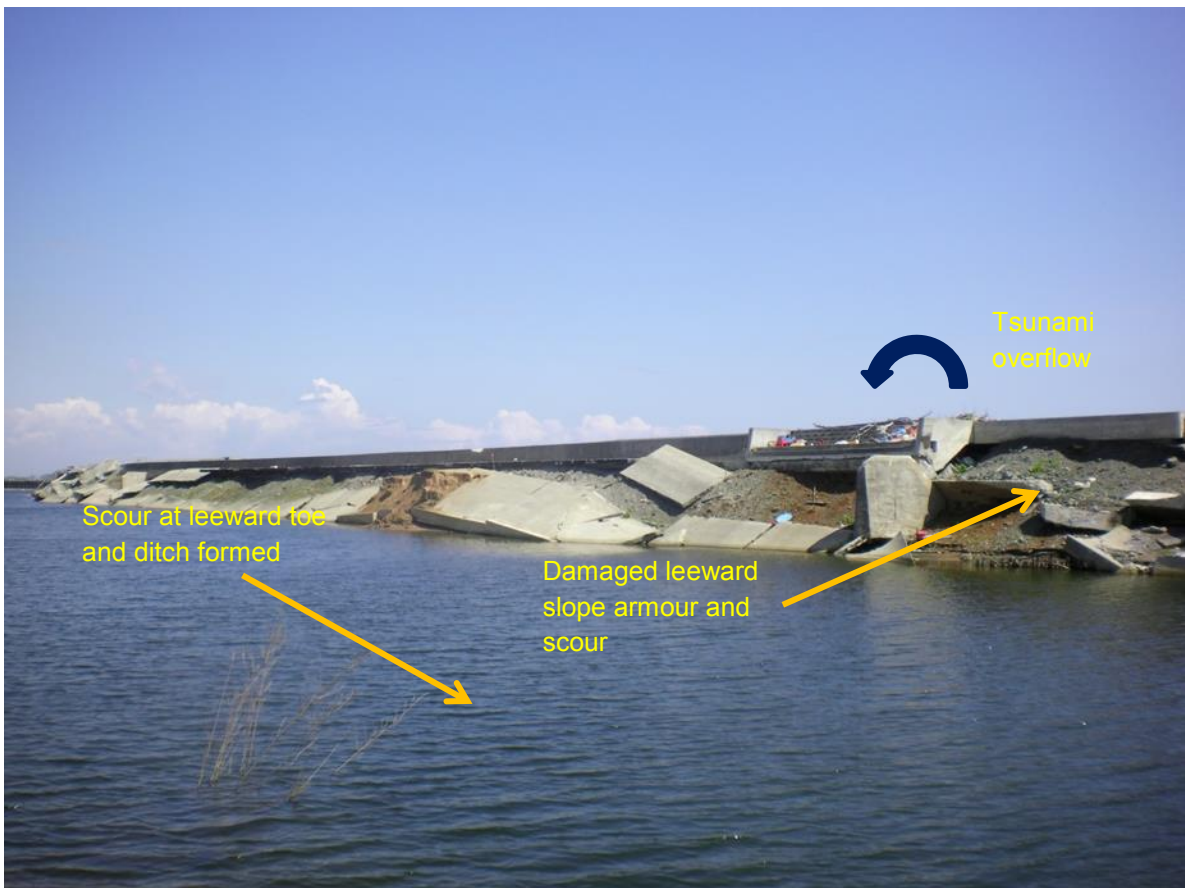
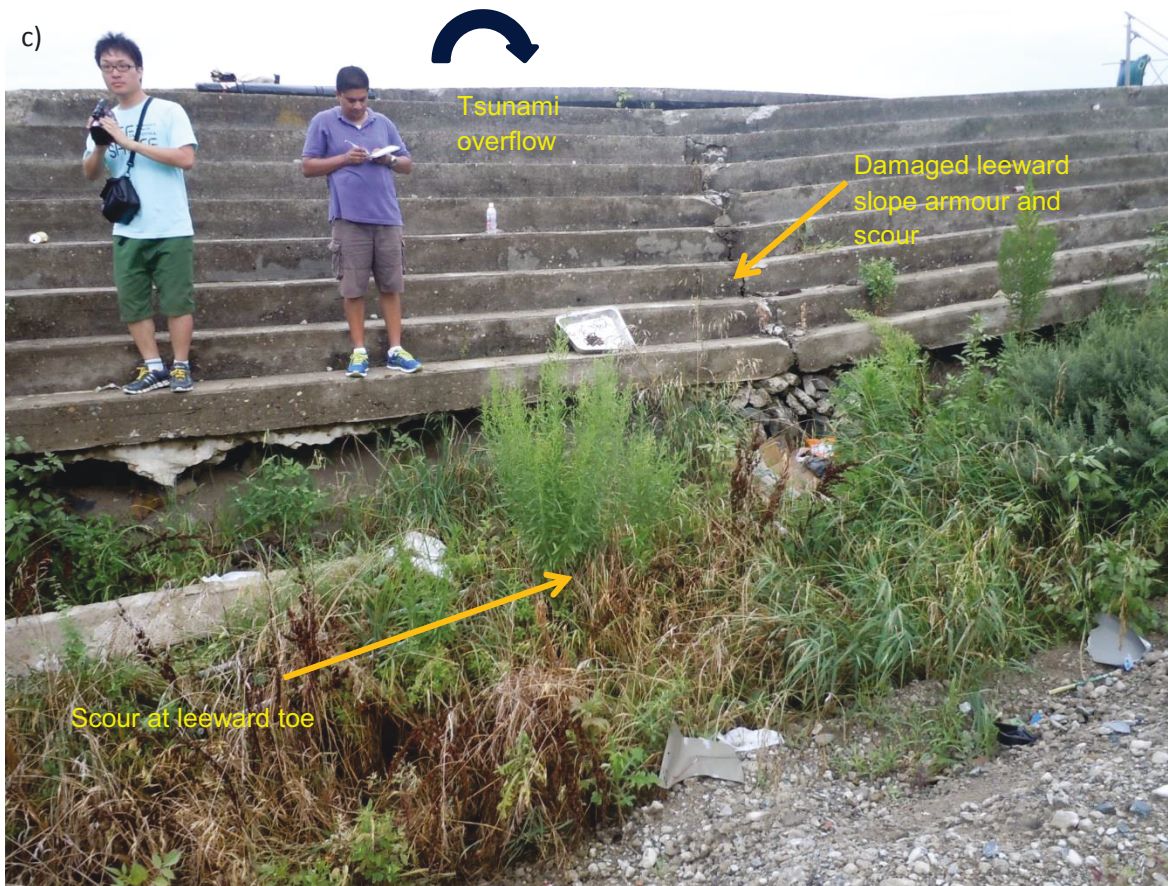
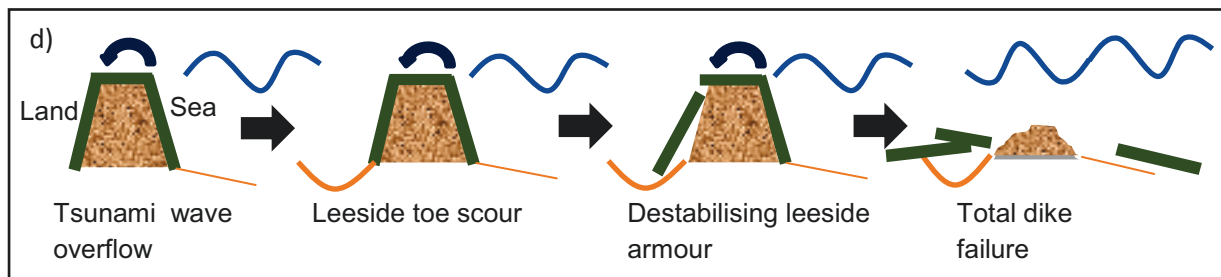
Figure 2. Leeward toe scour in sea dikes: a) Toe scour in sea dike at Iwanuma, b) Toe scour in sea dike at Soma city, c) Toe scour in sea dike at Shichigahama, and d) Physical process of sea dike failure due to leeward toe scour.

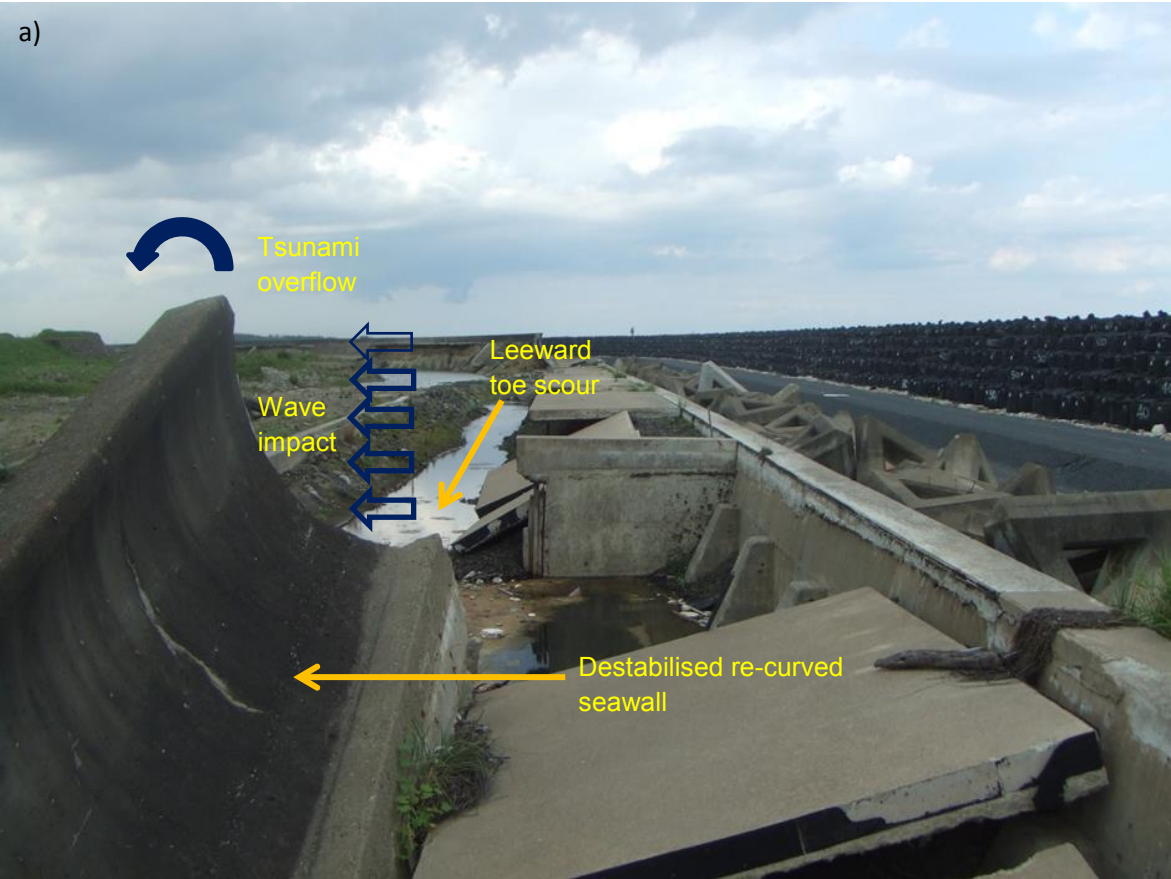
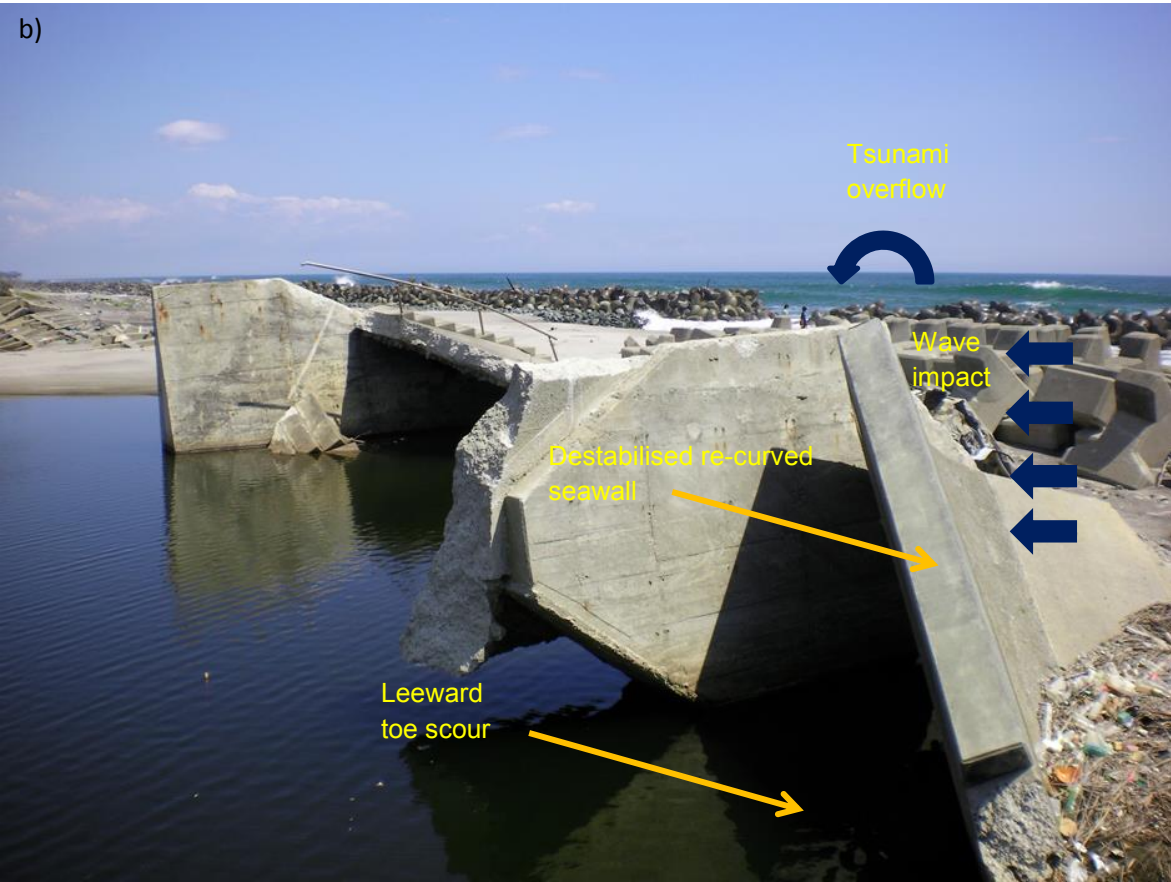
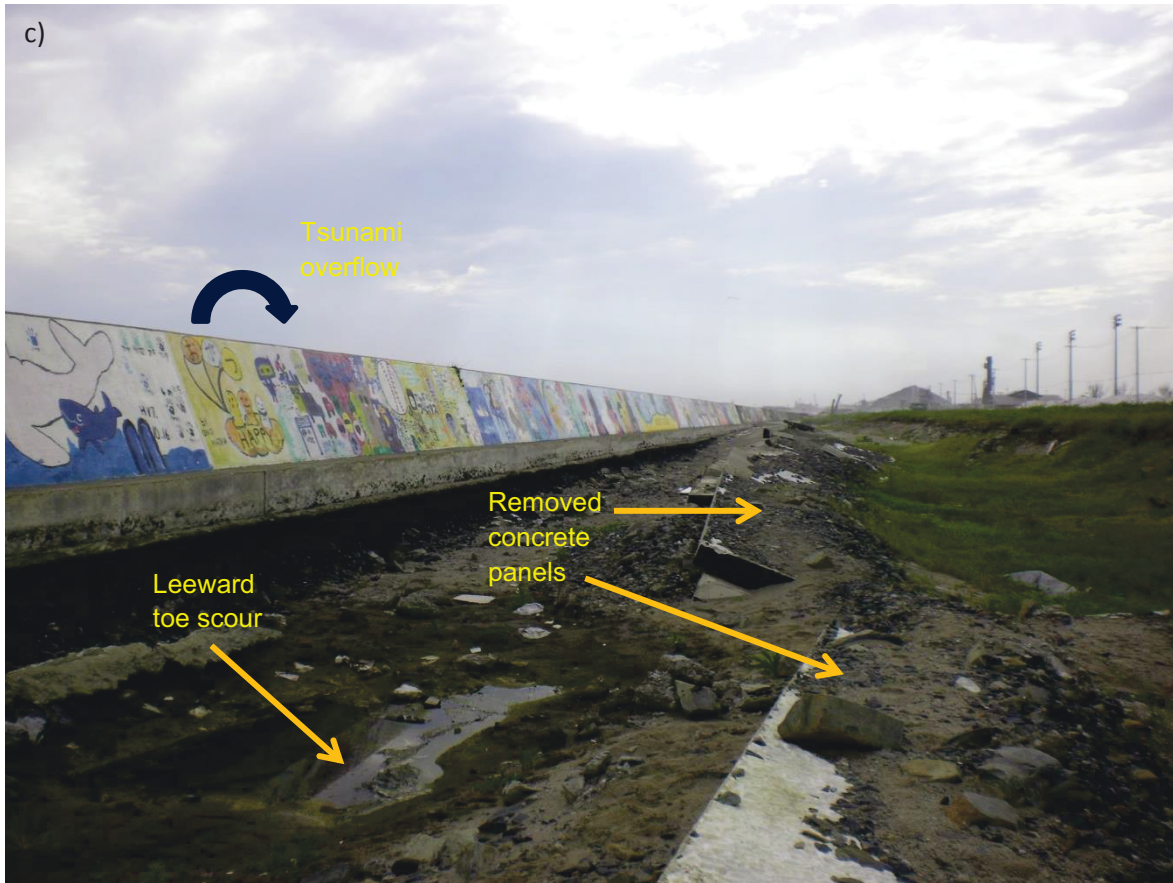
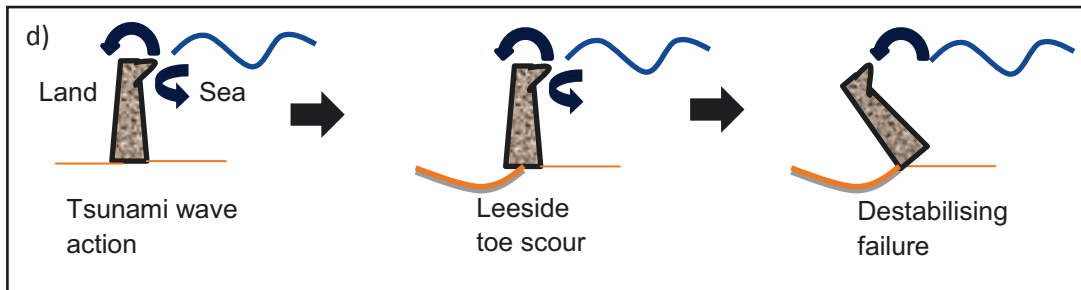
Figure 3. Leeward toe scour in re-curved seawalls: a) Toe scour in re-curved seawall at Watari (North), b) Leeward toe scour in wave wall at some city, c) Toe scour in re-curved seawall at Ishinomaki (East), and d) Physical process of re-curved seawall failure due to leeward toe scour.

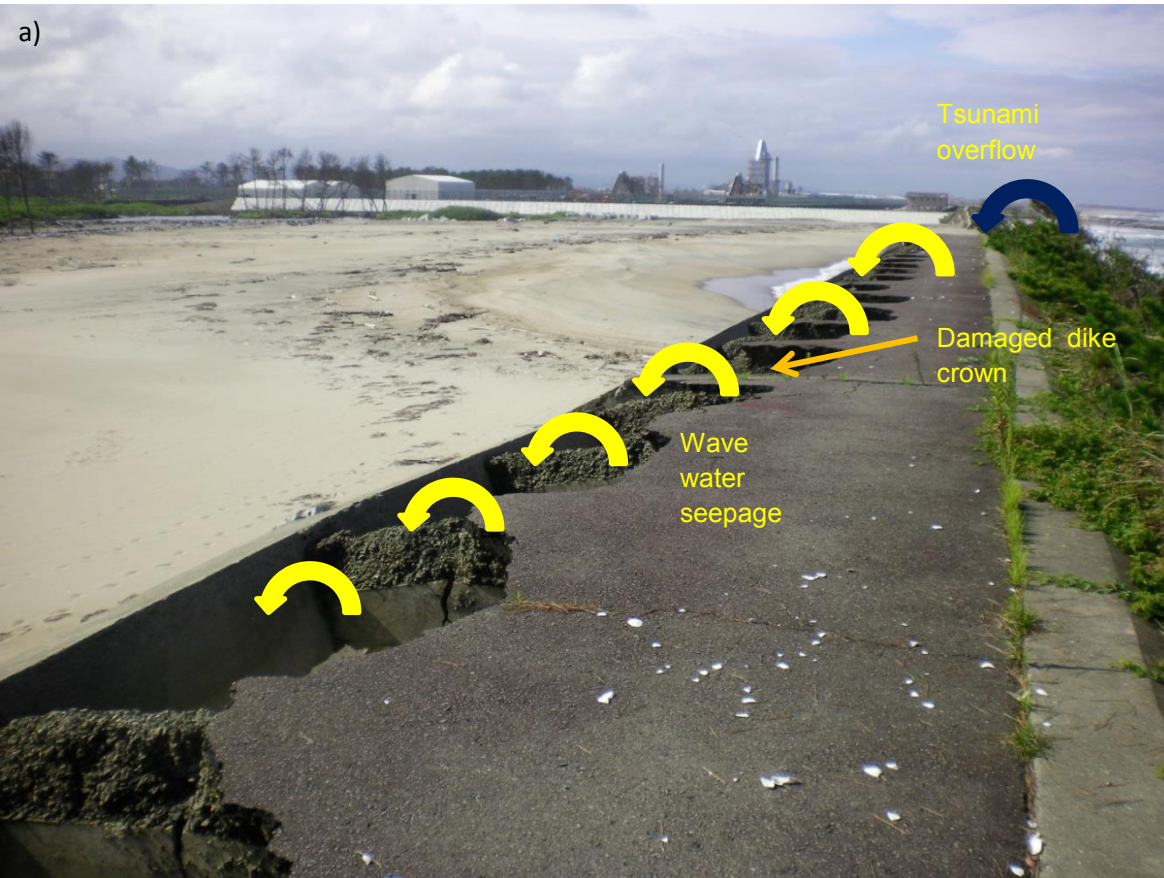
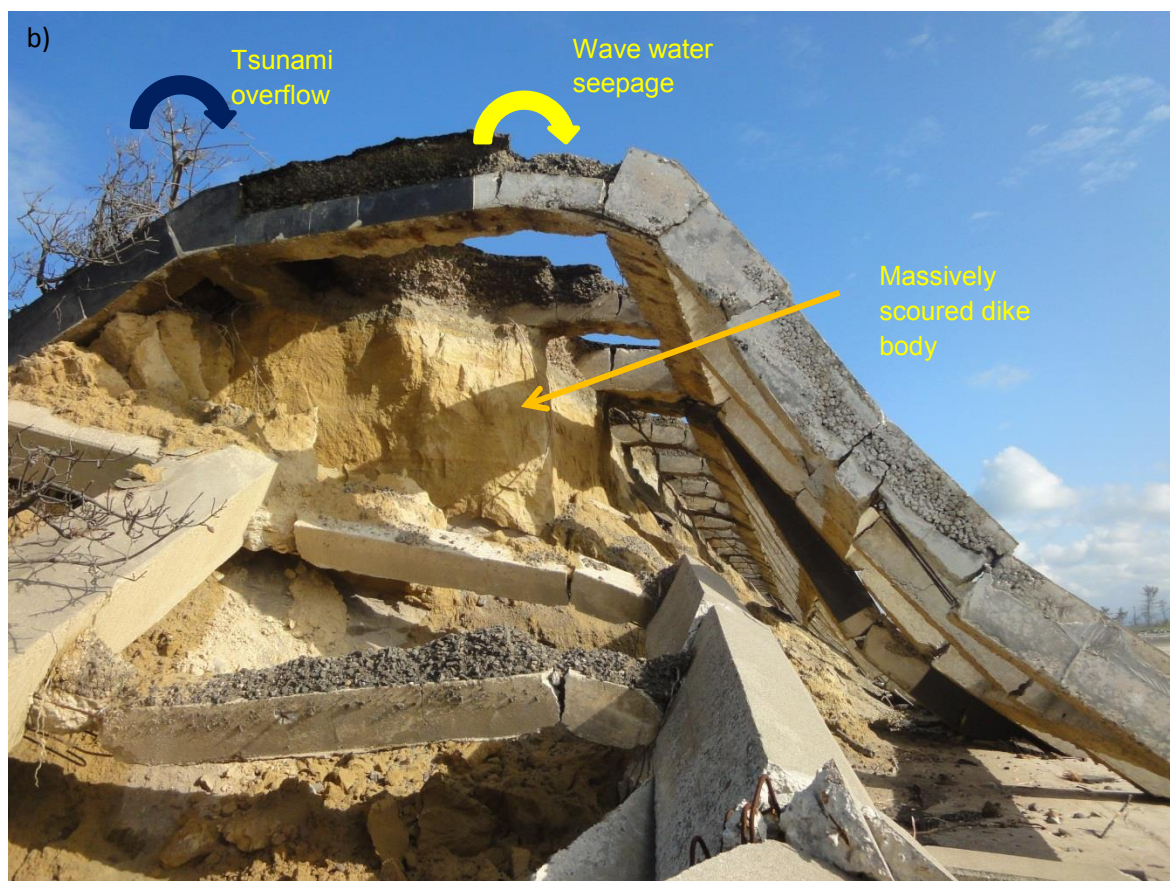
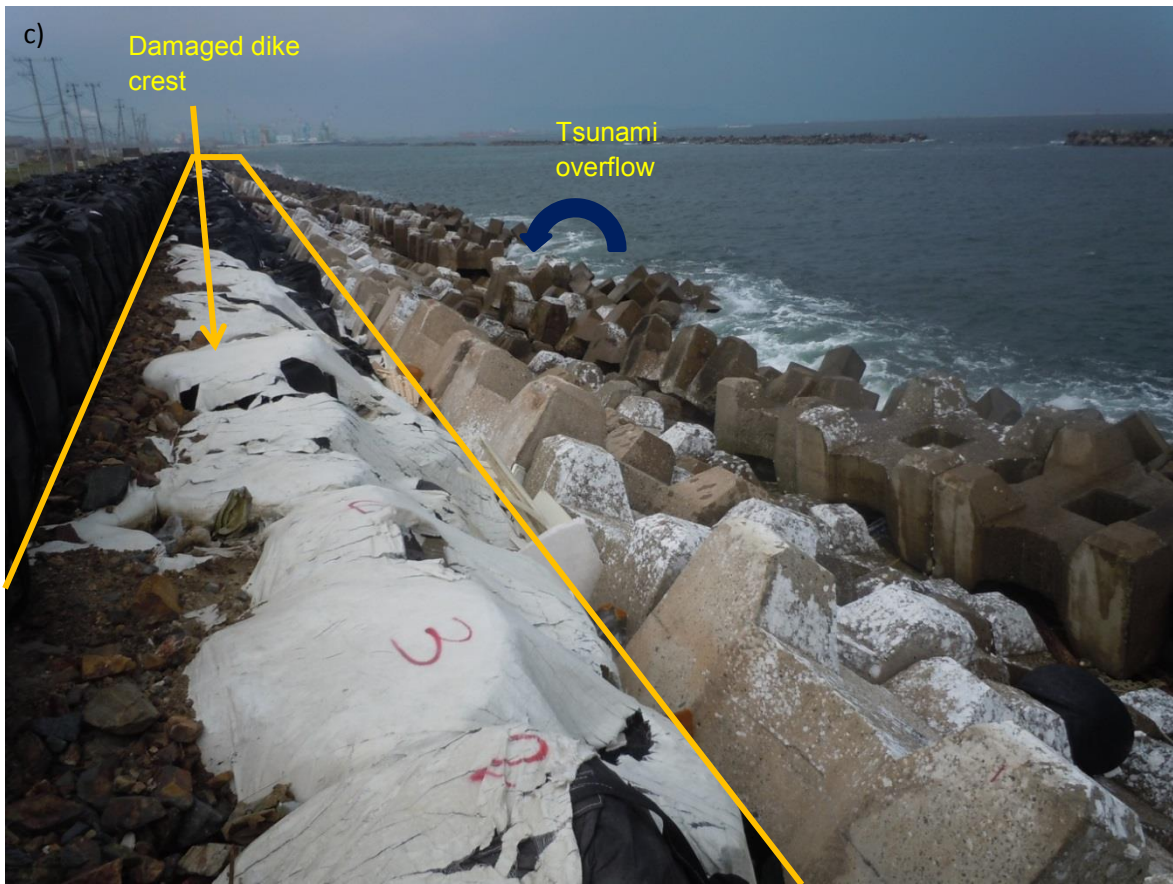
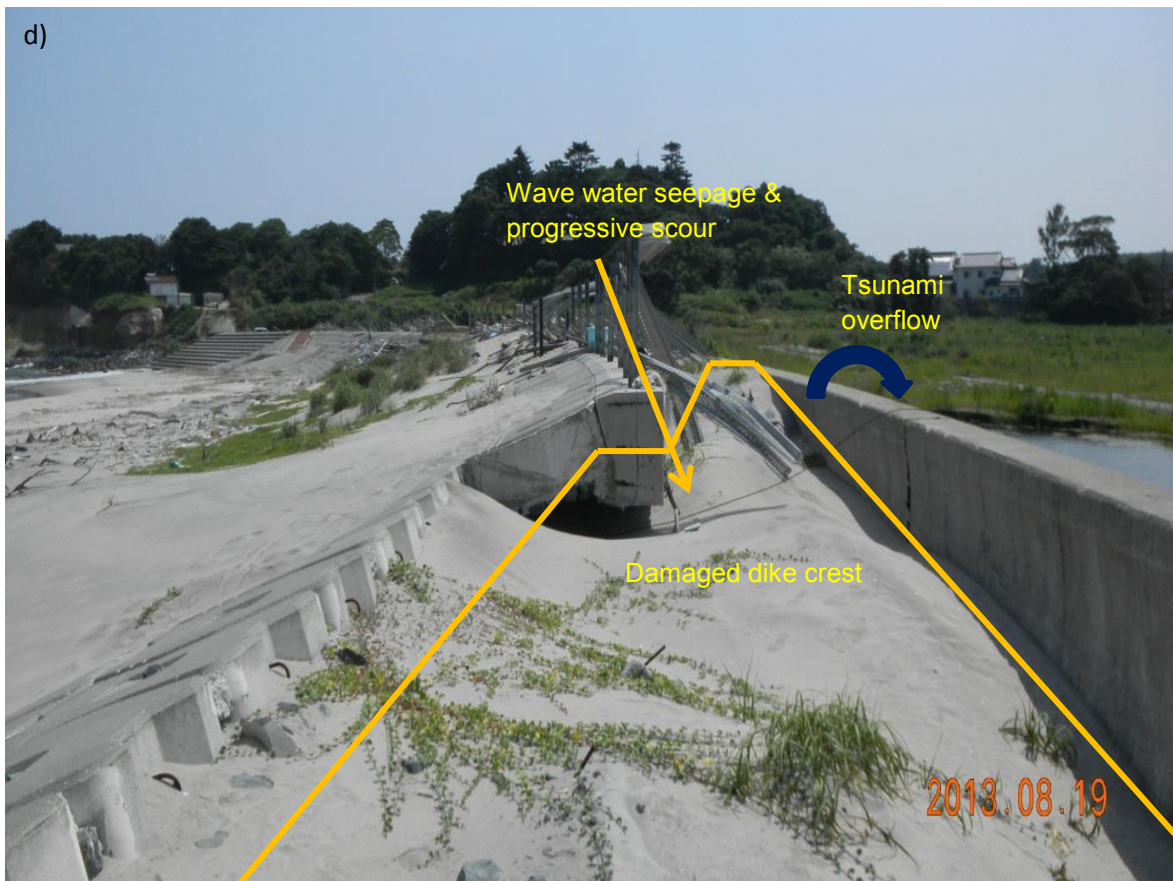
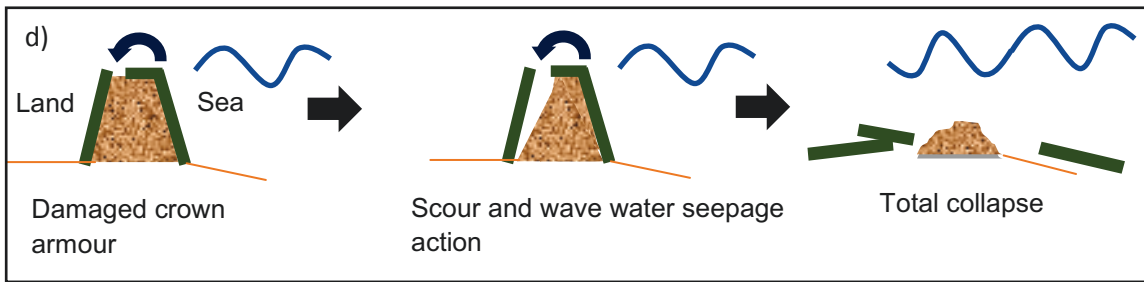
Figure 4. Crown armour failure: a) Top view of damaged dike crest at Yamamoto city, b) Side view of damaged dike crest at Yamamoto city, c) Damaged dike crest at Ishinomaki (West), d) Damaged dike crest at Soma city, and e) Physical process of sea dike failure due crown armour.

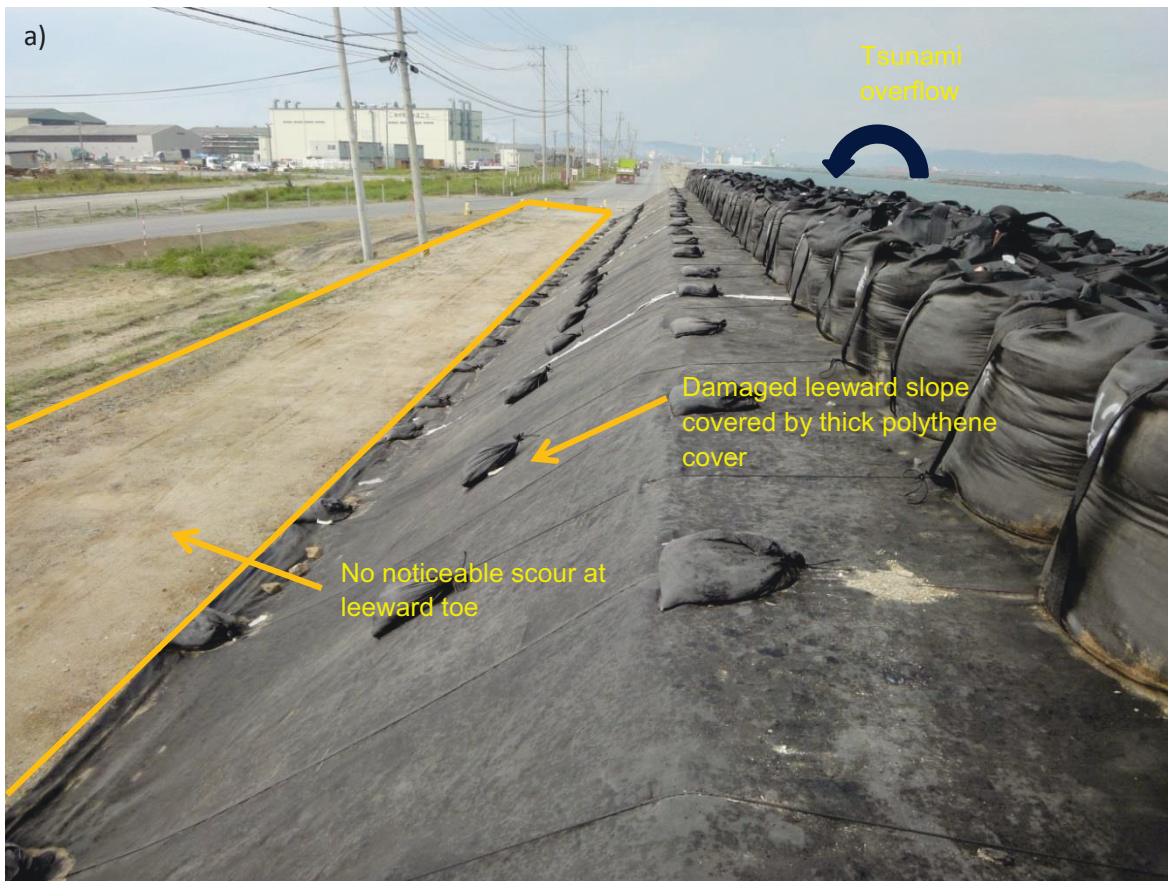
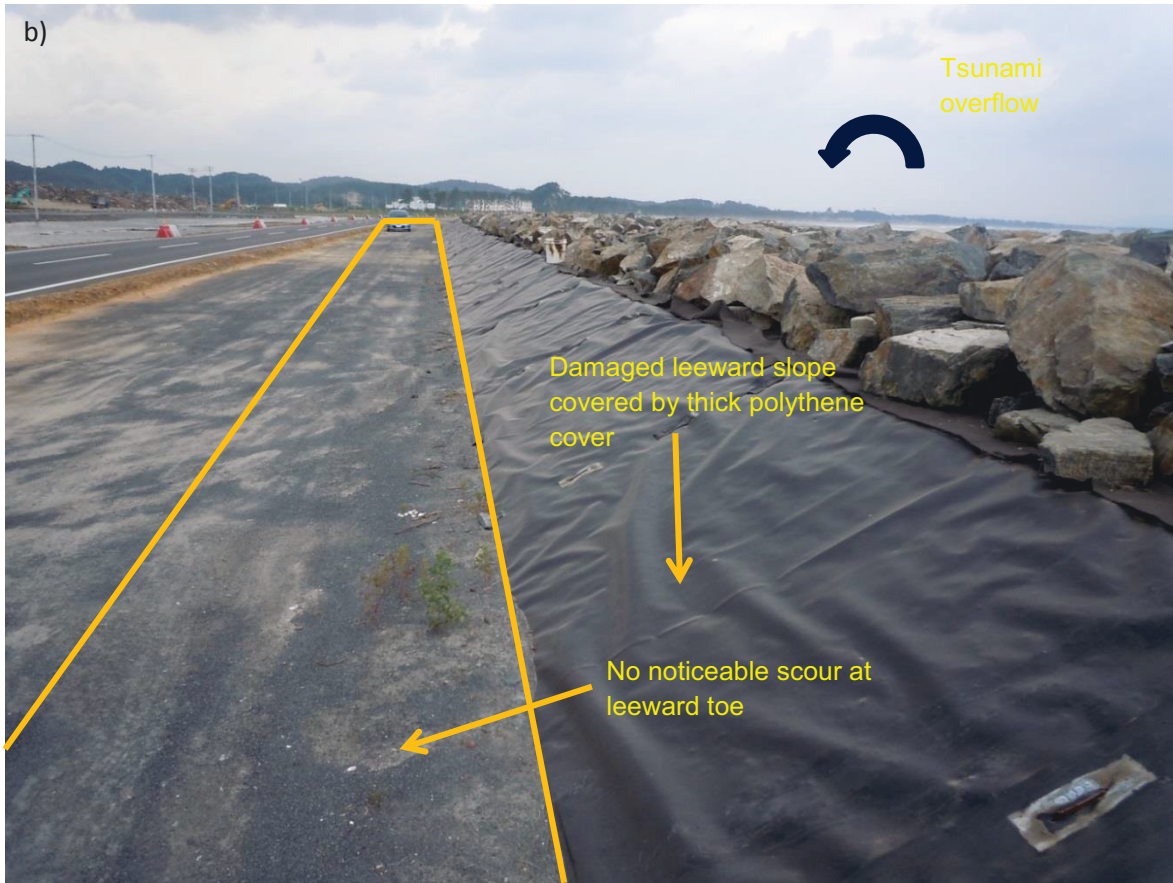
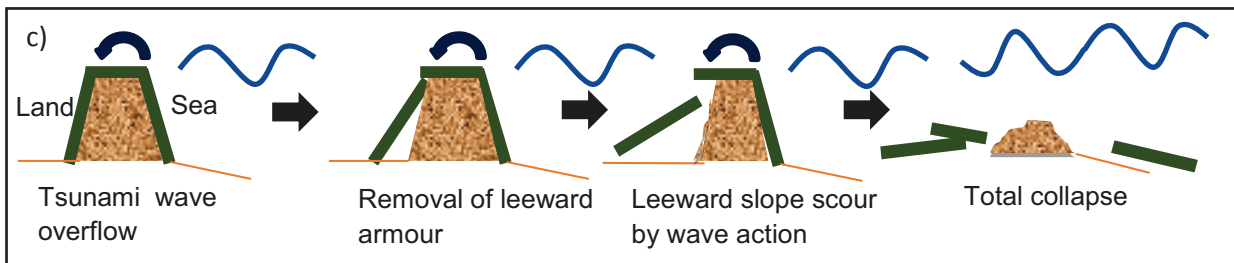
Figure 5. Leeward armour failure: a) Leeward slope armour failure at Ishinomaki (West), b) Leeward slope armour failure at Higashimatsushima, and c) Physical process of leeward slope armour failure.

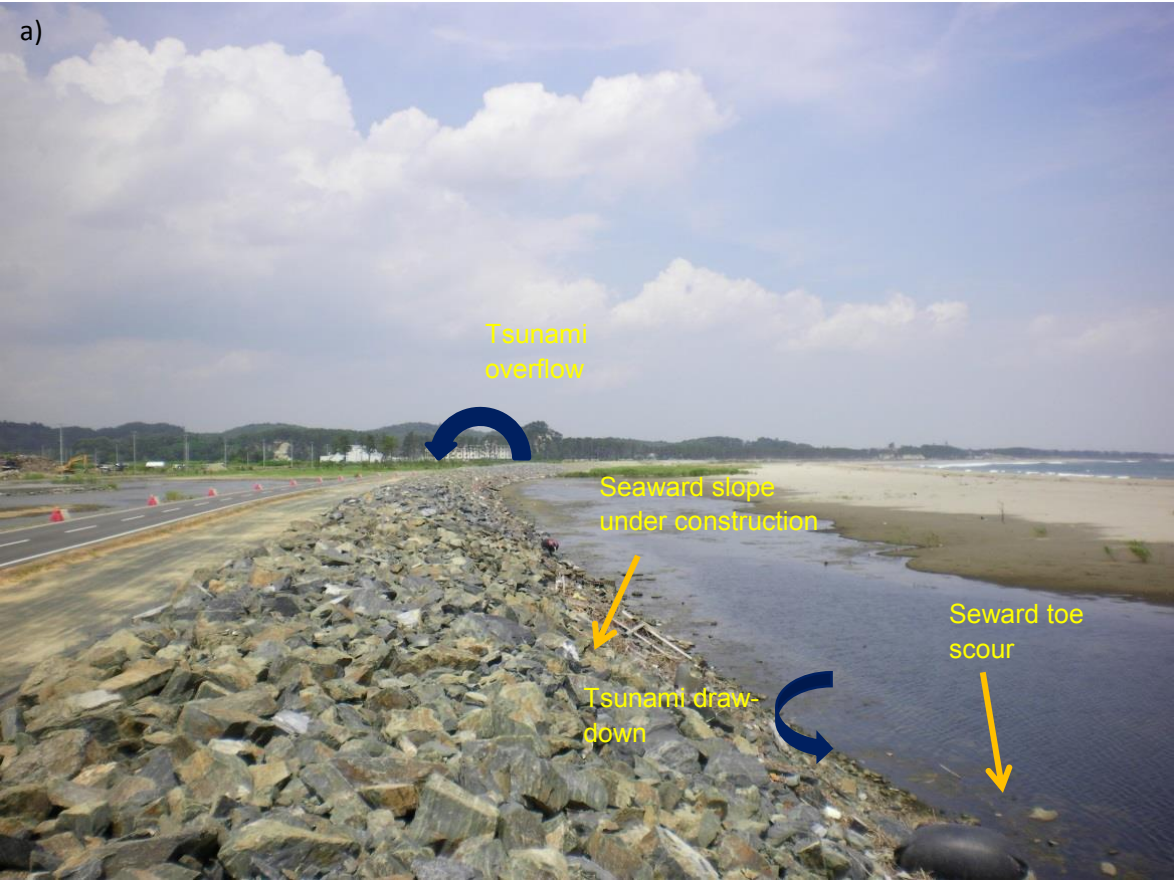
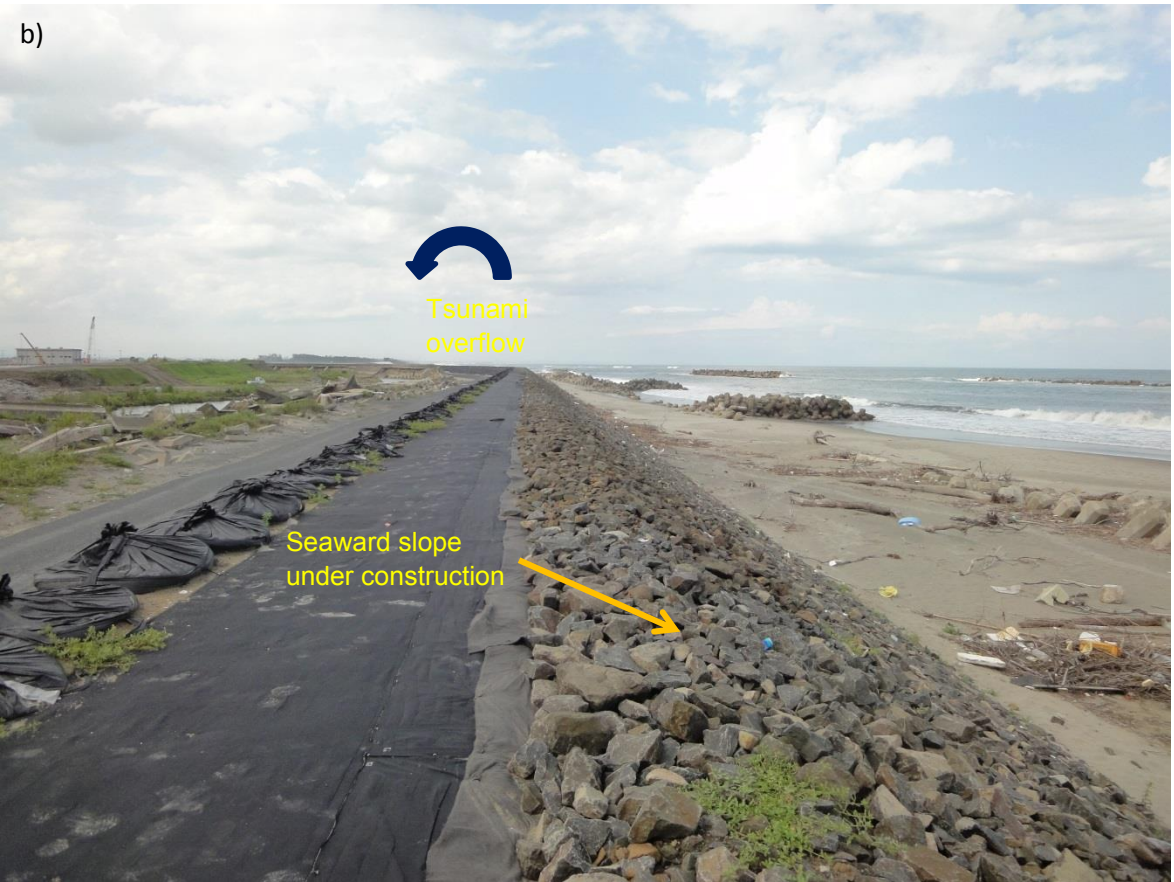
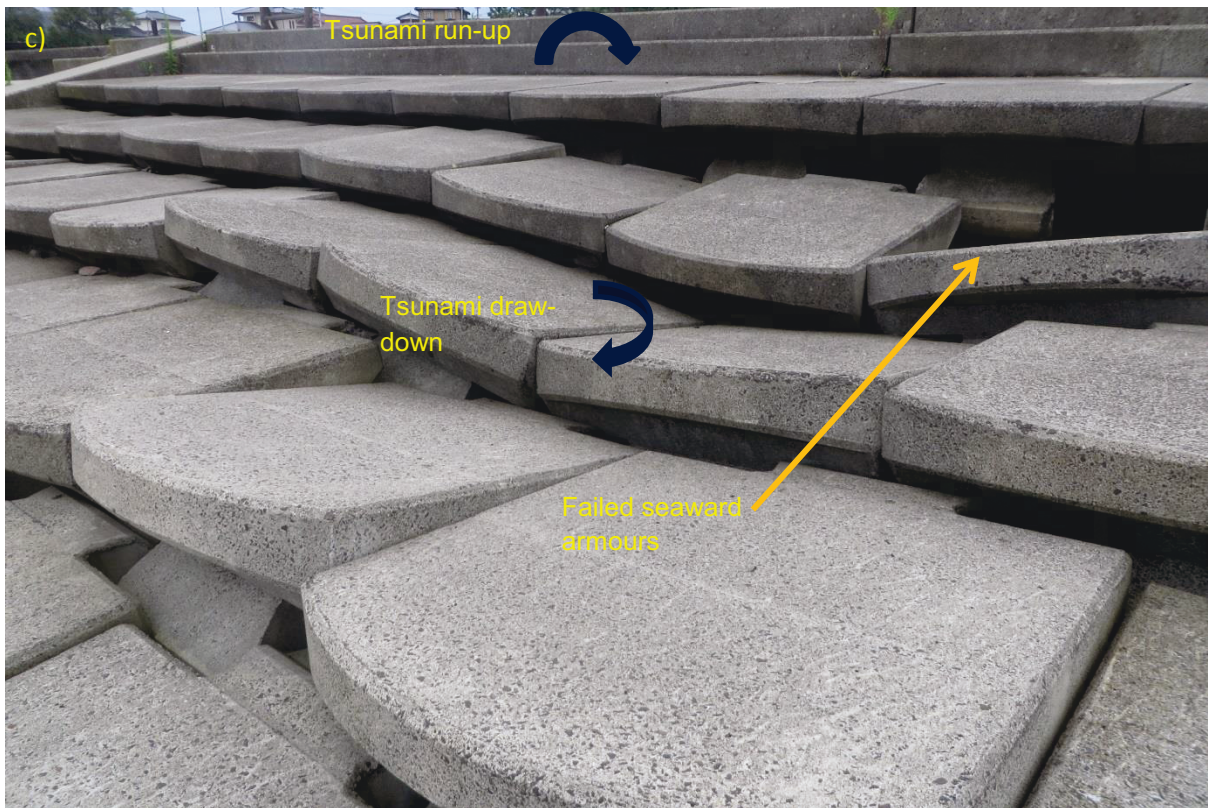
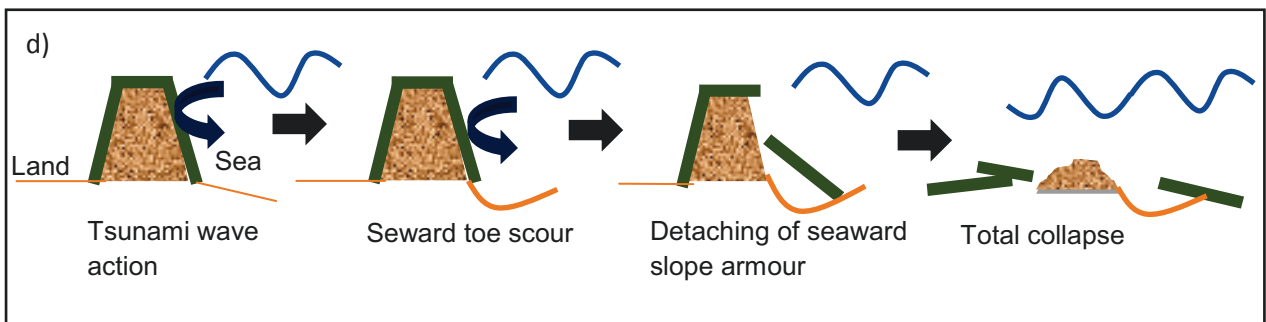
Figure 6. Seaward toe scour and slope armour failure: a) Reformed revetment at Higashimatsushima, b) Reformed revetment at Watari (North), c) Destabilised seaward slope armour at Shichigahama, and d) Physical process of seaward scour and slope armour failure.

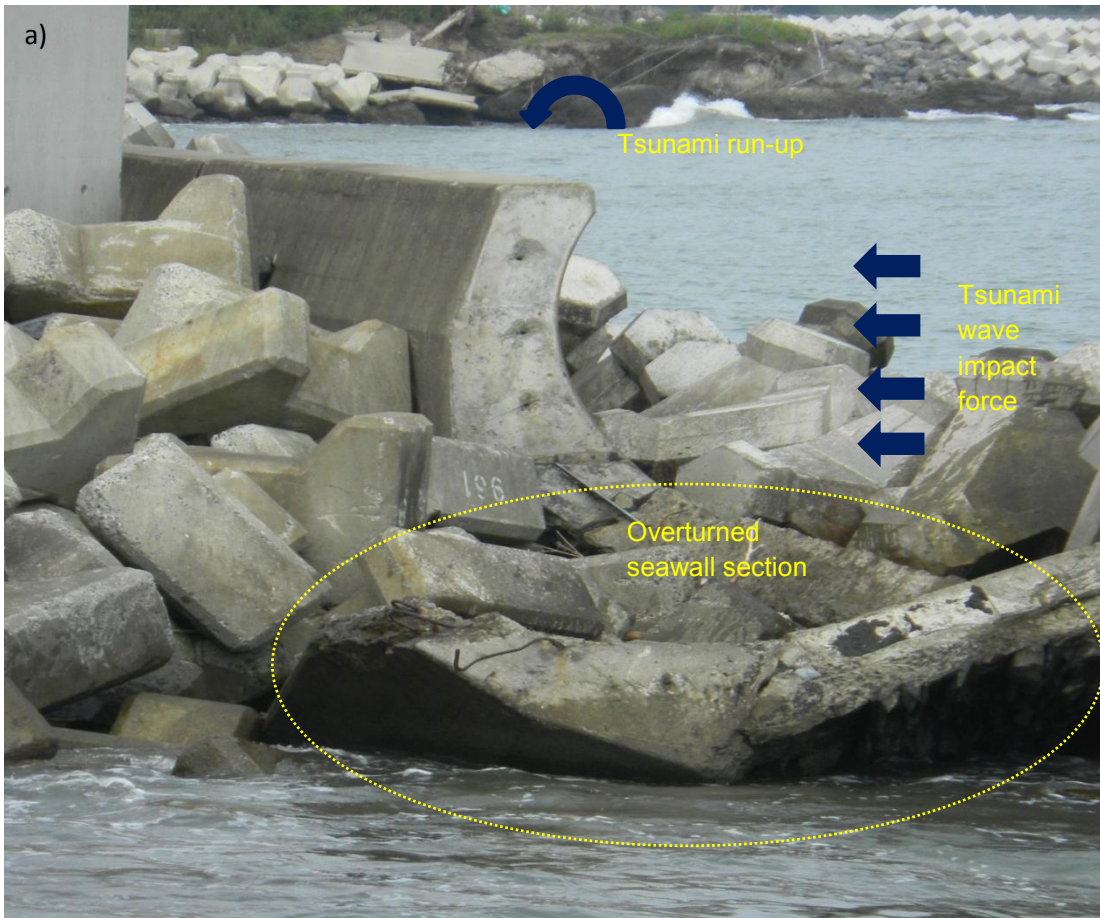
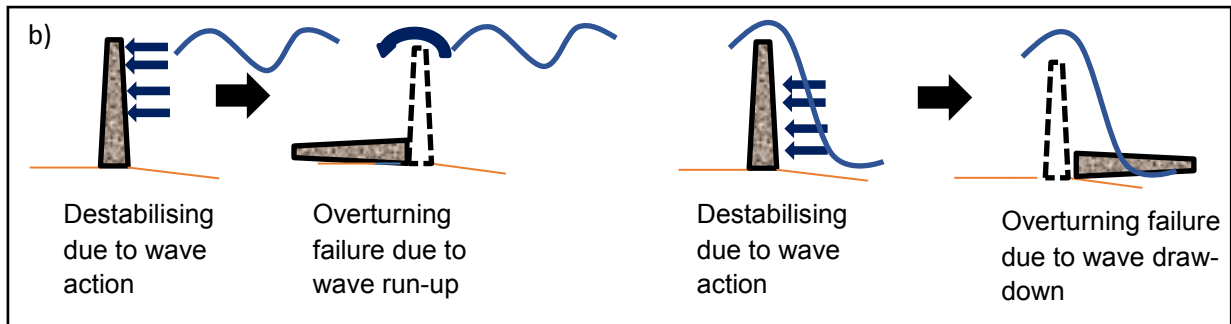
Figure 7. Overturning failure: a) Overturned re-curved wave wall at Kitakami and b) Physical processes of overturning failure due to wave run-up and draw-down.

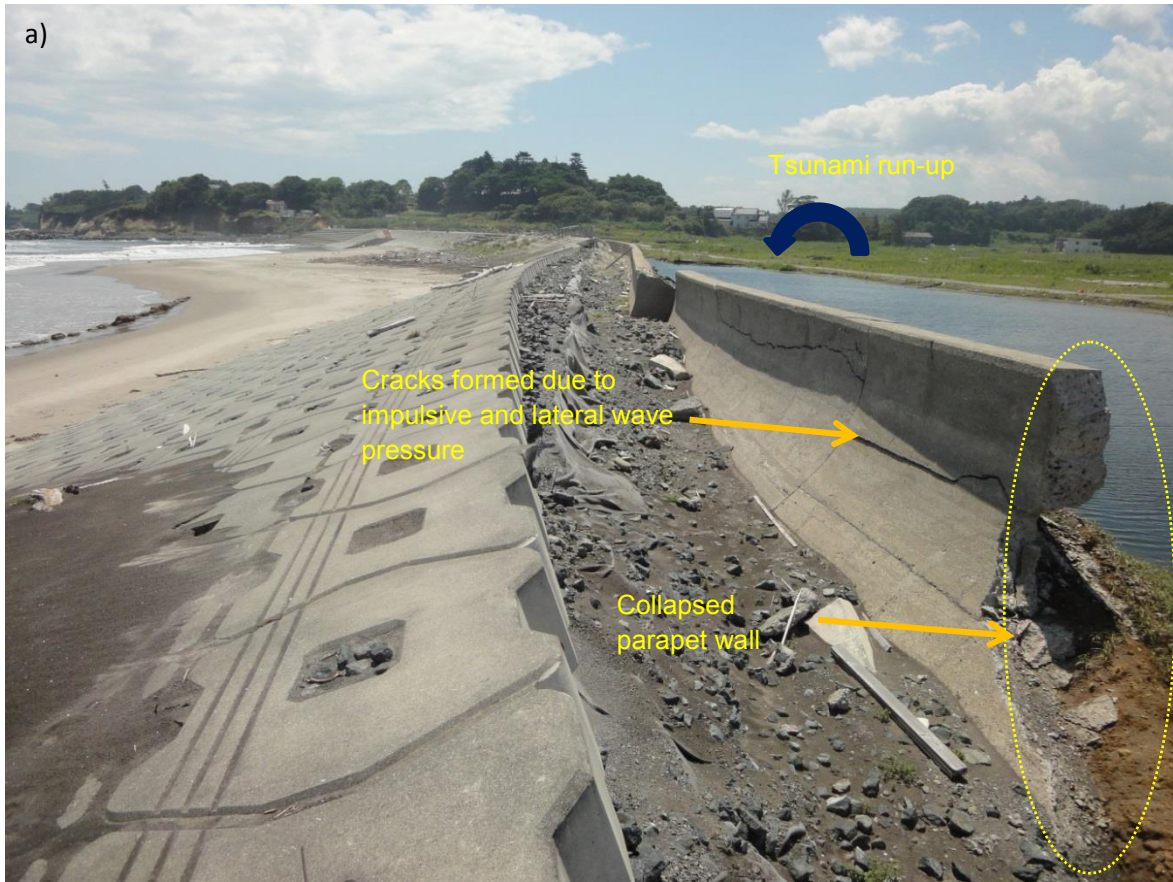
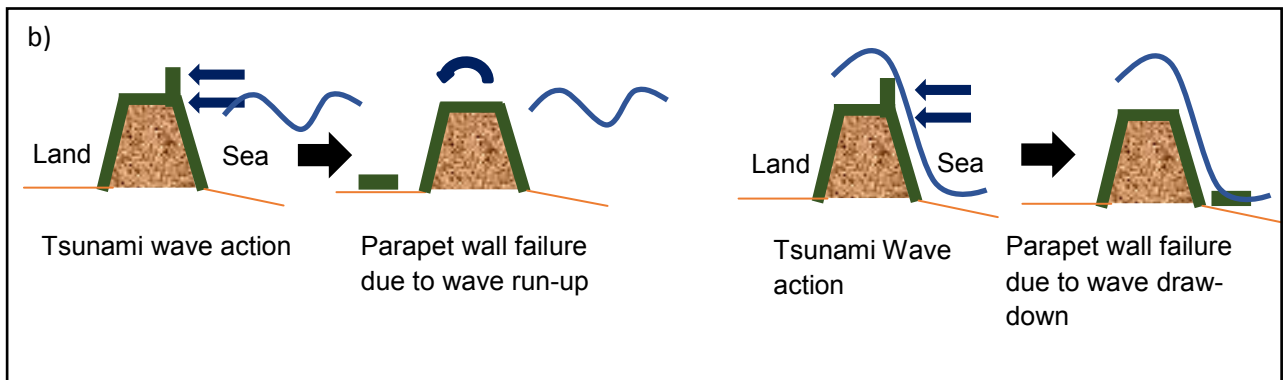
Figure 8. Parapet wall failure: a) Parapet wall failure in a sea dike at some city and b) Physical processes of parapet wall failure due tsunami wave run-up and draw-down.
