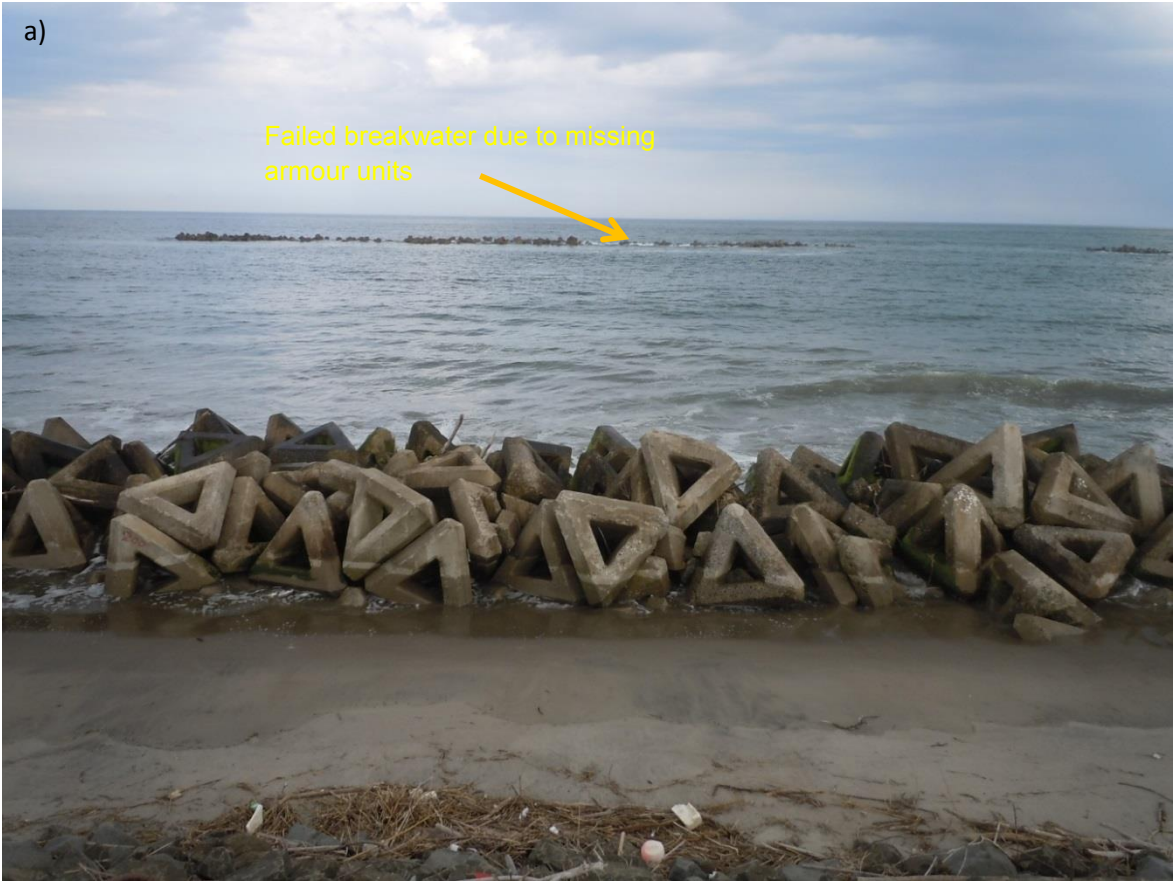
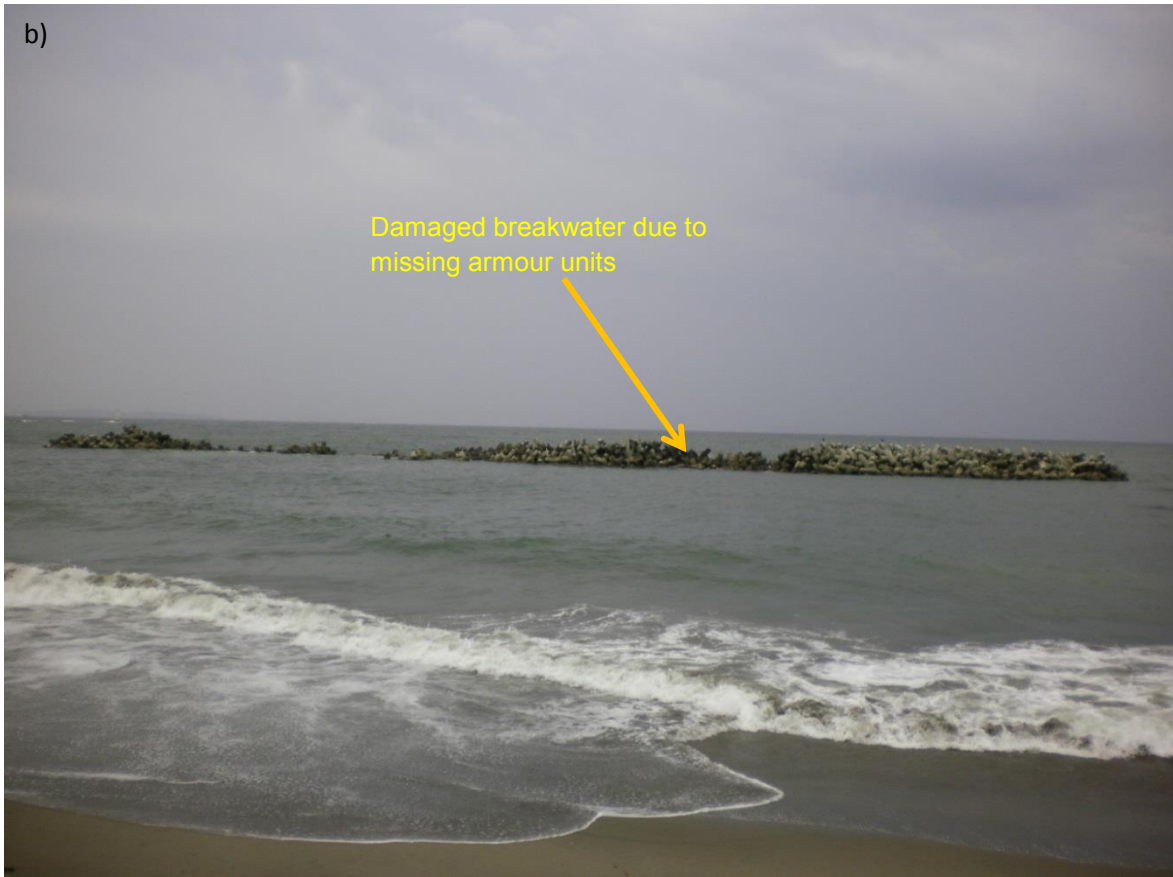
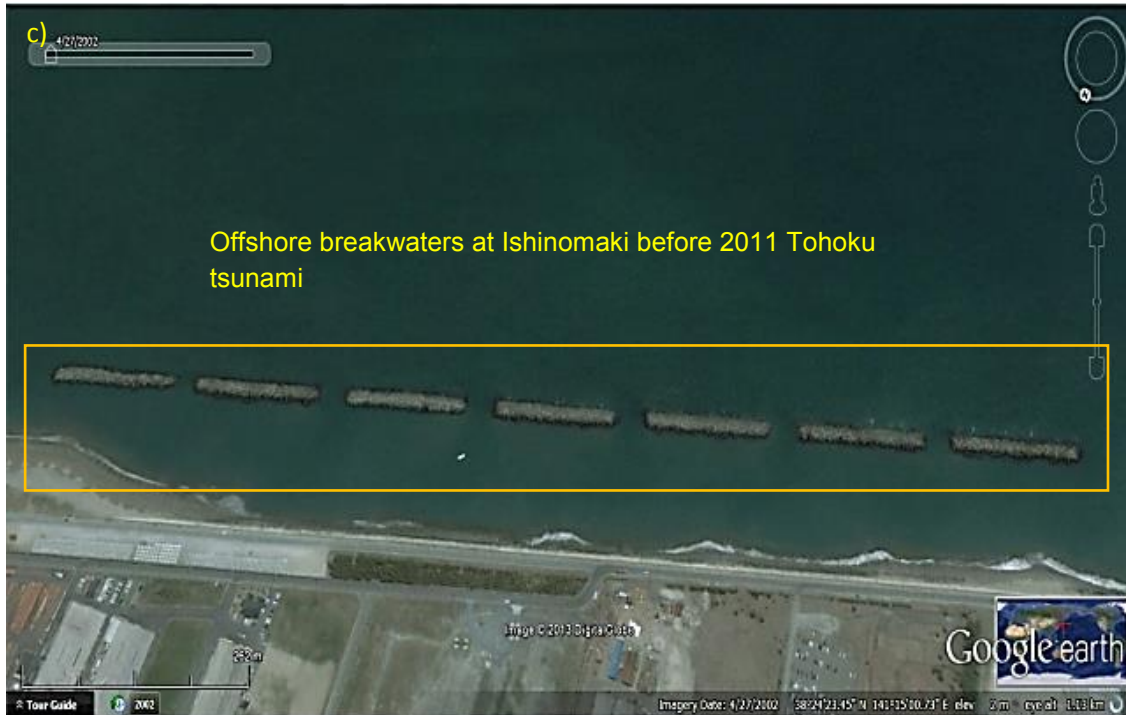
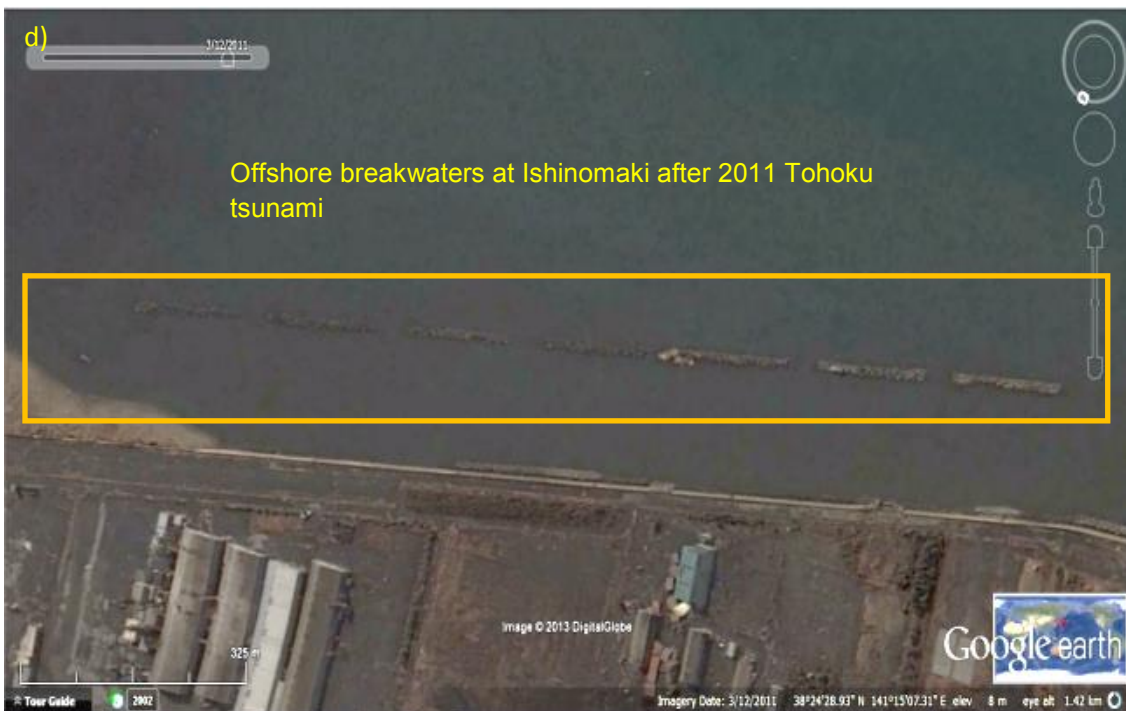
Figure 9. Breakwater failure: a) Offshore breakwater failure at Watari (North), b) Offshore breakwater failure at Ishinomaki (East), c) and d) Offshore breakwaters at Ishinomaki before and after 2011 Tohoku tsunami (Image Source: Google Earth).
