A Framework for Risk Analysis and Vulnerability Assessment of the Rubble Masonry at Tuzigoot National Monument

A FRAMEWORK FOR RISK ANALYSIS AND VULNERABILITY ASSESSMENT
OF THE RUBBLE MASONRY WALLS AT TUZIGOOT NATIONAL
MONUMENT

Advisor and Program Chair
Frank G. Matero
Professor

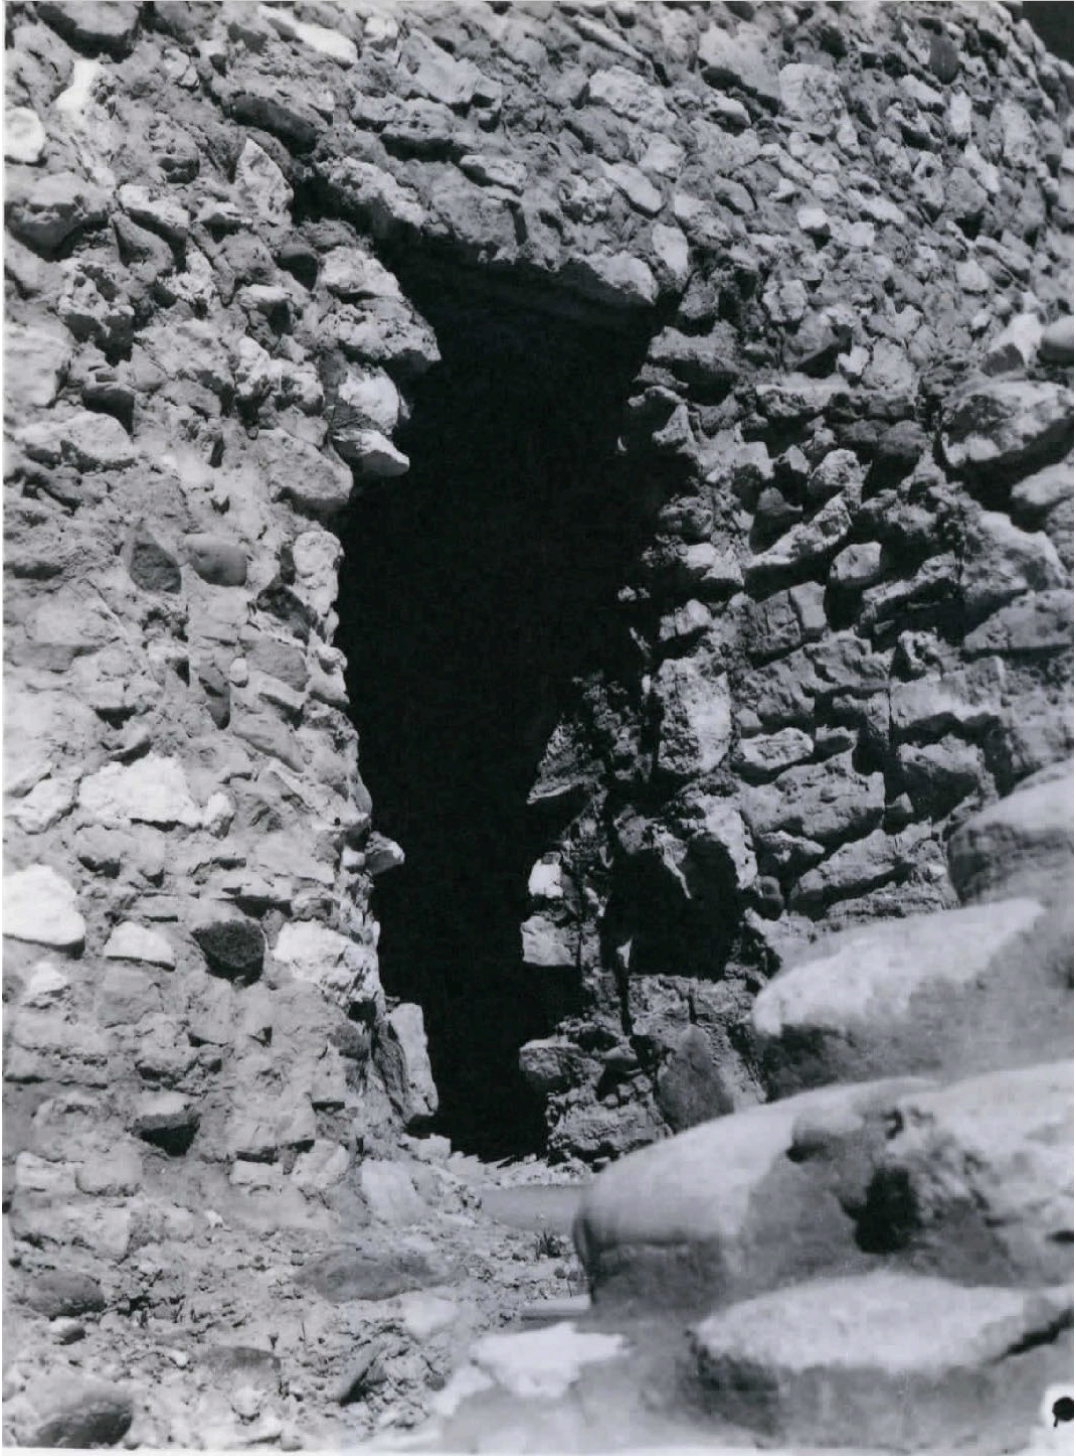
Figure 15 | Photograph of the 1952 opening in the south wall of Room III-14. Photograph from Roland Richert's Stabilization Report, page 66.

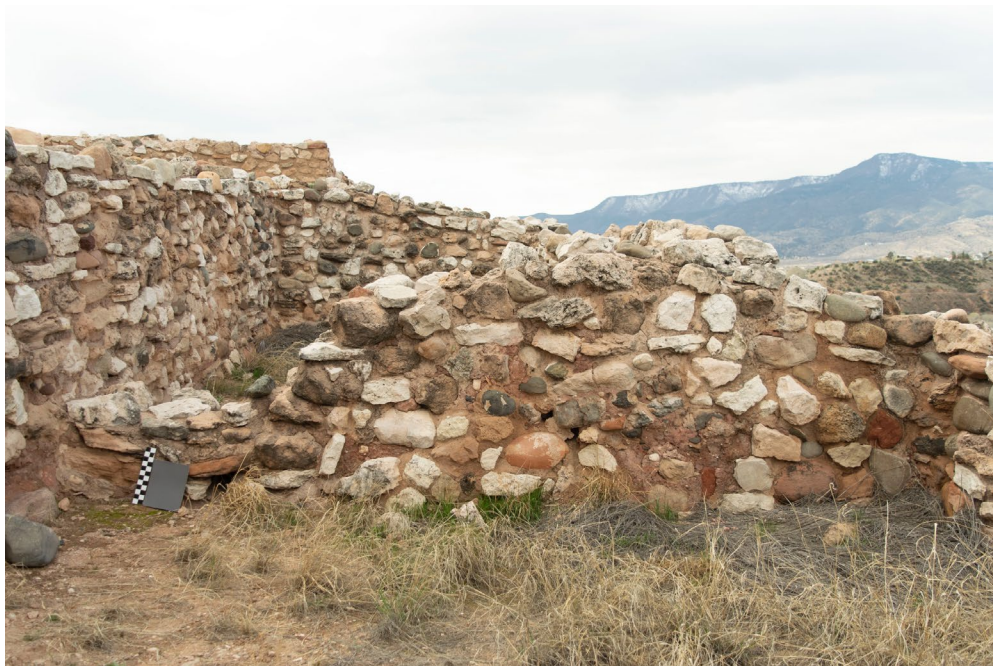
Figure 26 / Example of a wall at Tuzigoot with different mortar conditions.

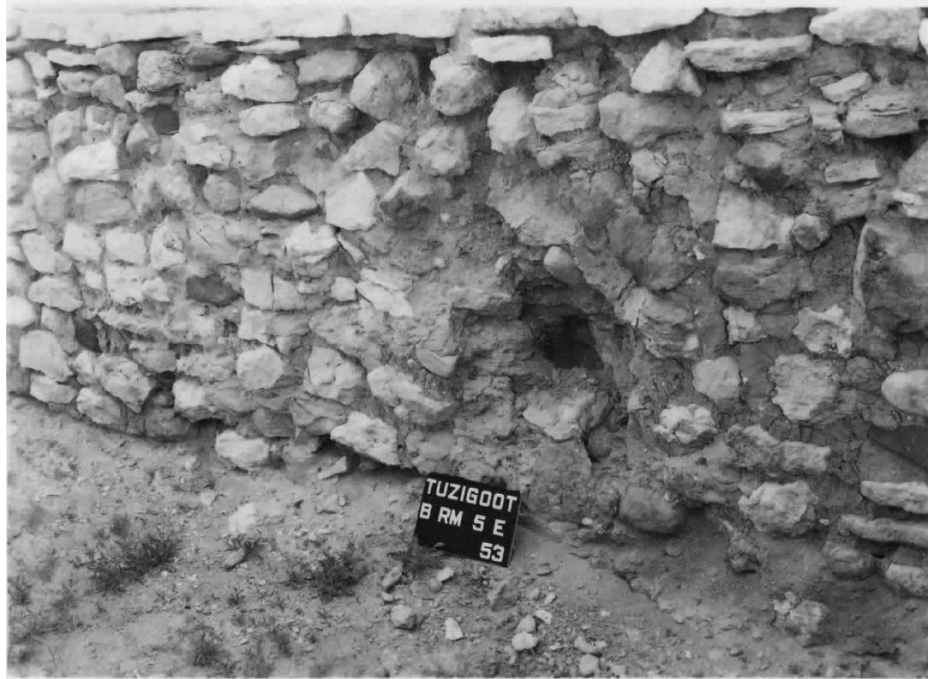
Figure 39 / Photos of damage found in wall segment 4C (east wall of room III-5) prior to stabilization completed by Richert in 1953. Source: Richert, Roland. *Stabilization Report Tuzigoot National Monument. (Arizona: Southwestern National Monuments Ruins Stabilization Unit Globe, 1953), 48.*

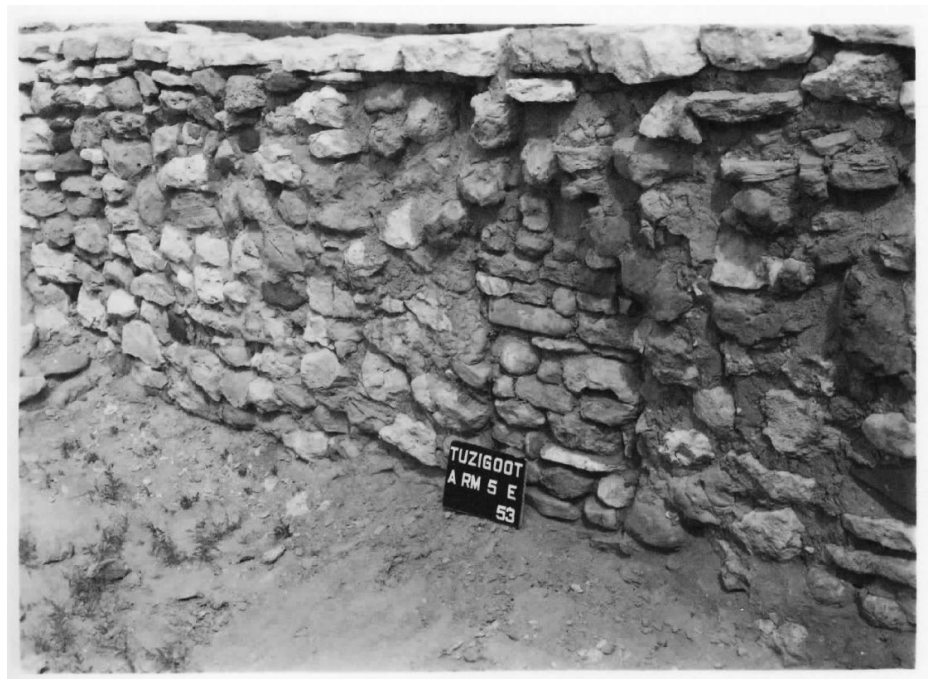
Figure 40 / Photo of wall 4C (east wall of room III-5) after stabilization completed by Richert in 1953. The work completed involved clearing the wall out, grouting it with cement, and masonry facing was pointed with soil cement.

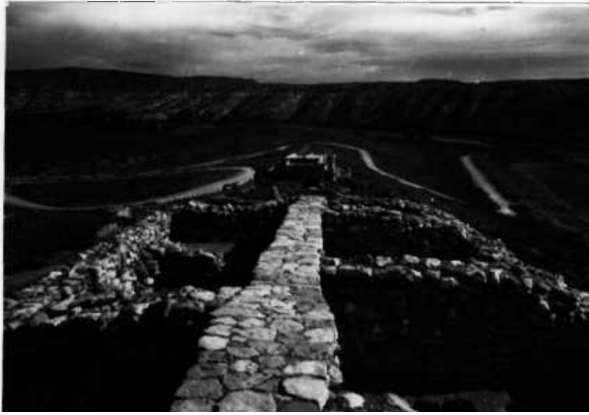
Figure 42 / Flat profile of wall caps prior to Shiner's work. Source: Shiner's 1962 Report, 33.

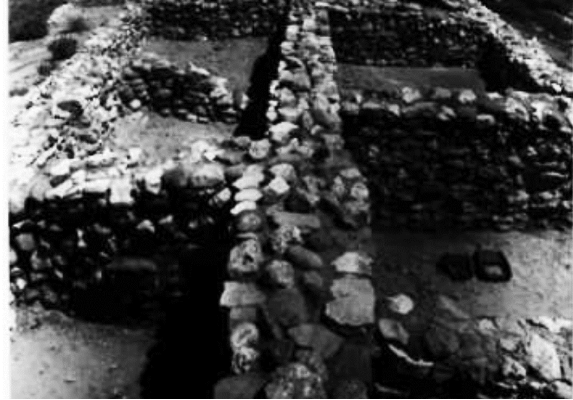
Figure 41 / New wall caps completed by Shiner. Source: Shiner's 1962 Report, 33.

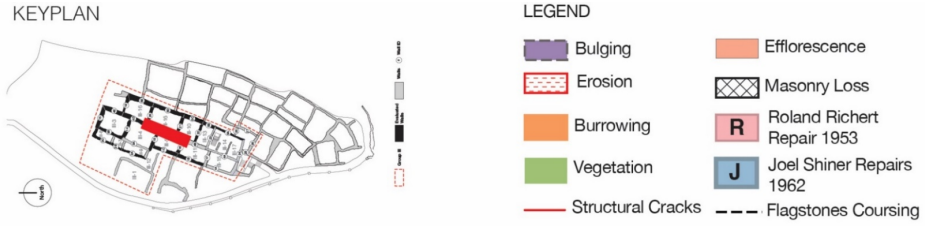
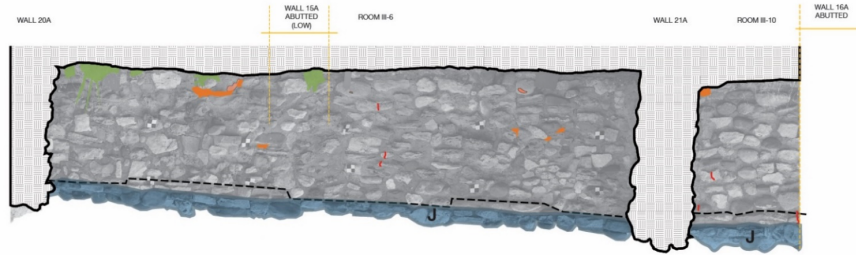
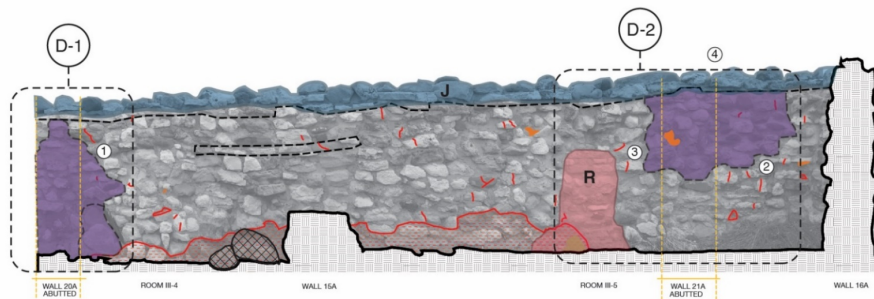
It is possible that moisture accumulated in the higher ground of Rooms III-10 and III-16 (to the east) have caused damage to the base of the other side of the wall. Although Tuzigoot does not get high amounts of precipitation, during the rainy season (summer) it gets an average of two (2) inches annually. During the winter the average is also two (2) inches, but this year prior to arriving at the site to complete the assessment, there was a 10-inch accumulation of snow during February. During the winter the wind mainly blows from east to west, pushing the moisture from snow into the east side of the wall.

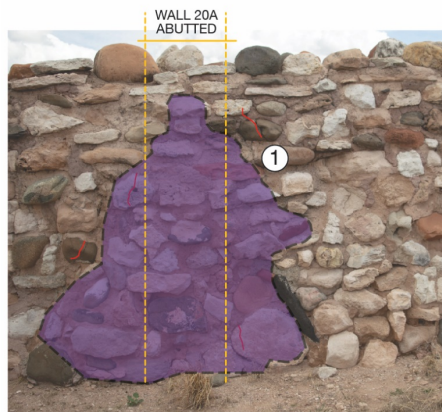
D-1 Detail Photo of Northmost Bulging West Wall

1. **Structural cracks** surrounding the northmost **bulging** on west wall support the fact that loads, probably from wall abutted behind is causing displacement.
2. Appearance of **structural cracks** surrounding the bulge, only in adjacent areas to abutted wall.
3. **Structural cracks** are visible between bulge, abutted wall and Richert's cement grouting repair.
4. Mortar on Shiner's **caps** have eroded to the point where a more clay-ish, silt-like material is visible. Caps might be susceptible to water intrusion.

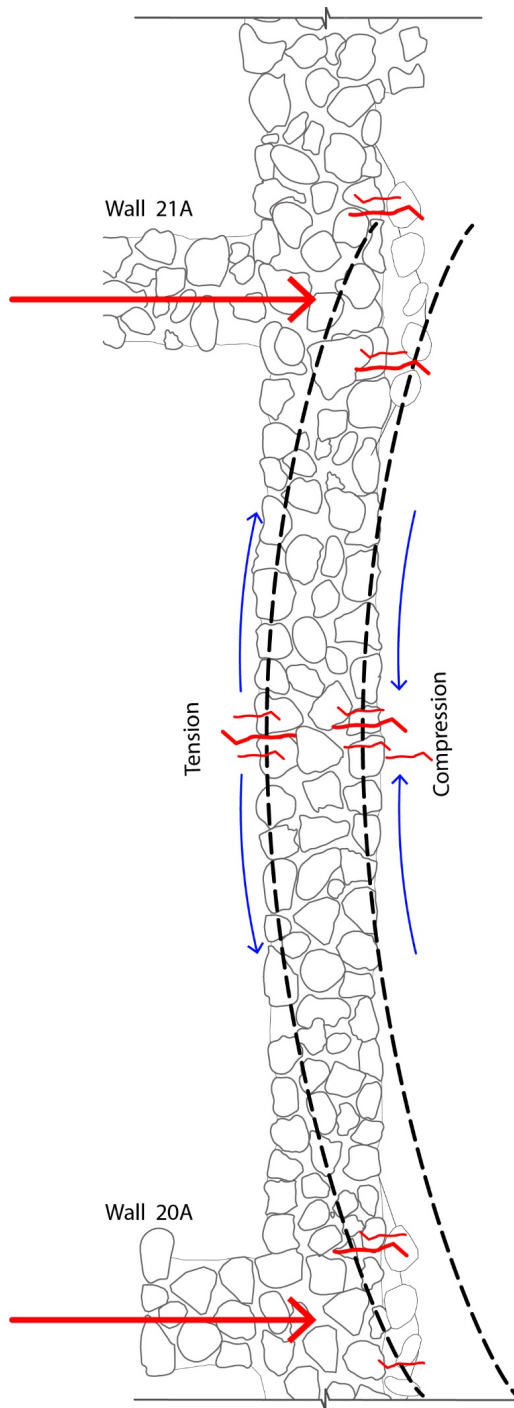
In summary, there are two main forces affecting the lateral loads from adjacent walls. The first is displacement and movement of the wall segment, due to lateral loads exerted by the abutted walls (Figure 45). This is evident in both the form of structural cracking and bulging. The bulging is the result of the loads exerted by the abutted walls. The cracking visible surrounding or where bulging occurs, evidences the origin of the loads. The cracks in the center of both sides of the wall show that these two loads are causing displacement and or distortion. The vertical cracks visible in stones of both sides of the wall are indicative of stress caused by the deformation of the wall. It is important to understand the reason for these walls to exert loads to this wall. A more comprehensive assessment of the abutted walls may inform the origin.

Figure 45 /Diagram of 4C with abutted walls (20A & 21A). It shows how loads (red arrows) from abutted walls are being exerted and cracks (red lines) appear due to tensional and compressive loads resulting from the wall deformation.

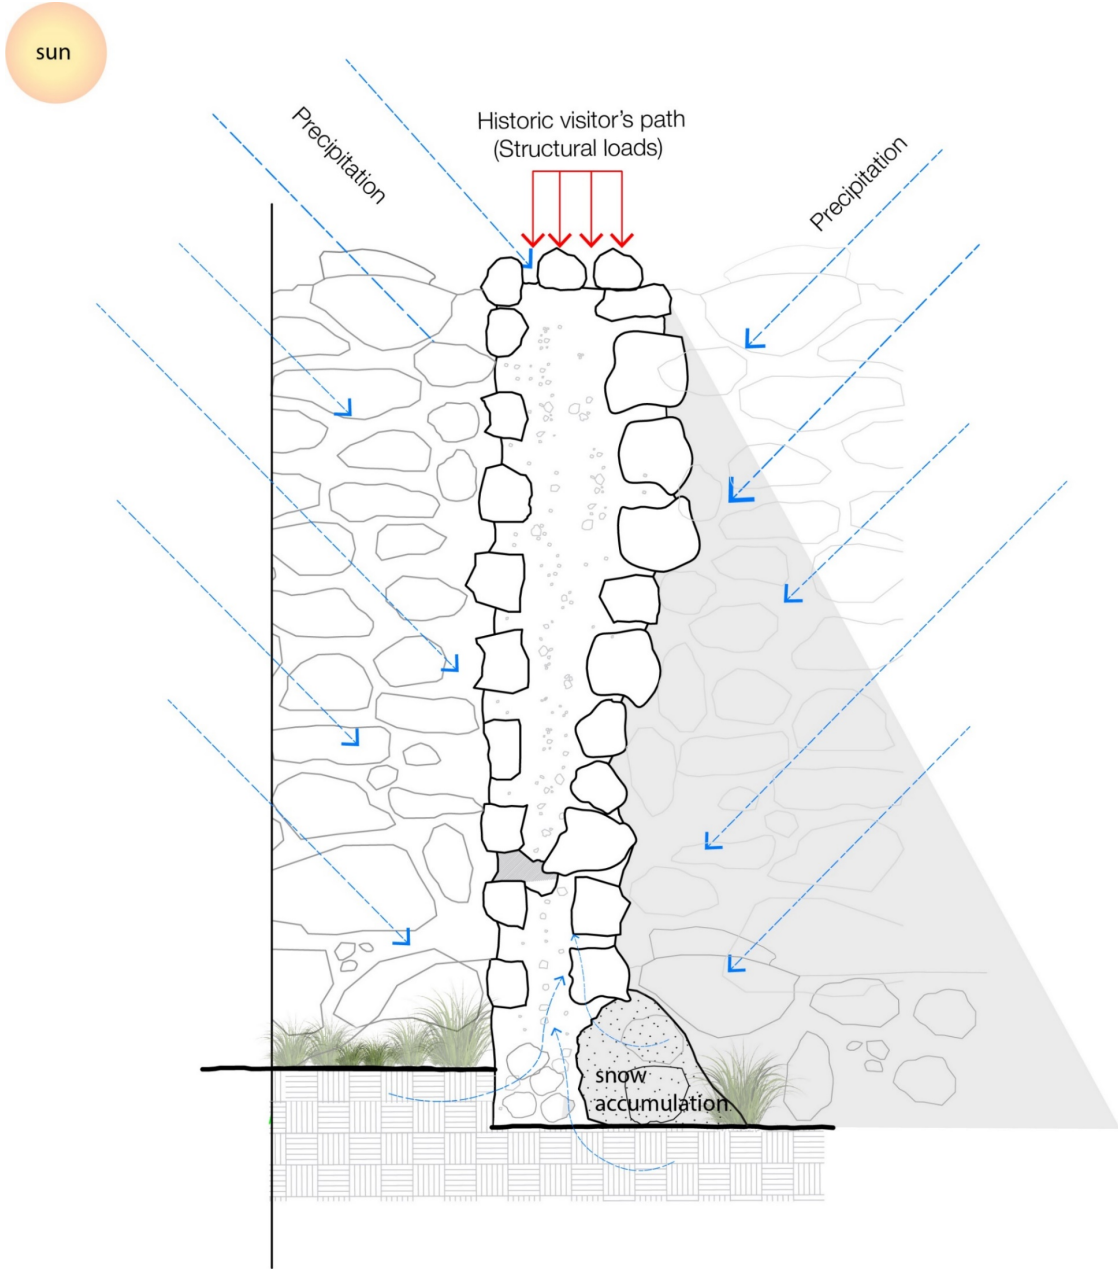
The second is the intrusion of moisture from two different sources (Figure 46). Moisture is entering the system through the caps and the wall base. If moisture is in fact entering from the caps, the interior earth and rubble core material might be dislodged and traveling down with the water, compromising the interior strength and exerting pressure on the wall faces. This damage may also be exacerbated by the expansion and contraction of the clays in the fill. However, the source for the moisture intruding the system from the base of the wall is accumulated precipitation (rain or snow) entering the system by capillary absorption. The higher ground on one side of the wall is accumulating water differentially that is absorbed by the wall causing damage from freeze-thaw, thermal expansion, and erosion. Due to the location of this wall segment and the surrounding wall locations the west elevation of the wall segment does not get much direct sunlight to dry the moisture absorbed fast enough. The sun rises from the east, around the south and as it sets towards the west side its elevation lowers, allowing for the east-west walls located on the south end of the segment, to provide shade while the sun sets. When the sun reaches the west, the south and west walls provide a period of the time of shade, preventing the sun from drying the base of the west elevation.

Figure 46 | Diagrammatic section of wall 4C showing precipitation, water intrusion, absorption and erosion of wall base.
