## Confusion due to Contractor Cascading Leads to Major Release of Ammonia During Test of Safety Device

*Published in:*  
Chemical engineering transactions

*Publication date:*  
2019

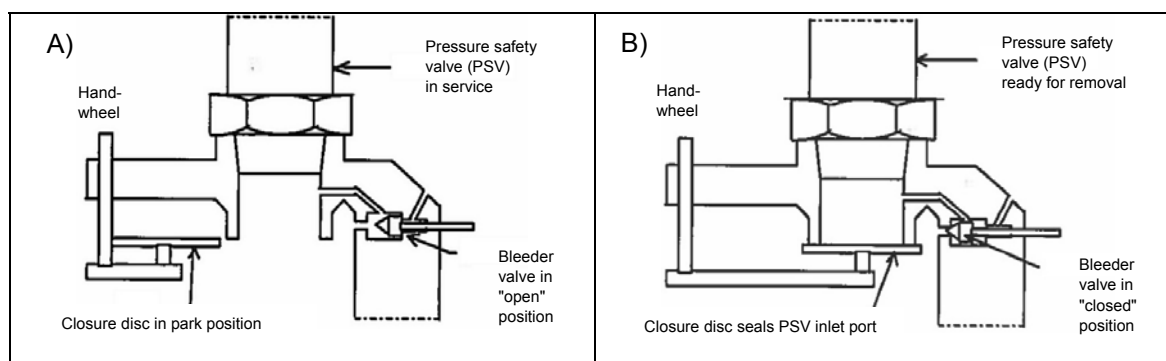
The investigation discovered that it was possible to install the handwheel incorrectly, such that it would not indicate the correct position of the closure disc. Testing revealed a similar incorrectly installed handwheel on

The inspector realized that the contractor did not understand the somewhat unusual design of the bleeder valve. The normal position of the bleeder valve was with the valve knob turned outwards, i.e. in the fully "open" position. In this back-seated position, the rear part of the plug would seal tight against the bonnet. With the knob turned inwards in the fully "closed" position, the plug firmly positioned in the valve seat, it would allow bleeding of the space above the closure disc (Figure 1).

When the contractor opened the bleeder valve, he was in effect attempting to bleed away the contents of the tank. Depressurization would never occur, which he interpreted as a leaking closure disc. This simple but very plausible misunderstanding rendered the safety function of the bleeder valve ineffective.

Figure 1. Bleeder valve detail of the RegO Multiport® Pressure Relief Valve Manifold Assembly. A) Normal position: Closure disc in park position, PSV protects the vessel, bleeder valve turned outwards in the "open" position. B) Service position: Closure disc seals the PSV inlet port, bleeder valve turned inwards in the "closed" position allowing bleeding of vapour trapped in the space between the closing disc and the PSV. Source: Drawing by DWEA Inspector Bent Schmidt.

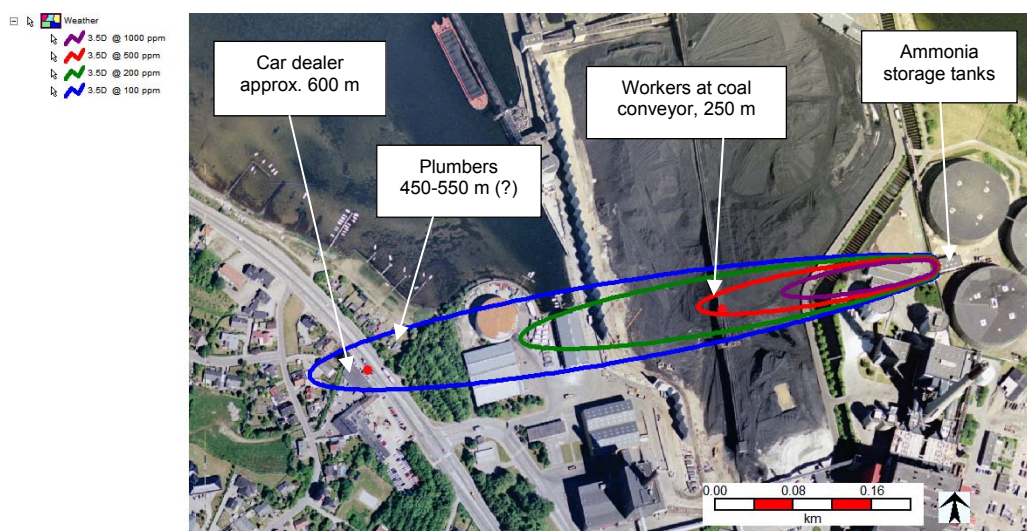
Calculation using PHAST (ver. 8.1) yields a release rate of about 2 kg/s (total release 2.4 t). The weather was fair, wind 3.5 m/s due east and ambient temperature 17 °C. As tanks were under cover, the jet release is assumed to have lost considerable momentum. Pasquill stability class set to D. Dispersion modelling (Figure 2) indicates that the maximum ammonia concentration at the property line (500 m) was about 150 ppm.

Figure 2. Modelling of ammonia vapour dispersion before activation of water curtains and sprinkler systems. Map: © COWI/DDOland 2004
