STATE-OF-THE-ART MONITORING TECHNIQUES FOR SAMARCO TAILINGS DAMS

LUKE CLARKSON¹

¹ The University of Queensland Geotechnical Engineering Centre, School of Civil Engineering, Brisbane, Queensland, Australia.

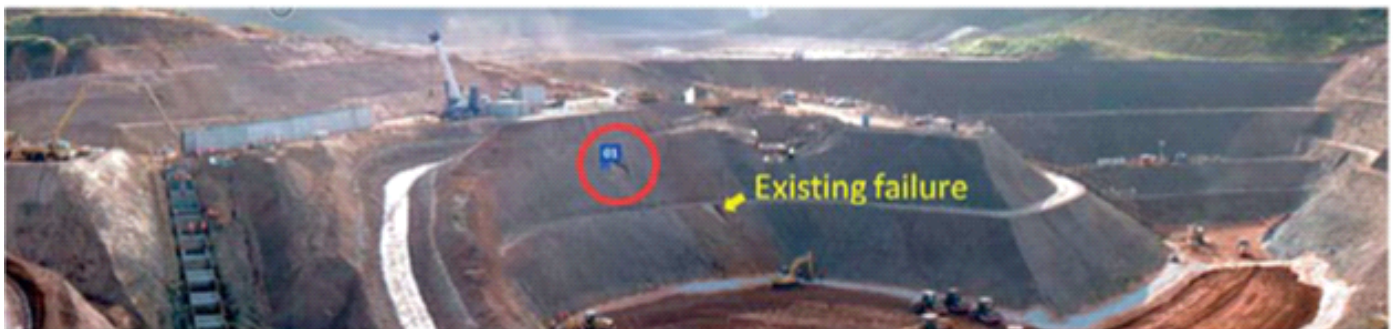
A minor local failure was observed on the spillway area at Santarém Dam on 12 June, 2016, at which time the slope was being monitored by slope stability radar (Figure 2). The material was displaced along a slip plane that formed two thirds of the way up the second bench. In the months preceding, GroundProbe radar surveillance reports documented negligible deformation rates that were not associated with operations, traffic, or when correlated against rainfall periods.

Figure 2 - Slope stability radar monitoring for Santarem Dam, showing location of local failure

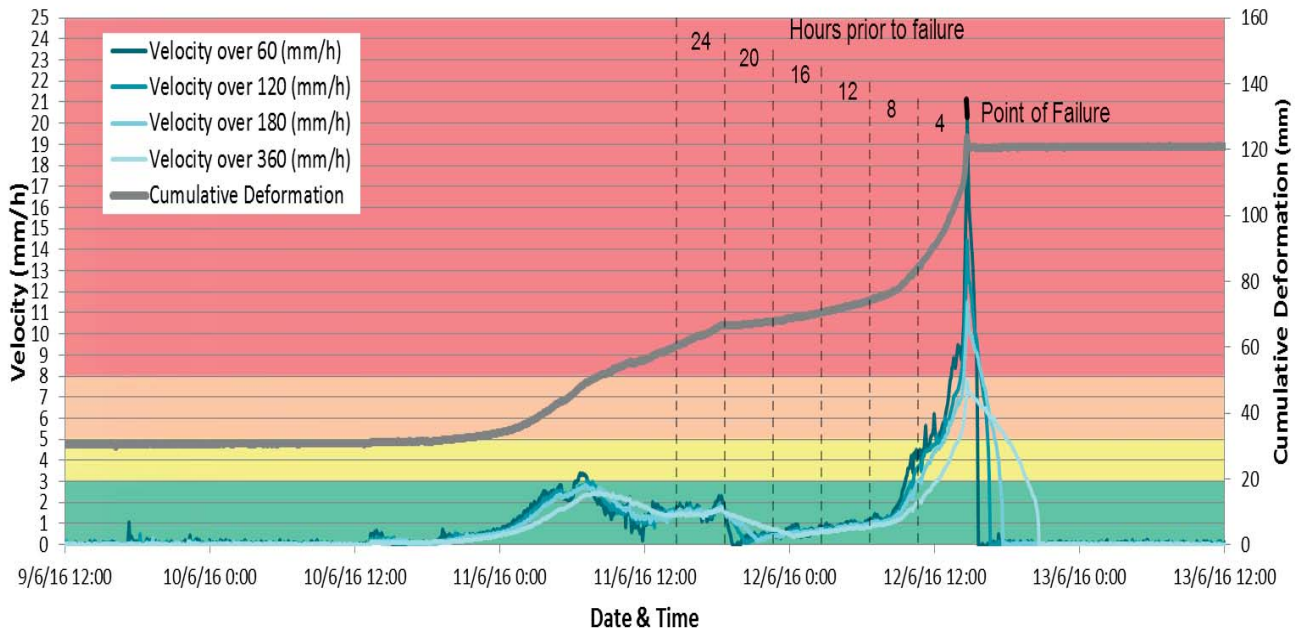
The compacted earthfill material exhibited regressive/ progressive deformation prior to failure (Figure 3). A regressive/ progressive (decelerating/ accelerating) failure condition can "rapidly lead to collapse" and be caused when "mining daylighting a sliding surface, [when there is] breakup, or excavation of rock at the toe of a slope, or [as a result of] an increase in water pressure" (Darling, 2011). The month of June was unusually wet; 72mm of rainfall was recorded between June 1 and June 12, which is compared to the negligible rainfall that characteristically occurs during these winter months on-site. Visual inspections detected water retention on the first and second berms below the crest. No other visual anomalies were detected.

The existing site thresholds for velocity proved effective in their ability to predict local failure, in particular when using the "Velocity over 60" calculation period (Figure 3). This provided warning at five hours, three hours, and one hour for

yellow, orange, and red alarms, respectively (Table II). In consideration of the responses designated for each alarm as seen in Table I, this degree of notice presents a safe and feasible response time.

The regressive/ progressive trends exhibited movement for almost two days prior to failure. During the regressive trending stage, a yellow alarm was triggered for a single hour. In comparison to triggers of 2 mm/h and 1 mm/h, which would have been cautioning for five hours and eight hours, respectively, this alarm proved effective in acknowledging the increase yet not escalating the alarm beyond what a regressive trend warrants.

Figure 3 - Velocity and deformation data trending for Santarém Dam, velocity alarm thresholds shown

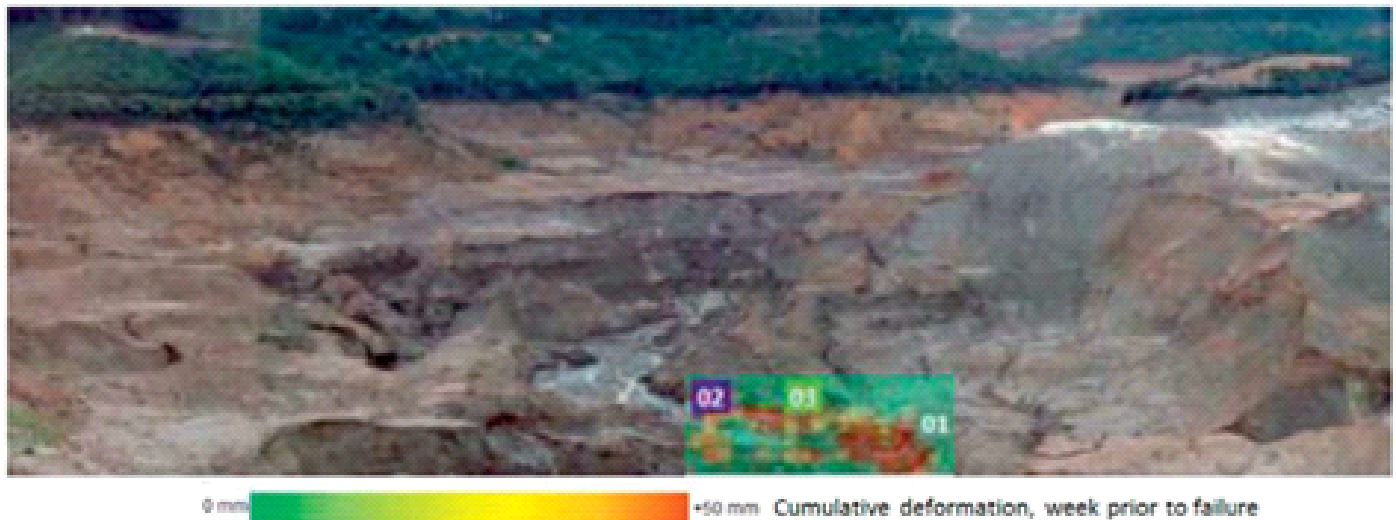
A collapse of debris was observed to progress at the toe of Dike 2 over the period of six days, from 8 August 2016 to 14 August 2016 (Figure 4). Debris flow was displaced downstream in a progressive failure trend, where the rate of displacement continued to increase until collapse; approximately 50% of the total material deformation occurred on the sixth day. No significant rainfall occurred during or prior to this event.

It is anticipated that loose, saturated slimes comprising high proportions of clay- and silt-sized particles remained after the 2015 collapse. The moisture content of the slimes is typically around 30%, while the liquid limit is approximately 25%: indicating low consistency. Based on the radar deformation trends and visual assessment of the surrounding area, it is the author's opinion that hydraulic forces induced by upstream runoff flows preferentially degraded a pathway through the material; the same forces that failed an upstream earthen buttress by erosion piping two months prior.

In the author's assessment, mass collapse of the material may have been observed as a result of progressive erosion of the surrounding banks driven by decreasing confining stresses, in combination with water recharge encouraging an elevated moisture content and the associated decrease in shear strength of the slimes. In terms of the data, this mechanism could be represented by the process of shear stress gradually reducing the shear strength until the point at which the slip triggers, as reflected by comparatively elevated rates of deformation.

Notably, deformation trending in the surrounding areas suggests steady creep, which is anticipated to be reflective of the same influences that failed the adjacent material, and may be early stage indicators of a similar event.

Figure 4 - Slope stability radar monitoring for Dike 2, showing location of slimes collapse

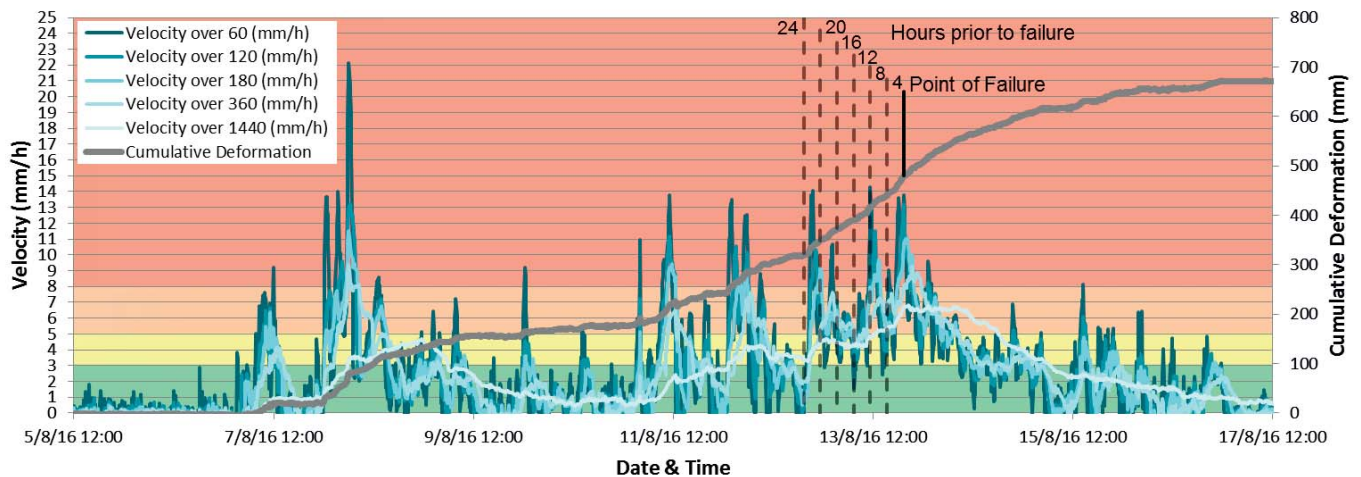
The existing site thresholds for velocity proved effective in their ability to predict collapse of the slimes at Dike 2, providing warning at up to 42 hours, 9 hours, and 1.8 hours for yellow, orange, and red alarms, respectively (Figure 5 and Table V). This degree of notice presents a safe and feasible response time. Unlike Santarém Dam, this failure was slow and ductile, exhibiting movement for six and a half days prior to failure: a duration that saw the larger calculation periods such as Velocity over 360 and Velocity over 1440 prove most effective in forecasting the failure.

Figure 5 – Velocity and deformation data trending for Dike 2, velocity alarm thresholds shown

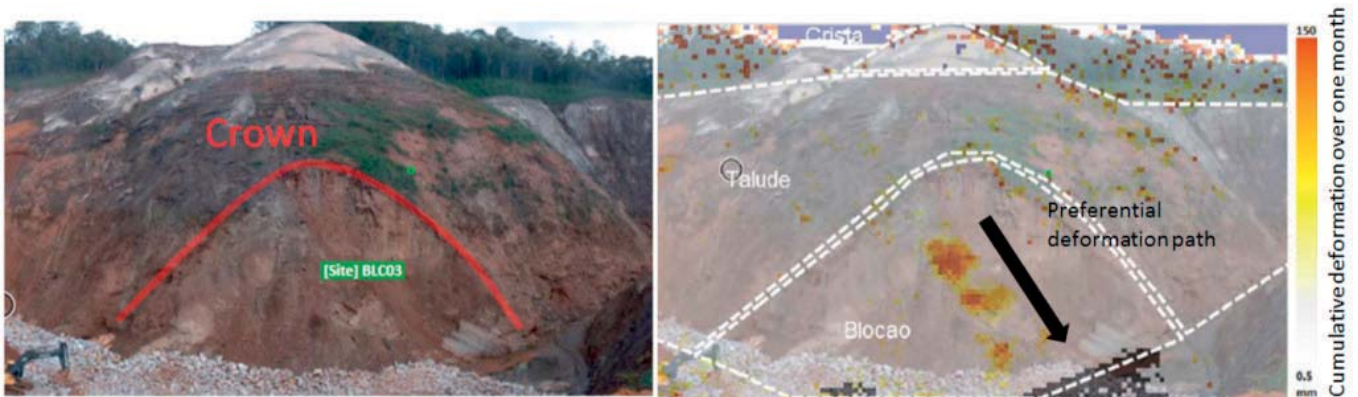
Local, regressive-progressive deformation processes were observed to be drivers behind the dislodgement of material at the Eixo 1 natural slope on 14 November, 2016. The time between deformation being first observed and material failure was 7.5 days.

The slope material comprised large quantities of loose rock, initially intact but anticipated to have weathered and degraded over time. Two primary mechanisms are anticipated to have driven the regressive-progressive failure of the natural slope: breakup of rock at the toe of the slope, in addition to an increase in water pressure. With complexity added as a result of interaction between these two drivers, it is observed that the failed and exposed sections of the slope became susceptible to further degradation from weathering, in turn entering a cycle of progressive instability.

This is evidenced by the successive recorded events, all of similar behaviour, in addition to the incremental trend of movement along a preferential deformation path down the side of the slope (Figure 6).

Figure 6 - Slope stability radar monitoring for Eixo 1 in November, 2016, showing location of circular slip failure

The existing site thresholds for velocity proved ineffective in their ability to predict local failure of Eixo 1. Velocity over 60 triggered a yellow alarm half an hour prior to failure, however could easily be missed if read without the knowledge that a failure were about to occur. No orange alarms were triggered.

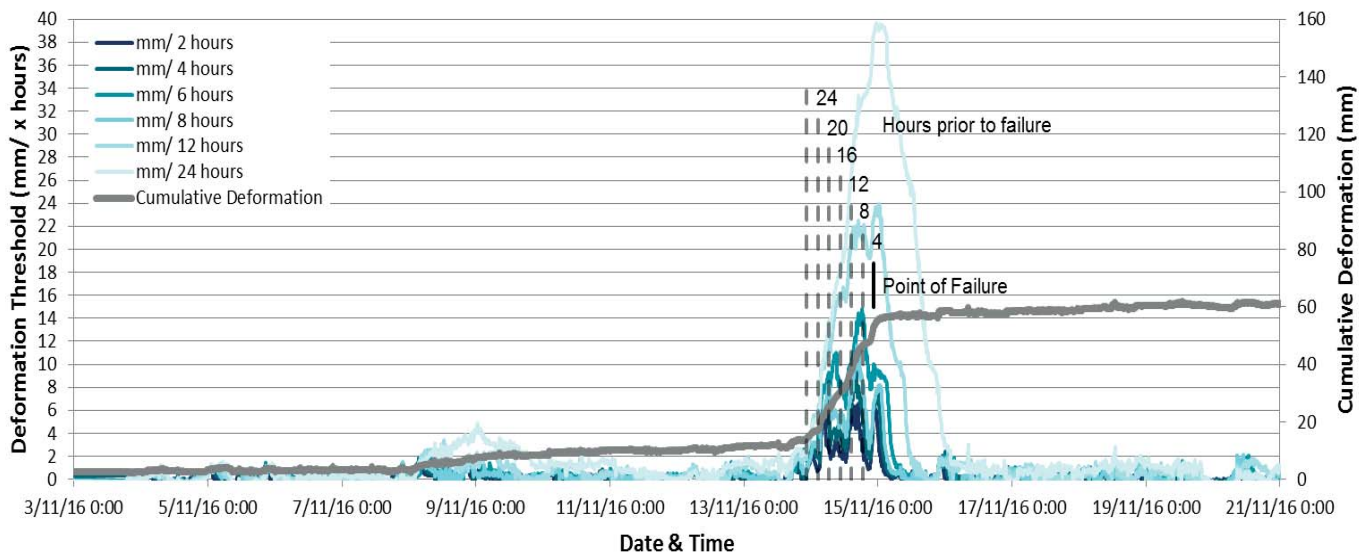
Figure 7 - Deformation data trending for Eixo 1

The ability to confidently forecast developing movement in the progressive trend using the approach described in Figure 7 was not possible until at least five scans into the trend. This was because a deformation trend that is averaging movement over previous hours will capture the regressive trend prior, lagging current movement trends by a number of scans. To eliminate this, the deformation data would need to be averaged over 24 hours, which is less practical for forecasting short term events such as the Eixo 1 event as the data will simply reflect the deformation trend itself.

Calculated rates for mm/ 2 hours presented three of the more desirable warnings at 83, 60, and 36 minutes prior to failure. The risk exists that unwanted alarms will trigger at such low rates, however assessment reported that for the month prior to initiation of this event, 1.7% of operating time would be alarming for 1mm/ 2 hours, and 0% for 2 and 3 mm/ 2 hours.

Alternate metrics are recommended as additional control measures. Inverse velocity was investigated to also be ineffective, so an assessment of deformation triggers was conducted (Figure 7 and Table III). Deformation triggers are useful in disaggregating data noise from small deformation data, and hence will present slightly different results than the velocity analysis.

It is anticipated that geotechnical engineering judgement will be applied to the deformation assessment approach, both on setup for conditional suitability of the alarm, and on response should it trigger. While this deformation trigger may be appropriate for Eixo 1, it may alarm more frequently when monitoring slopes of different material properties. In contrast, when the deformation alarm is applied to stable operating conditions for Santarém Dam and Dike 2 (analysed over the entire duration of data capture at these sites), uneventful alarms for 2mm/ 2 hours are presented 1.1% and 8.8% of the time, but would trigger approximately 8 hours and 24 hours prior to failure, respectively.
