DAMAGE SEQUENCE AND SAFETY MARGIN ASSESSMENT OF EXPANSION JOINTS BY SHAKE TABLE TESTING

Yu Otsuki¹, Masahiro Kurata², Konstantinos A. Skalomenos², and Yoshiki Ikeda²

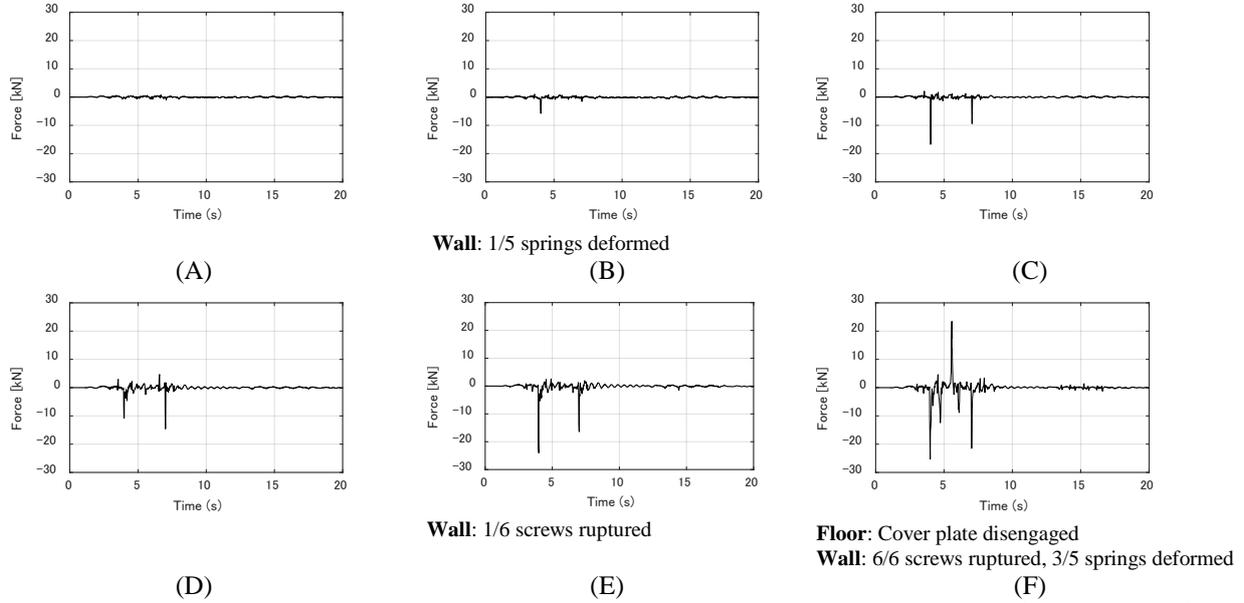
FIGURE 10 Force applied to HP expansion joints with damage descriptions: (A) 350 cm/s², (B) 400 cm/s², (C) 450 cm/s², (D) 500 cm/s², (E) 550 cm/s², and (F) 600 cm/s²

The force F_{expj} applied to the HP expansion joint specimens was derived from the above procedures. Figure 10 shows the time history of F_{expj} with damage descriptions for the specimen subject to different amplitudes of sine wave 1.0 Hz. The negative value indicates that a force was applied when the two frames approached. Note that F_{expj} is the total force applied to the floor and wall expansion joint specimens. At first, during the input of the 350 cm/s² excitation, no force was observed on the expansion joints, which validated the smooth movement of the expansion joint specimen. Under 400 cm/s², damage occurred at one of the five springs of the HP wall expansion joint specimen. This could be related to the peak force in the negative side. From 450 cm/s² and beyond, the two steel frames collided repeatedly, and the resulting force increased as the input amplitude increased. Under 550 cm/s², approximately -25 kN was observed at the first collision, which resulted in the fracture of one of

the six screws. After 600 cm/s², all six screws and two other springs at the HP wall expansion joint specimen were broken. The cover plate of the HP floor expansion joint specimen was also disengaged when the two frames moved away from each other.

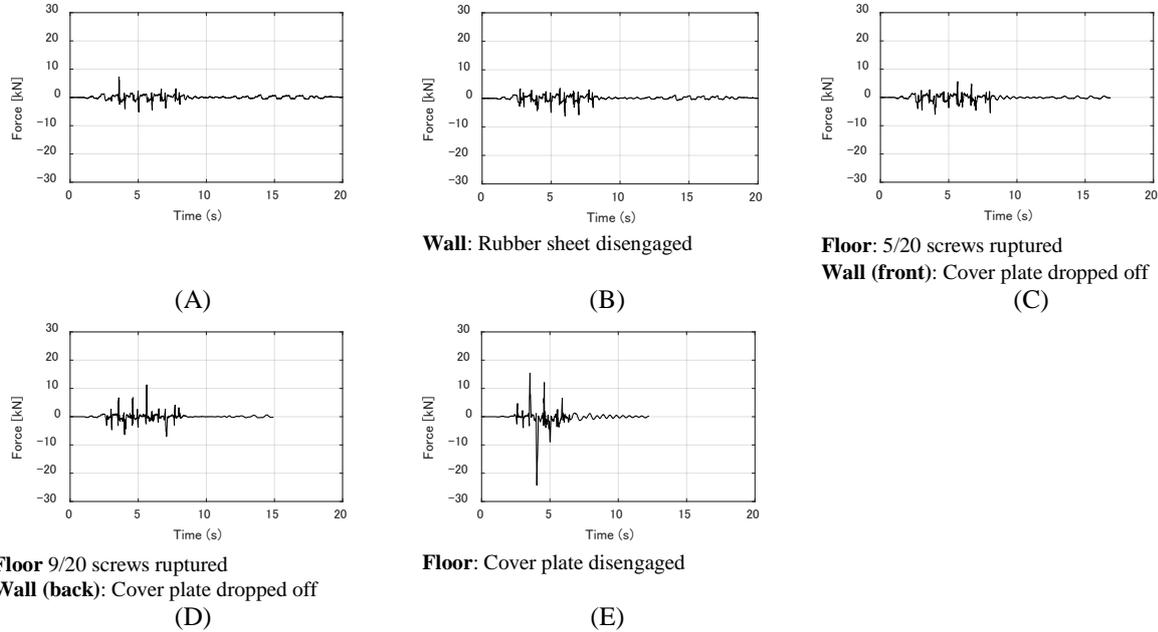
FIGURE 11 Transition of force applied to SD expansion joints with damage descriptions: (A) 350 cm/s², (B) 400 cm/s², (C) 450 cm/s², (D) 500 cm/s², and (E) 550 cm/s²

Figure 11 illustrates the time history of F_{expj} for the SD floor and wall expansion joints with damage descriptions. In general, F_{expj} was smaller for the SD specimens than for the HP specimens because the two frames connected with the SD expansion joint specimens did not experience a collision. Several peaks of small forces were observed due to collisions between the cover plate and the screws of the SD floor expansion joint specimens. Even though the cover plate of the SD wall expansion joint specimens fell off under the 450 cm/s² and 500 cm/s² excitations, a large force did not appear. This was because the sliders of the SD wall expansion joint specimens railed off smoothly. Under 550 cm/s², the large negative force was observed because the cover plate of the SD floor expansion joint specimen collided with the side plates. The large positive force appeared when the cover plate of the SD floor expansion joint was disengaged.

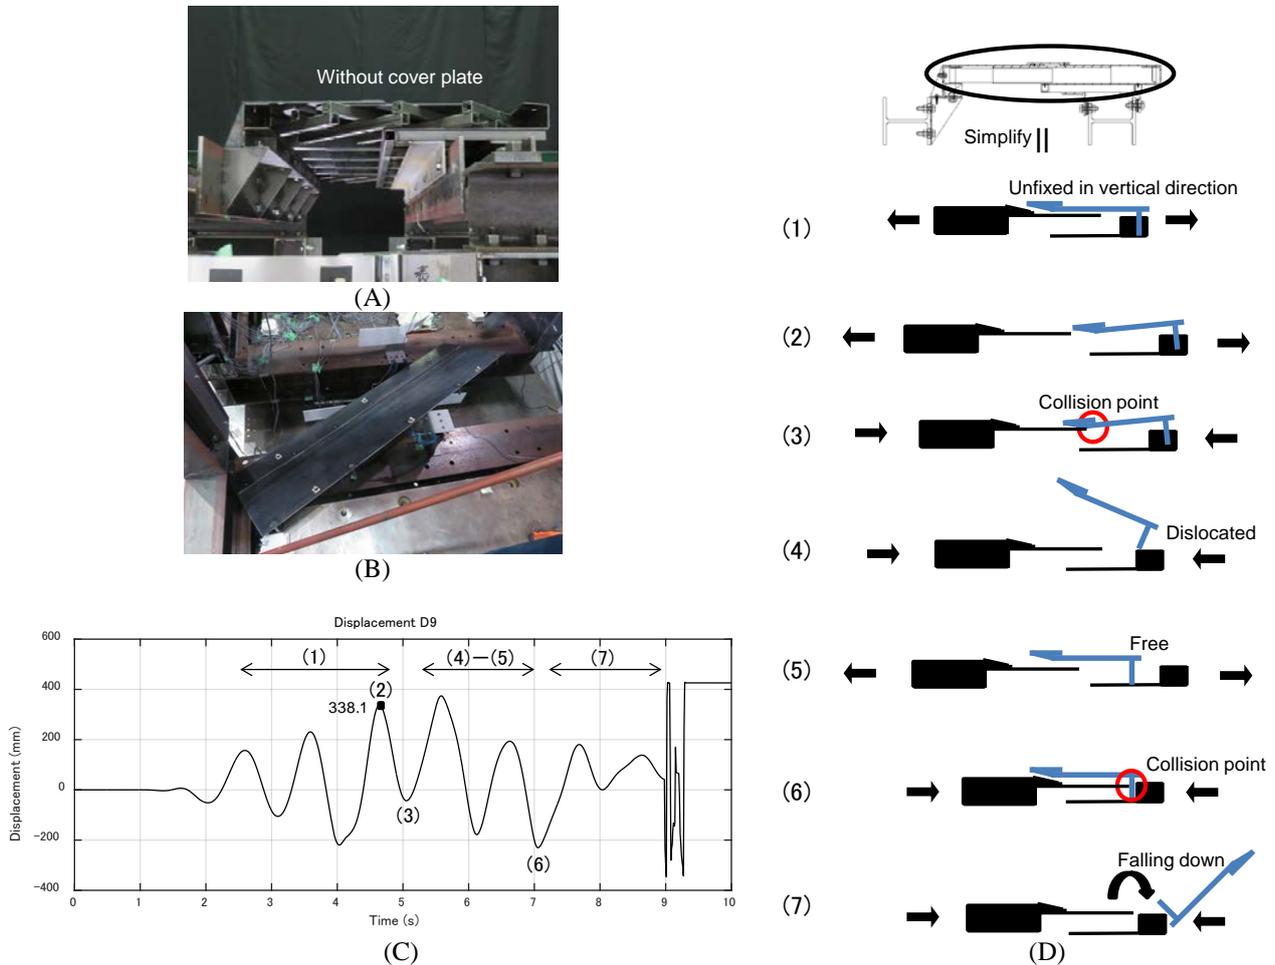
The first damage pattern observed for the HP floor expansion joint was cover plate disengagement during the input of 600 cm/s², as shown in Figure 12(A)-(B). Figure 12(C) shows the relative displacement corresponding to each condition described in Figure 12(D). Based on Figure 12(D) and videos, the relative displacement in the tension side immediately before the collision, noted as (2), was 33.8 cm. At this deformation, the plate underneath the cover plate could no longer support the cover plate. As a result, the cover plate was inclined to the inner side, and the collision (3) occurred. After the collision (3), the cover plate was dislocated from the holes, noted as (4), and freely stood (5). Then, the two frames approached the relative displacement of 23.0 cm, and the collision (6) occurred. Finally, the cover plate fell off and disrupted the displacement sensor D9 (7). This damage was induced by the two collisions at (3) and (6) in Figure 12(D), and these collisions caused the large peak accelerations in Figure 9 as mentioned before. The second collision did not occur without the first collision, but there is also a possibility that the cover plate fell off due to the first collision. Therefore, the first collision was considered critical, and the critical relative displacement of this damage was evaluated as 33.8 cm in the tension side. This value is 193% of the design motion range of 17.5 cm, and thus the tested HP expansion joint has a sufficient safety margin beyond the design tolerance.

This expansion joint can be reused immediately after re-engaging the cover plate according to the expansion joint manufacturer. Therefore, following the definition in Table 2, this damage was defined as damage state 1. Even though this was not a failure state, loadings were finished because the displacement response of the SSBs nearly reached the maximum capacity of 40 cm.

FIGURE 12 HP floor specimen DS1 (cover plate disengaged): (A) after cover plate disengagement, (B) dropped cover plate, (C) relative displacement during input of 600 cm/s², and (D) descriptions of damage sequence

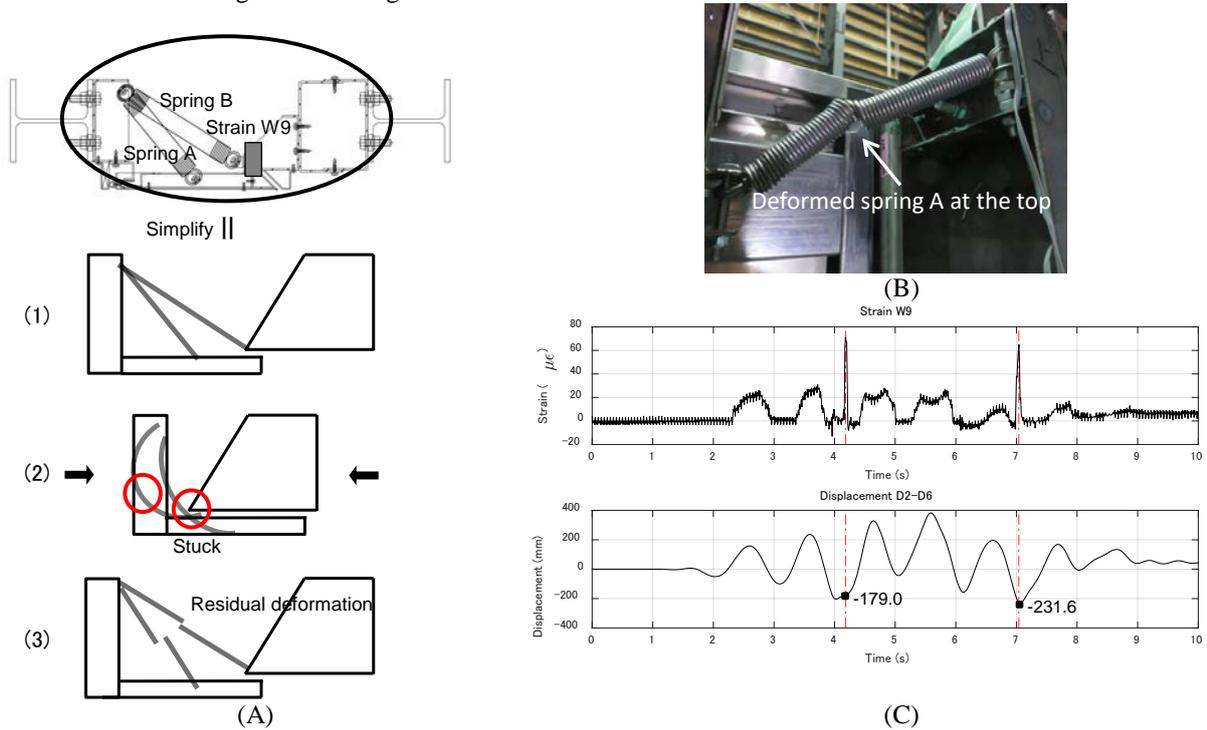
There were five springs (three of spring A and two of spring B in Figure 13(A) inside the HP wall expansion joint specimen. Their function was to pull back the cover plate from rotation. Excited by the sine wave of 400 cm/s², one spring A at the top was caught on a surrounding member at the time of compression, and a residual deformation remained in the spring. This was confirmed by video. Because there was no residual rotation at the cover plate, this damage was classified as damage state 1.

After the input of 600 cm/s², two spring B sustained residual deformation. Figure 13(C) shows the time history response of the strain gauge labeled W9 attached close to the base material and the relative displacement between two frames. There were two peaks in the response of strain W9, which were attributed to a collision with springs or other materials. The relative displacements at the timing of the strain peaks were 17.9 cm and 23.2 cm in the compression side. Therefore, this damage depended on the relative displacement in the compression side. The critical relative displacement of this damage was evaluated as the maximum relative displacement in the compression side, which was 23.2 cm for the input of 600 cm/s² and 19.1 cm for 400 cm/s². These values are beyond the design motion range, and the seismic performance of this expansion joint satisfied the required performance in Table 1.

FIGURE 13 HP wall specimen DS1-A (spring deformation): (A) damage sequence, (B) residual deformation of spring A after input of 400 cm/s², and (C) strain and relative displacement response during 600 cm/s²

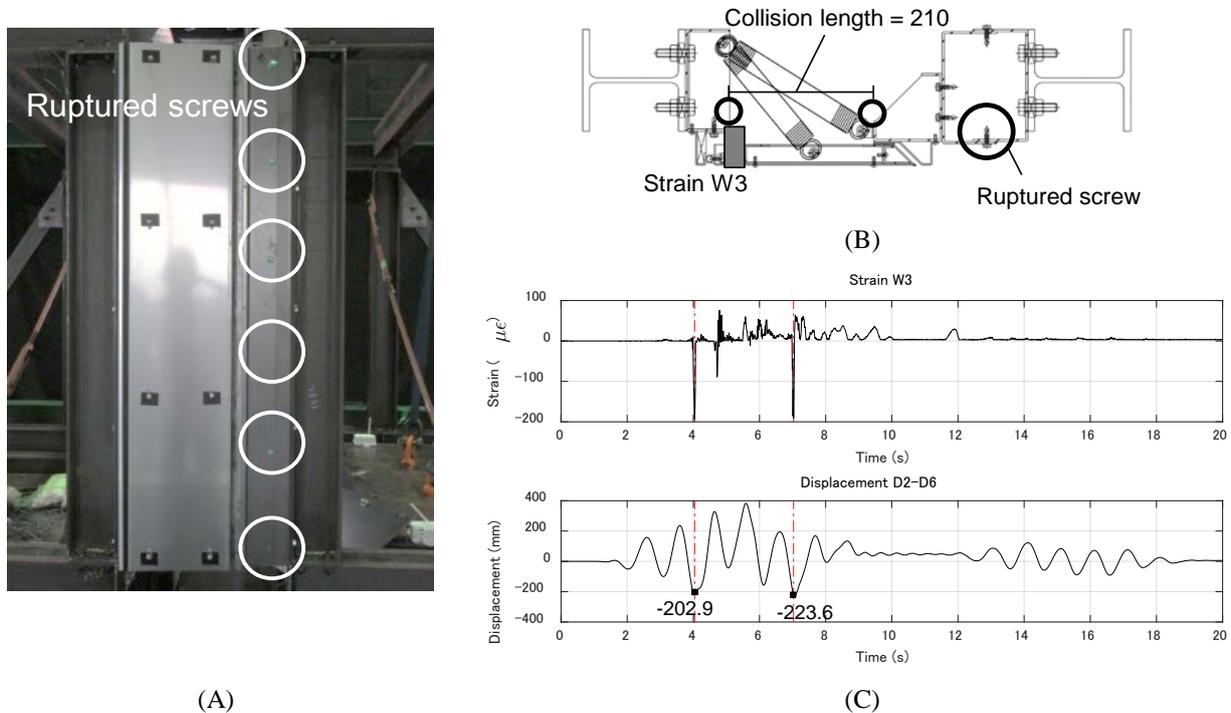
Another damage state observed for the HP wall expansion joint was the rupture of screws at the base materials as shown in Figure 14(A) and (B). The damaged screws were M6 drill screws. At the input of a sine wave of 550 cm/s², the base materials collided twice at the collision point indicated in Figure 14(B), and one of the six screws fractured. Under the input of 600 cm/s², the other five screws were also fractured. Even without screws, this expansion joint retained its function, and a small repair was required. Thus, this damage was defined as damaged state 1. Because “DS-1A: spring deformation” occurred at the same time, these damage states were classified as simultaneous damage.

construction errors. All screws were nearly fractured at the first collision, and thus a larger relative displacement of 22.4 cm was required at the second collision because the surrounding materials moved due to the loss of the screws.

FIGURE 14 HP wall specimen DS1-B (screw rupture) (unit: mm): (A) damage location; (B) damage descriptions in the drawing, and (C) strain and relative displacement during the excitation under 600 cm/s²

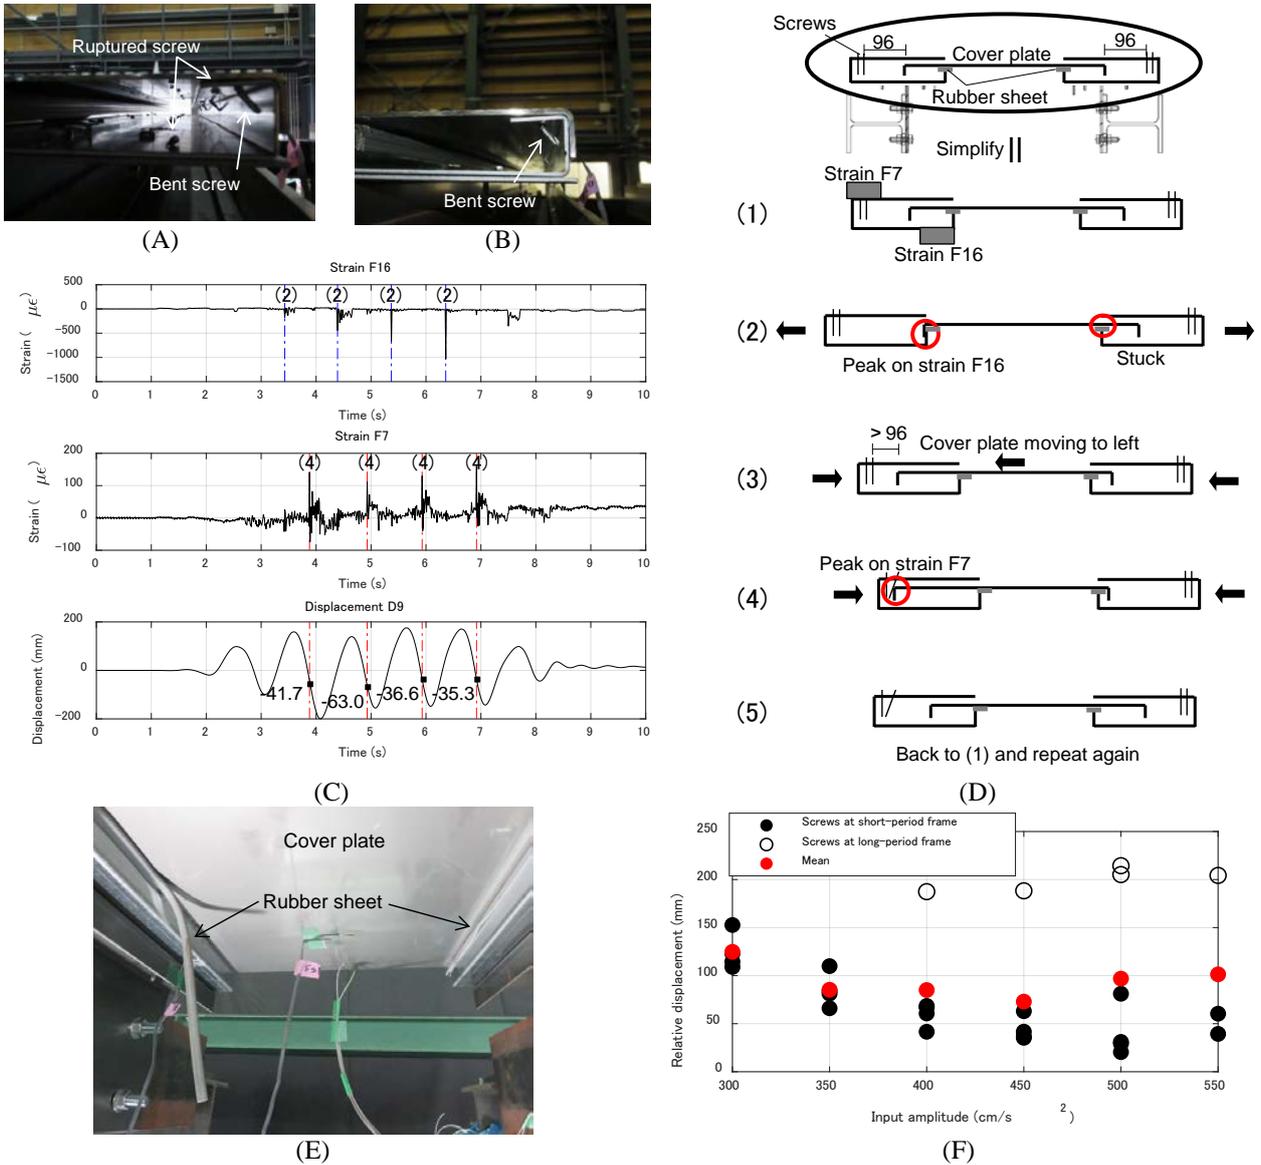
FIGURE 15 SD floor specimen DS1 (screw rupture) (unit: mm): (A) bending and fracture of screws, (B) bent screw, (C) strain and relative displacement during the input of 450 cm/s², (D) damage sequence, (E) disengagement of rubber sheets, and (F) relative displacement at the moment of collision for each input

In the SD floor expansion joint specimen, the first observed damage was the fracture of several drill screws, as shown in Figure 15(A)-(B). In the design drawing in Figure 15(D), the distance between the edge of the cover plate and the screws is 9.6 cm. Under the input of 300 cm/s² or larger, the cover plate hit the screws, resulting in bending and fracture of the screws. Under the input of 450 cm/s², five of twenty screws were shear fractured. Four more screws were shear fractured under the input of 500 cm/s². Damaged screws can be easily replaced from above the cover plate and thus this damage was considered damage state 1.

The sequence of the damage during the input of 450 cm/s² is described in Figure 15(D). Ideally, a collision between the cover plate and screws should occur at a relative displacement of $9.6 \times 2 = 19.2$ cm. However, in the experiment, the cover plate moved toward one side due to the imbalanced friction force between the cover plate and the two rubber sheets, and the collision occurred at less than 19.2 cm. For example, under the 450 cm/s², the cover plate collided with the screws on the short-period frame side only. The collisions at (2) in Figure 15(D) represent peaks at strain gauge F16 in Figure 15(C). Assuming that the timing of the collisions at (4) in Figure 15(D) correspond to peaks at strain gauge F7 attached close to the screws, there were four collisions (double-checked by videos). From Figure 15(C), the relative displacements at the moment of these collisions were measured as 4.2 cm, 6.3 cm, 3.7 cm and 3.5 cm in the compression side. Due to the repetition of those collisions, the screws ultimately fractured. After repeated loadings, the rubber sheet was also disengaged as shown in Figure 15(E), and the friction force between the cover plate and rubber sheet differed between the short-period and long-period frame sides.

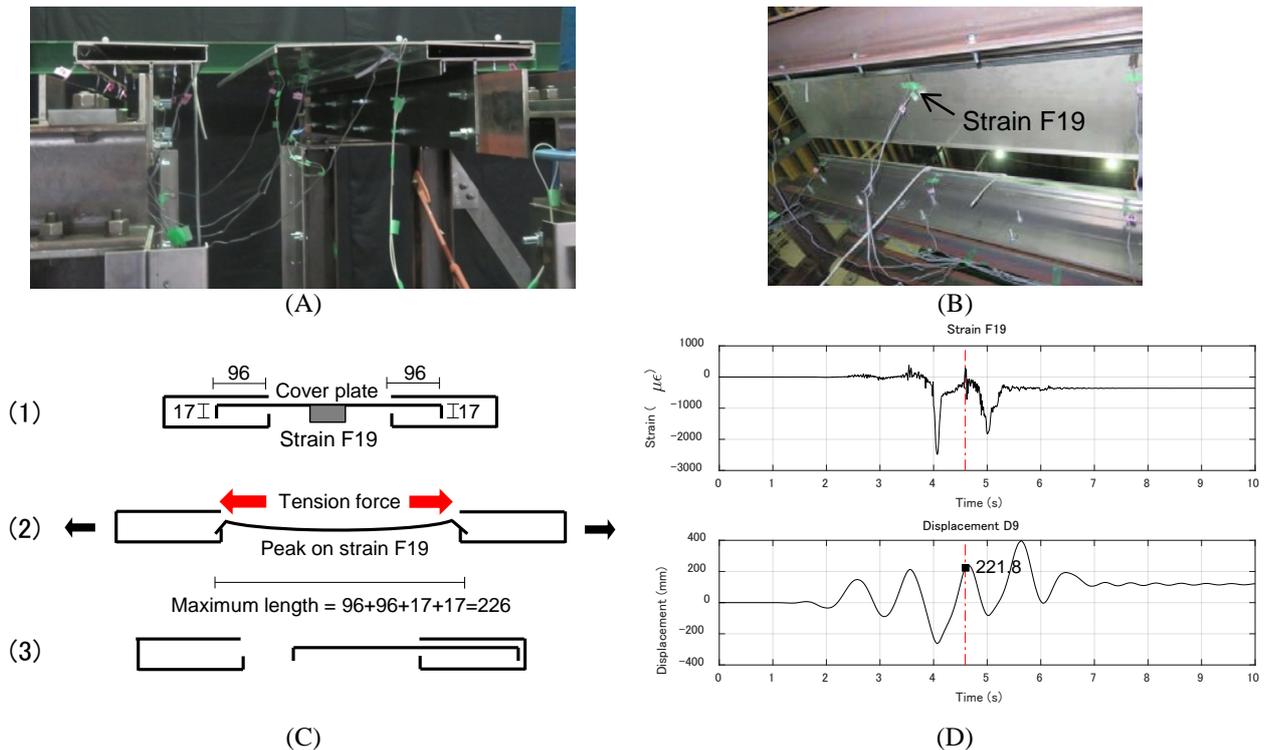
Figure 16(A)-(B) illustrates the failure mode of the SD floor expansion joint specimen. During the input of 550 cm/s^2 , the cover plate was disengaged from the side plate, creating a gap between floors. Since the cover plate could no longer sustain human weight, its function was lost. Therefore, this damage state was classified as failure. The relative displacement at the timing of failure can be estimated by the response of the strain gauge attached to the cover plate. A large tension force was applied to the cover plate at the moment of failure, as shown in Figure 16(C). From the response of strain gauge F19 attached to the center of the cover plate, this moment was identified as 4.59 s, as shown in Figure 16(D). Note that large peaks in the compression side were observed at F19 due to the cover plate collision with the side plate. From the relative displacement obtained by the D9 transducer, the critical value was calculated as 22.2 cm (127% of the design motion range 17.5 cm). This value is similar to the maximum affordable length of 22.6 cm calculated from the dimension of the cover plate, as shown in Figure 16(C). Therefore, this damage depends on the dimension of the cover plate and is displacement sensitive. In summary, damage state 1 was observed when the relative displacement reached nearly one half of the design tolerance, and the failure occurred at approximately 130% of the design tolerance. Compared to the HP floor expansion joint specimen, which exhibited damage state 1 at 193% of the design tolerance, the margin of safety of the SD floor expansion joint is significantly smaller.

FIGURE 16 SD floor specimen failure (cover plate disengaged) (unit: mm): (A) front view, (B) inside view, (C) damage sequence, and (D) strain and relative displacement response during the excitation of 550 cm/s^2

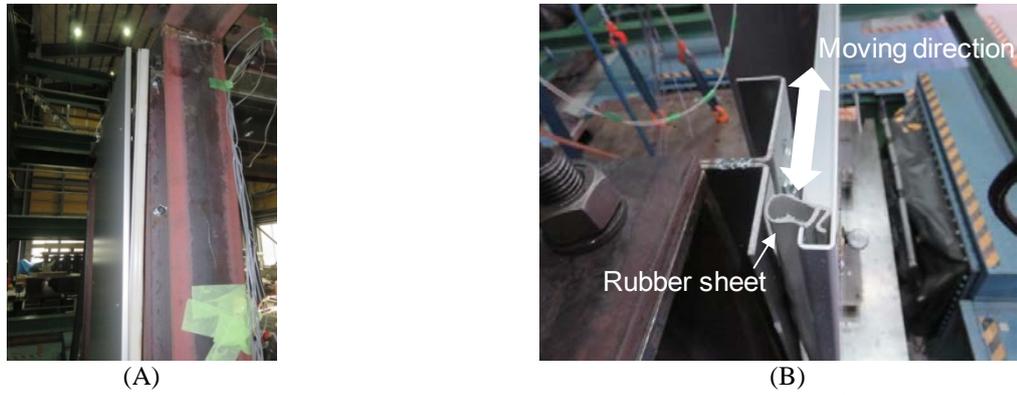
Damage state 1 for the SD wall expansion joint specimen was rubber sheet disengagement, as shown in Figure 17. The gap indicated in Figure 17(A) led to concern about air and water leakage. This damage was first observed after the input of 400 cm/s^2 . For each wall expansion joint, two rubber sheets at the edges were attached as a sealing material. During excitations, a rubber sheet on one side moved along with the cover plate and was rubbed by the surrounding materials as shown in Figure 17(B). Under 400 cm/s^2 , the rubber sheet on the back wall was largely detached, and a gap of approximately 5 cm was created. This damage resulted from repeated loading during shakings, and therefore it is difficult to identify the critical demand value that initiates this damage. This damage can be repaired by an adjustment and thus was classified as damage state 1.

FIGURE 17 SD wall specimen DS1 (rubber sheet disengagement): (A) gap and (B) deformed rubber sheet

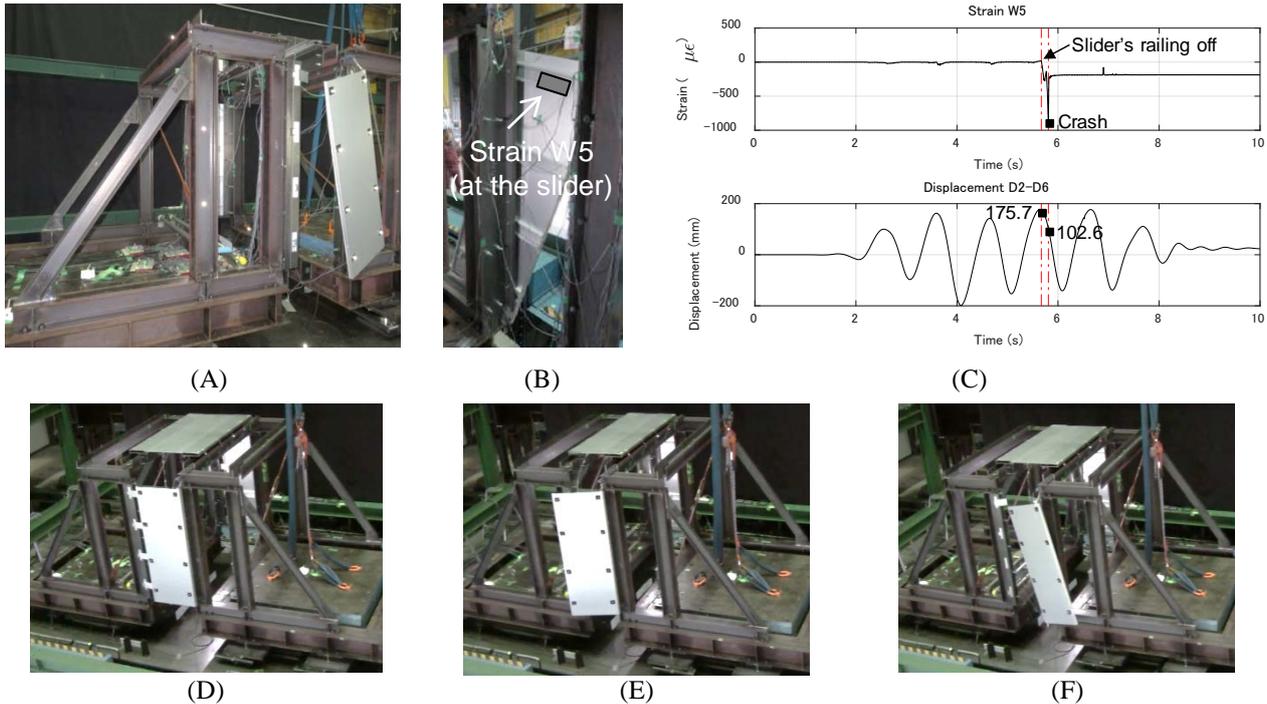
FIGURE 18 SD wall specimen failure (cover plate dropped off) (unit: mm): (A) front view, (B) inside view, (C) strain and relative displacement response during the input of 450 cm/s^2 , (D) at the moment when the relative displacement equaled 17.5 cm, (E) at the moment of crash, and (F) immediately after the crash

Figures 18(A)-(B) show the failure of the SD wall expansion joint specimen. During the input of 450 cm/s^2 , the cover plate of the front wall fell off because its sliders railed off. Immediately after the sliders dropped off, the short-period frame crashed into the cover plate (Figure 18(D)-(F)). This damage sequence can be explained from the strain responses. As shown in Figure 18(C), the response of the strain gauge W5 attached to the slider had a large peak in the compression side. The large compression force was applied when the cover plate was crashed by the short-period frame, and thus the moment at which the sliders railed off should be at the peak in the tension side immediately before the crash. Therefore, the relative displacement at the time of falling was evaluated as 17.6 cm. This result corresponds well with the design motion range, which was defined as a slider length of 17.5 cm. Thus, this damage state was displacement sensitive. Note that under the excitation of 450 cm/s^2 , only the cover plate of the front wall dropped off because the relative displacement at the back wall was smaller than that at the front wall due to the rotational movement of the long-period frame.

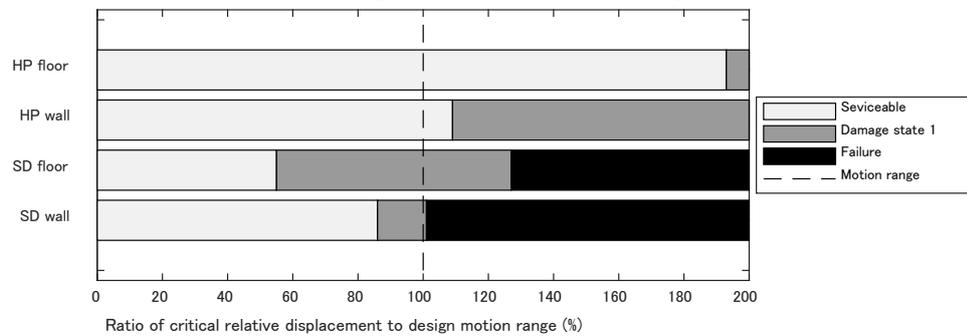
The relationship between the damage states and the ratio to the design motion range is summarized in Figure 19. The differences in the safety margin beyond the design motion range of the HP and SD expansion joints specimen are significant. The HP expansion joint specimens exhibited only damage state 1 within 200% of the motion range, whereas the SD expansion

joints showed damage state 1 within the motion range and failure at approximately 100% to 130%. Because the safety margin of the HP specimens was sufficient, this section mainly focuses on the SD specimens. Note that “DS1: rubber sheet disengaged” of the SD wall was not dependent on displacement, but the maximum relative displacement under the input of 350 cm/s² was used here because this damage was first observed after 400 cm/s².

Between the SD floor and wall expansion joints, the margin of failure beyond the motion range differed because the design motion range of 17.5 cm is a nominal value that depends on the manufacturer. The motion range can be easily identified from the drawing for some expansion joints (for the SD wall) but not for others (for the HP floor). Some other motion ranges are determined by the critical length, i.e., the collision length, plus a safety margin (for the HP wall and SD floor). Thus, the safety margin considered in the design motion range differs by manufacturer and type. For the SD wall expansion joint, the safety margin was zero, and failure occurred immediately after the motion range.

FIGURE 19 Relationship between the damage states and the ratio of the critical relative displacement to the design motion range

Manufacturers should include at least some extent of safety margin in the nominal motion range, especially for expansion joints that are difficult to repair and whose damage may hurt people on the ground, such as wall expansion joints. For example, as seen in the tested SD floor expansion joint, a safety margin of at least 30% beyond the motion range is recommended to guarantee the performance expected from the drawing.
