Dellingr: Reliability lessons learned from on-orbit

Larry Kepko, Luis Santos, Chuck Clagett, Behnam Azimi, Dean Chai, Alan Cudmore, Scott Starin, James Marshall,
John Lucas
NASA Goddard Space Flight Center
Space Weather Laboratory, Greenbelt, MD, 20771; 301-286-2728
Larry.kepko@nasa.gov

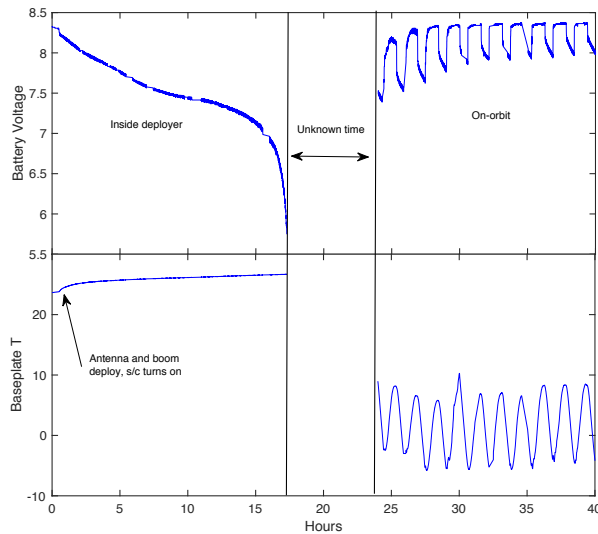
Analysis of the onboard data collected prior to deployment is consistent with the satellite having turned on while still inside the ISS. Figure 2 shows the battery voltage and temperature for the first hours of Dellinger’s mission and includes pre- and post-deployment data. The system clock booted into a default epoch, as it was intended to sync with GPS once deployed, so the initial time of the pre-deployment data is unknown. But we can infer the most likely scenario for when this initial deployment occurred.

system. The battery voltage depleted slowly over the course of 17 hours until the safety circuits, triggered off the low voltage, shut down the power system. At this point, the satellite was still inside the deployer with uncharged batteries. The satellite turned on again after deployment from the ISS (approximately hour 24 in Figure 2), once the batteries had recharged sufficiently via power from the solar panels. The time between the EPS shutoff due to low battery voltage and the turn-on once batteries were recharged is unknown, since the internal clock was reset. The 7-hour gap in Figure 2 is for illustration purposes only.

Figure 2. On-orbit battery voltage (top) and temperature (bottom) telemetry indicates that Delligr had turned on inside the deployer while onboard the ISS. After deployment the spacecraft tumbled until the batteries recharged sufficiently to turn the spacecraft back on, at which point it acquired the sun, and entered stable sun-point mode.

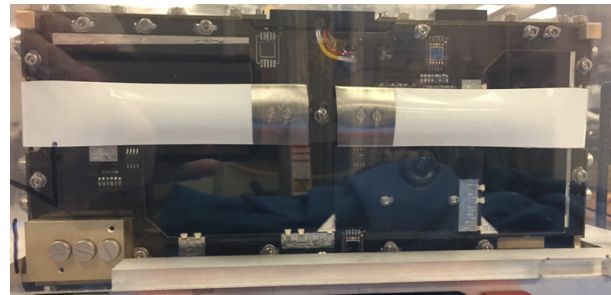
redundancy. The most likely timeframe is between removal of the deployer preload aboard ISS and robot arm operations. Our leading theory suggests that the clustering of the sensors on a small surface area of the spacecraft combined with the NanoRacks deployer geometry lead to an inadvertent release of the switches.

Figure 3 shows the location of the three Delligr separation switches, which are concentrated in a corner of the 2U face (bottom left). This side of the satellite rested against the deployer door. From delivery to pre-deployment, a static preload was applied to keep the satellite from moving during launch and handling. During ISS operations, the preload was removed by an astronaut, thereby removing pressure at the door, and causing the door to move 0.025". In principle, the pusher plate should have had enough force to depress the switches against the door and maintain the inhibit. It is believed that interactions between pusher plate, clearances on the rails, ganged switches, door movement, and friction caused a distribution of pusher plate force that was not sufficient to keep switches pressed down in the off position. We confirmed that the satellite waited 30 minutes after disengagement of the switches to deploy the boom and antenna (Figure 2).

Figure 3. Delligr's separation switches were located at the bottom left corner of a 2U face and depressed by pressure against the NanoRacks deployer door.

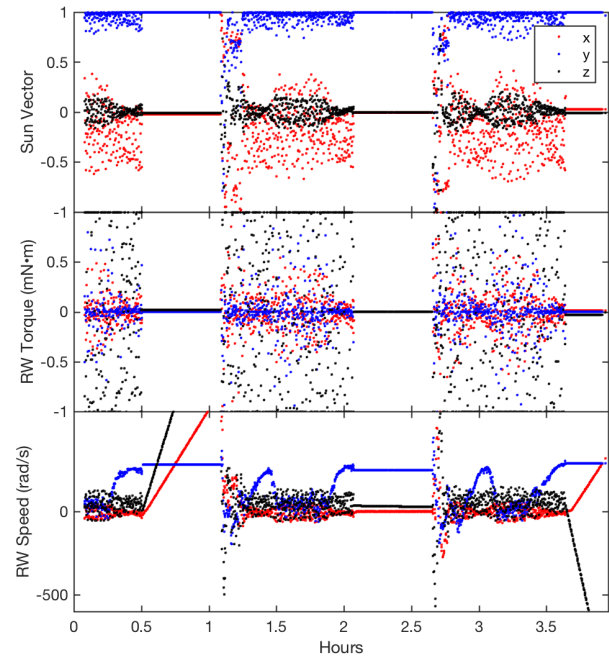
The effects of this noisy sun sensor data were twofold. First, the reaction wheel torque commands (Figure 4 middle panel) shows that the spacecraft was heavily torquing the wheels to respond to what it believed to be pointing errors, often to maximum torques and with rapid switches in direction. Second, the sensor noise made it impossible for the Kalman filter to converge on a good attitude solution to achieve eventual ram pointing for mass spectrometer science. Since this impacted INMS science operations, this issue halted the progression of the commissioning phase until the team could determine the source of the noise.

Another anomaly observed, shown in the bottom of Figure 4, is the occasional increase of reaction wheel speed to maximum values during eclipse. The speeding up of the wheels, which was later attributed to a software bug, by itself was not a major concern, as the small CubeSat wheels could not destabilize the spacecraft, and after exiting eclipse the spacecraft appeared to reacquire sun-point mode fairly quickly. Since it was not related to the pointing accuracy issue observed during sun pointing, and as it did not seem to adversely affect the system, we deferred further investigation of the wheel speed-up issue.

Figure 4. The ACS system exhibited noisy sun vector solutions (top panel), particularly in the x component, which resulted in heavy commanding of the reaction wheels (middle panel). Reaction wheel speed also exhibited unexpected behavior during eclipse. (bottom panel), sometimes accelerating to maximum value.

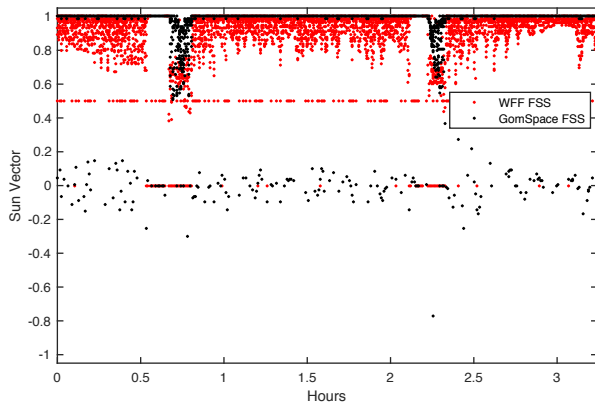
sensor was used, in an effort to reduce spacecraft bus telemetry size. The team commanded the spacecraft to retain individual sun sensor data to investigate sun sensor performance. Figure 5 shows simultaneously collected Y-axis (6U face, nominally pointed towards the sun) data from the in-house and GomSpace sun sensors. The figure shows the WFSS produced noisy and erroneous sun vector data, while the GomSpace accurately reported stable sun-pointing. Stable pointing was also confirmed by the energy entering the system from the solar panels. Erratic sun pointing such as the one reported by the in-house sun sensor would show non-constant power harvesting, but this was not observed. Despite a noisy FSS, stable sun-pointing was achieved since the control algorithm was designed such that random noise errors canceled. The resulting torque commands on the reaction wheels were a major concern, however, because they were driving the reaction wheels very hard and changing direction.

Figure 5. Delligr was commanded to send data from both sun sensors in an attempt to pinpoint the source of noisy sun vector data. Sun-pointing is indicated by a value of 1.

Diagnosing and solving the problem without a second sun sensor would have been difficult. The information in-hand indicated noisy in-house sun sensor data and the failure detection and correction on-board did not switch to the secondary sun sensor because noisy data was not considered a credible failure mode. The team switched off the in-house WFSS, to verify that the FDC would switch automatically to the backup GFSS. As expected, FDC performed as designed, and the sun vector data became very clean once the in-house WFSS was switched off, then noisy again immediately when the in-house WFSS was turned back on (Figure 6). Figure 6 also shows the reaction wheel torque, demonstrating a more stable control while utilizing the GomSpace sun sensor.

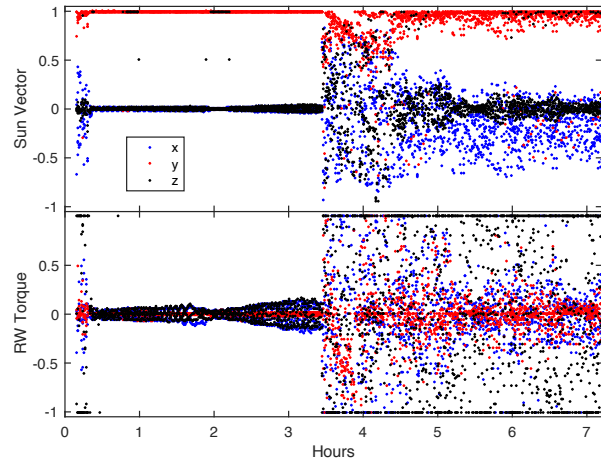
Figure 6. Delligr carried two fine sun sensors. From ~0.5-3.5 hours, the GomSpace FSS was active and indicates accurate sun pointing with Y-axis measuring 1 (pointed to sun), X and Z near 0 (perpendicular to sun) when sunlit. At hour ~3.5, we switched to the WFF FSS, and saw an immediate increase in the noise level. WFSS sun sensor data were the default for the first few months of the mission

to using the noisy WFSS. A permanent fix required a software change to prioritize the GomSpace sun sensor over the in-house sun sensor. While working on such patch other, higher priority, issues appeared and temporarily halted the sun sensor patch work.

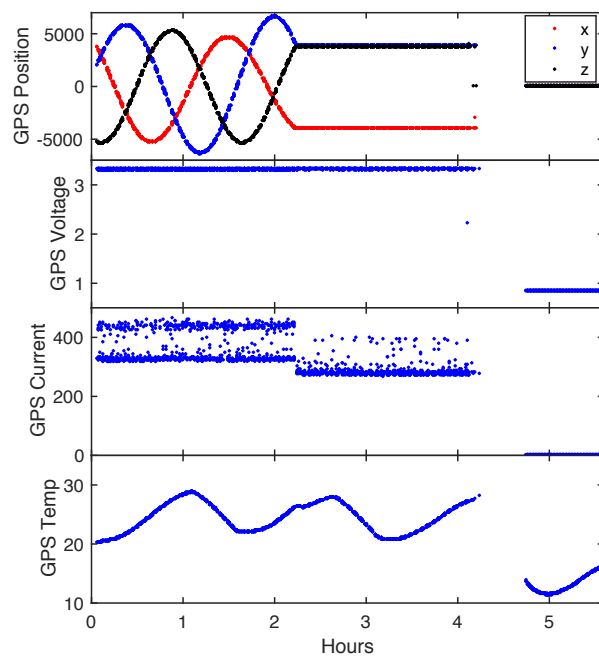
Dellinger carried a Novatel GPS (OEMV-1G) that failed on December 16, 2017, less than 1 month into the mission. The GPS telemetry shown in Figure 8 appears to show the moment the GPS failed. For the first 2 hours of the interval, the GPS reliably calculated the location of the spacecraft (top panel). During this time, it alternated between pulling ~327 mA and 440 mA; the majority of the telemetry was at 327 mA. Near 2:15, the telemetry showed a sudden change in the current draw, down to 280 mA, and a slight drop in temperature, suggesting a component failure on the GPS card. The next set of telemetry, just before hour 5, showed no current draw and zeros for the GPS-derived location.

Figure 8. Interval when the GPS failed.

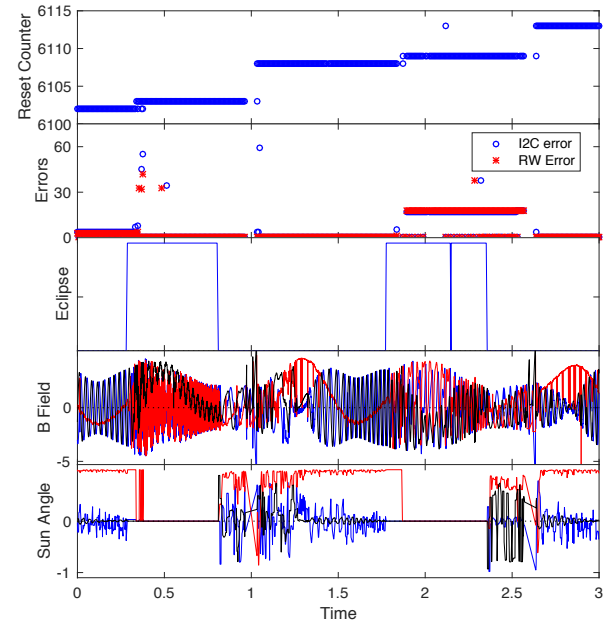
In the middle of January, the spacecraft started to show resets outside the expected daily reset. At first, the data showed a potentially thermal-related issue that caused multiple system resets a few minutes after entering eclipse, and then again a few minutes after exiting eclipse (Figure 9). Resets are indicated by an increase in the reset counter (top panel). The frequency of the resets rapidly increased to the point that by January 27th the spacecraft had entered a state of constant resets, once

Figure 9. Data from January 26, 2018, showing an example of resets and I2C errors seemingly associated with entering and exiting eclipse. Resets are indicated by increases by the reset counter.

In normal operation the flight computer sends data to the radio for later download. Furthermore, the radio is connected directly to the voltage busses without switches. Since we could not communicate through the flight computer, on January 31st the team sent commands directly to the radio to download data, to test if the reset was localized to the on-board computer or if the power system was resetting the entire satellite. During these ground passes, we were able to communicate to the radio without interruption, thus isolating the reset issue to the on-board computer, rather than the EPS. If the EPS had been triggering the resets, the spacecraft would have rebooted during the typically 5-7 minute duration of the passes. As the system booted up we noted that the FSW was sending limited telemetry to the radio – telemetry that included the boot-up logs. Review of this telemetry indicated that the flight computer crashed at the same point of the boot cycle, 63 seconds in, when it attempted to communicate with the I²C devices. We were able to reproduce the crash on the ground with the flatsat and isolated the issue to a bug in the I²C driver. The bug is in the code that is supposed to prevent simultaneous access to the I²C driver by different tasks in the FSW. If two or more tasks were trying access the I²C bus at the same time, one would gain access to the bus, and the others would wait with a 10 second timeout. If the task that had access was delayed due to I²C device errors, the waiting tasks would eventually timeout and access the bus

Although we had isolated the problem, we could not alter the driver onboard the spacecraft to avoid the crash. It was not in an area of the FSW that we could modify through ground uploads. The EPS had a 4-minute watchdog timer on the I²C line. If it did not see activity for 4 minutes it would power cycle the spacecraft. But during the 63 second reboot sequence, the flight computer utilized the I²C line just enough so that the watchdog never tripped.

It worked. By constantly commanding the radio to reset the flight computer we had effectively jammed it and triggered an EPS watchdog reset. During the interval of constant resets, the team had theorized that the issue was high traffic on the I²C line. The current theory revolves around degraded components on the I²C line, making the line unstable. After recovering the spacecraft, the team immediately disabled the reaction wheels to decrease I²C traffic, as the reaction wheels are by far the worst offender on I²C traffic, with each of the 3 wheels communicating on the bus at 10 Hz.

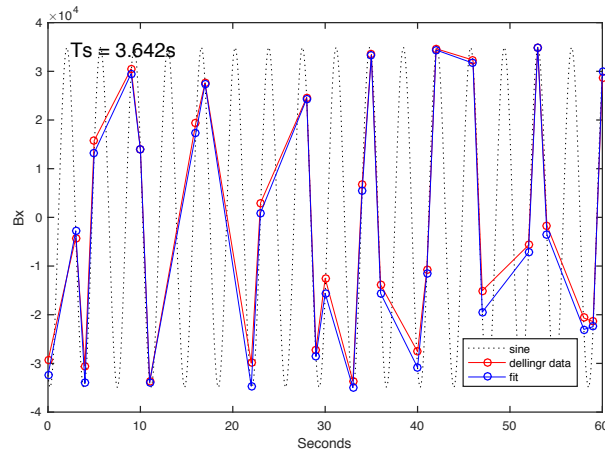
Yet it soon became clear that the ACS system was not keeping the 6U face pointed towards the sun and, in fact, the ACS system seemed to be having no effect on the attitude at all. On March 6th, 2018, by fitting a sinusoid to the science magnetometer data, we saw the first indication that Dellinger was in an uncontrolled, fast-spinning tumble (Figure 11). The maximum observed spin rate was about 105°/sec (17.5 RPM) primarily about the body-Y axis (6U face), and all the reaction wheels were saturated at maximum speed. The ACS system was designed to work at spin rates below about 5.0°/sec/axis, so Dellinger was operating well outside the design limits. The ACS system appeared unable to unload the spin

momentum. The tumbling rate faced some initial skepticism because it wasn't clear to the ACS engineers how Dellinger could have reached that high spin rate (about 20x Dellinger momentum capacity). Also, 17.5 RPM is just under the Nyquist frequency where one can deterministically assess rate based on the 1 Hz sampling rate. Between that and limited and noisy data, it seemed serendipitous for Dellinger to be in an uncontrolled yet observable state. Nonetheless, the de-tumbling effort soon commenced. Determining how the spacecraft entered the uncontrolled, rapid spin rate would have to wait.

Figure 11. Sine wave fits to the x component of the magnetic field data from March 6th provided accurate assessment of the spin rate, even with unevenly sampled data.

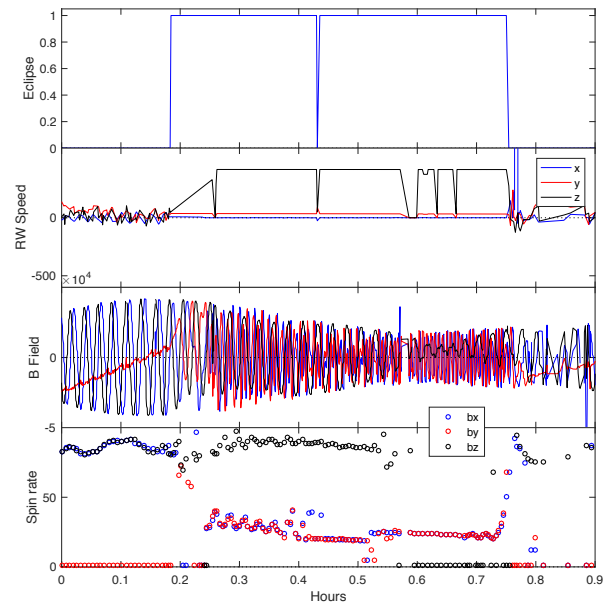
The leading theory to explain the root cause that brought Dellinger to the high-rate tumbling state appears to be a magnetic control software implementation error that occurs during eclipse. The Dellinger ACS was designed to send zeroed torque commands to the reaction wheel during eclipse while momentum unloading of the wheels continued. It was discovered during in-flight operations that the last reaction wheel command before eclipse entry was *effectively stuck* in the command queue and caused the wheel speeds to linearly increase till saturation (see Figure 4). At the same time, the magnetic control loop continuously attempted to unload the wheel momentum for a prolonged period. This continuous magnetotorquing spun up the spacecraft to a high spin rate.

Although we do not have data from the interval that spun up the spacecraft to the uncontrollable state, we have seen the effect throughout the mission. An example is shown below in Figure 13. Prior to eclipse the spacecraft was spinning about the y-axis, as indicated by the magnetic field measurements, with the x and z component seeing a quadrature magnetic field. Upon entering eclipse near 0.2 hours, reaction wheel Z (2U face) accelerated to maximum speed, and the spin orientation of the spacecraft changed. The spin period

(bottom panel) calculated via fits to the magnetic field observations tells the story. The z axis spin rate remained relatively constant at ~80 seconds, but the x and y axes saw an initial decrease to ~35 seconds (i.e., sped up), followed by a slow decrease that was due to the magnetotorquers attempting to unload wheel momentum. By the end of the eclipse, the spacecraft was spinning with a 20s spin period about the z axis, then recovered quickly once leaving eclipse.

Figure 13. Example of Dellinger body rate changes during eclipse. Spin fits of zero indicate a bad fit and should be ignored.

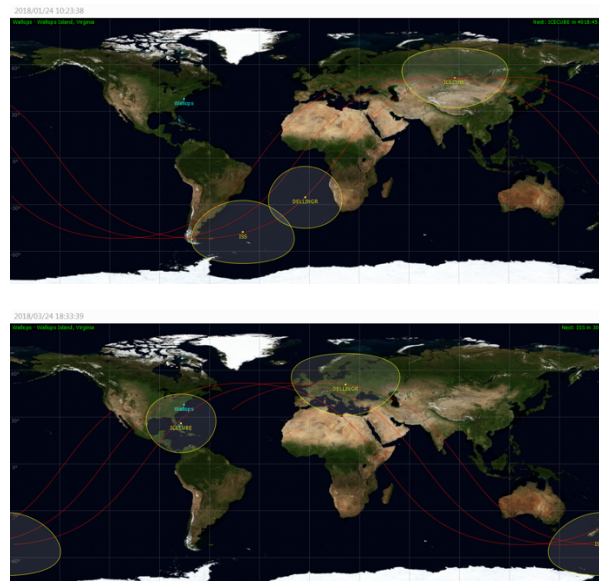
Dellinger's radio memory bank was deleted twice during the mission without an identifiable reason. In both cases the satellite was neither in the range of the WFF ground station nor in the same geographic location. The first incident occurred on January 24, 2018, around 10:23 am EST, losing approximately 650,000 packets of data. The location was estimated to be over the south Atlantic Ocean near South Africa and the South Atlantic Anomaly (SAA), as shown in Figure 14 (top). The second incident occurred on March 24, 2018 at 6:33 pm EST, losing around 700,000 packets. This incident

Figure 14. Approximate locations of the first (top) and second (bottom) data deletion events.

At this point in time we do not have a good explanation for the data deletion events. Direct command of the satellite by a UHF ground station seems unlikely since knowledge of Cadet radio operations is required since it will reject any commands not formatted correctly. While a single event upset is possible, particularly since the first event occurred near the SAA, we do not have an explanation for why an SEU would cause data deletion. An SEU does not seem likely for the second deletion event.
