Steel Bridge Research, Inspection, Training, and Engineering (S-BRITE) Center

October 2015

# Member-Level Redundancy of Built-Up Steel Girders Subjected to Flexure

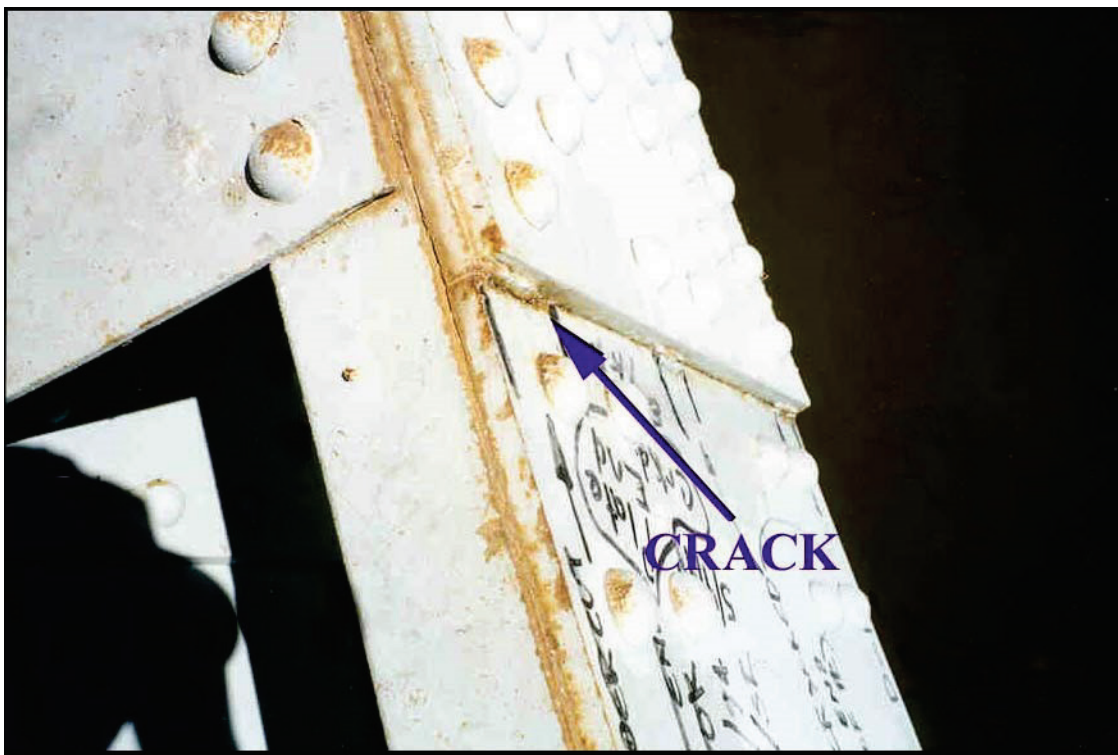
**Figure 2-6 Fractured tie girder plate, Hastings Bridge (Niemann, 1999)**

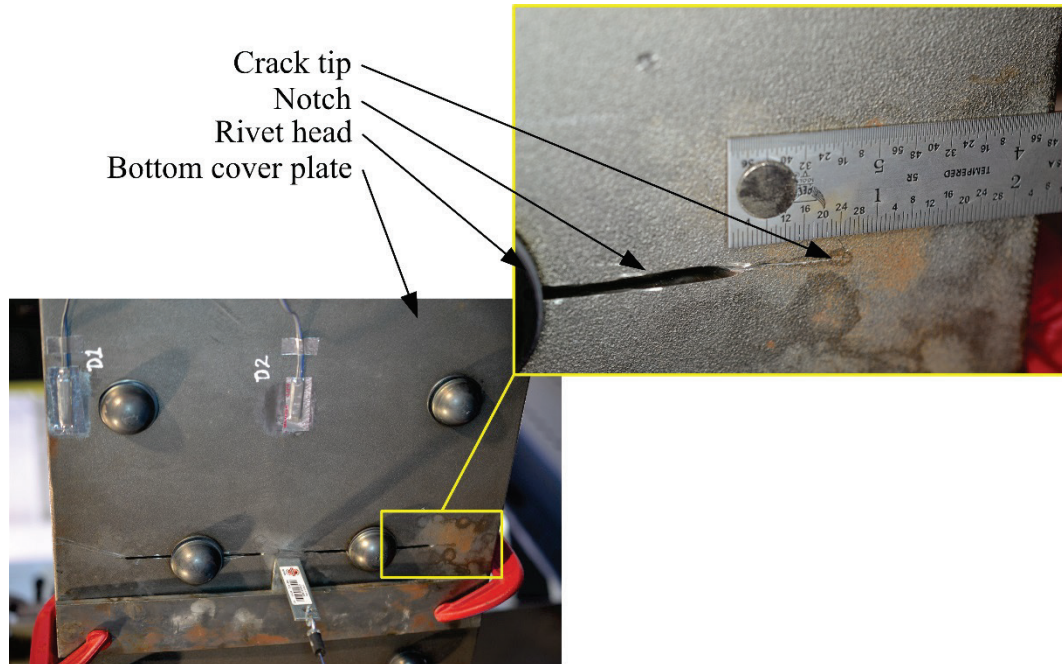
**Figure 3-20 Crack growth from notch at a hole (Specimen 46-3)**

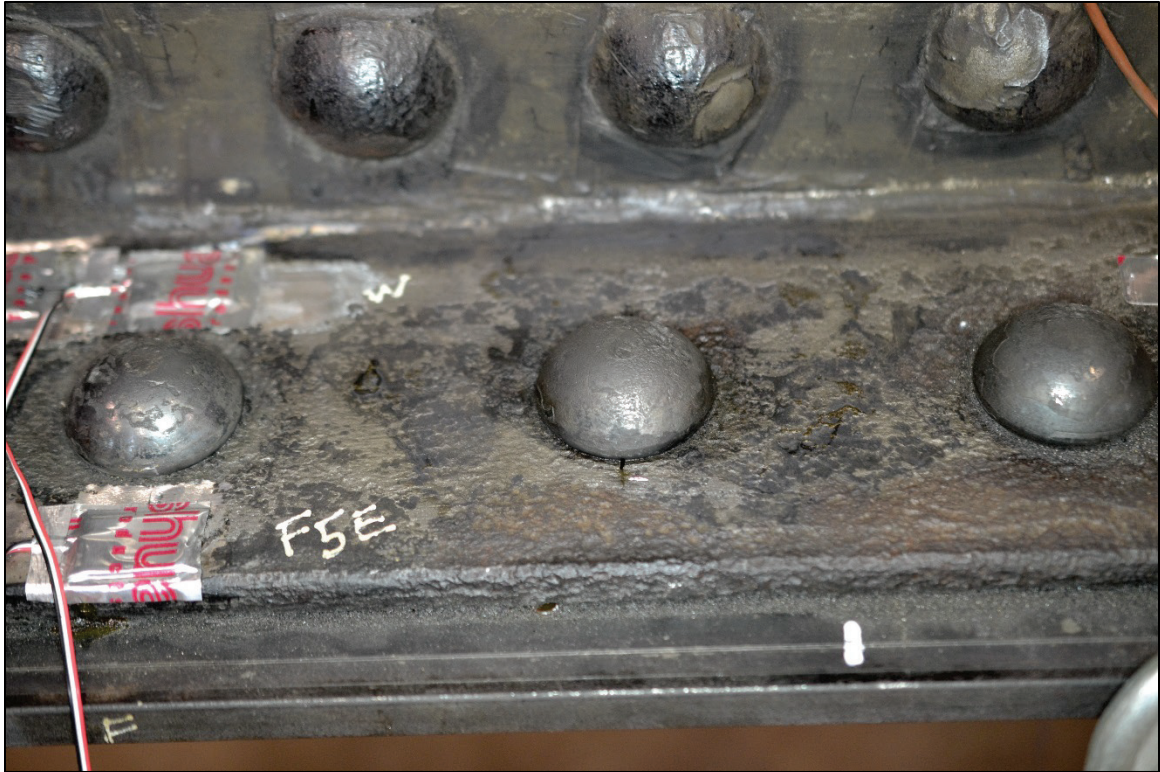
bottom flange). No fracture occurred during the test. The specimen was allowed to warm up to ambient air temperature and then cyclic loads were continued to grow the crack length. The crack quickly grew through the remaining portion of the horizontal leg of the east flange angle. At this point, since no brittle fracture occurred, the fatigue portion of the test was begun.

**Figure 3-37 Crack growth from Specimen 23-3 hole notch**

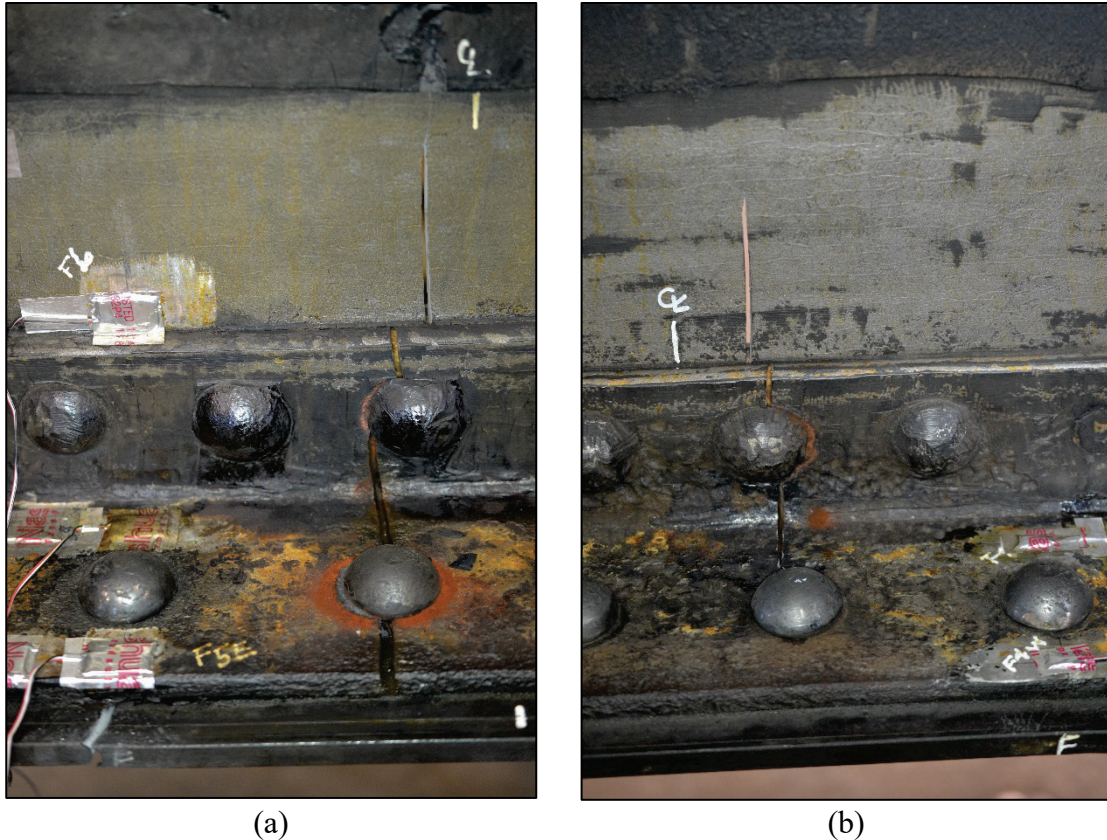
east flange angle. Shortly thereafter (52,000 cycles) a crack was detected growing in the web plate (directly above the original flange angle crack). Cracks were detected 184,000 cycles later in the vertical leg of the west flange angle in the same longitudinal location as the original east flange angle cracks. After another 237,000 cycles the test was stopped. At this point the east flange angle was completely cracked, the cover plate had a crack running from the east side, through the east rivet hole and had arrested in the west rivet hole. Additionally, the west flange angle had a crack through the entire vertical leg and had arrested in the rivet hole of the horizontal leg, and the web plate had a 7.2" crack. Figure 3-38 shows the extents of the cracks (under load) at the end of the test. A total of 3.78 million cycles were accumulated between the failure of the horizontal leg of the east flange angle and the time that the test was stopped.

**Figure 3-38 Cracks in Specimen 23-3; (a) East side, (b) West side**

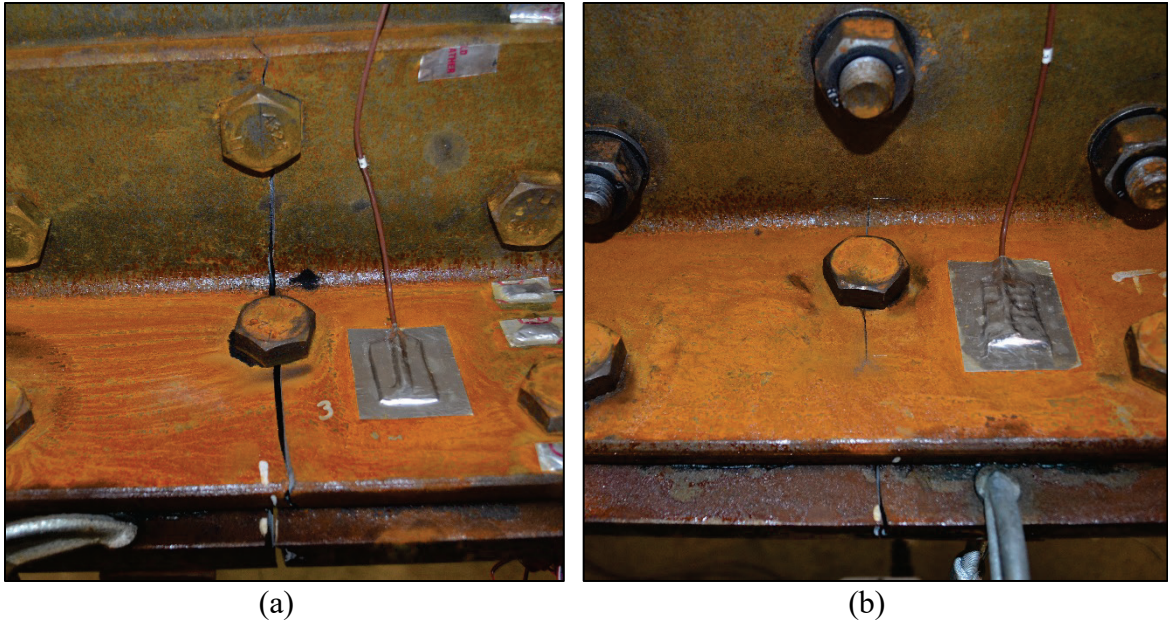
The specimen was cyclically loaded from 80 kips to 180 kips to measure the fatigue life of the remaining components. The test was kept continuously running throughout the day and night to decrease the duration of the test. The east flange angle was found completely cracked through one morning. Additional cracks were also found in the hole of the horizontal leg of the west flange angle. Based on the cyclic load frequency and the data collected, it was calculated that the east flange angle had failed after approximately 74,400 cycles at a calculated net section stress range of 24.2 ksi. Figure 3-40 shows the cracked flange angles and cover plate on the east and west side of the specimen.

**Figure 3-40 Specimen 46-1 cracked flange angles; (a) East, (b) West**

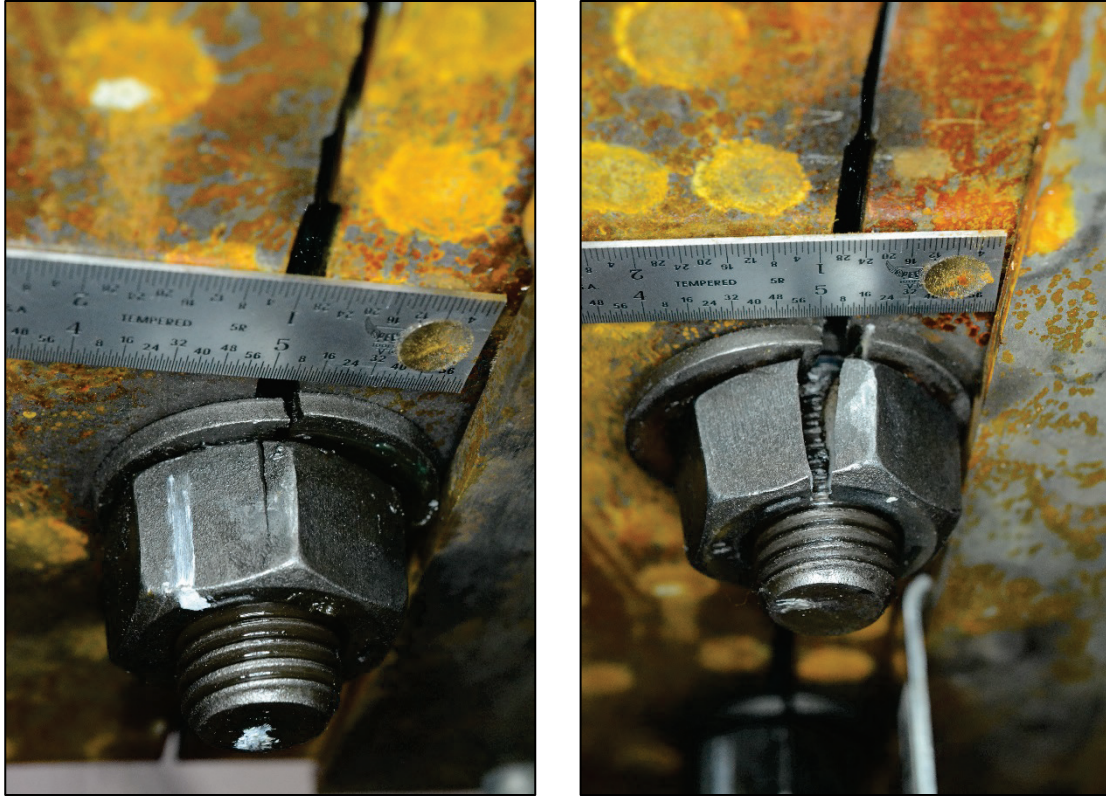
Both the high-strength nuts and washers that were attached to the bolts at the location of the cover plate notch were found to have significant fatigue cracks (see Figure 3-41). As the specimen was cyclically loaded it went through a cyclic displacement which resulted in a gap opening of the failed cover plate. It was believed that the frictional force between the nut, washer, and cover plates (which was caused by the pretension in the fastener) resulted in cyclic axial forces (out-of-plane for both the bolt and washer) which resulted in the fatigue of the washers and bolts.

**Figure 3-41 Specimen 46-1 cracked nuts**

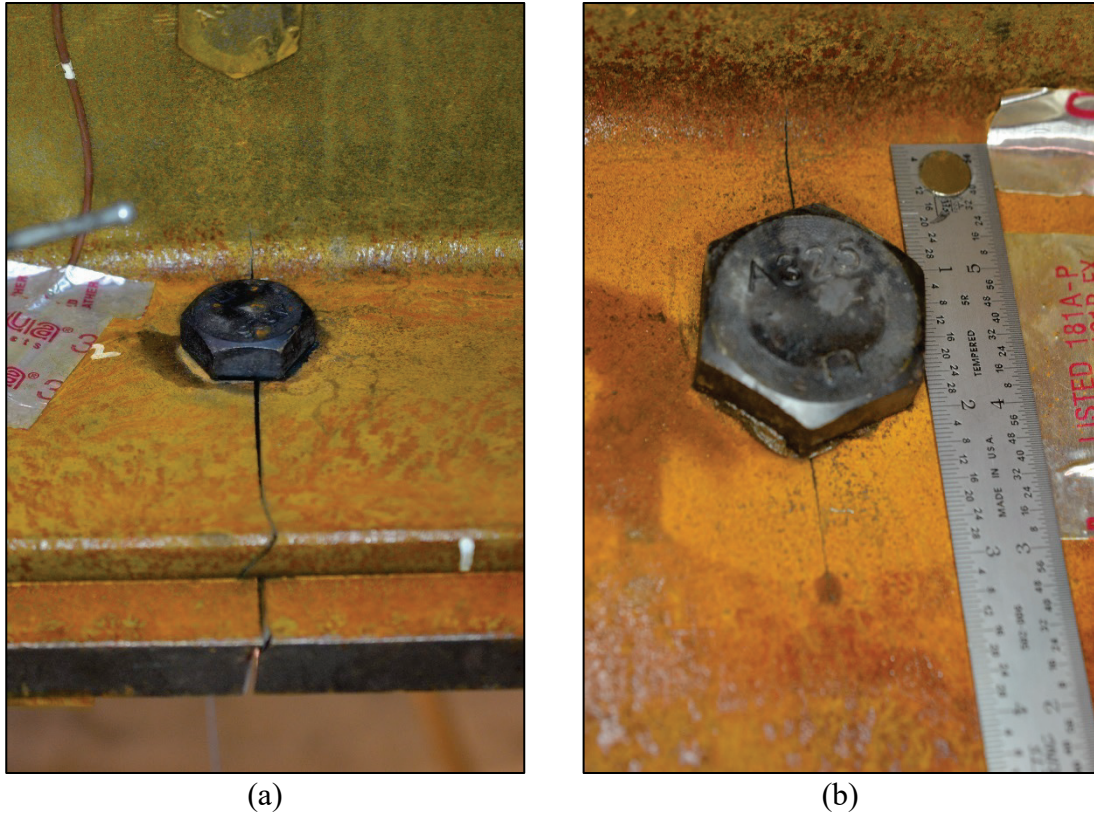
The specimen was loaded cyclically at the same magnitude which created a calculated net section stress range of 24.2 ksi on the remaining bottom flange components. After 21,000 cycles cracks were detected in both the east and west flange angles as well as the nut on the east side at the location of the cracked cover plate. After a total of 31,200 cycles, cracks had grown through the entire length of the horizontal leg of the west flange angle and the test was stopped (see Figure 3-43). At this point 56% of the horizontal leg of the east flange angle was also cracked. The fatigue data is presented along with other specimens in Section 3.5.2. The nuts and washers on the bolts at the location of the cover plate crack initiated fatigue cracks in this specimen, similar to Specimen 46-1.

**Figure 3-43 Specimen 46-2 cracked flange angles; (a) West, (b) East**

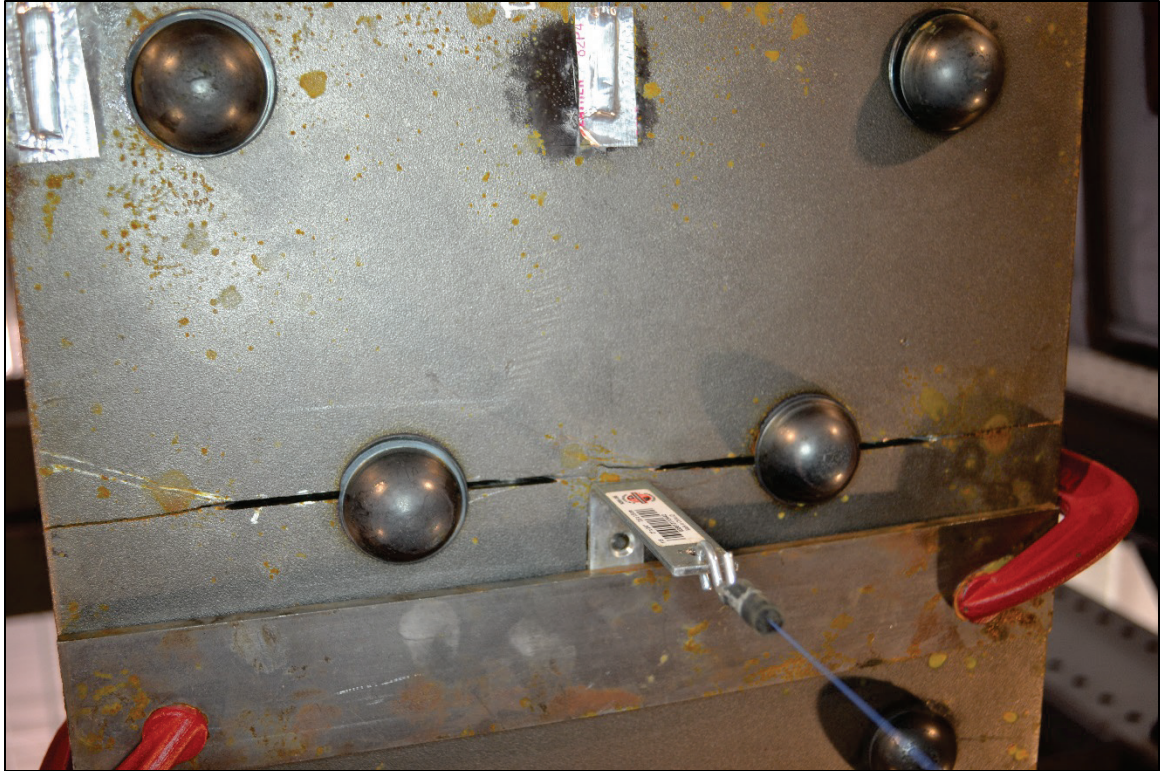
Prior to the fracture test, the specimen was cycled in fatigue between 80 kips and 180 kips with a calculated stress range in the bottom flange cover plate of 16.8 ksi. After 37,000 cycles cracks were detected at both interior notches and the east exterior notch of the cover plate. After an additional 3,000 cycles were applied, a crack was detected which had just started growing out of the west side notch. At this point the cracks growing at the interior portion of the cover plate had grown together. The total lengths of the cracks were 1.84", 2.21", 2.55", and 2.39" (from west-to-east). The specimen was prepared for the fracture test by cooling to a temperature of  $-75^{\circ}$  F. A load of 200 kips was applied on each actuator. At this point the cover plate of the specimen fractured. After a thorough inspection, no other cracks were found in any of the other components. Figure 3-45 shows the cover plate of the specimen after the fracture (from below).

**Figure 3-45 Specimen 46-3 fractured cover plate (from below)**

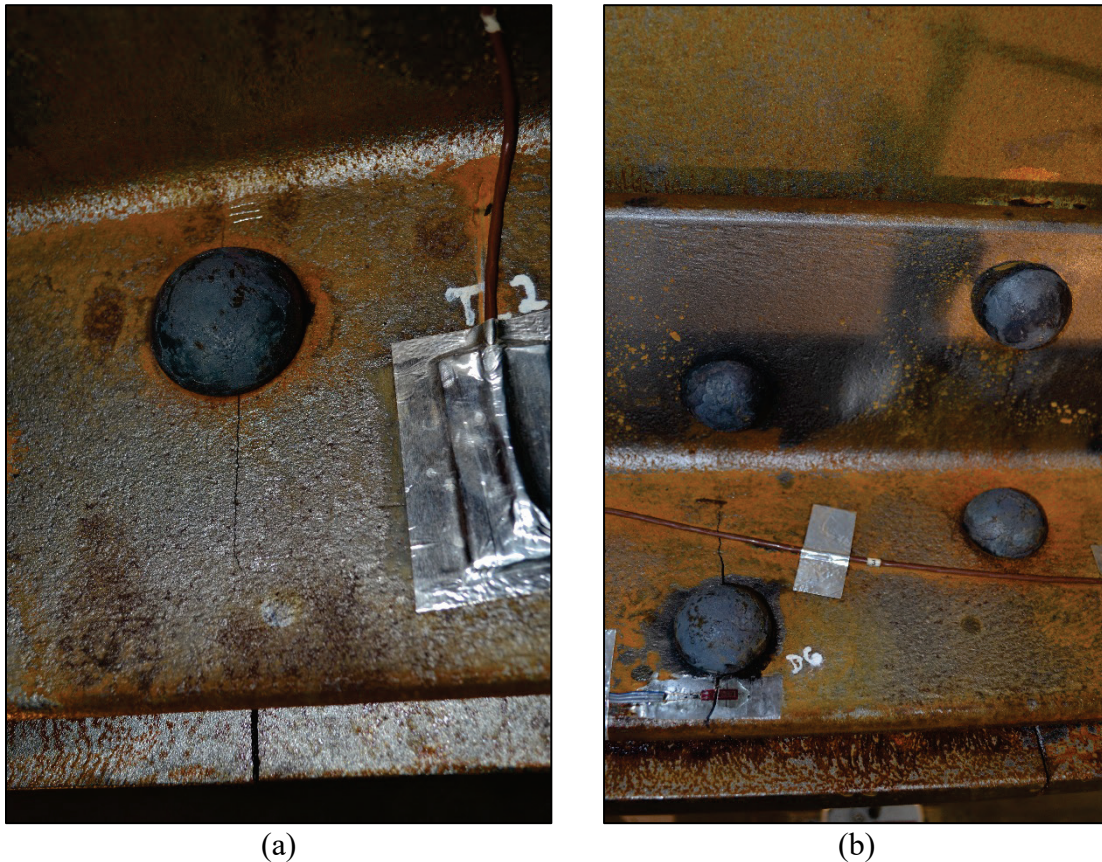
specimens). The total number of cycles from the time the cover plate fractured until the test was stopped was 153,000.

**Figure 3-46 Specimen 46-3 cracked flange angles; (a) West, (b) East**

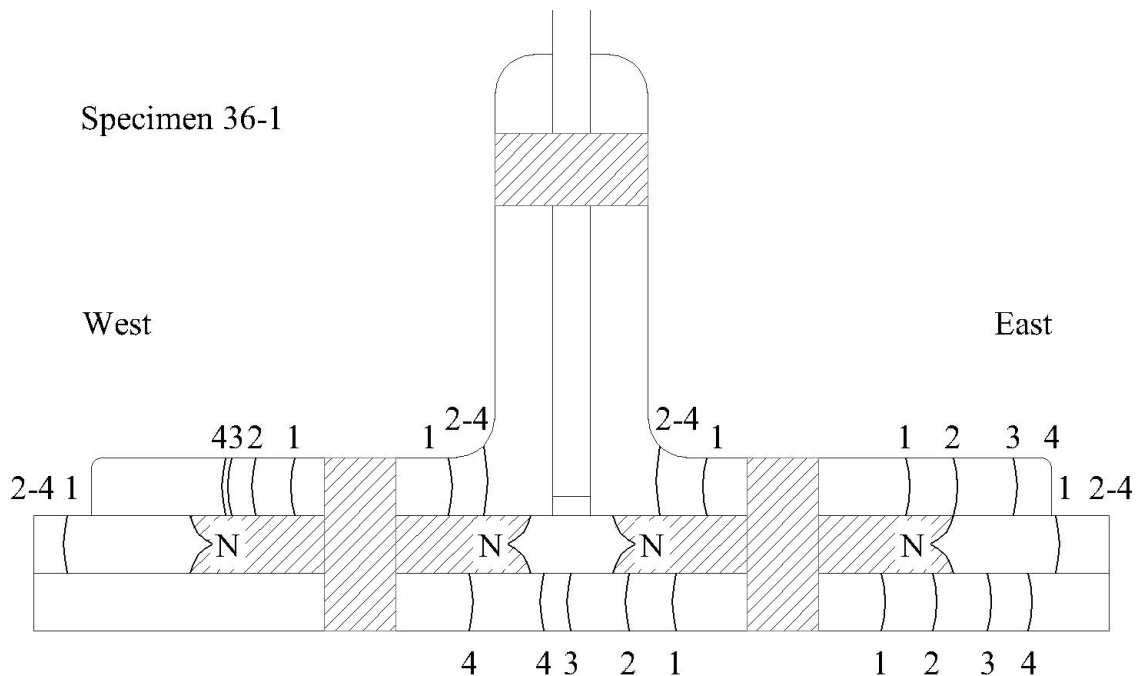
After 116,000 cycles, the second interior crack detection gage was triggered. In another 94,000 cycles the west exterior crack detection gage was triggered. Due to previous failed attempts to fracture specimens, the test was continued to cycle to attempt to get all four crack tips to a critical length prior to the fracture test. After a total of 404,000 cycles, the fourth crack detection gage stopped working. It was at this point, however, that cracks were also detected in both flange angles and the lower cover plate (cracks were present in all bottom flange components). The specimen was then cooled to  $-65^{\circ}$  F and prepared for the fracture test. No fracture occurred at this point. The specimen was allowed to warm to ambient temperature, the cracks were grown through cyclic loading, and the fracture was reattempted three more times at temperatures of  $-72^{\circ}$  F,  $-70^{\circ}$  F, and  $-64^{\circ}$  F. Figure 3-48 shows the notch locations in the upper cover plate as well as the crack lengths at each of the four different fracture attempts.

**Figure 3-48 Specimen 36-1 crack growth and fracture attempts**

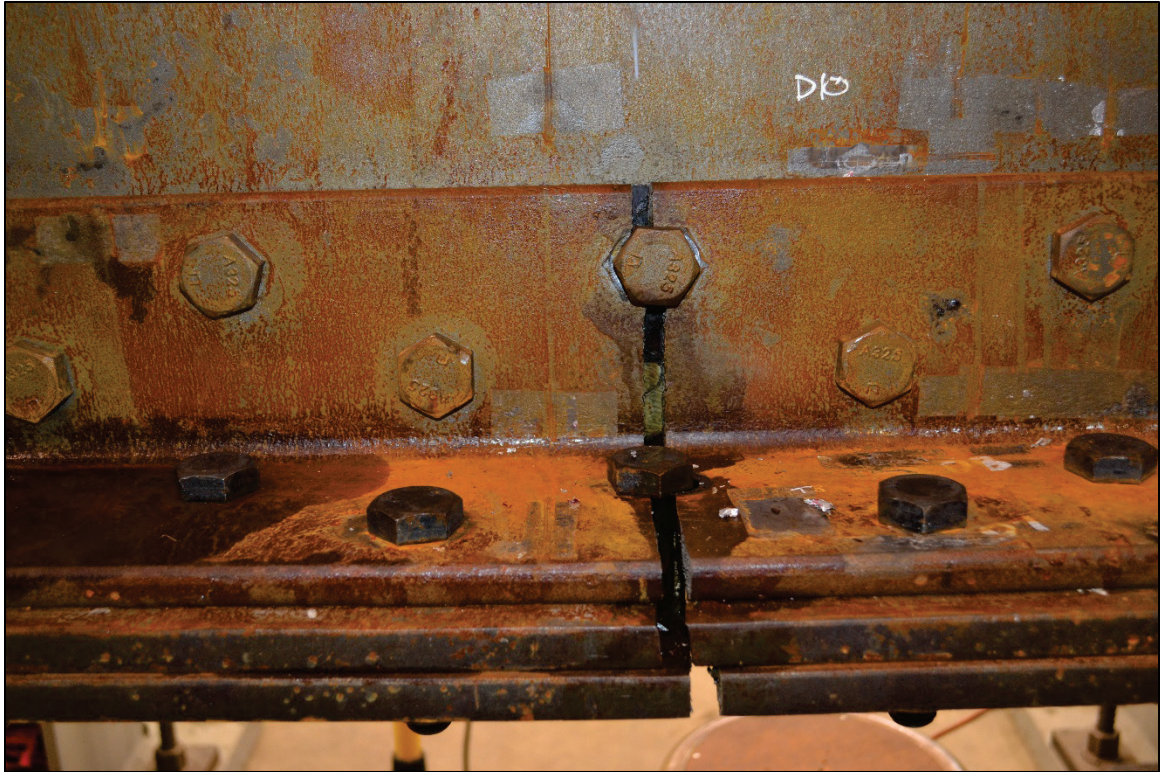
fracture. Due to the localized reduced stiffness, the actuators reached a deflection interlock in the MTS hydraulic software and the hydraulic pressure was shut off for the test. Figure 3-49 shows the east flange angle and both cover plates in the failed condition. Figure 3-50 shows the failure surface of the lower cover plate after disassembly.

**Figure 3-49 Specimen 36-1 fractured bottom flange components (east side)**

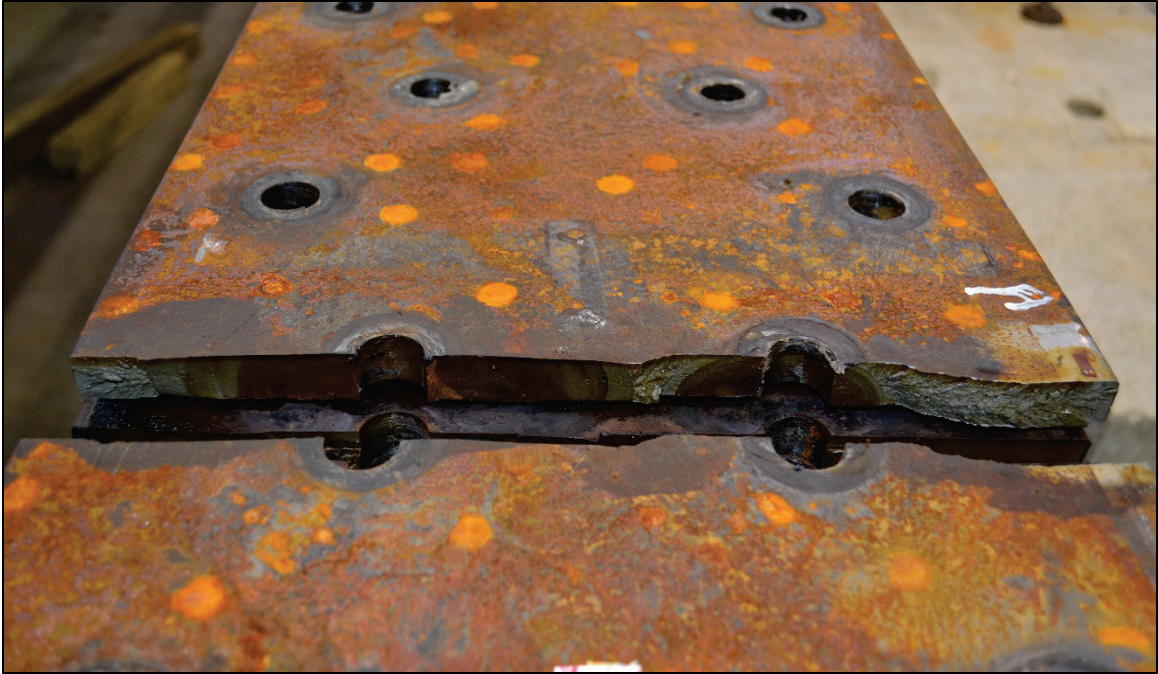
**Figure 3-50 Specimen 36-1 fractured bottom flange components (bottom view)**

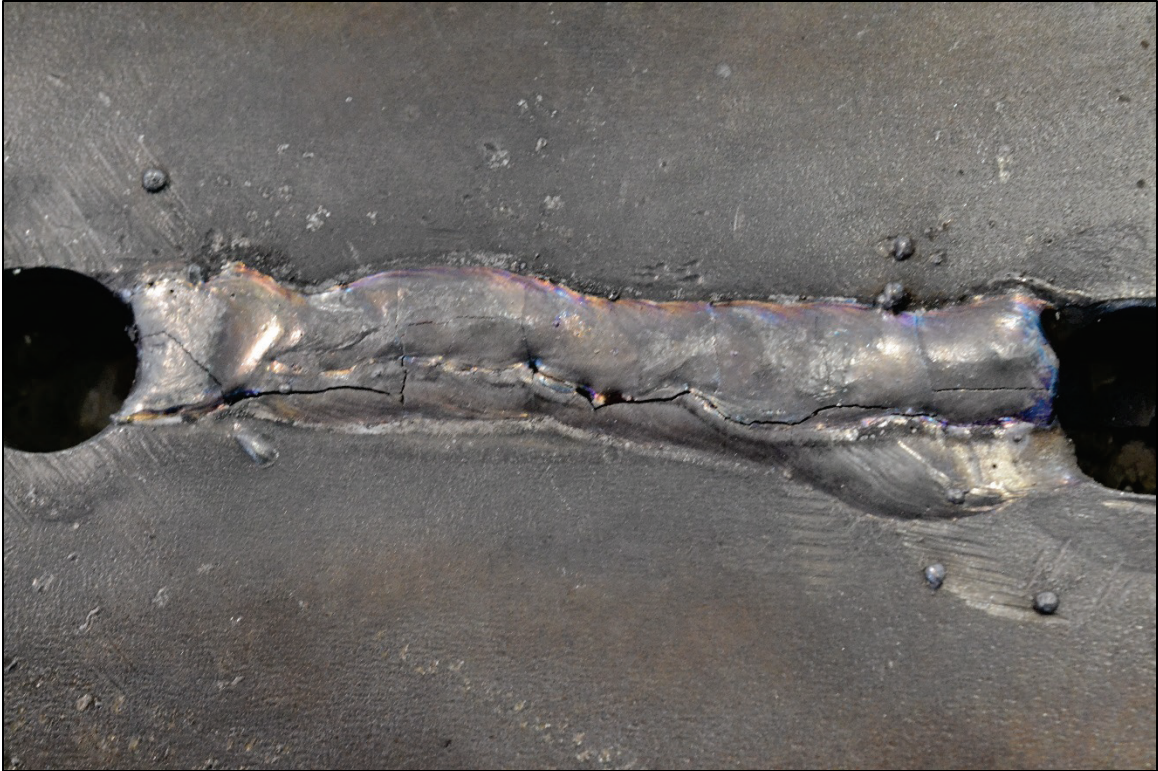
The weld was composed of Lincoln Electric Excalibur 7018 MR welding rod layered with Lincoln Electric Wearshield ME hardfacing welding rod. The intention was to create a ‘bad’ weld by layering the two weld metals together which would be used as a fuse element to increase the likelihood of a fracture. Figure 3-52 shows the substandard weld with many cracks which were expected to initiate a fracture. It was found that after three layers of the hardfacing weld were laid, the quality of the joint quickly decreased, creating multiple types of flaws including porosity and longitudinal cracks (in conjunction with the transverse cracks).

**Figure 3-52 Specimen 36-2 cracks in lower cover plate weld**

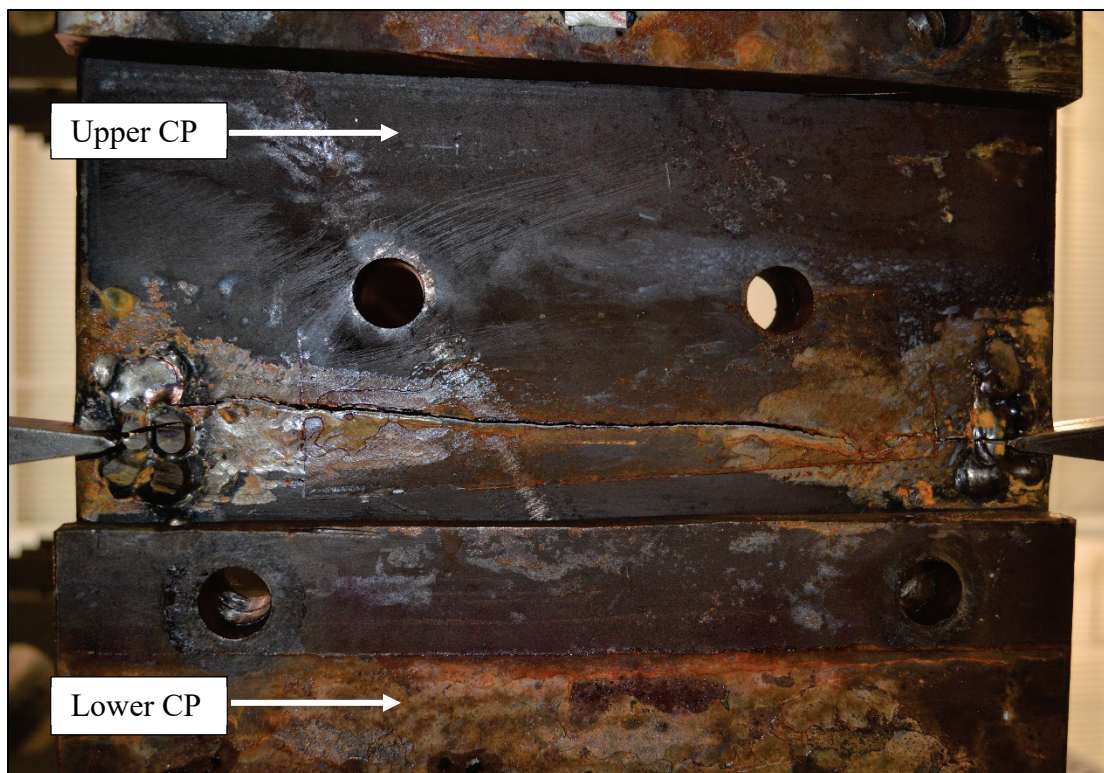
**Figure 3-56 Specimen 36-2 failed upper cover plate (from below)**

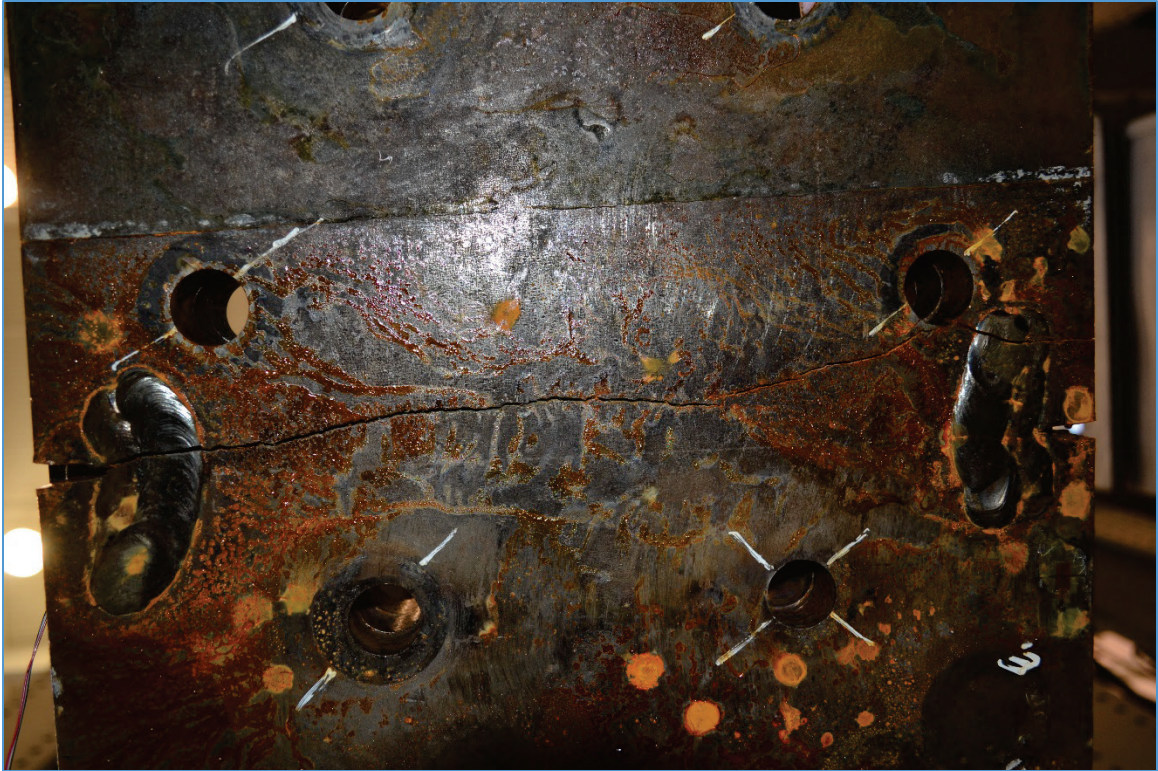
**Figure 3-62 Specimen 36-4 fractured cover plate**

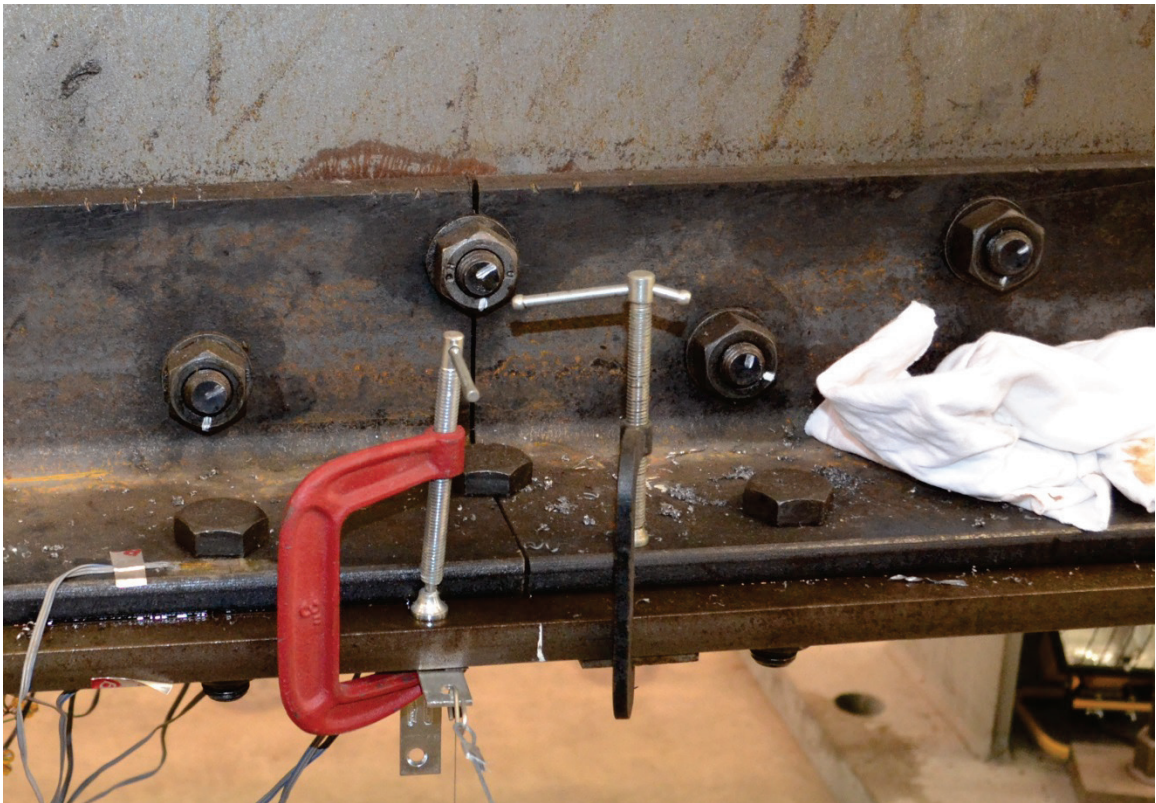
**Figure 3-63 Specimen 46-5 severed flange angle**

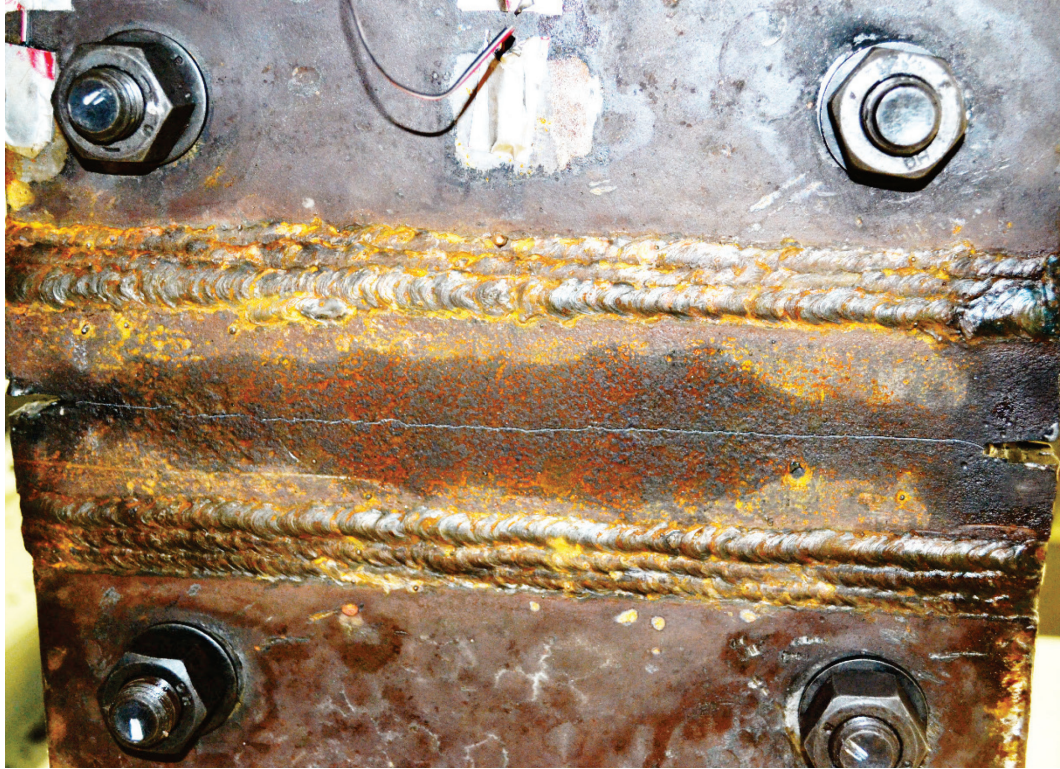
**Figure 3-67 Specimen 30-1 fractured cover plate**

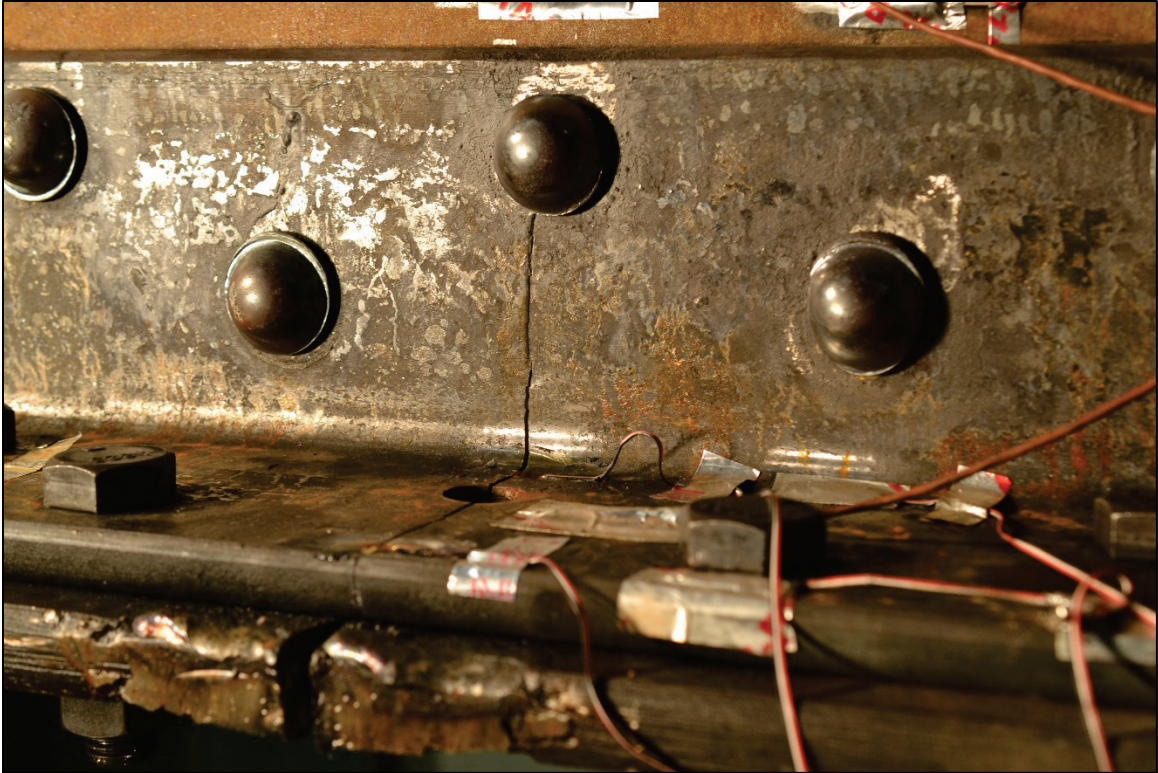
**Figure 3-69 Specimen 30-1 fractured west flange angle**

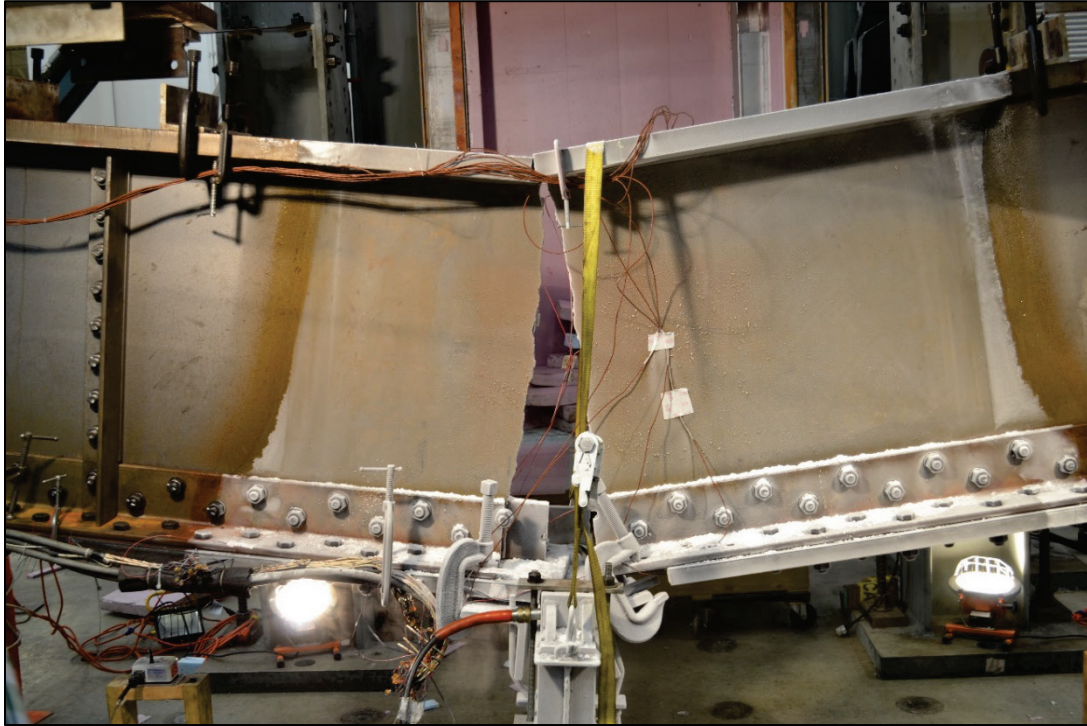
**Figure 3-71 Fractured Specimen 36-5**

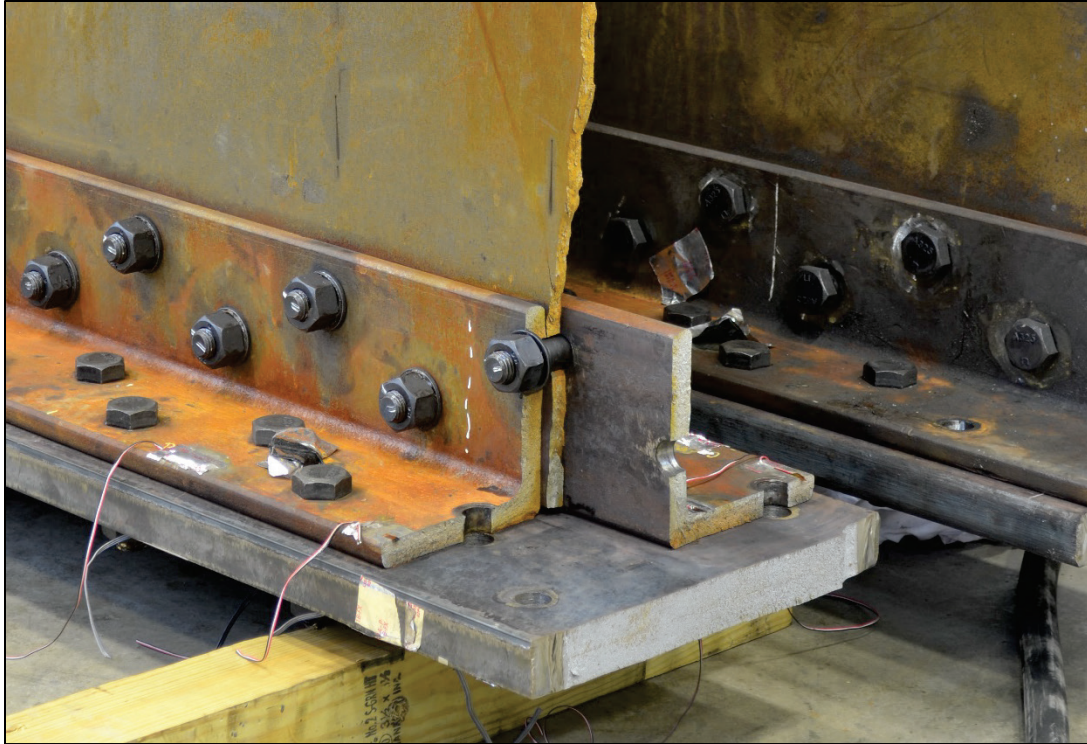
**Figure 3-72 Specimen 36-5 south fracture surfaces**

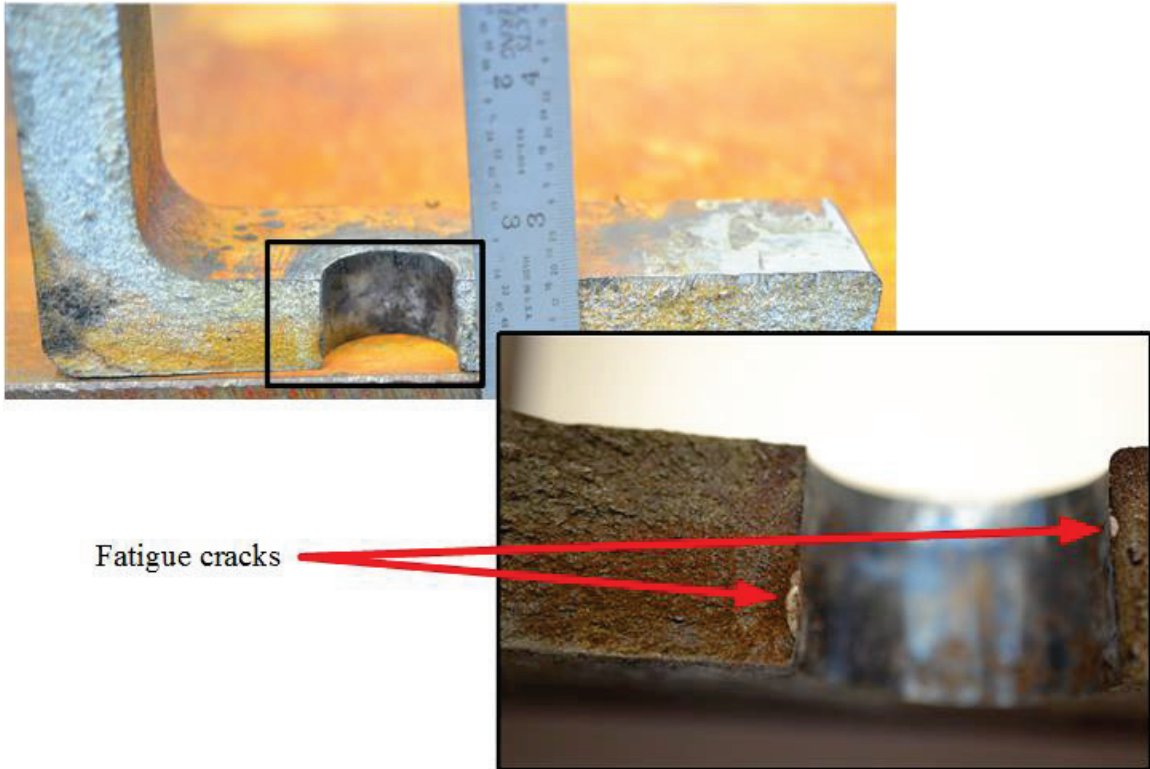
**Figure 3-73 Specimen 36-5 rivet hole fatigue cracks**

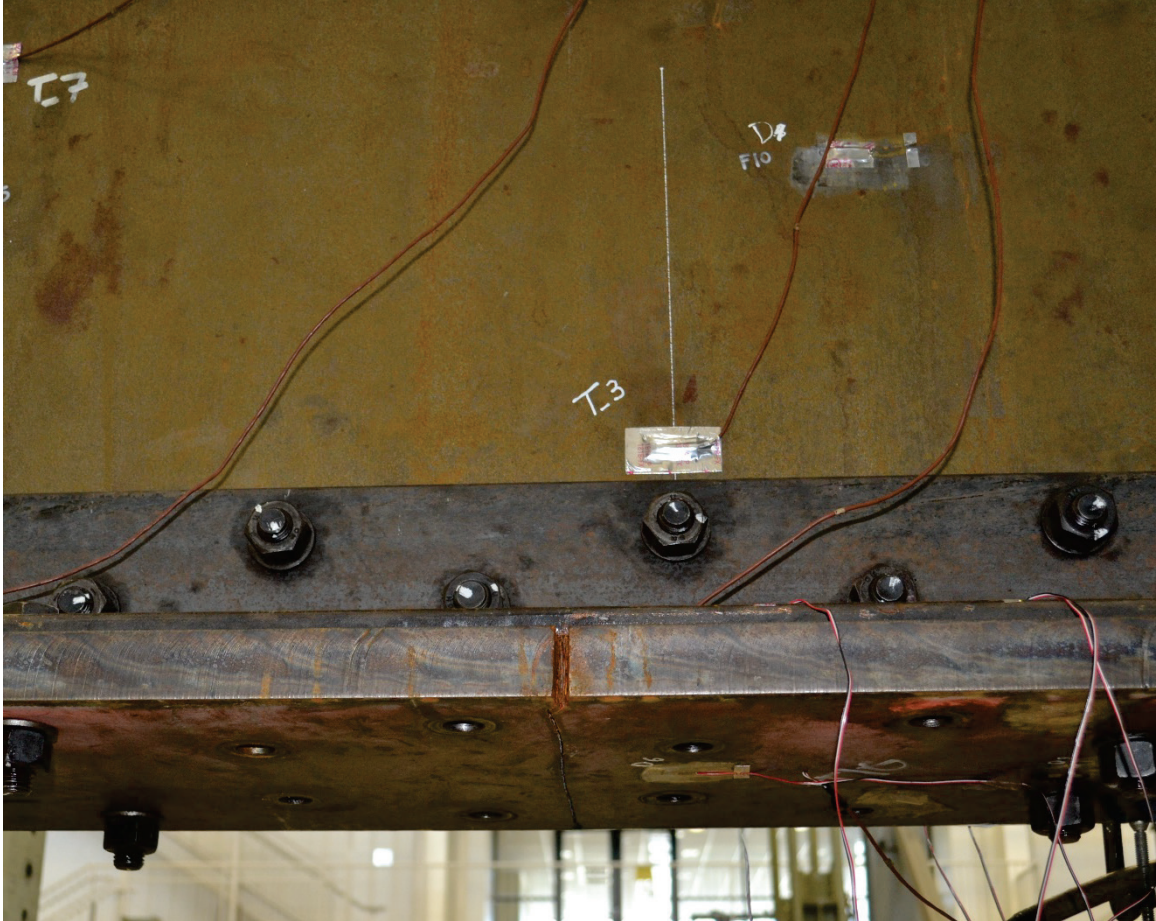
**Figure 3-74 Specimen 36-6 post fracture**
