Materials (ISSN 1996-1944)

Low Velocity Impact Behavior of Glass Filled Fiber-Reinforced Thermoplastic Engine Components

Zakaria Mouti ¹, Keith Westwood ², Kambiz Kayvantash ¹ and James Njuguna ^{1,*}

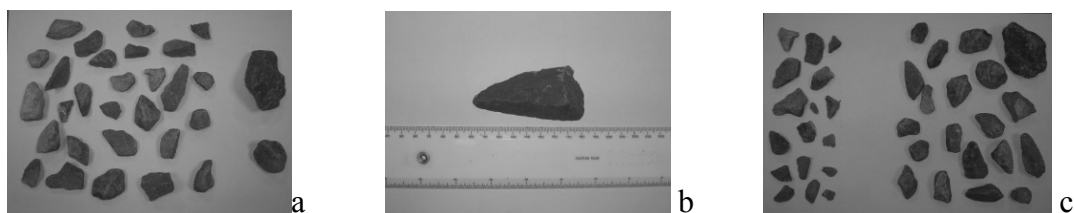
Figure 1. Selection of random stones collected on the road.

In order to quantify the size of stone likely to cause damage to an oil pan, a search and a selection of random granite stones are collected from regular roads (Figure 1). This approach is taken to allow measurement of the mass and size of road stones. The granite stones shown on the left of Figure 1a weigh less than 17 grams and all fit into the damaged area between two consecutive ribs. The two stones on right do not fit; the rounded stone weighs 21 grams and the larger stone weight 78 grams. There are variable gaps between the ribs in the area of impact. A 87 gram random stone with a triangular profile is able to fit into the gap where damage is evident (Figure 1b). A possible solution would be to reduce the rib spacing (Figure 1c) so as to exclude more stones.

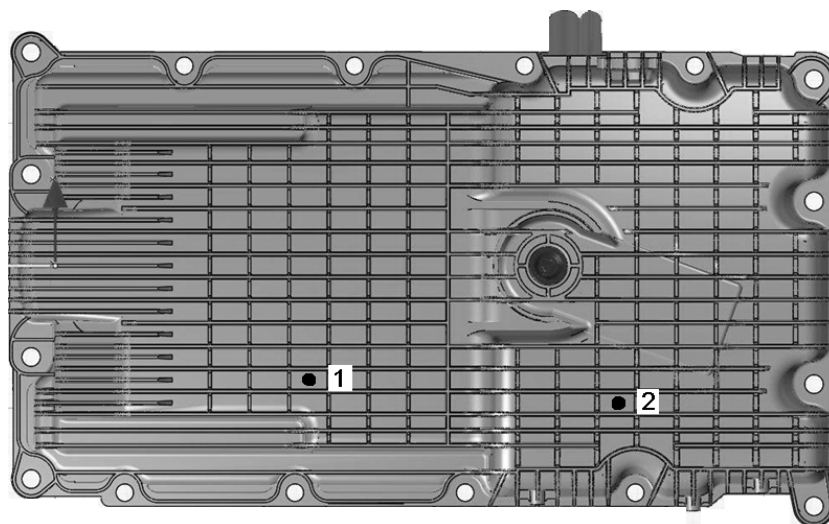
Figure 3. Two different impact locations highlighted.

The drop-weight tower allows accurate impacts on the desired target. Many impact positions were tested (over 1000 impacts taken) on different oil sumps and at different velocities. Figure 3 shows two locations that are representatives of all the impacts positions of the bottom oil pan.

According to the charts in Figure 4, it seems that the structure, and more specifically the impacted surfaces, have undergone the efforts in two different ways. There is a distinction to be made between impact 1 and impact 2. For impact 2, the forces histories demonstrate that the structure has undergone micro-damages if we look at the variations in force intensities before reaching the maximum force. The displacement histories confirm that the structure has recovered its initial position after oscillation and been displaced with the return to zero. The energy histories illustrate the energy absorbed by the component which is actually practically equal to the impact energy transferred by the impactor. Impact 2 has passed successfully the test as defined previously, however there was an oil pan rib broken which can be seen in the Figure 4b when the curve is falling down before beginning to increase again (at 3 ms). For impact 1, there is a small difference which could have an opposite outcome. The force history is quite similar to the other impact scenarios studied. Nevertheless, it is important to note that

the return to zero force is quicker than the impact 2 and there is a small fall in the curve which could indicate a broken oil pan rib, as revealed in this case. The displacement history reveals that the structure has oscillated but it has not recovered after the impact and did not return to zero (not recorded in the chart). According to the energy history, it has not completely absorbed the impact energy from the projectile. Nonetheless, the pan has absorbed a big part of the impact energy and has released comparable energy as the other impact 2. This is actually difficult to interpret since a small detail could result in a big change in the component integrity and this component has a complex shape. The real observation has revealed the actual initiation of a crack zone.

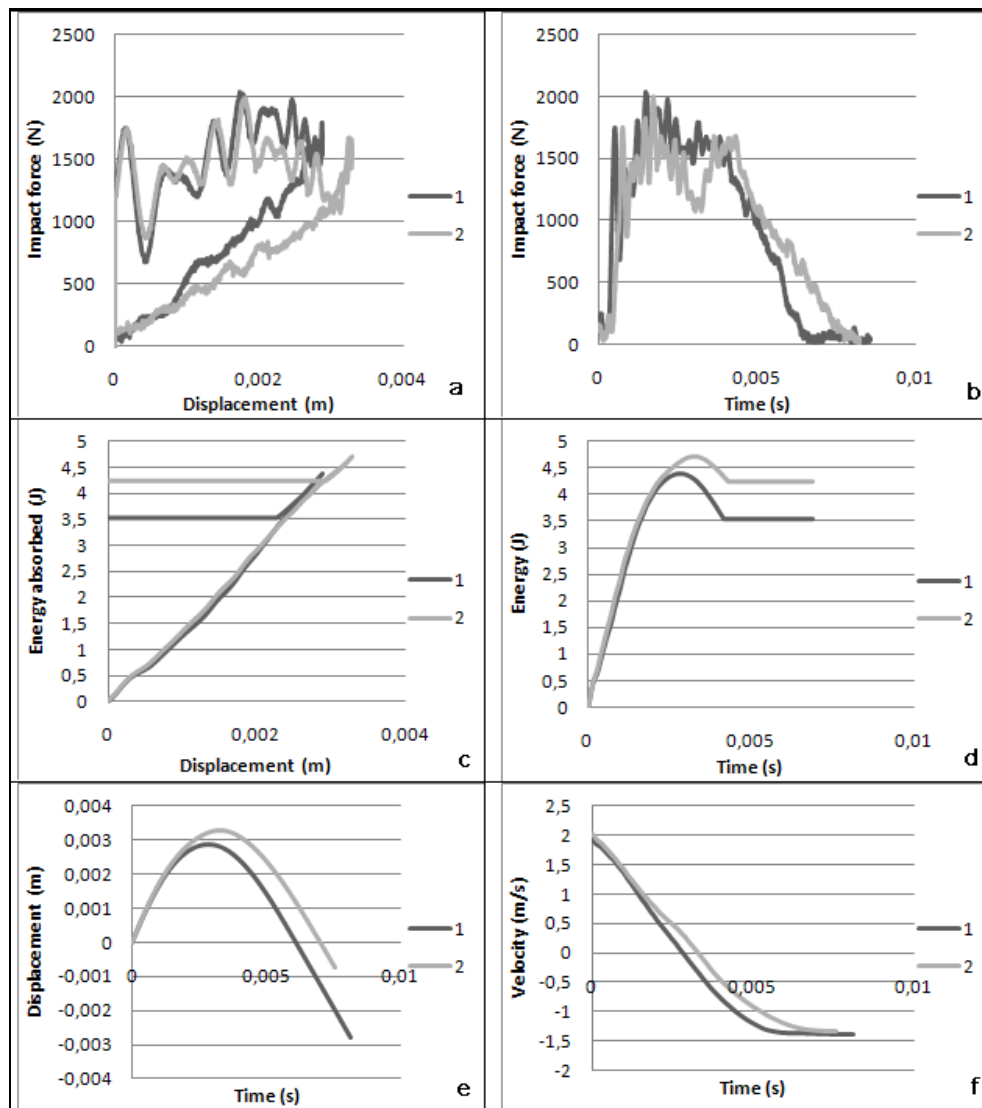
Figure 4. Data obtained after a 2.28 kg falling weight impact onto the oil pan at 5 Joules.

The magnitudes measured are force, displacement, energy, impact velocity and the duration time of the event. The forces histories in Figure 4a and Figure 4b show a large oscillations zone which can be an indication of material damage. When the force between the oil pan and the impactor returns to null, it is the end of contact time and the end of penetration. Figure 4a shows closed loops in which the area under the curve is the deformation energy that is initially transferred from the impactor to the oil pan surface and then given back from the oil pan surface to the rebounding impactor. The area included inside the loop refers to the energy absorbed during the impact. In the Figure 4c and Figure 4d, the energy grows until the maximum displacement is reached (3 mm) then the energy decreases until the impactor detaches from the oil pan surface. We consider that from this point to the end of the test, the oil pan surface does not dissipate energy any further, only releasing the residual part of the elastic energy stored during the penetration of the impactor. At the final instant, the energy value shown in the graph is equal to the dissipated energy. It is important also to notice that the maximum energy level is equal to the initial kinetic energy of the impactor. The maximum deflection for these tests was around

3 mm (Figure 4a and Figure 4c). They show that the component has recovered its initial position as deflections return to zero. The impact has reached its maximum penetration into the oil pan surface (Figure 4e) when the impactor velocity becomes zero (Figure 4f) [19].

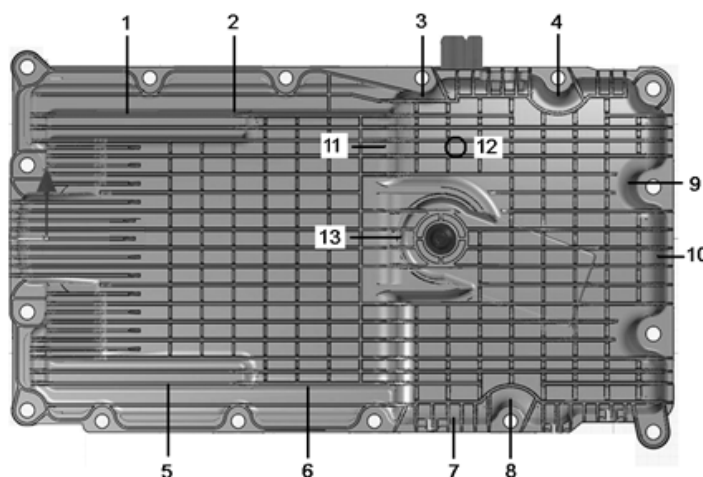
Figure 5. Map of the impact locations.

Figure 5 shows some of the impacts realized on the oil pan. Depending on their location, the impact intensity used is variable. Figure 6 provides details of the impact energies applied for each impact location and the outcomes for each shot indicated in terms of percentage of failure in part integrity.

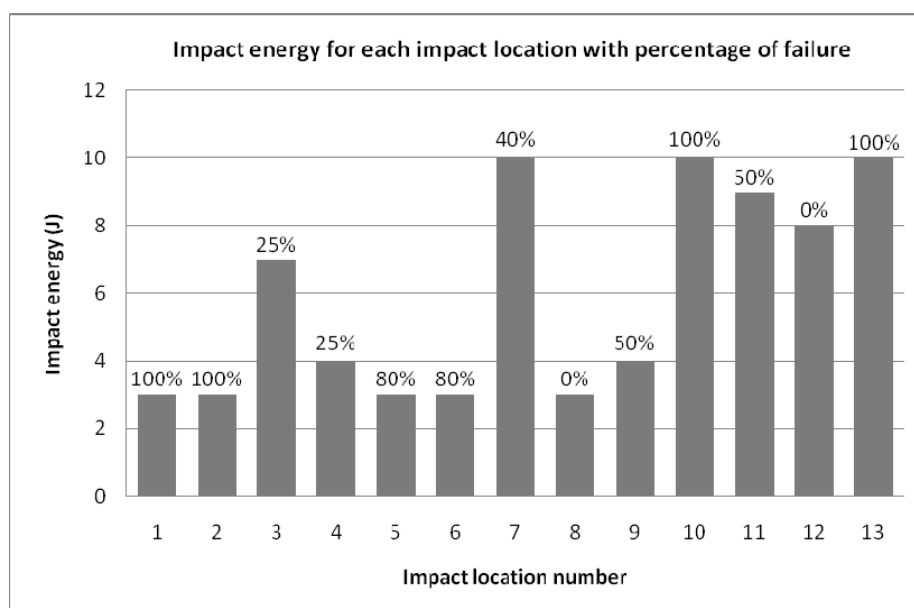
Figure 6. Percentage of failure for each impact location at different impact energies.

Figure 6 shows an overview of the impact limits that the oil pan can withstand and points out where the areas of weakness exist. The disparity in terms of impact resistance is clear. This is due to the complexity of the oil pan in its structure (with surfaces more or less stiffened in the inside of the oil pan) and its material arrangement (*i.e.*, fiber direction arrangement). The understanding of material failure is not easy. This judgment is blurred by the complexity of the material. Nevertheless, a resistance limit more or less constant was determined for each location shown in the map (Figure 5). Explicitly, the unlikely sides to receive an impact have to undergo 3-4 Joules, the edges of the pan and some medium level risk sides have to withstand 7-8 Joules. The most exposed areas should be able to withstand 10-12 Joules. The sides likely to fail in Figure 6 have to be improved, redesigned or stiffened. As expected, the ribbing is the relevant geometric parameter. It plays a big part in the impact resistance of the component. In addition, it is evident that the ribbing dimensions should be contained following the following values. The rib height should be between 4 to 10mm and for a height between 2-3 mm. For ribs less than these dimensions, it seems that the ribs are less efficient while above this height, the ribs are too fragile and brittle. Figure 7 shows various damage types that can result after an impact.

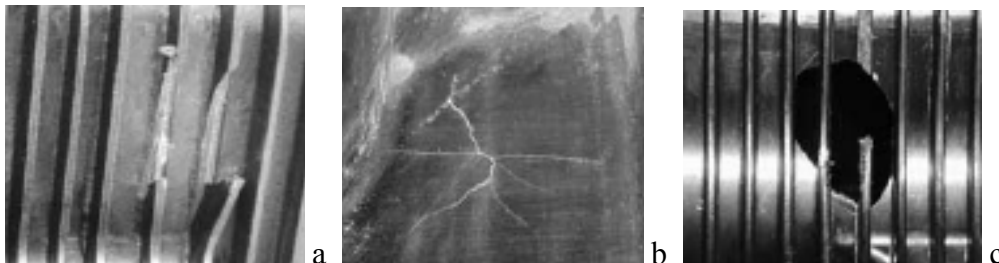
Figure 7. Damage types that can result after an impact. Broken ribs (a), Interior cracks (b), Perforation (c).
