Weathering of Sandstone in the Iowa State Capitol Building

C. S. Gwynne
Iowa State College

WEATHERING OF SANDSTONE IN THE IOWA STATE CAPITOL BUILDING

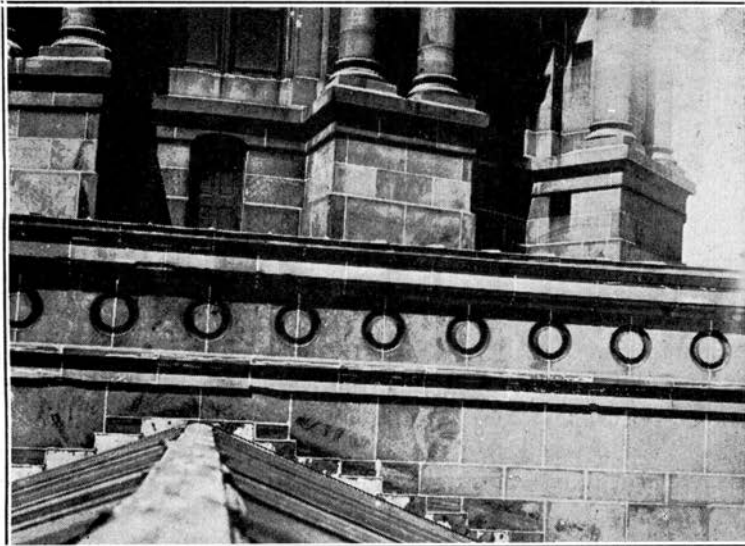
The solid masonry composed of the Aux Vases stone is apparently not affected to any great degree, although the cross-bedding has been brought out by the weathering and in places scaling and blistering have occurred. (Fig. 1) The extreme decay is shown

Fig. 1. South side of main dome. Most of the projecting parts are blue stone. Broken edges and cement replacements, showing white, are prominent. Most of the masonry is Aux Vases; weathering has made the cross-bedding apparent in the surface and has produced some surface hardening and blistering.

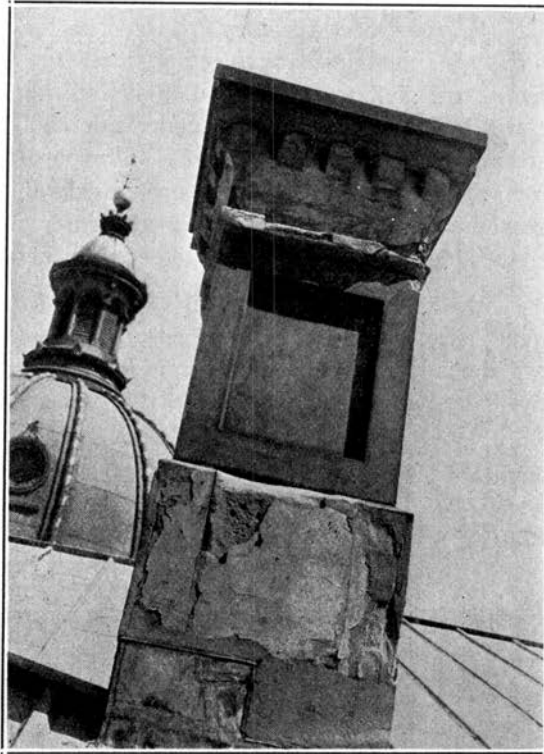
by the blue stone from Carroll Co. which constitutes such parts as the decorations, pediments, entablatures, cornices, etc., (Fig. 2) and it is to that stone and its weathering that most attention has been given.

Fig. 2. The most decayed (west) side of chimney on south wing. Decay at the top and bottom are typical of the blue stone in exposed places. Aux Vases block in middle is only slightly decayed, and that near contacts. Thin repairs at base are shelling off.

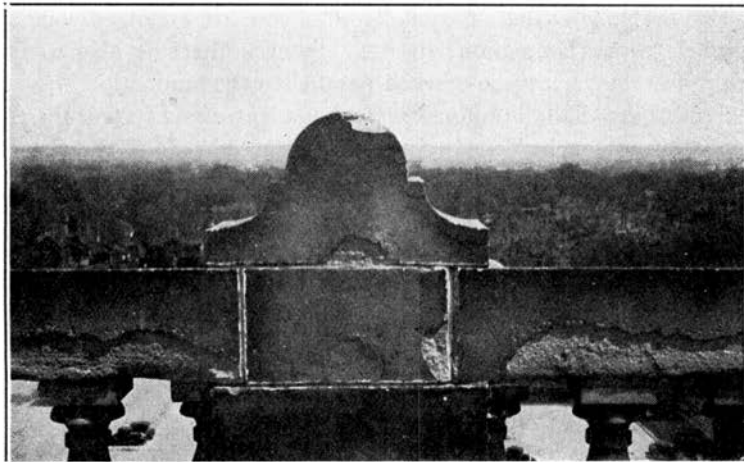
Many cracks, parallel to the lamination, have developed in material which is still in place. (Figs. 3 and 4) Some of the pieces of the bottom rails of balustrades have lost several inches by the development of this sort of weathering. Such weathering proceeds

Fig. 3. West side of top of balustrade on the east side of south wing. Decayed blue stone has been chipped off. Shows decay at the bottom of the rail, and cracking, parallel to lamination and to surface, of the piece on top of the rail. Typical blue stone weathering.

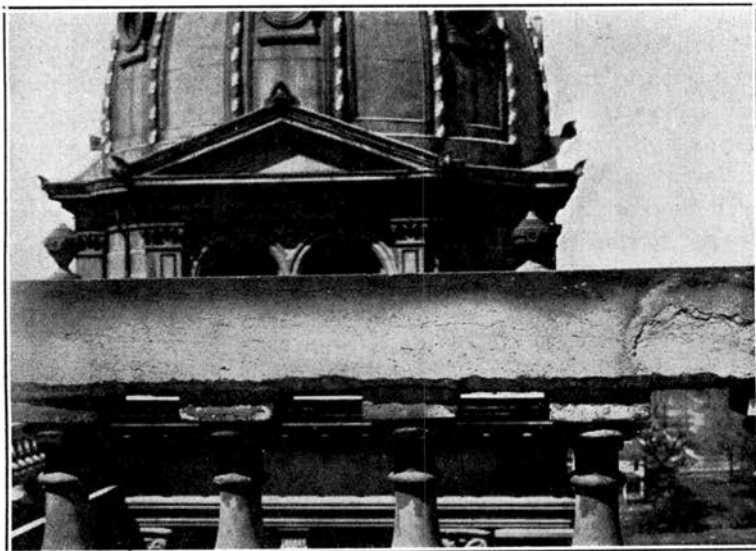
Fig. 4. South side of blue stone railing on north side of east wing. Cracking, parallel to surface and lamination, is evidently caused by loss of natural cement and subsequent frost action. Pronounced decay at the bottom is aided by repeated crystallization of soluble materials.

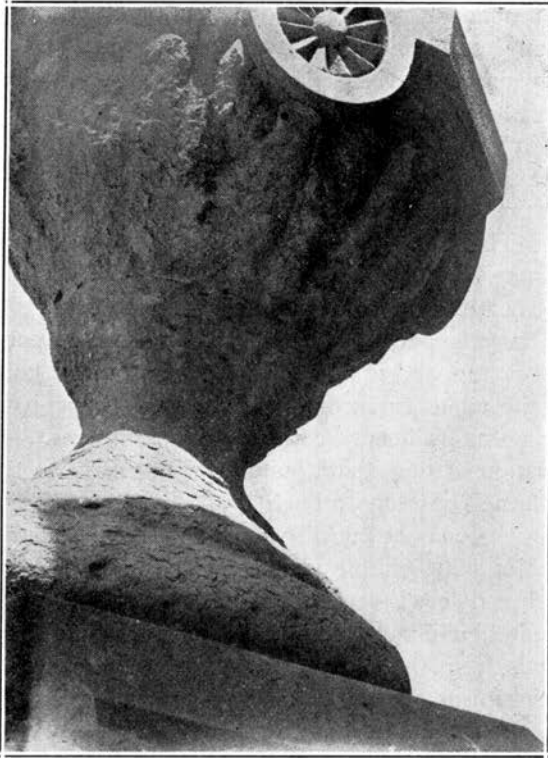
Fig. 5. View from below, of south side of urn at northwest corner of southeast dome, showing decay of blue stone in an apparently sheltered position.

Some parts of the blue stone, such as the lower parts of the bottom rails of balustrades and the bases of urns, become scaly and friable. It is believed that these parts, some of them apparently in sheltered places, decay partly because of the repeated crystallization in their pores of the soluble constituents. They are so exposed that they suffer much wetting and drying, and are not freely washed. Repeated crystallization in this manner is well known to cause decay of porous rocks.

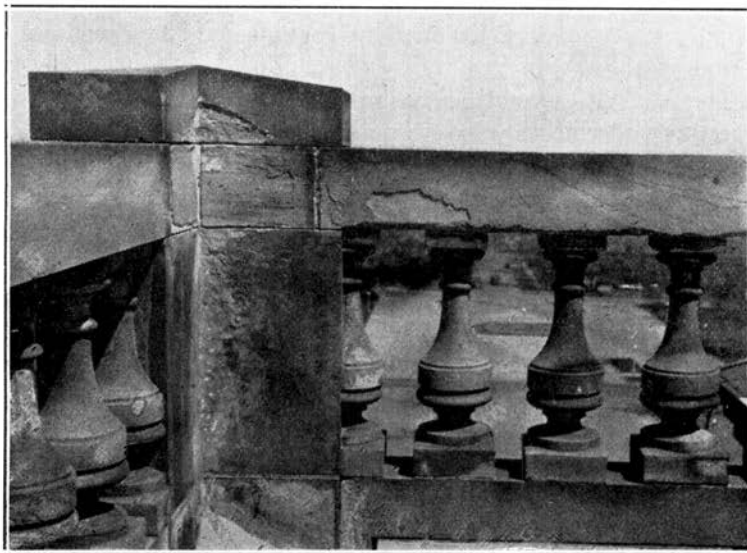
to be so friable that some of it has been chipped away during repair work. Such places are generally below or have adjoining them some of the blue stone, and this deterioration is believed to be associated with that fact, the soluble material having been derived from the blue stone. (Fig. 6)

Fig. 6. Balustrade at northeast corner of east wing. The Aux Vases block in the corner beneath the rail has been affected by the bringing in of soluble salts from the blue stone above.

It is known through studies in England¹⁰ that where a limestone or a calcareous sandstone and a non-calcareous sandstone are in contact, decay of the surface may take place in the latter through the carrying into it and the subsequent action of CaCO_3 and other salts from the more soluble rock. Soluble materials from mortars may have the same effect. The Aux Vases sandstone may thus in the course of time be more affected, since CaCO_3 and more particularly CaSO_4 from the deteriorating Carroll Co. stone, will be carried into it, and result in surface crumbling and in the formation of crusts and blisters.

The Aux Vases sandstone has proven a durable stone. Whatever effects weathering may have upon it they will not render it unattractive nor weaken it for a long time to come. Care should be exercised however to keep lime rocks and mortars away from it. As long as there is blue stone in a position where soluble material from it may be drawn into the Aux Vases the latter will show the effect in scaling and blistering.
