# Recent structural interventions to the eighteenth-century Greatham Bridge, UK.

## **ABSTRACT**

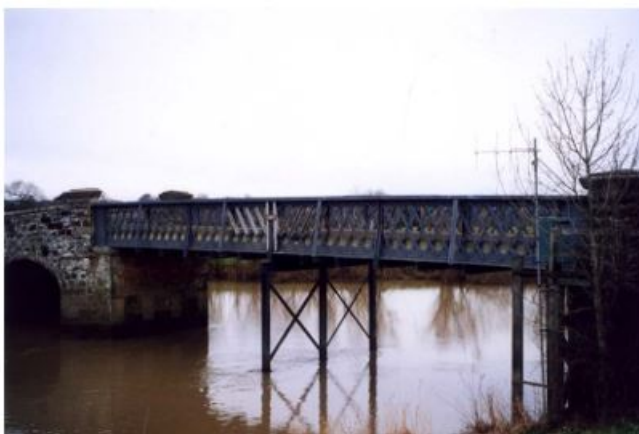
Fig 2 View of Greatham Bridge from South East prior to works being carried out. Showing central temporary stiffeners added.

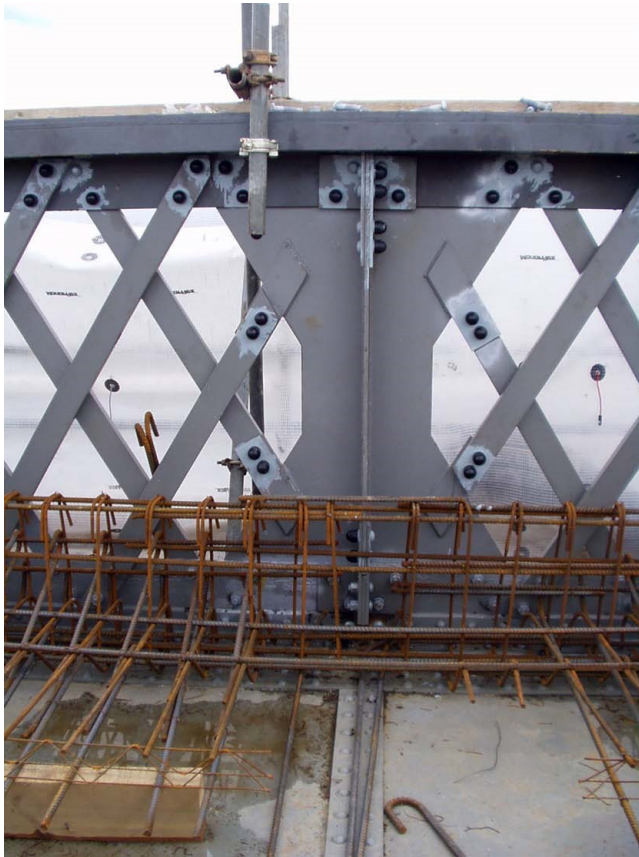
Fig 4 New design of central stiffening plate

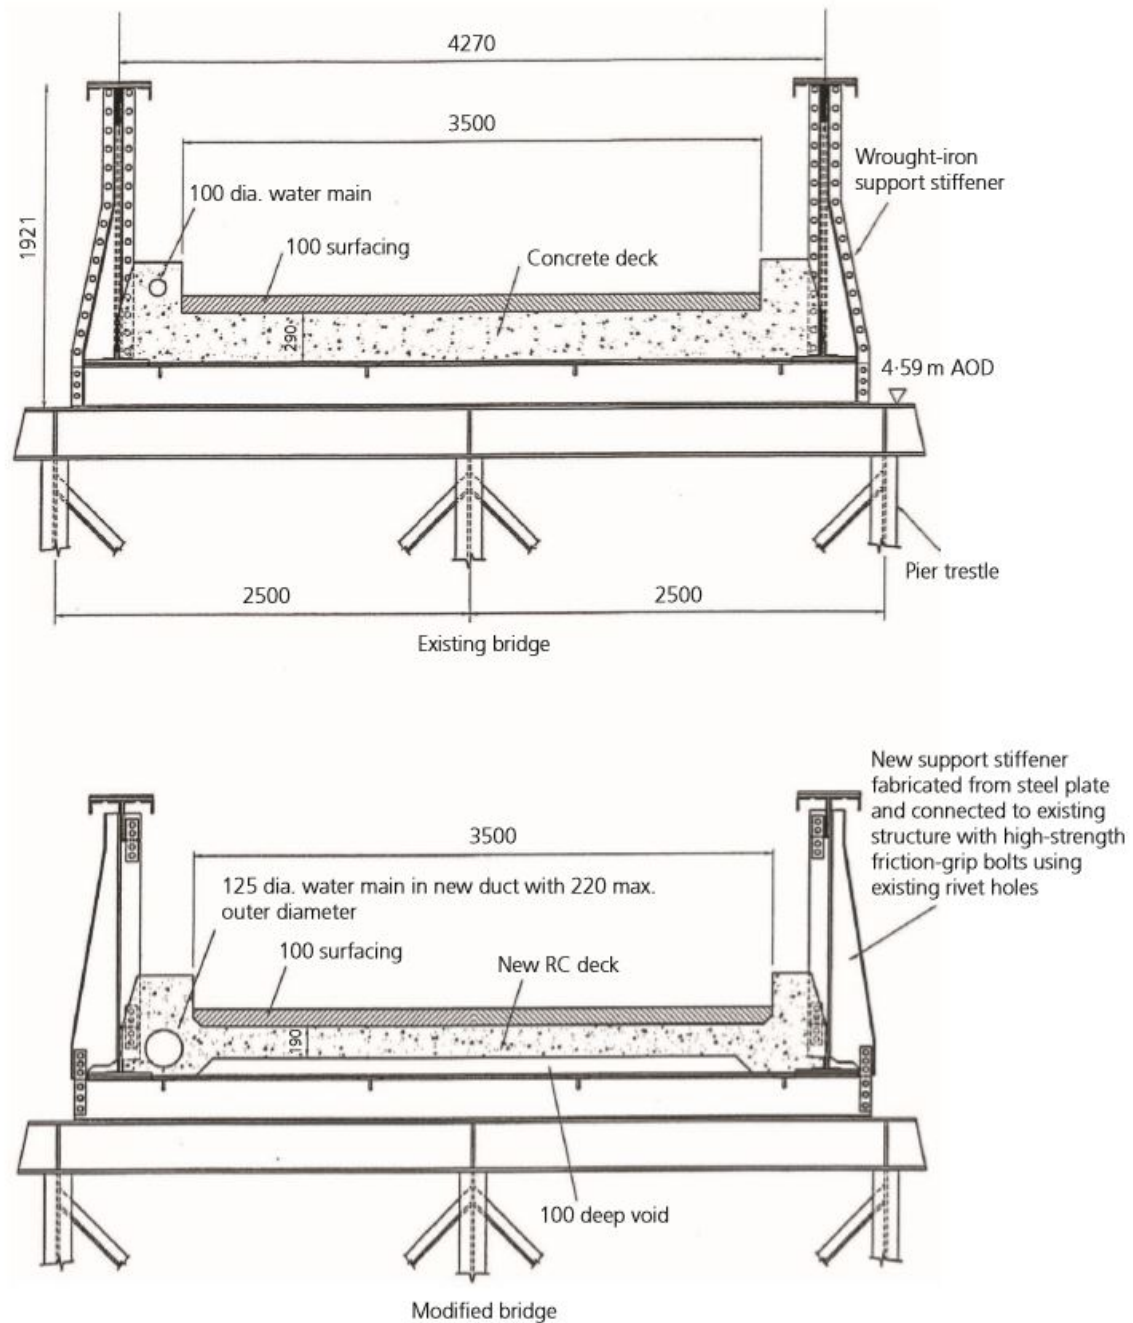
Fig 5 Drawing of previous deck profile and new voided deck slab profile

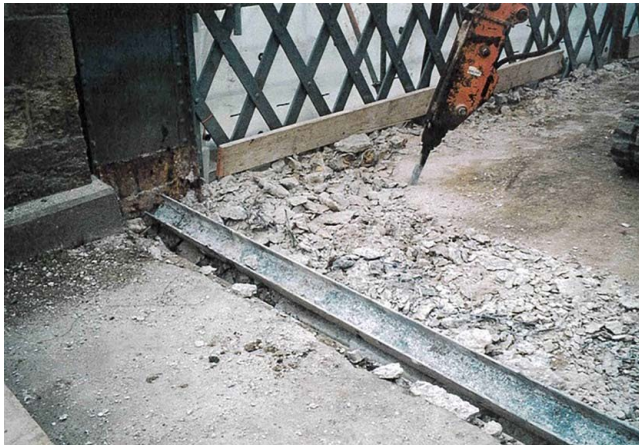
The removal of the concrete deck took longer than anticipated by the Contractor. The concrete was stronger than expected and the transverse girders within the concrete were very effectively welded in place, see figure 6.

Fig 6 Original concrete deck being broken out

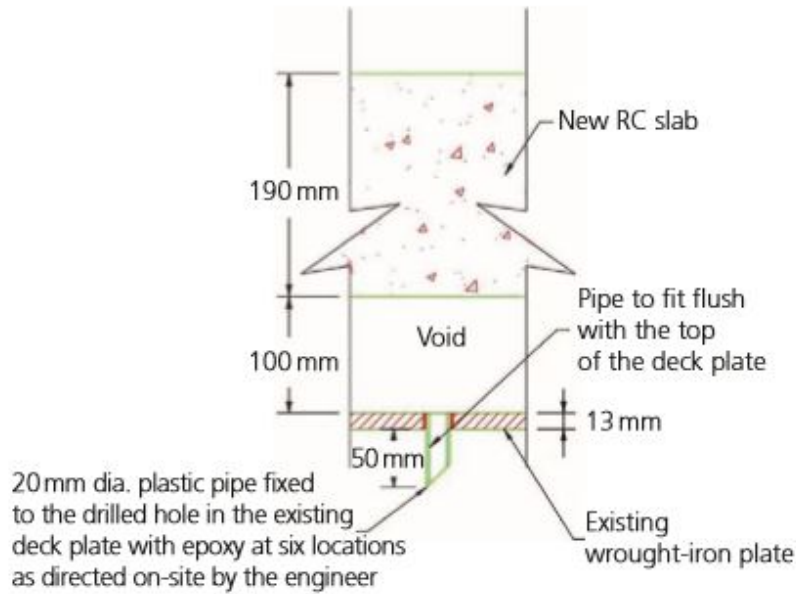
Once the old deck slab had been broken out, the wrought iron deck plate was inspected for signs of corrosion and there were very little. The plate was remarkably clean and intact. Before placing the polystyrene deck void former panels, 6 drainage holes were drilled through the 13mm plate and fitted with 50mm long 20mm diameter drainage pipes which were epoxied into place, flush with the top of the plate (see figure 7). The later 2018 refurbishment was only to the masonry arch elements of the bridge after inspections revealed their poor condition. During these works, no inspection was made of the iron deck plate. However, the deck plate has been inspected in other regular inspections and has not suffered any great deterioration.

Fig 7 Deck plate drainage details

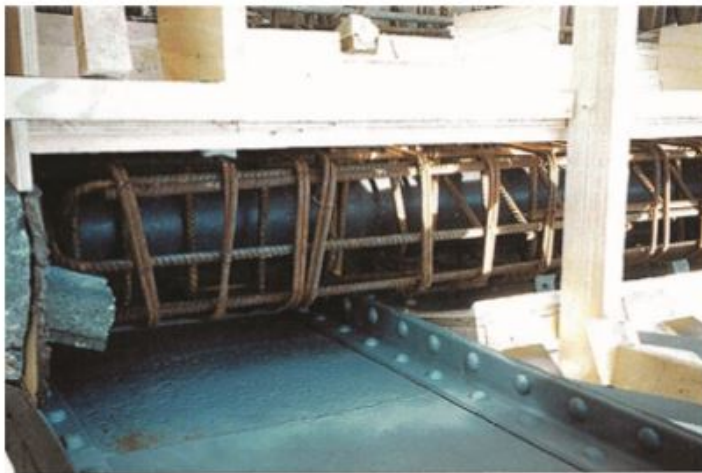
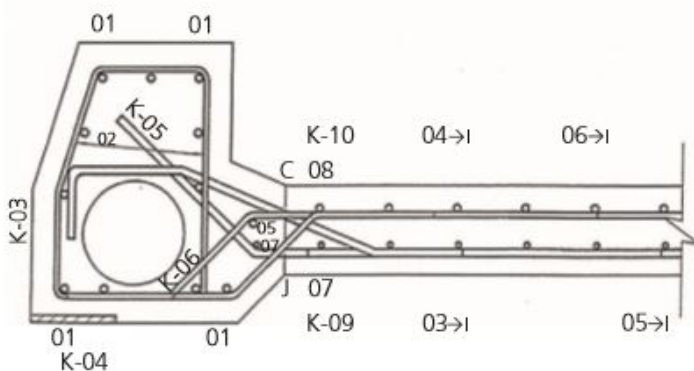
It was decided to locate the new water main duct within the new southern edge beam/kerb. The duct was rather large (as per the requirements of the water company) and this did cause an element of congestion with the steel in the edge beam, see figure 8. Before each pour checks had to be carried out for adequate clearance between the steel and the duct.

Fig 8 Southern edge beam showing replacement water duct

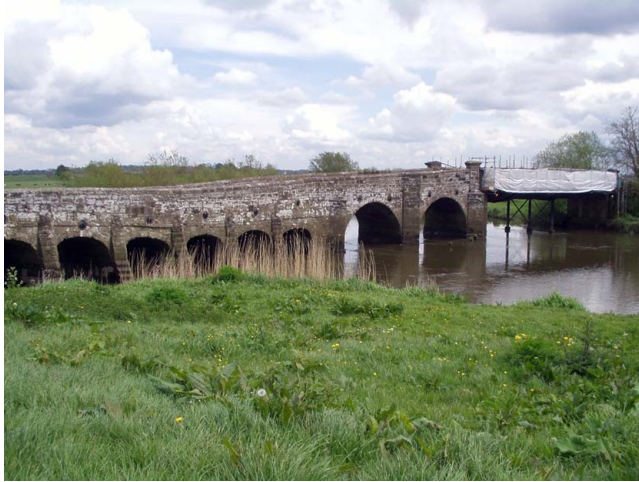
Fig 9 Extra (double) Sheeting During Repainting Operations

As for the preparation, high-pressure water washing as opposed to grit blasting, was suggested and agreed upon. This required an increased environmental protection in the form of extra (double) sheeting (see figure 9) and the wet vacuuming of all arisings. Meetings between EA representatives, Fisheries Officers, Pollution Control Officers and the Contractor to discuss the matter resulted in the requirement (amongst others) that the washing operations be carried out on an outward tide. It took several (extra) weeks to gain approval for these operations.

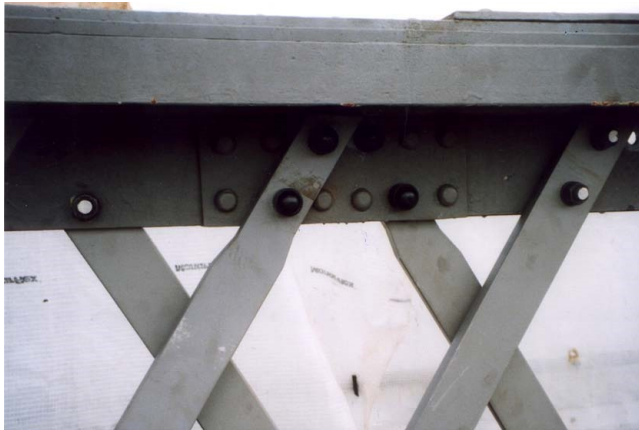
A potential problem was found in the attachment of the new steel work to the existing truss where there were splices along the girder. The original truss was joined together using rivets. The fishplate's rivet heads protruded from the face of the plate and would have obstructed the flush attachment of the new steel members. It would have been possible to either reduce the section size of the new members near their ends or to pack out the new members (to bring the ends away from the splices at the point of attachment). For ease of fabrication, it was decided to choose the latter option and to also neck the ends of the new members (see figure 10).

Fig 10 Splice plates and lattice member attachments to top flange

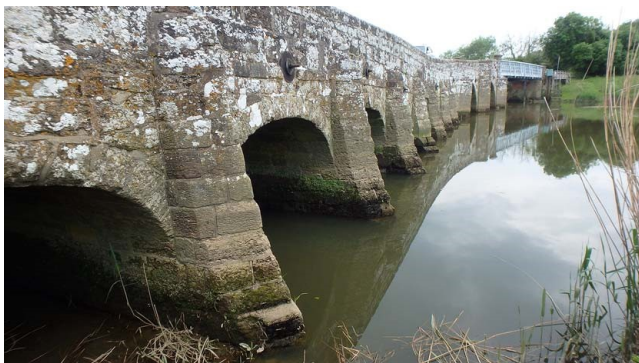
The 2018 masonry arch refurbishment followed the observation of significant areas of failing (eroded) stone work. Some of this is shown in figs 12 - 14. The refurbishment gave the council the opportunity to excavate into the top of the arches and make a true measurement of the ring depth. This was necessary because an earlier analysis had suggested that the ring depth of these arches was critical to the weight limit of the bridge. The measurement was carried out by taking levels from above the top of the ring (after excavation of the road surface) and from below. It was found that the ring depth was 310mm rather than the initial assessment estimate of 300mm. Anything greater than 300mm gave the arches a 7.5 tonne rating. However, if the depth had been below 300mm while the arch refurbishment work was going on it would have been possible to strengthen the arches at the same time. This would probably have been accomplished by excavating from above and constructing a lightweight concrete slab above the ring and then pinning the arch from below to the slab.

Fig 12 Eroded stone work prior to 2018 refurbishment

The scope of the works involved the removal and replacement of severely deteriorated stonework and the repointing of eroded mortar joints. Previously eroded cementitious mortar joints were repointed with a lime mortar/grout (for increased durability). Lime mortar mixes were selected to match as closely as possible the original mortar. However, lime is highly alkaline and can cause pollution to waterways. To minimise the risk of run-off entering the watercourse, the lime mortar mixing area was sited away from the surface water gullies and within designated washout areas provided. This washout water was transported and disposed of away from the site.

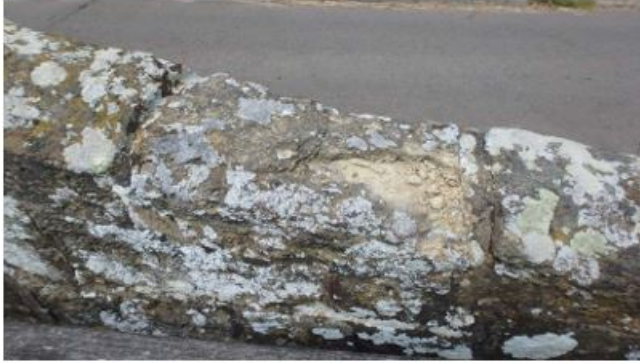
Fig 13 Eroded stone work prior to 2018 refurbishment

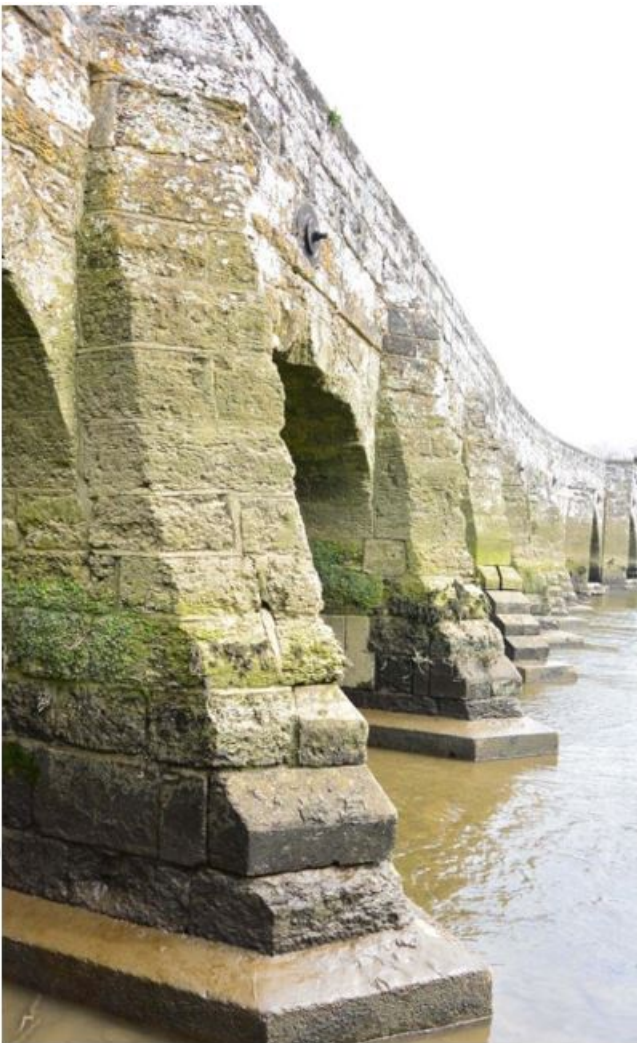
Fig 14 Eroded stone work prior to 2018 refurbishment

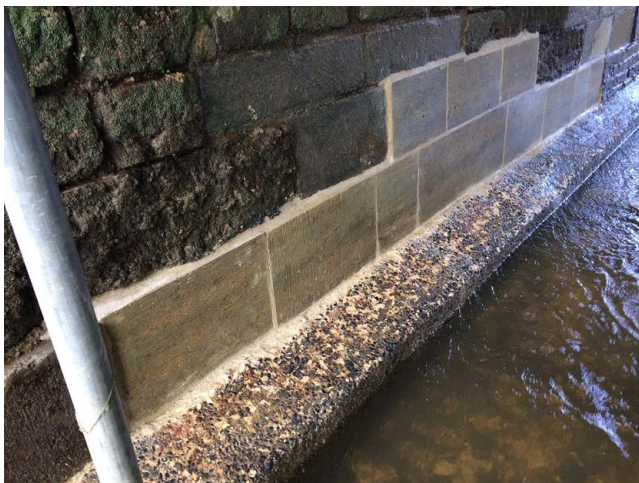
Fig 17 New masonry work

Many masonry arch blocks had to be replaced to restore the integrity of this section of the bridge and figures 17-19 show some of the affected areas. These figures can be compared with figures 9-11, prior to the refurbishment.

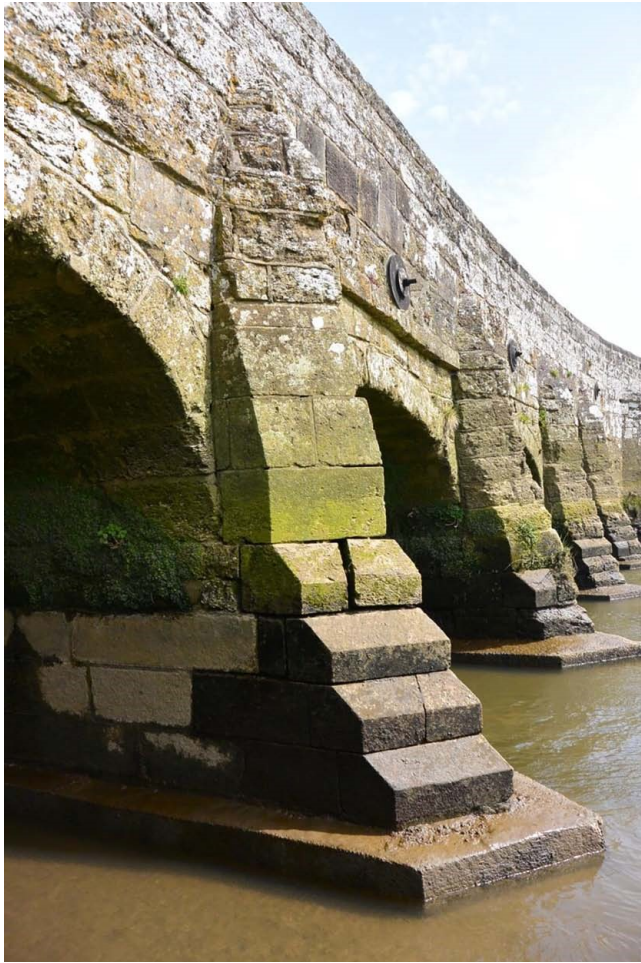
Fig 18 Refurbished pier

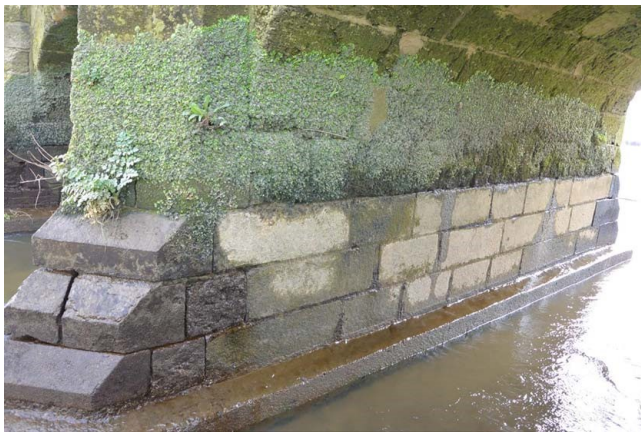
Fig 19 New masonry work

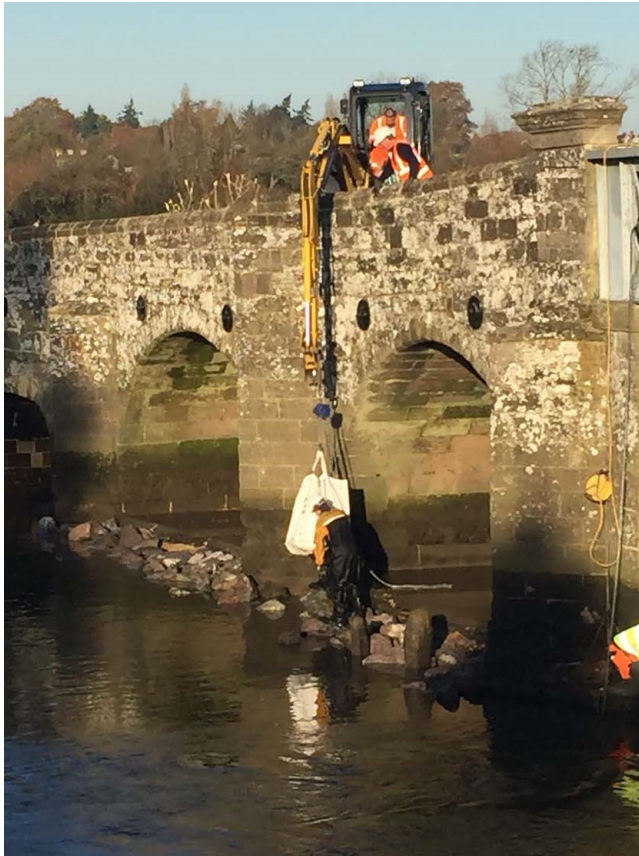
Fig 20 Rock armour installation

After all refurbishment works were completed a new rock armour defensive barrier was placed around the arch footings, shown in figure 20.
