Increased Span Length for the MGS Long-Span Guardrail System Part III: Failure Analysis

INCREASED SPAN LENGTH FOR THE MGS LONG-SPAN GUARDRAIL SYSTEM PART III: FAILURE ANALYSIS

1. Report No. TRP-03-362-17	2.	3. Recipient's Accession No.	
4. Title and Subtitle Increased Span Length for the MGS Long-Span Guardrail System Part III: Failure Analysis		5. Report Date September 29, 2017

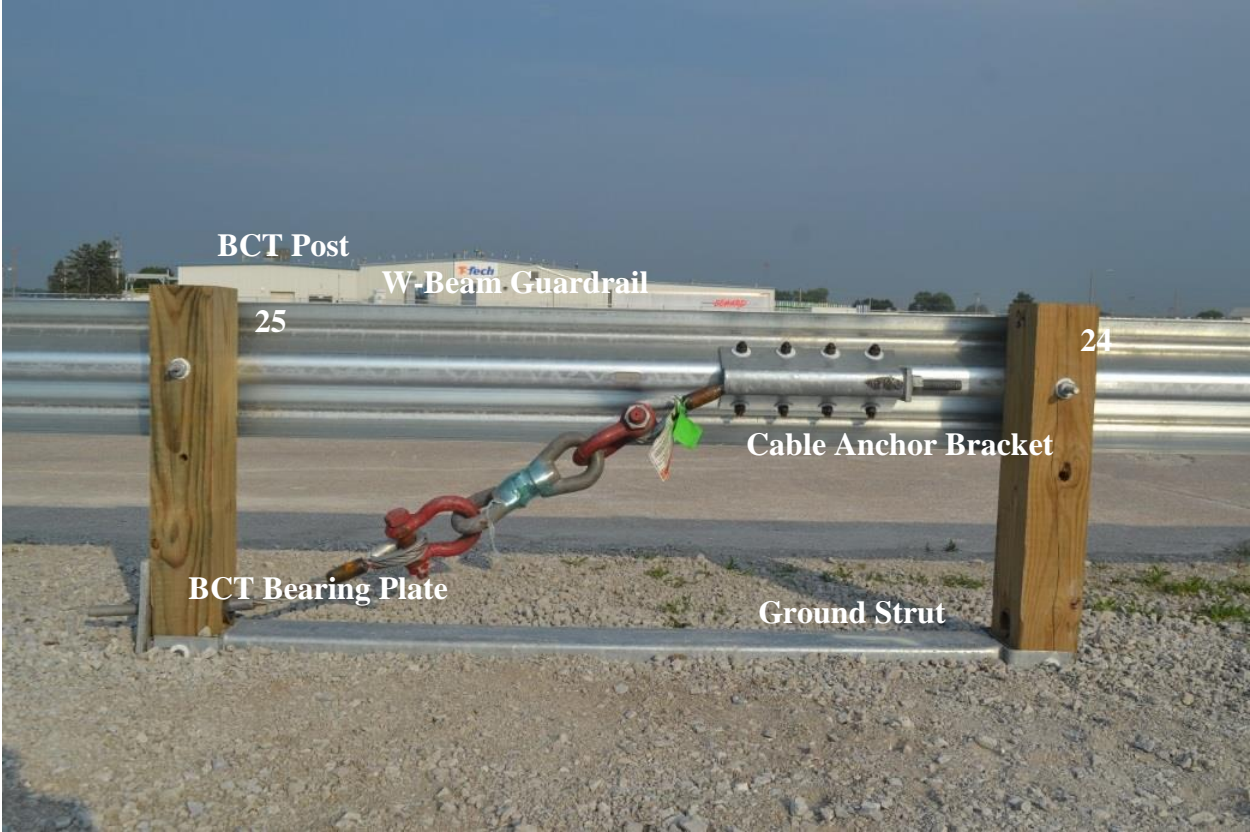
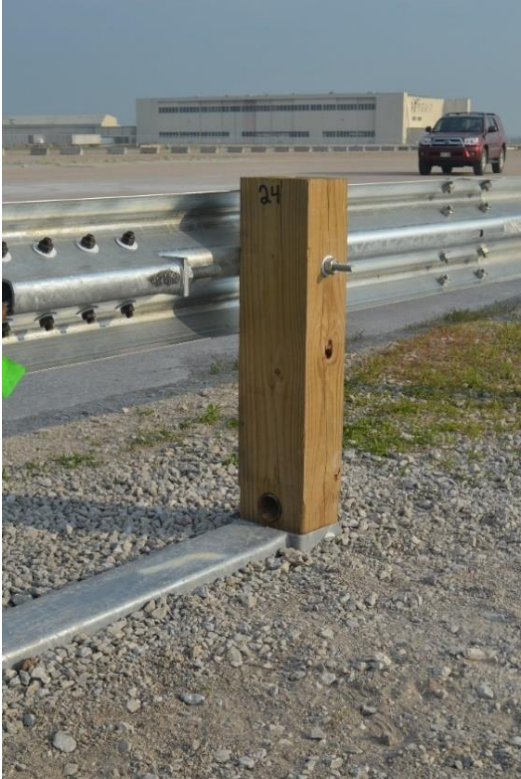
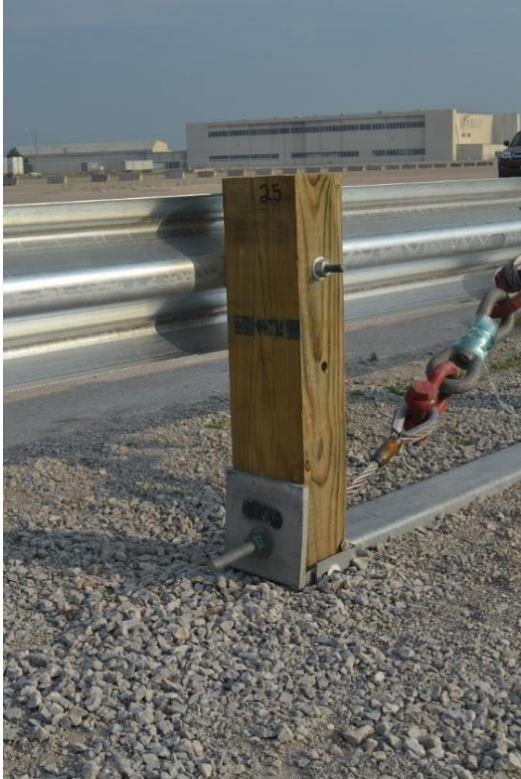
Figure 3. Long-Span End-Anchorage System, Test No. MGSL-2

As the vehicle was redirected, the BCT posts at the downstream end anchorage, post nos. 24 and 25, were deflected longitudinally upstream due to tensile loads in the guardrail and the cable anchorage. Vertical cracking in post no. 24 was initiated at approximately 0.095 sec due to longitudinal loading of the post through the post bolt connecting the post to the guardrail, as shown in Figure 6 and Figure 7. As loading of the downstream anchorage continued, a diagonal crack initiated near the top of the BCT cable anchor plate on the downstream face of post no. 25. This crack propagated down to the hole in the base of the BCT post and caused complete fracture and release of post no. 25 at approximately 0.140 sec after impact. Following the release of the cable anchorage at post no. 25, post no. 24 fractured and released as well. Release of the downstream end anchorage caused the guardrail to lose tensile on the downstream end of the system and allowed the 2270P vehicle to penetrate into the barrier system in an uncontrolled manner.

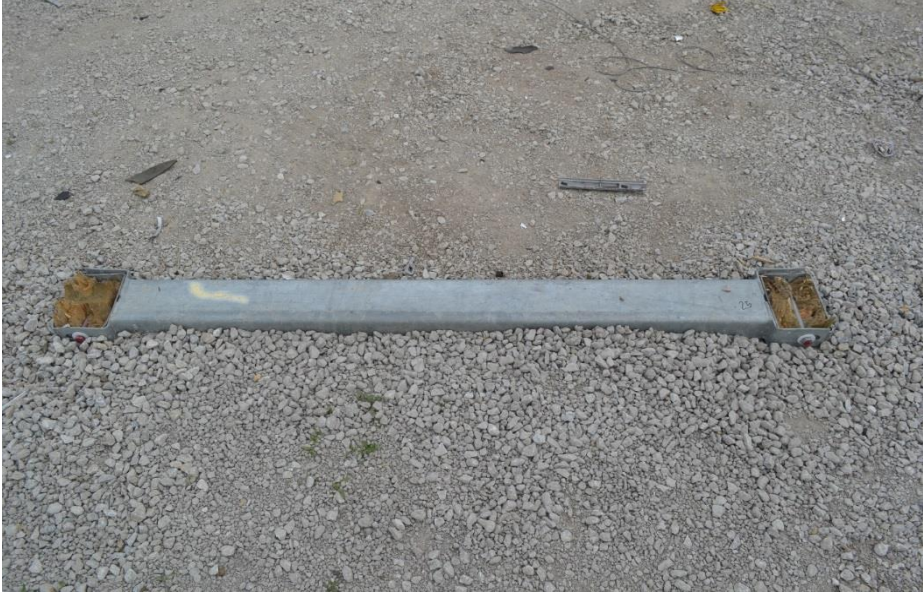
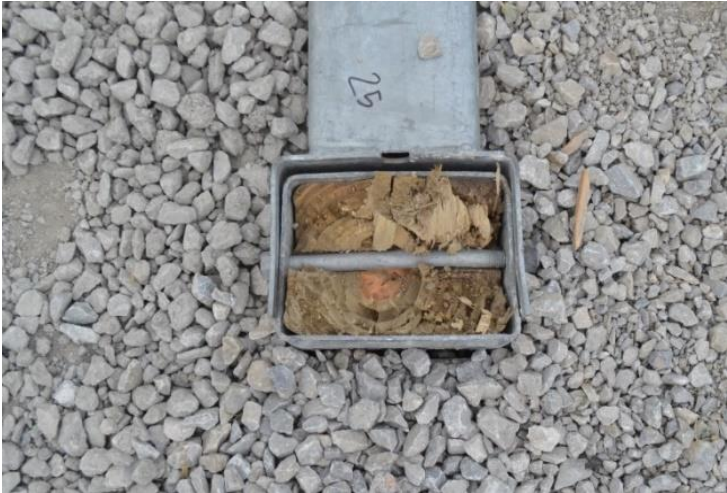
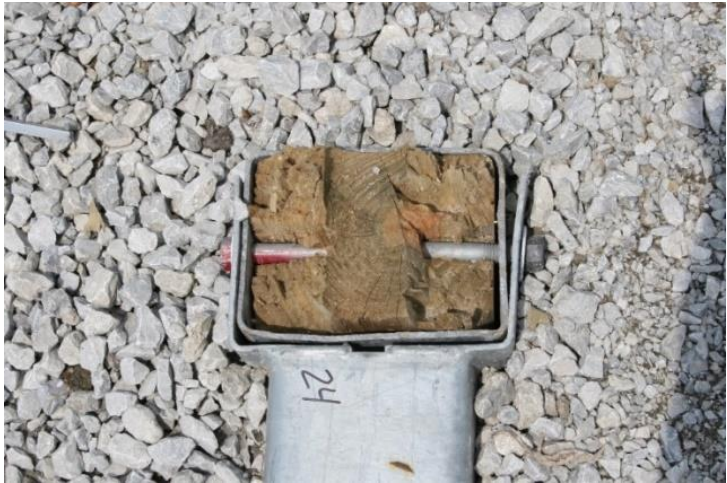
Figure 8. Post-Test Photographs of End Anchorage System, Test No. MGSLs-2

Wood post damage included fracturing, gouging, and displacement of posts. Post no. 1 had gouging on the front face due to rail contact. Post no. 2 split vertically along the height of the post through the guardrail bolt hole on the front side. Post nos. 24 and 25 fractured at the ground line and post no. 24 also split along the vertical plane of the centerline of the post. Post no. 25 had a 7½-in. (191-mm) deep by 3-in. (76-mm) wide crack located 2¼ in. (57 mm) downward from the top of the back face of the post, as well as a 3-in. (76-mm) diameter dent on the back downstream face of the post. The post-test photographs of the end anchorage system for test no. MGSLs-2 are shown in Figure 8. No knots or asperities were observed in the fracture region of post no. 25, as shown in Figure 9.

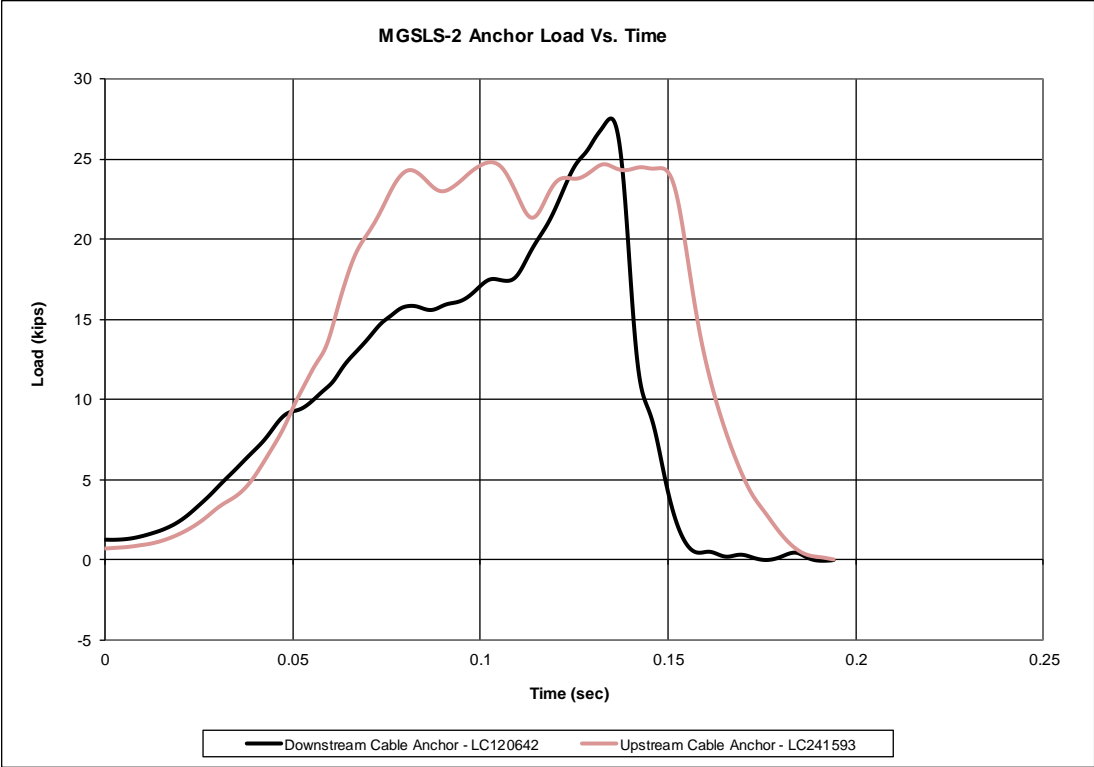
Figure 20. Anchor Load Vs. Time, Test No. MGSL-2

The anchor loading of failed test no. MGSLS-2 was reviewed first. Anchor load versus time and anchor load versus foundation tube deflection for the upstream end anchorage and the downstream end anchorage that failed in test no. MGSLS-2 are shown in Figure 20 and Figure 21, respectively. The downstream anchorage in test no. MGSLS-2 developed a peak load of 27.5 kips (122.3 kN) at approximately 1.6 in. (41 mm) of deflection prior to failure of post no. 25 and release of the anchor cable. The upstream anchorage in test no. MGSLS-2 developed a peak load of 24.4 kips (108.5 kN) at approximately 1.8 in. (46 mm) of deflection, but the upstream end anchorage did not show any signs of anchor failure. Thus, similar load and deflection were observed in the upstream and downstream anchorages, but only the downstream anchorage failed.

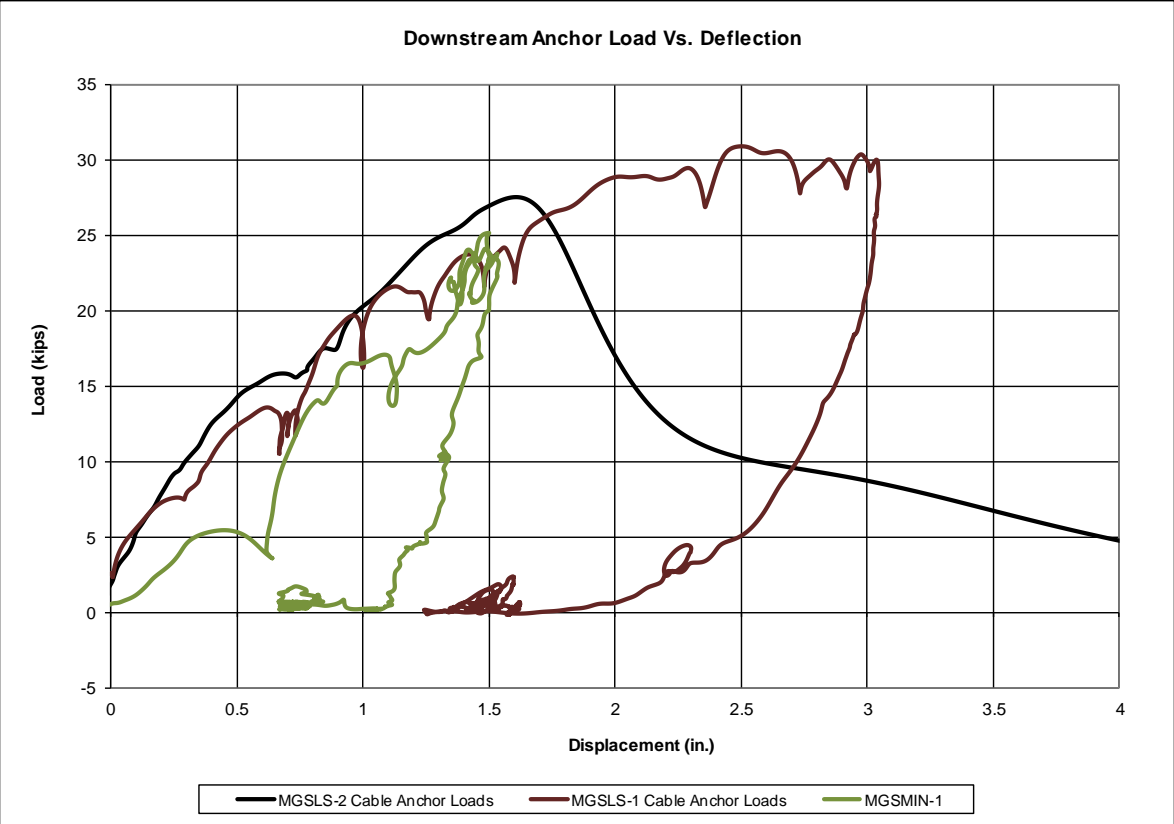
Figure 26. Downstream Anchor Load vs Deflection, Test Nos. MGSLS-2, MGSLS-1, and MGSMIN-1

Comparison of the downstream end anchorage load versus deflection data from test nos. MGSL-1, MGSMIN-1, and MGSL-2 showed similar trends. The stiffness or slope of the load versus deflection curves were similar for each of the three tests with available data. Additionally, test no. MGSL-1 developed a peak load in the downstream end anchor of 30.9 kips (137.5 kN) without failure, which was 12.3% higher than the measured peak load in the downstream end anchorage that failed in test no. MGSL-2.

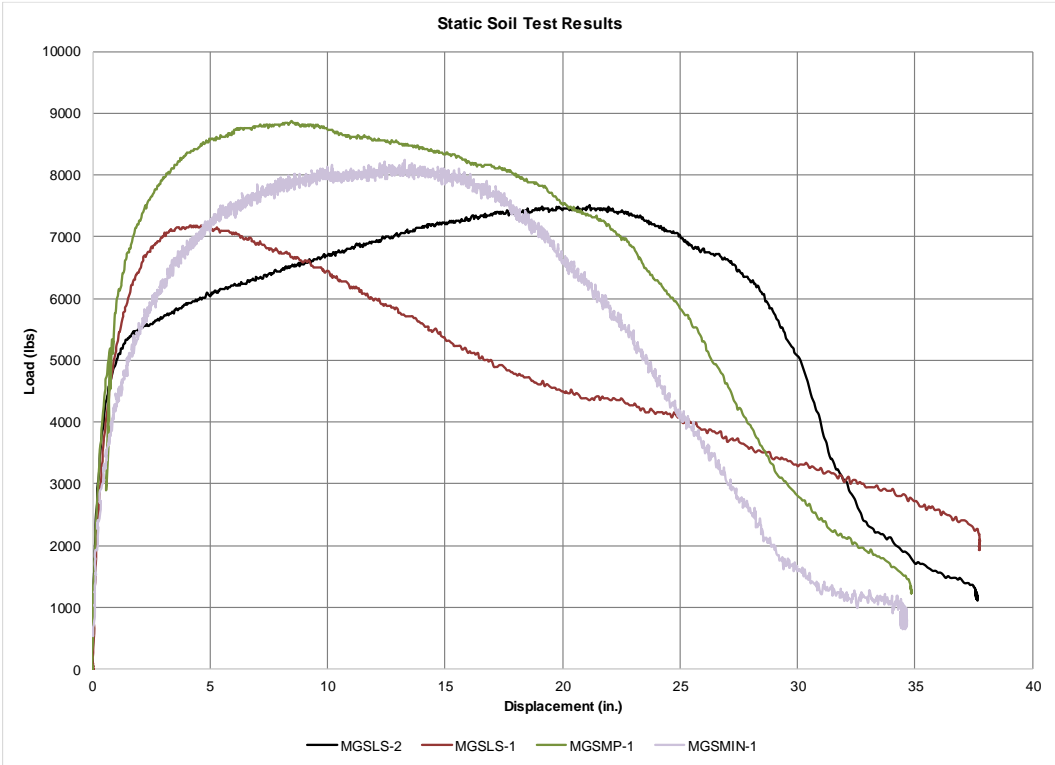
Figure 43. Static Soil Test Comparisons

A comparison of the force versus deflection data from test nos. MGSLS-2, MGSLS-1, MGSMIN-1, and MGSMP-1 is shown in Figure 43. The data showed that the peak load developed in the static soil test for test no. MGSLS-2 was similar to that of previous tests. The initial slope or stiffness of the soil response was similar as well. The general shape of the curves shown do differ from test to test, but all the soil tests reviewed were acceptable under the MASH soil requirements for full-scale crash testing. Based on these results, the soil response from test no. MGSLS-2 would not have been expected to produce more severe loading of the end anchorage. This conclusion would be consistent with the anchor load comparison, which indicated that the loading of the end anchor was consistent with previous tests of similar anchorages.
