Phase II Evaluation of Floor Pan Tearing for Cable Barrier Systems

MIDWEST ROADSIDE SAFETY FACILITY

MwRSF Research Report No. TRP-03-359-18

March 30, 2018

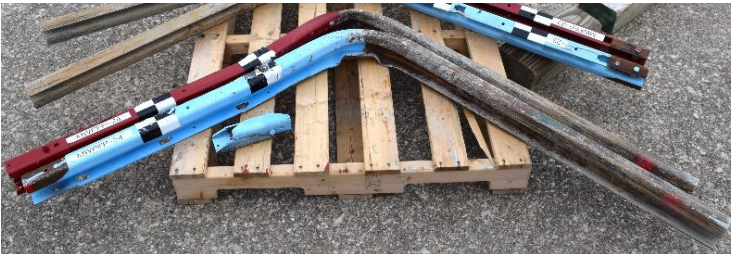
Figure 31. Time-Sequential and Post-Impact Photographs, Test No. MWPF24

Sequential and post damage photographs are shown in Figure 31. The posts were bent plastically near the ground line, and the top corners of both posts left minor creasing on the bottom of the simulated floor pan, as shown in Figure 32. During the test, the edge protector retainer bolt for post no. 2 sheared upon impact with the second floor pan's horizontal member, which allowed both edge protectors to disengage. This disengagement allowed the posts' free edges to impact the bogie floor pan, but did not cause tearing.

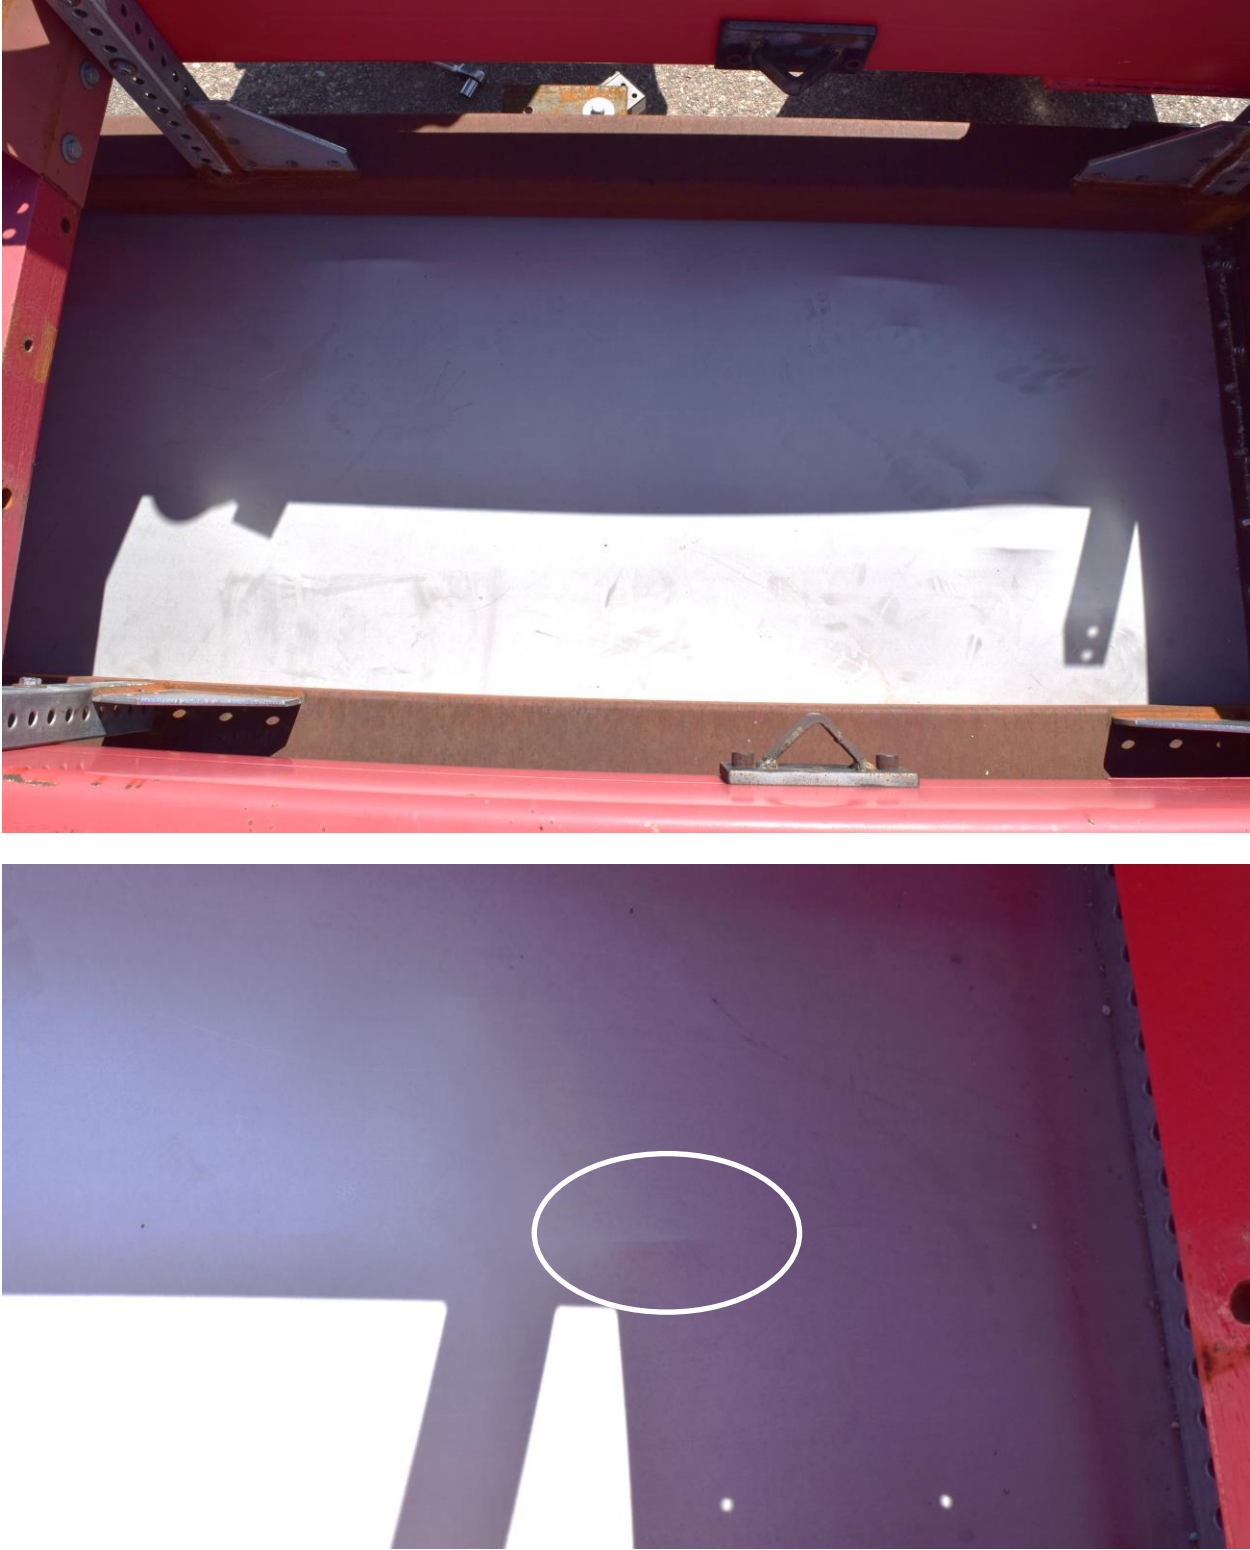
Figure 35. Simulated Floor Pan Damage, Test No. MWFPF-25

Test nos. MWPF25 and MWPF26 were conducted on MWPs with 3/4-in. (19-mm) diameter weakening holes at the groundline and edge protectors affixed to the top of the posts. In test no. MWPF25, the posts were oriented at 0 degrees, whereas in test no. MWPF26, the posts were oriented at -25 degrees. In both tests, the posts bent and tore at the groundline, and contact marks were found on the edge protectors. During both tests, the simulated floor pan was creased from the contact with the edge protectors.
