Post Irradiation Evaluation of Inconel Alloy 718 Beam Window

H.T. Bach^{a,1}, T.A. Saleh^b, S.A. Maloy^c, O. Anderoglu^d, T.J. Romero^a, M.A. Connors^a,
C.T. Kelsey^d, E.R. Olivas^e, K.D. John^f

^aC-IIAC, ^bMST-16, ^cMST-8, ^dLANSCE-LC, ^eAOT-MDE, ^fSPO-SC, Los Alamos National Laboratory, Los Alamos, NM 87545

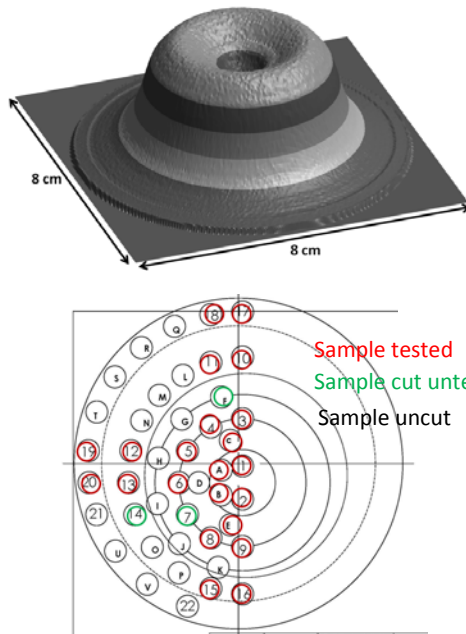
A cutting plan was developed based on the IPF rastered beam profile (Fig. 1). 3-mm OD samples were cut out from the window and thinned to 0.25-mm thick. Shear punch tests were performed at 25 °C on 21 samples to quantify shear yield, ultimate shear stress, and ductility. From 1-mm OD, 0.25-mm thick shear punched out disks, 4 TEM specimens of $\sim 30 \times 10 \times 2 \mu\text{m}$ were obtained using standard FIB lift-out techniques. TEM was performed on an FEI Tecnai TF30-FEG operating at 300 kV.

FIGURE 1. A 3D beam profile from MCNPX simulations (top) and cutting plan (bottom).

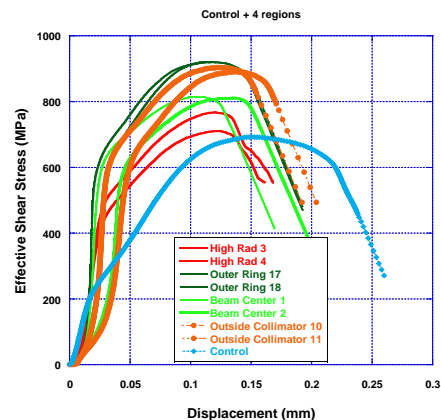
Typically increases in shear yield and shear maximum stress occur with increasing dose. In this case, highest shear yield and ultimate stress was on the lowest dose samples at the outer edge (Fig. 2).

FIGURE 2. Shear punch results of samples at various locations shown in the cutting plan and control sample from un-irradiated Inconel 718.

Optical microscopy images of the fracture surfaces on the shear punched out disks show no significant change in the fracture mode or reduction in ductility in the un-irradiated, high and low dose irradiated samples.

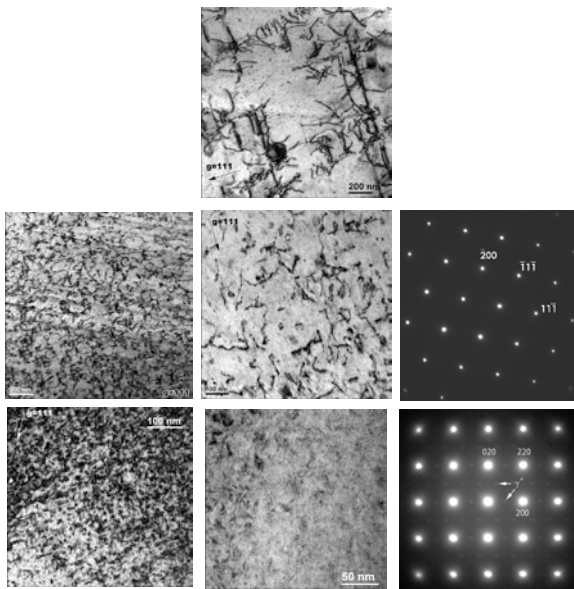
One un-irradiated and 4 irradiated samples (5, E, 16 and 19) were selected for TEM analysis. Figure 3 shows bright field TEM images of an un-irradiated, high and low dose irradiated samples.

FIGURE 3. TEM images of un-irradiated (top row), high dose sample #5 (middle row), and low dose sample #19 (bottom row)

Un-irradiated sample shows some dislocations and some large precipitates. The high dose sample #5 (~11 dpa, 122 °C) shows small loops and dislocations (left and center images) and no γ' or γ'' precipitates in SAD from $z = [011]$ (right image). Low dose sample #19 (~0.7 dpa, 40 °C) shows a high density of dislocation loops (left image), high density of H/He bubbles (center image) and presence of γ'' precipitates in SAD from $z = [011]$ (right image).

Radiation induced-hardening is highest at the low dose region in the outer most edge. The hardening from γ'' precipitates is determined to be more pronounced than that from trapped bubbles. The lack of significant hardening in the highest dose region is attributed to a lower dislocation density and no γ'' precipitates or bubbles [3]. Identification of H or He bubbles and the higher accumulation of these bubbles in the low dose region (no direct beam hitting) warrant further studies.

Despite the evidence of irradiation-induced hardening, this spent beam window appears to retain useful ductility after 5 years in service. At the conclusion of 2013 run cycle, the current in-service beam window had reached the same dpa as of the spent window. We plan to extend the service of the current in-service window until it reaches its intended design threshold limit of ~20 dpa (in the highest dose region). Additional measurements at higher dpa values will enable better decision-making in managing risks of the window failure.
