Fractographic Study to Characterise the Interaction Between Intralaminar and Interlaminar Fracture From Embedded Defects Under Compression Loading

Carla Canturri¹, Emile S. Greenhalgh^{†2}, Leif E Asp³, Silvestre T Pinho²,

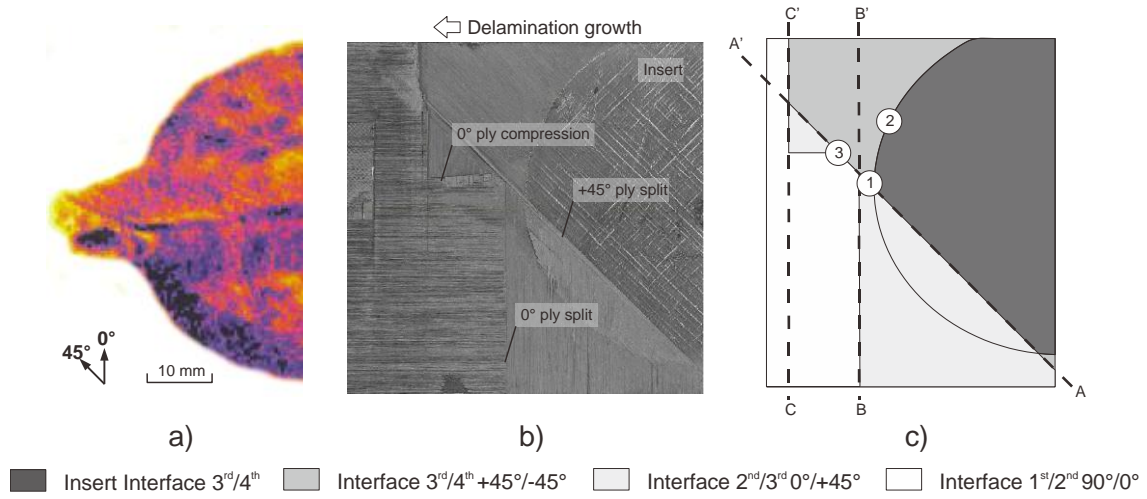
from the end of the test (Figure 6a), an optical image of the equivalent delamination surface (Figure 6b) and a schematic of the delamination surface indicating the ply interfaces (Figure 6c), are shown. Visual inspection of the delamination surface of Specimen I (Figure 6b) identified long intralaminar splits in the third ($+45^\circ$) and second (0°) plies and delamination migration. The delamination migration was driven towards the back face of the specimens and two migrations were observed. It has been shown by the authors in [14], that delamination migration is driven by the sign of the shear at the delaminating interface. In this configuration and for compressive loading, the resolved shear stresses at the transverse boundary, indicate that the delamination migration will be driven towards the back face. The ply towards which delamination migration is being driven is identified by means of an underline in the micrographs. The shear stresses at the transverse boundary (Figure 3c) arise from the difference between the transverse deformations of the back and front sublaminates. There were imprints of these ply splits on the matching surfaces of the fourth ply, from which it was inferred that these ply splits had occurred before delamination between the third and fourth plies.

Figure 6 a) C-scan, b) front fracture surface and c) schematic showing the positions of the subsequent images from Specimen I (defect at the +45°/-45° ply interface).

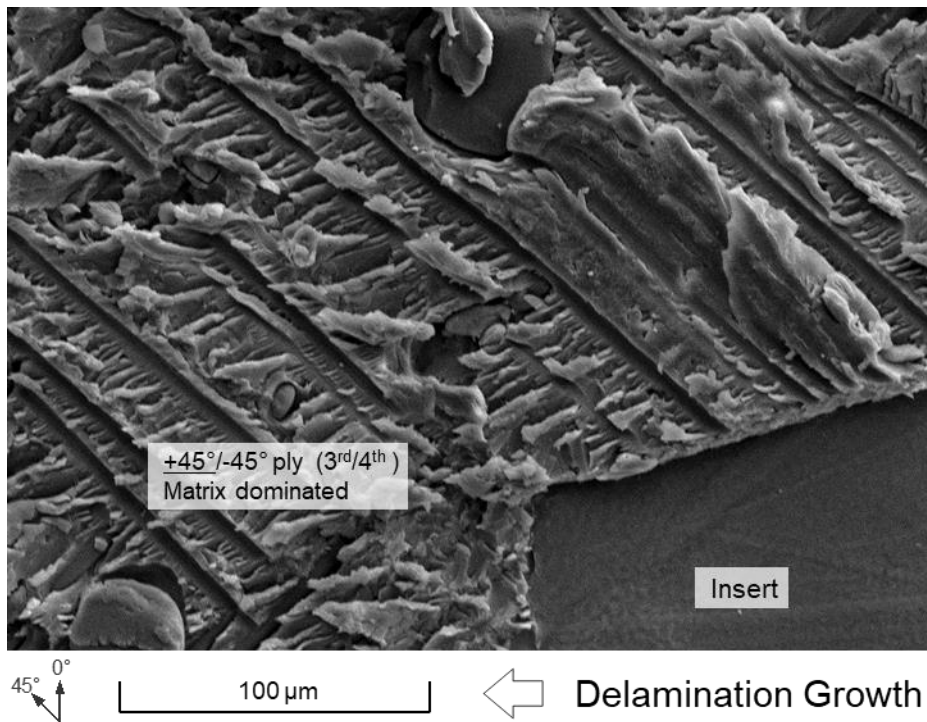
Scanning electron microscopy presented evidence of further small ply splits in the third ply ($+45^\circ$) adjacent to the insert boundary. Figure 7 shows detail of the delamination growth initiation from the insert boundary (site 1 in Figure 6c); fibre imprints from the third ply ($+45^\circ$) whilst the fibres of the fourth ply (-45°) are visible underneath. From the tilt of the cusps it can be inferred that the growth had extended from the insert [23]. Figure 8 (site 2 in Figure 6c) shows the delamination morphology further around the insert boundary. The continuity of the delamination morphology across the ply splits in the third ply was consistent with the delamination having occurred prior to ply splitting in this region. The delamination growth had been mode I dominated in this region on the insert boundary.

Figure 7 Delamination growth at the insert boundary of Specimen I (defect at the +45°/-45° ply interface). Site (1) in Figure 6.

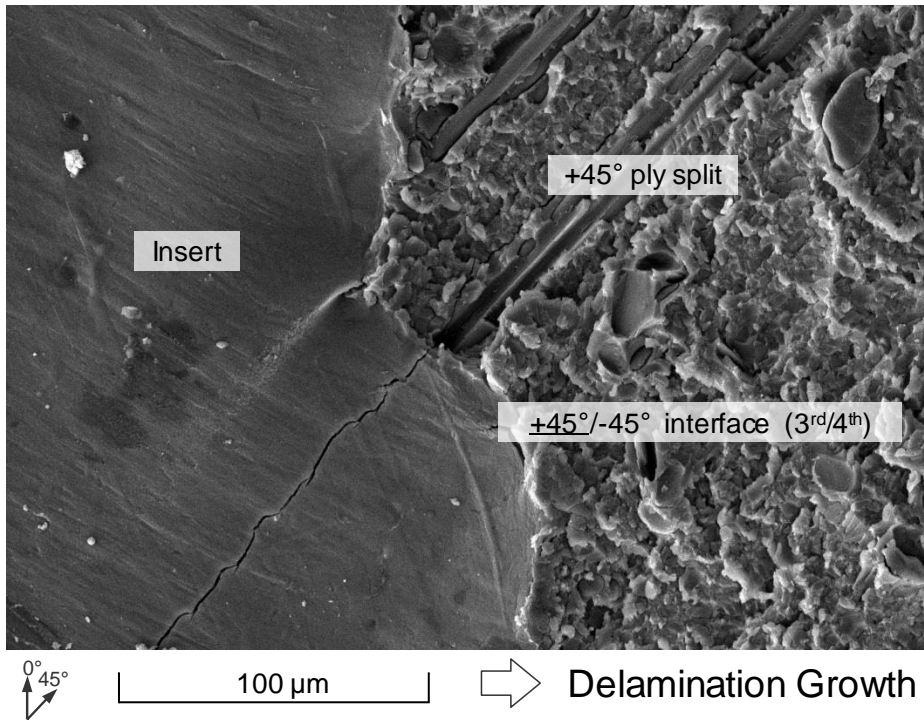
Figure 8 Ply splitting of the third ply (+45°) of Specimen I (defect at the +45°/-45° ply interface). Site (2) in Figure 6. Note that this micrograph was taken at the back matching surface (Figure 3).

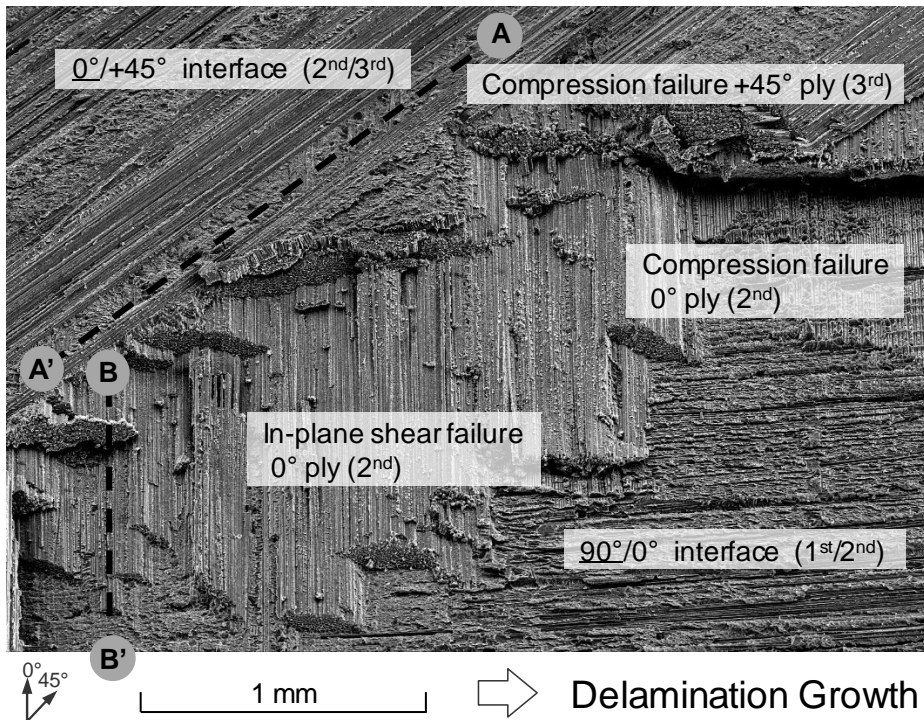
Moving away from the starter defect in the direction of delamination growth, there was evidence of fibre fracture having occurred. Figure 9 (site 3 in Figure 6c) was at the intersection of a region containing $+45^\circ$ fibre compression failure, 0° fibre in-plane shear failure and ply splits A-A' and B-B' (Figure 6c). These ply splits acted as initiation sites for the 0° shear failure presented in Figure 9. This in-plane shear failure then transformed into a 0° compression failure until reaching ply split C-C' (Figure 6c) in the second (0°) ply. Since the fibre failure of the second ply was confined between these two ply splits (A-A' and B-B' in Figure 6c) it was inferred that these two intralaminar failures had occurred prior to fibre failure.

Figure 9 Compression failure of the third (+45°) and second (0°) plies in Specimen I (defect at the +45°/-45°). Site (3) in Figure 6. Note that this micrograph was taken at the back matching surface (Figure 3).

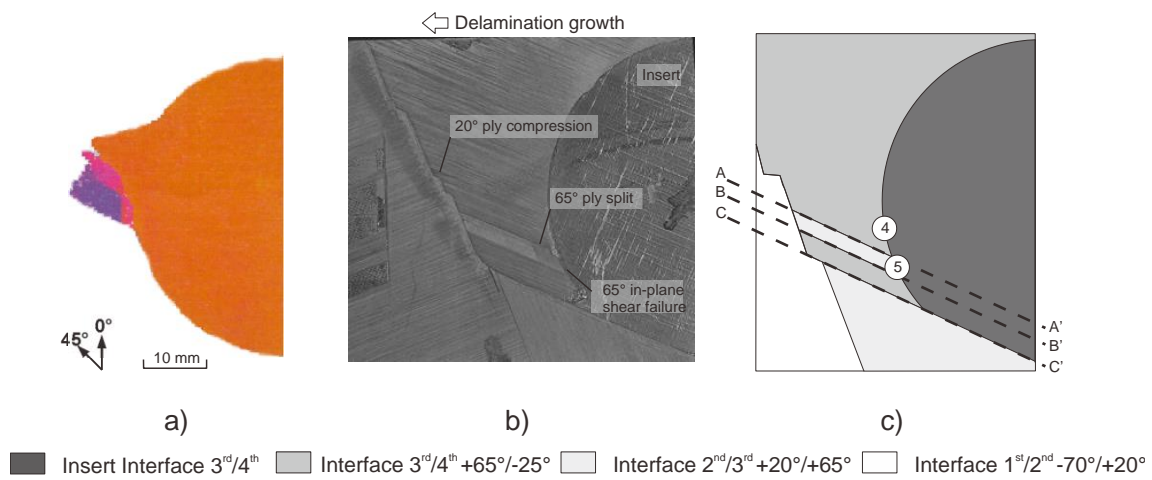
The next configuration studied (Specimen H2) had a stacking sequence $[-70^\circ/+20^\circ/+65^\circ/-25^\circ]_{4S}$: i.e. it was rotated $+20^\circ$ with respect to the Baseline, such that the initial defect was located at a $+65^\circ/-25^\circ$ ply interface. As can be seen in Figure 11, this specimen exhibited three long ply splits (labelled A-A', B-B' and C-C' in Figure 11c) in the third ply which had

resulted in migration of the delamination to the adjacent $+20^{\circ}/+65^{\circ}$ ply interface (i.e. between the second and third plies). Splits A-A', B-B' and C-C' had led to a change of the delamination growth interface. Similarly to Specimen I, these ply splits had formed prior to the delamination growth, and hence provided a path by which the delamination migrated. These ply splits, however, were not sufficient for delamination migration as can be seen in Figure 12 (site 4 in Figure 11) in which the ply split towards the back of the image having occurred prior to delamination growth (contrarily to the ply split in the foreground) did not lead to delamination migration. In-plane shear fibre failure of the third ply (Figure 13) was observed between a narrow zone that was bounded by ply splits A-A' and B-B' (site 5 in Figure 11).

Figure 11 a) C-scan, b) front fracture surface and c) schematic showing the positions of the subsequent images of Specimen H2 (defect at the $+65^\circ/-25^\circ$ ply interface).

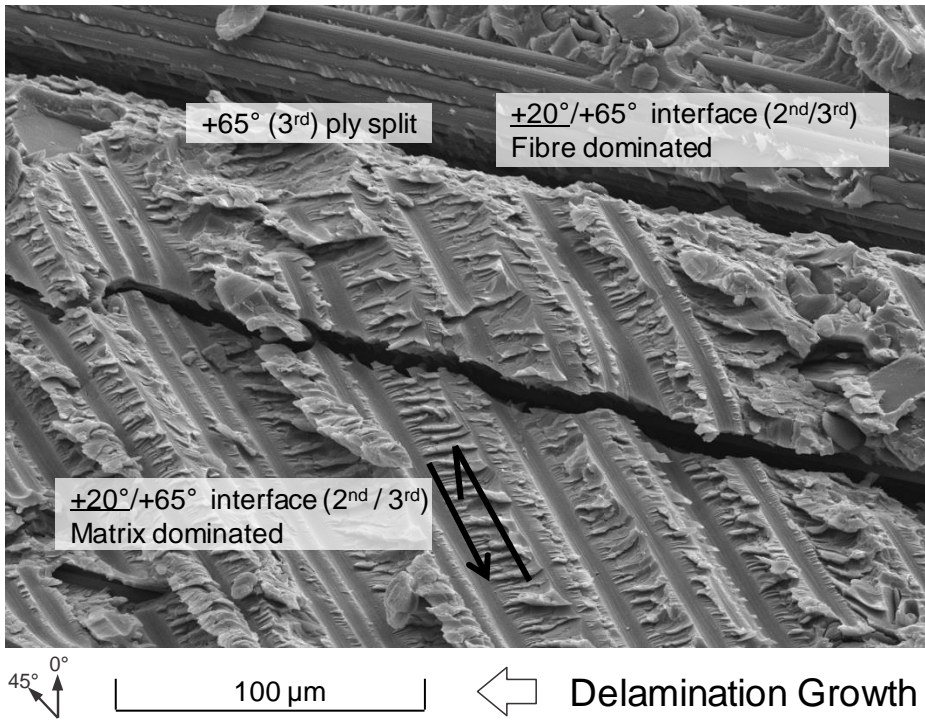
Figure 12 Ply splits of the third ply (65°) in specimen H2 (defect at the $+65^\circ/-25^\circ$). Site (4) in Figure 11.

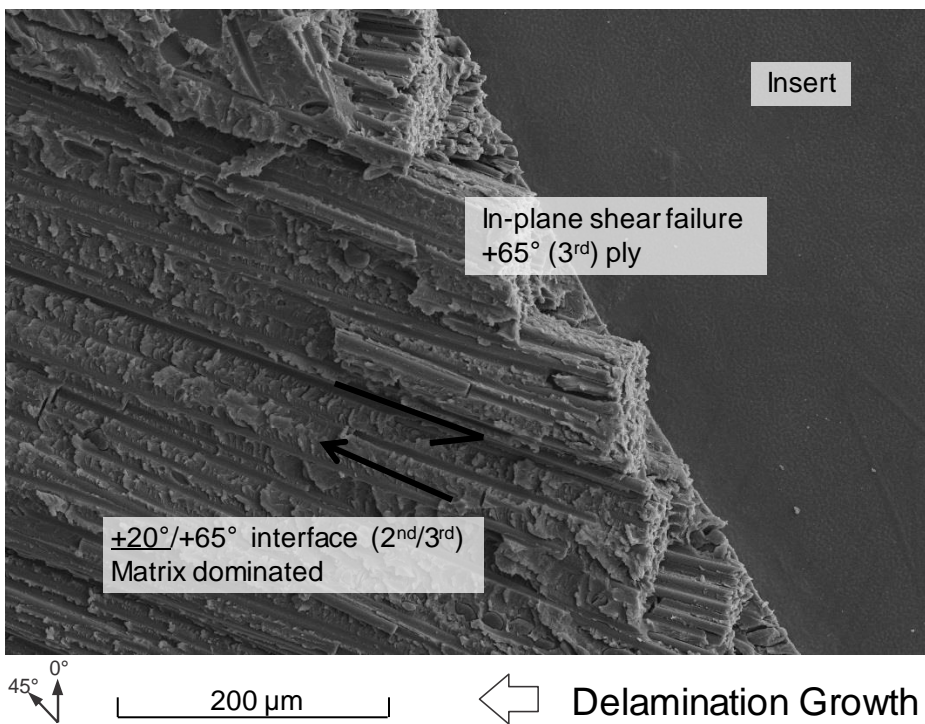
Figure 13 Boundary of the insert showing an in-plane shear failure of the third ply (65°) in specimen H2 (defect at the $+65^\circ/-25^\circ$) Site (5) in Figure 11.

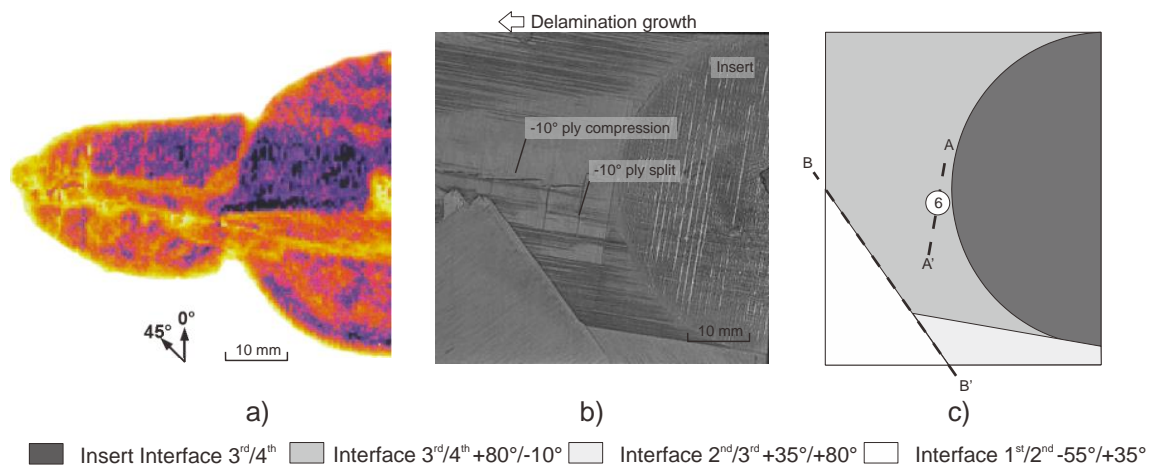
Specimen E2 ($+80^{\circ}/-10^{\circ}$) had a stacking sequence which had been rotated by $+35^{\circ}$ as compared to that of the Baseline (i.e. $[-55^{\circ}/+35^{\circ}/+80^{\circ}/-10^{\circ}]_{4S}$), and is shown in Figure 15. However, unlike the Baseline, the delamination surface in Specimen E2 (Figure 15b) was entirely contained within the original defect plane (i.e. between plies three and four). It was notable that the delamination had propagated asymmetrically, having grown 35 mm on one

side and 10 mm to the other: the C-scan presented in Figure 15a corresponds to the former side.

As can be seen in Figure 15, a ply split had developed in the third ($+80^\circ$) ply tangentially to the lowermost part of the insert boundary (B-B' in Figure 15c). However, its location was far from the delamination growth initiation sites at approximately the axial boundary of the defect. Therefore, unlike in the Baseline (Specimen I), no interaction between the third ply splitting and delamination growth had occurred.

Tangential to the transverse boundary of the defect, a ply split of the fourth (-10°) ply had developed (A-A' in Figure 15c). From the middle of this ply split, fibres micro-buckled leading to a compression failure that extended away from the embedded defect, as shown in Figure 16 (site 6 in Figure 15c). From the continuity of the fracture morphology at this site, it was inferred that the delaminated surfaces had been generated prior to formation of the ply splitting in the fourth ply. The compression failure was inferred to have initiated at the ply split, since it was only present on one side of this ply split surface. Similarly to the Baseline, the compression failure was located at a load bearing ply.

Figure 15 a) C-scan, b) front fracture surface and c) schematic showing the positions of the subsequent images of Specimen E2 (defect at the $+80^{\circ}/-10^{\circ}$ ply interface).

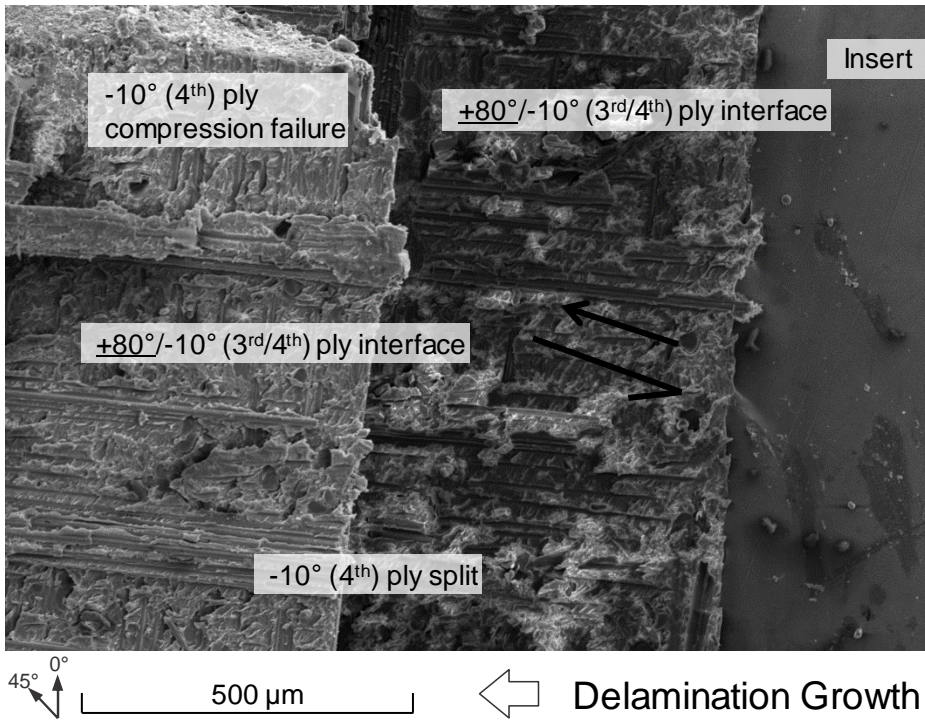
Figure 16 Boundary of the insert in Specimen E2 (defect at the $+80^\circ/-10^\circ$) showing compression failure and ply splitting of the fourth ply (-10°). Site (6) in Figure 15.

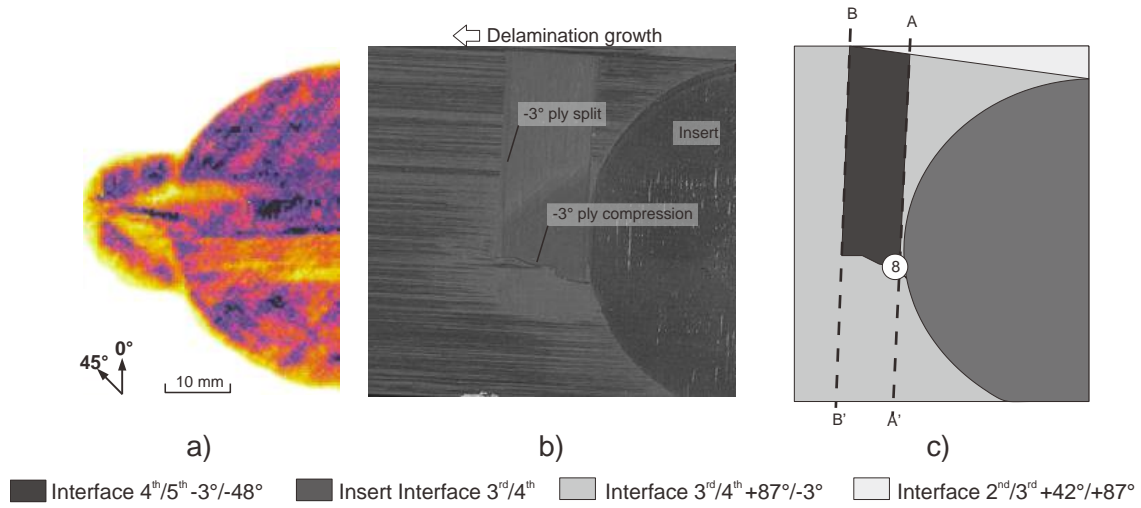
shown in Figure 18, this specimen presented similarities with Specimen E2 (+80°/-10° ply interface), by which it only differed in orientation by +7°. As with Specimen E2, Specimen C also presented delamination in the original defect plane and fibre failure of the fourth ply. However, upon closer examination, it was apparent that there was a different failure sequence. Unlike specimen E2, ply splitting of the fourth ply (-3°), which are shown as splits A-A' and B-B' in Figure 18b, was after the translaminar compression failure of this ply. In Figure 19 (site 8 in Figure 18c), the intersections between these -3° ply splits and the translaminar compression failure are shown. It was apparent that the compression failure was continuous across the ply splits, from which it was inferred that the compression failure had occurred first.

Figure 18 a) C-scan, b) front fracture surface and c) schematic showing the positions of the subsequent images of Specimen C (defect at the +87°/-3° ply interface).

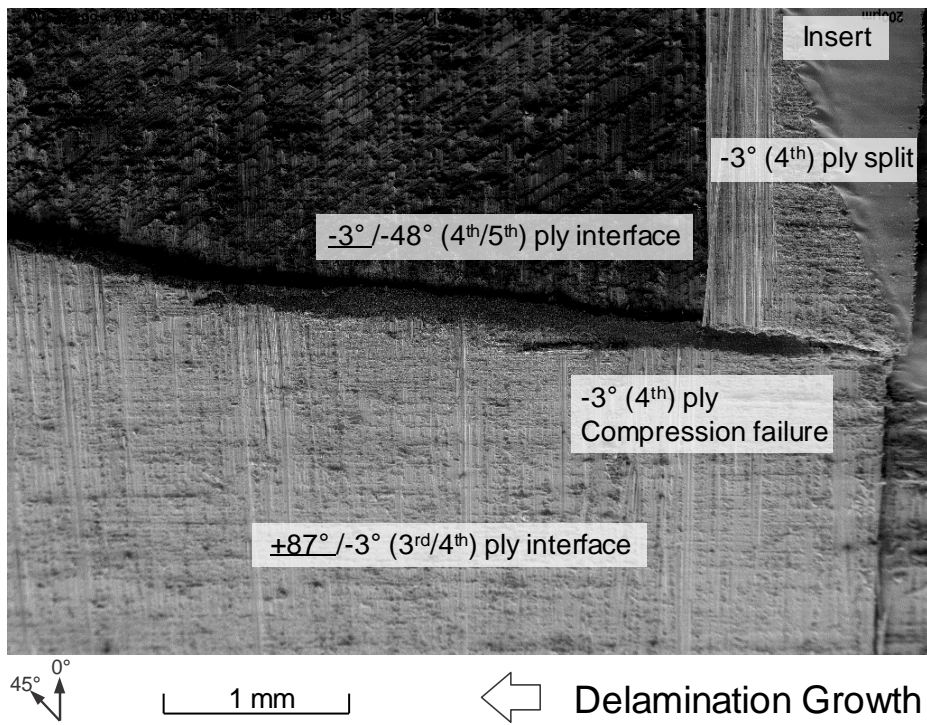
Figure 19 Surface detail of the third ply (+87°) in Specimen C (defect at +87°/-3°). Site (8) in Figure 18.

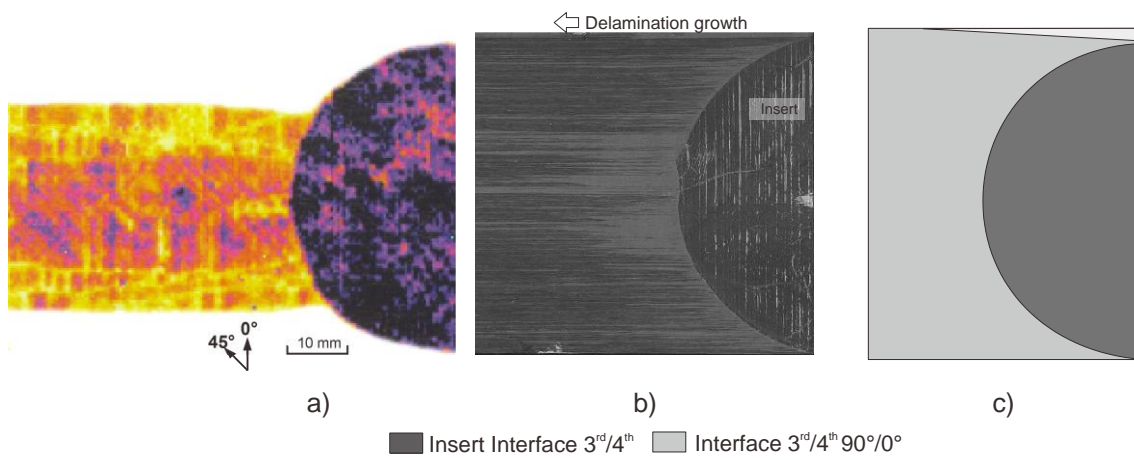
Specimen B (defect located at the 90°/0° ply interface) was the only specimen that did not exhibit substantial local buckling prior to delamination therefore the observations from this specimen were limited. As can be seen in Figure 21, the delamination had propagated across the entire specimen upon global buckling (Figure 21a) and delamination migration or ply splitting had not occurred (Figure 21b).

Figure 21 a) C-scan, b) front fracture surface and c) schematic showing the positions of the subsequent images of Specimen B (defect at the $+90^{\circ}/-0^{\circ}$ ply interface).
