Damage to Roadway Infrastructure from 2016 Central Italy Earthquake Sequence

Maria Giovanna Durante,^{a)} M.EERI, Luigi Di Sarno,^{b)}
Paolo Zimmaro,^{c)} M.EERI, and Jonathan P. Stewart,^{c)} M.EERI

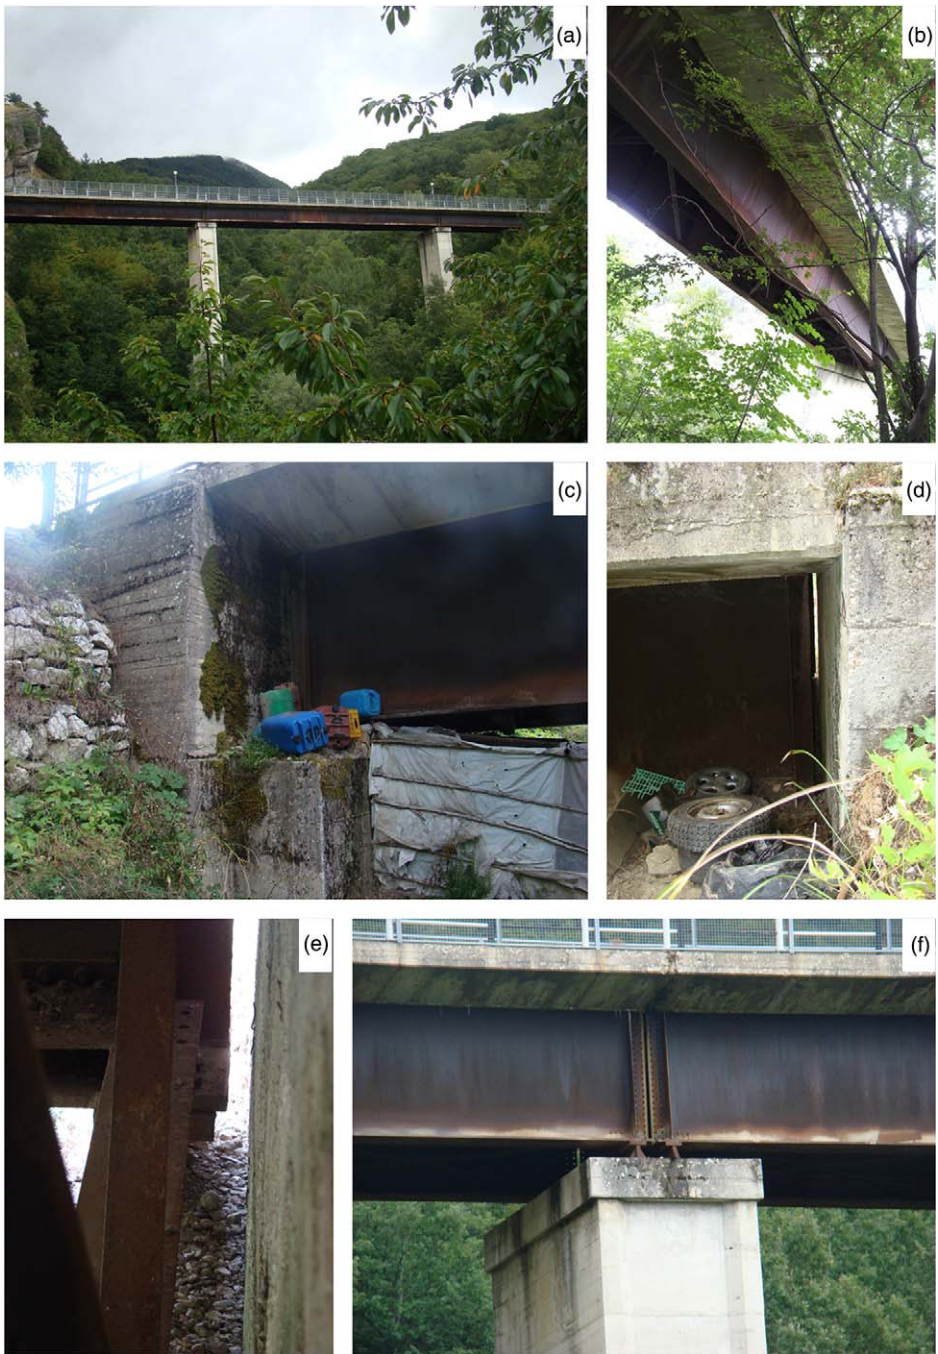
As shown in Table 1, the bridge likely to have experienced the largest ground shaking was the composite steel and concrete bridge along the Strada Provinciale (SP) 20 Colle (km 9+650), also called *Ponte Ramazzotti* (Figure 3). *Ponte Ramazzotti* (C1 in Figures 1 and 2) is formed by three composite steel and concrete spans, two RC piers, and two abutments. The bridge experienced some movements during the 24 August 2016 event (Figure 3). The movements have been accommodated by the bridge deck and did not affect the road surface or the structural components and, for this reason, limits on bridge utilization were not required.

Figure 3. *Ponte Ramazzotti*: Composite steel and concrete bridge along the SP20 in Colle (42.7276 deg, 13.3111 deg). (a, b) overview of the bridge, (c) abutment, and (d, e, f) bridge support details.

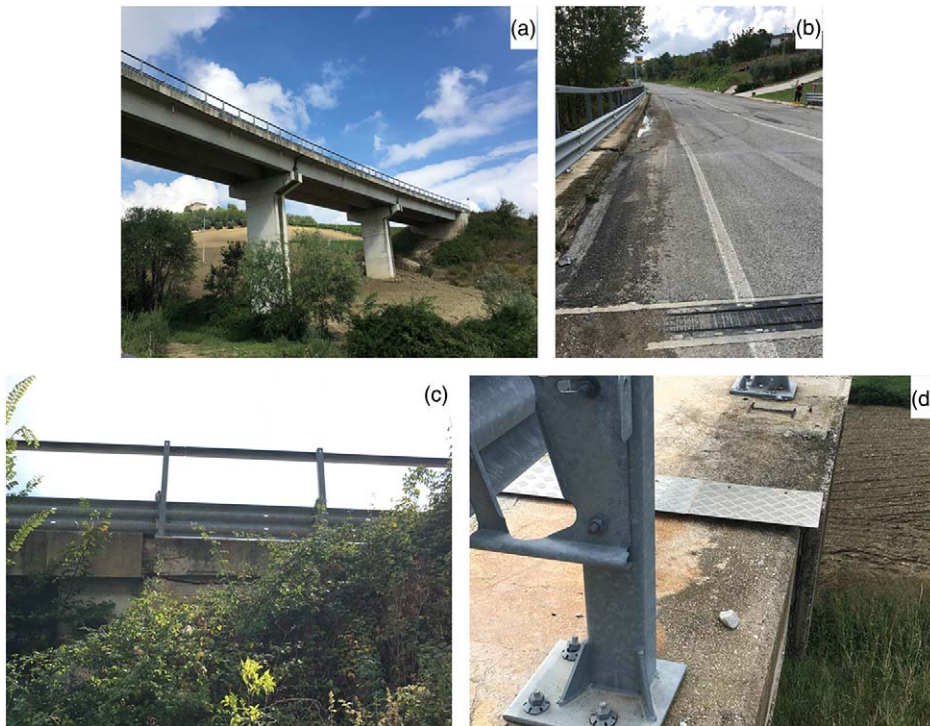
Another interesting bridge that was inspected is the RC bridge along the SP173 in Offida (Figure 4). This bridge (R1 in Figures 1 and 2) had significant settlement of the roadway close to the abutments (Figure 4b), which caused damage at the structural elements (Figure 4c). These settlements, which existed before the earthquake, appear to have been exacerbated by seismic compression of backfill during the 24 August 2016 main shock. Thus it was suggested to limit the maximum load to be carried by the bridge until specific geotechnical improvements to stabilize the area could be performed.

Figure 4. RC bridge along the SP173 in Offida (42.9417 deg, 13.7023 deg): (a) Overview of the bridge; (b) settlement of the road; (c) crack; and (d) relative displacement of the abutment.

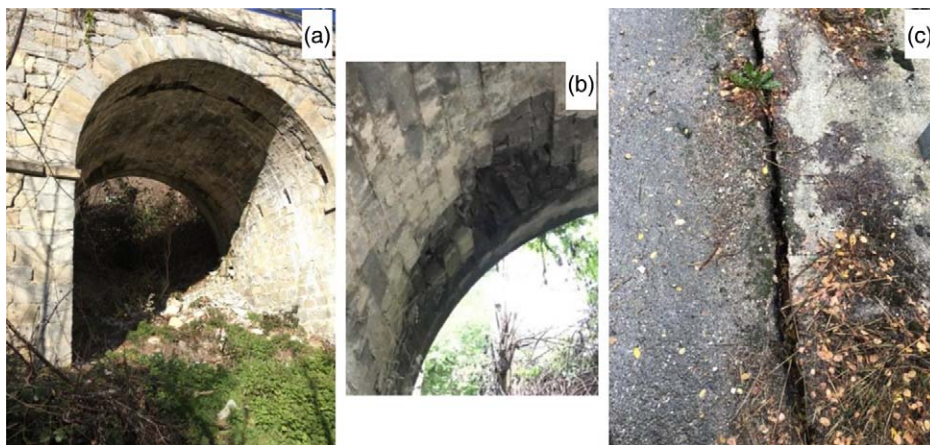
In the first inspection, a one-span masonry bridge along the Trisungo route near Tufo (M3 in Figures 1 and 2) presented cracking within load-bearing masonry elements within the arch

Figure 5. Roman-era bridge along the Trisungo route (1 span bridge, Tufo area, Arquata del Tronto: 42.7360 deg, 13.2549 deg): (a) View of the arch following the October event; (b) spalling of the interior of the arch; and (c) road cracks after the 24 August event, which grew slightly during the October event

(Figure 5a), including spalling (Figure 5b). Cracking adjacent to the roadway surface was observed immediately behind the wall, which increased slightly between the first and second inspections. Otherwise, the damage at this location were not appreciably different at the times of the two inspections.

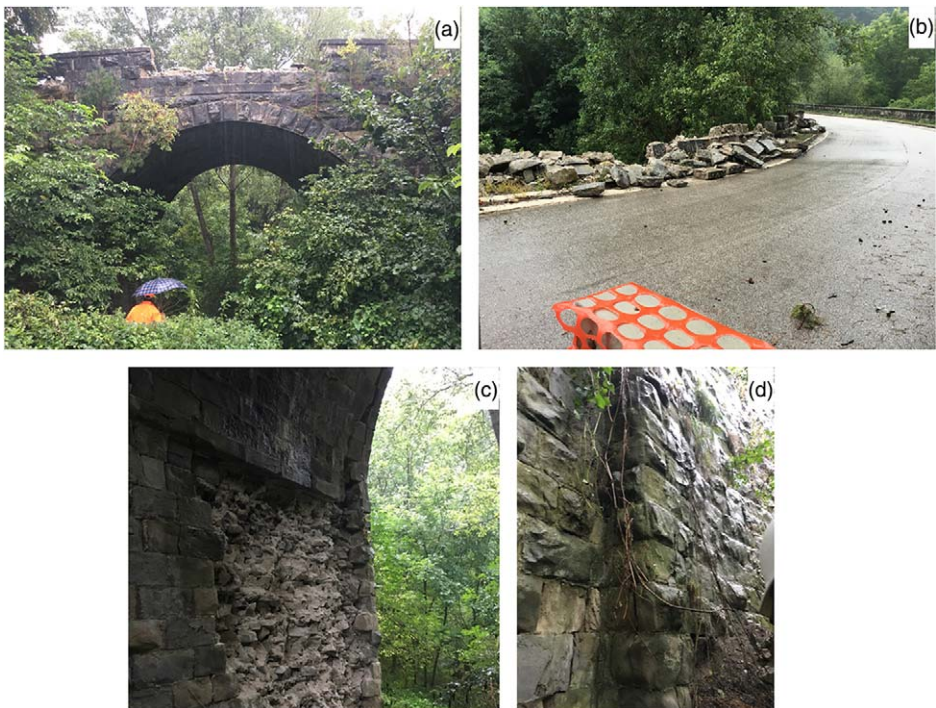
In the first inspection, the three-span bridge (M4 in Figures 1 and 2, hereafter Tufo bridge) presented partial collapse of short walls above the roadway surface (Figure 6a and 6b), spalling of several elements in the central arch (Figure 6c), and significant cracks of some masonry elements on the east support of the central arch (Figure 6d). This damage occurred in relatively recently added sections of the bridge. The older Roman-era portions of the bridge did not exhibit obvious signs of damage.

Figure 6. Central arch of the Roman-era three arches masonry bridge along the Trisungo route (42.7354 deg, 13.2537 deg) as observed following the August 2016 event: (a, b) Partial collapse of the railing; (c) spalling; and (d) cracking of some masonry elements in the central arch.

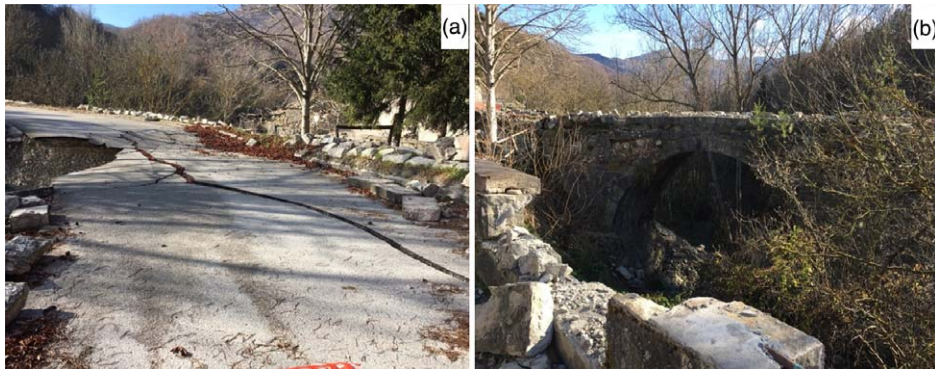
The Tufo bridge was inspected again in December 2016 after the October 2016 sequence. Significant additional damage was observed (Figure 7). In particular, part of the central arch, already damaged after the first event, collapsed as a result of the October earthquakes. Figure 7a shows large longitudinal cracks on the roadway surface (not present following the 24 August earthquake). The masonry rail, which was damaged during the 24 August event (shown in Figure 6a and 6b), totally collapsed following the October events (Figure 7b).

Figure 7. Three-arches bridge along the Trisungo route (same location as in Figure 6) after the 30 October 2016 event (photos taken on 13 December 2016). (a) Large longitudinal cracks on the roadway surface (same location as Figure 6b); and (b) total collapse of the masonry rail (same location as Figure 6a). The collapse of the arch is not visible in the pictures.

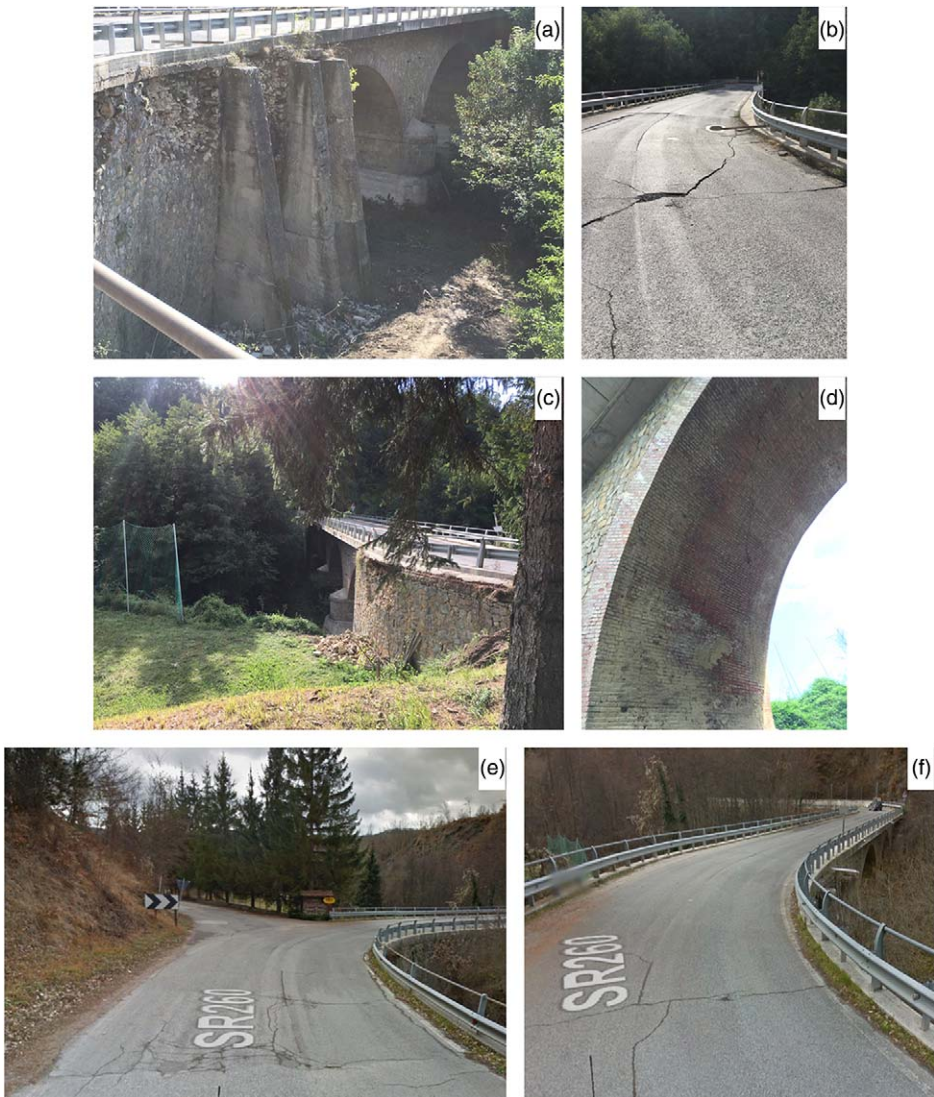
The masonry bridge referred to locally as the *Ponte a Tre Occhi* in Amatrice (M1 in Figures 1 and 2) was inspected following the 24 August and 30 October earthquakes. This bridge crosses the Castellano River and represents a critical lifeline for access to Amatrice, and it was closed on the date of our first visit (8 September 2016). The bridge is formed by three arches and the main structure is composed of *muratura a sacco*, which is a typical method of masonry construction (Giuliani 1993). This method consists of using regular-shaped masonry elements on the external part of the construction, sometimes with between-element mortar. The interior part of the construction is composed of relatively irregularly-shaped cobbles, usually without mortar. During the 24 August 2016 earthquake, several sections of the external (regular-shaped) layer collapsed (Figure 8a and 8c). This resulted in a lack of confinement of the interior uncemented cobbles, which then underwent lateral relaxation and settlement that was observable on the roadway surface (Figure 8b). These diffuse transverse cracks along the road surface had maximum openings of about 5 cm and 2.7 cm horizontally and vertically, respectively. Some deformation of the road surface was evident before the main shock, as shown in Figure 8e and 8f (dated December 2011). Moreover, internal cracking was observed on all the arches of the bridge (Figure 8d).

Figure 8. *Ponte a Tre Occhi*: Masonry bridge along the SR260 in Amatrice (42.6207 deg, 13.2902 deg). (a, c) Abutment deformations on two sides of the bridge, (b) road settlement, (d) cracks on the arch, (e) pre-event cracks along the SR260, and (f) bridge–abutment connection [source for (e, f): Google Maps (<https://www.google.com/maps/>; last accessed 13 September 2018)].

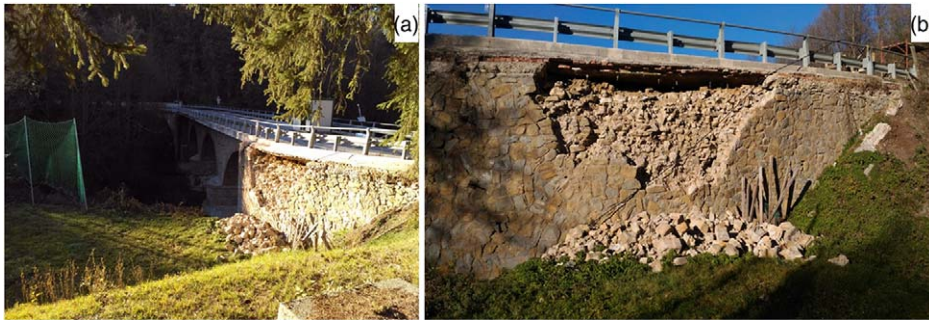
As a result of the October events, the *Ponte a Tre Occhi* experienced additional damage, consisting mainly of spalling of outer layer masonry elements located along abutment areas (not involving the three arches; Figure 9a and 9b). At the time of the reconnaissance (2 December 2016), repairs had been carried out on one of the two abutments, while the bridge masonry and structure appeared to have not yet been repaired.

Figure 9. *Ponte a Tre Occhi* (same location as in Figure 8) after the 30 October 2016 event (photos taken of 13 December 2016): (a) Damage to abutment in same section shown in Figure 8c; and (b) closer view of masonry collapse along abutment.

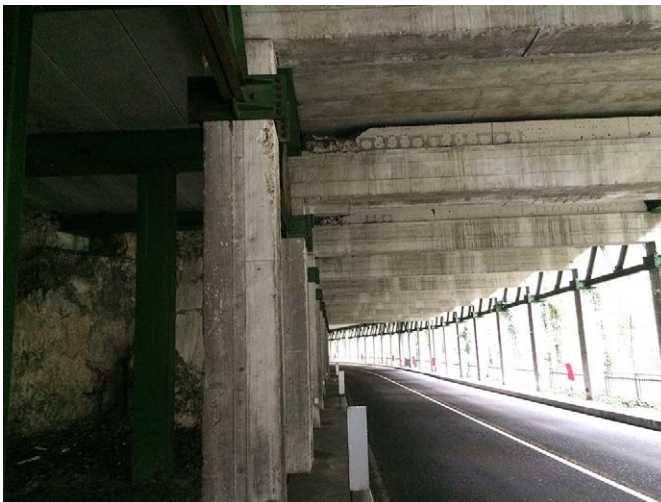
The performance of the rockfall protection tunnel along the *Tre Valli Umbre* highway before the 30 October 2016 event is unknown. As shown in Table 1, PGA values at the site for the three main shocks are 0.11g, 0.07g, and 0.17g for the 24 August 2016, 26 October 2016, and 30 October 2016 events, respectively (PGV values were similarly highest for the 30 October 2016 event). Figure 10 shows an overview of the structural arrangement of the

Figure 10. Overview of the composite steel-RC rockfall protection tunnel near Norcia.

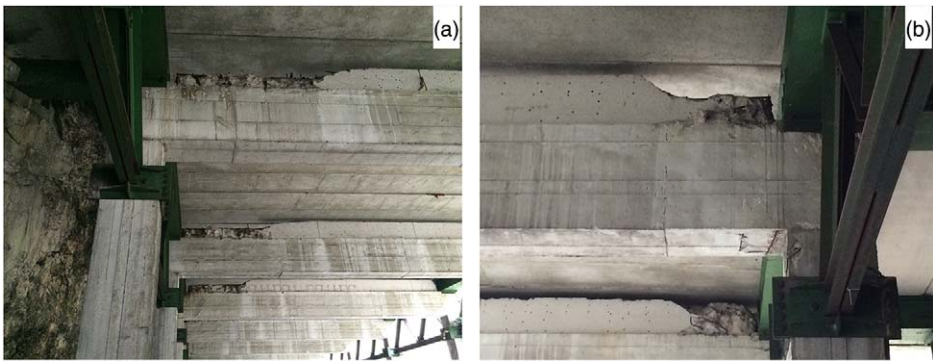
Figure 11. (a, b) Close-up views of reinforced concrete beam-column joint and the steel frame.

rockfall protection tunnel, which consists of a combination of RC columns and RC and steel beam segments. Figure 11 shows details of steel–concrete joints. Prior to the earthquakes, some deterioration and spalling of concrete occurred, which exposed steel rebars (Figure 11a). As shown in Figure 11b, the structure suffered slight damage from pounding. This was evidenced by freshly spalled pieces of concrete.

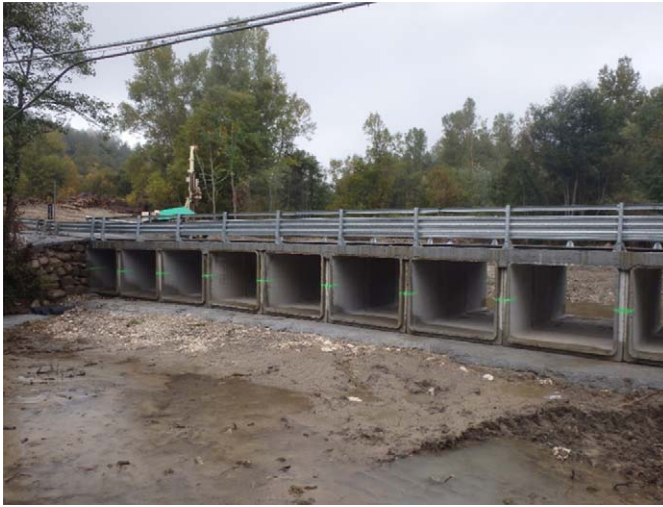
Figure 12. Temporary bridge bypassing the *Ponte a Tre Occhi* in Amatrice (Mr. Totaro, personal communication).

As a result, a joint group formed by the National Civil Protection and the Italian Army built two temporary bridges within 10 days of the 24 August 2016 main shock. The first temporary bridge (Figure 12) was built to bypass the *Ponte a Tre Occhi*. The temporary bridge was built rapidly and traffic was opened within one week of the main shock. The construction of this temporary bridge started with a diversion of the river that allowed the construction of a concrete sublayer slab on the river bed and a placement of ten 3×3 m precast concrete void elements. Those elements were selected to allow the restored river flow to pass through them. Vehicle loads were distributed over the vertical webs of the precast elements through a cast *in situ* deck slab.

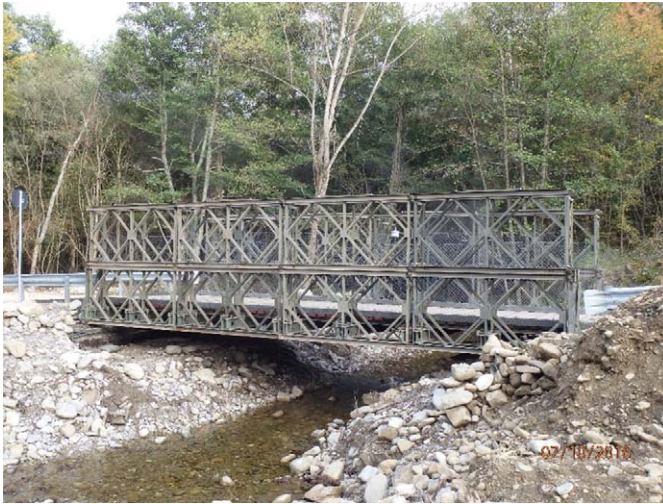
Figure 13. Temporary bridge near *Ponte Rosa*.

The second temporary bridge (Figure 13) was built to increase traffic capacity of the east access road and overcome traffic restrictions resulting from partial closure of the *Ponte Rosa*. It is a 12-m span Bailey bridge, a typical military construction typology that can be deployed quickly. This bridge is a modular construction, covering relatively small spans by assembling preformed steel frames connected into truss beams. Two truss beams are connected by transverse steel beams forming the deck and the bridge parapets.
