Flow Analysis through Collector Well Laterals: A Case Study from Sonoma County Water Agency, California

Matteo D'Alessio ¹, John Lucio ², Ernest Williams ³, James Warner ², Donald Seymour ⁴, Jay Jasperse ⁴ and Chittaranjan Ray ^{1,*}

Abstract: The Sonoma County Water Agency (SWCA) uses six radial collector wells along the Russian River west of Santa Rosa, to provide water for several municipalities and water districts in north-western California. Three collector wells (1, 2, and 6) are located in the Wohler area, and three collector wells (3, 4, and 5) are located in the Mirabel area. The objective of this paper is to highlight the performance of the three collector wells located in the Mirabel area since their construction. The 2015 investigation showed a lower performance of Collectors 3 and 4 compared to their original performances after construction in 1975, while the performance of Collector 5 was relatively stable since 1982. The potential change in capacity could be due to the increase in encrustation observed during the visual inspection of laterals in all three collector wells. Overall, the three collectors are still within the optimal design parameters (screen entrance

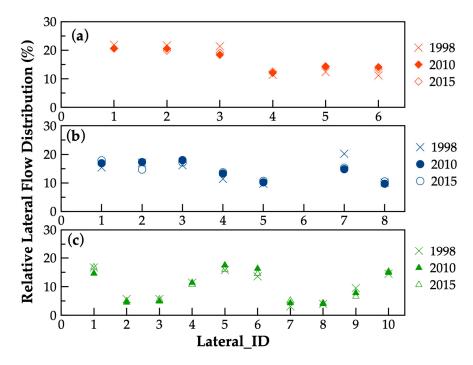
Throughout the three investigations (1998, 2010, and 2015), minimal changes in relative percentage flow were observed (Figure 4). In Collector 3, the laterals (1, 2, and 3) closest to the river had the largest percentages of flow (Figure 4). The collective gain in flow in these three riverward laterals balances the collective loss of flow in the three landward laterals. During the 2015 evaluation, the relative distribution of flow among Collector 3 laterals ranged between 12.5 (Lateral 4) and 20.7% (Lateral 1). Lateral 6 had the largest decline in flow (-2.7%) compared to the 2010 results [1,3]. The limited changes observed may be related due to varying influence of recharge from the Russian River, as well as Infiltration Ponds 2 and 3 northeast and east of Collector 3 (Figure 2), respectively.

Figure 4. Relative lateral flow distribution (%) in (a) Collector 3, (b) Collector 4, and (c) Collector 5.

In Collector 4, during the three investigations, the productions of most of the laterals slightly improved over time. Laterals 1 and 2 (oriented toward the river) and Laterals 7 and 3 (parallel to the river) showed the highest percentages of flow. On the other hand, the lateral with the lowest percentage of flow (Lateral 8) is oriented on about a 45-degree angle towards the river, similar to Lateral 2, but it is also the shortest lateral (29.41 m) (Figure 2). The two landward laterals projected towards the infiltration ponds collectively provided 24.4% of the well's total production. During the 2015 evaluation the relative flow percentages ranged between 10.5% (Lateral 8) to 17.9% (Lateral 1). Lateral 2 showed a decline (-2.5%) in production between 2010 and 2015 (Figure 2) [1,3]. Based on the video obtained, this decline was probably due to the presence of sand and gravel within the lateral.

In contrast with the trend observed in Collectors 3 and 4, in Collector 5, the laterals showed constrasting results. The production slightly increased in Laterals 1 and 7, slightly decreased in Laterals 4, 5, and 9, and remained constant in the remaining laterals. In addition, the impact of the 10 laterals is different. Four laterals individually procuded 14.5% or more of the total capacity, while five laterals individually produced less than 6.6% (Figure 4). The orientation of the laterals had no impact on the percentage of flow distributions. On the other hand, the length of the laterals impacted the flow distribution. The four longest laterals (>51.20 m) were also four of the five highest producing laterals, while the three shortest laterals (<26.52 m) were also the three lowest producing laterals. The three remaining laterals were of intermediate lengths (37.49 to 40.54 m), as well as in producing capability [1,3].

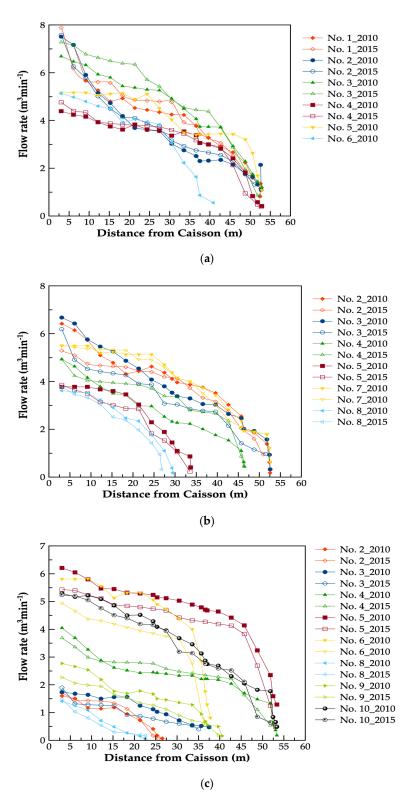
Non-uniform flow occurred along the laterals from the three collectors (Figure 5). In fact, for uniform flow along the lateral, the trend for each lateral would be a straight line beginning with zero m min⁻¹ at the outer end of the lateral and concluding with the total flow for the lateral where it enters the caisson. However, none of the laterals follow this straight-line trend of uniform distribution. Each lateral displays steeper gaining trends in production in the outermost segments of their length where they are obtaining most of their flow. After these steep gains in flow in the outer segments, the remaining trends of flow while moving progressively closer to the caisson were more gradual because of the generally slower production in those segments. Similar overall trends were

observed during the 2010 and 2015 monitoring events. However, for Collector 3, regardless of the lateral, higher flow was observed during the 2015 campaign. On the other hand, for Collectors 4 and 5, a slightly higher flow was observed during the 2010 campaign [1,3].

Figure 5. Flow versus distance at (a) Collector 3, (b) Collector 4, and (c) Collector 5.

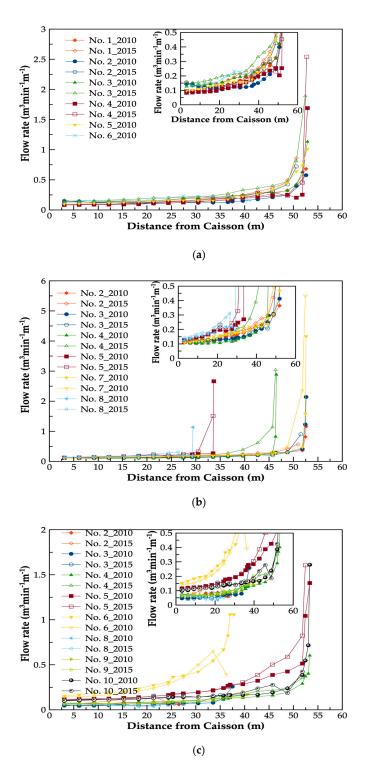
Average unit flow capacity of each lateral, which is also greater at the end of lateral flow, effects large gains in production within only a few meters. This is particularly noticeable in Laterals 3 and 4 from Collector 3. In these outermost few feet, unit flow capacities can approach or even exceed $2 \, \text{m}^3 \, \text{min}^{-1}$ per m. On the other hand, while moving along the lateral toward the caisson, the gains in flow progressively decrease and the average unit flow capacity begins to assume a more consistent trend (Figure 6).

Figure 6. Flow along different laterals at increasing distances between the screen length and the caisson for (a) Collector 3, (b) Collector 4, and (c) Collector 5.

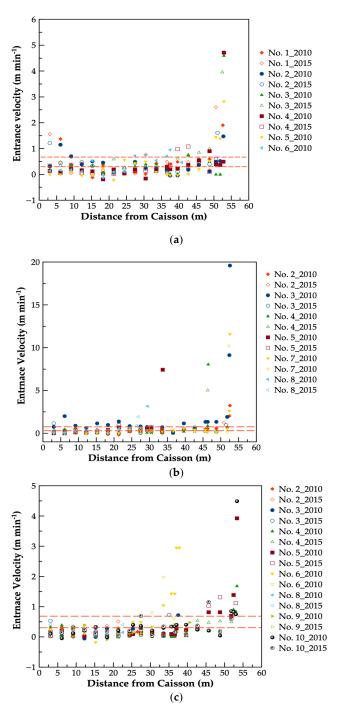
Overall, the three collectors are still within the optimal design parameters (entrance velocity < $0.305~\rm m~min^{-1}$ and axial velocity < $1.524~\rm m~s^{-1}$ [8,9]) (Figure 7 and Figure S3). Collector 6, constructed in 2002, consisted of a larger steel reinforced concrete caisson (5.49 m vs. 3.96 m inside diameter) with larger laterals (30.48 cm vs. 24. cm) than the Collectors discussed in this investigation, showed a lower entrance velocity (consistently < $0.610~\rm m~min^{-1}$) and axial velocity (<1.524 m s⁻¹) during the 2010 monitoring campaign. This can also be related to lower presence of deposited materials and rust in Collector 6 (Figure S6) compared to the older collectors (Figure S2).

Figure 7. Entrance velocity through different laterals with increasing distances for their ends for (a) Collector 3, (b) Collector 4, and (c) Collector 5. Ideal and optimal design < 0.305 and < 0.610 m min⁻¹ (bottom and top red line).

While Collectors 3 and 4 achieved lower performances compared with their original performances (1975), Collector 5 was relatively stable since 1982. The potential change in capacity could be due to the increase in encrustation observed during the visual inspection of laterals in all three collector wells. Overall, the three collectors are still within the optimal design parameters (screen entrance velocity < 0.305 m min^{-1} and axial flow velocity of lateral screens < 1.524 m s^{-1}). The underwater structures in three collector wells are in generally good condition, early stages of rusting and encrustation are present. A more frequent cleaning and/or replacement of some of the rusted units may be required to further improve the efficiency of the collector wells.
