Novelli, V., Ngoma, I., Kloukinas, P., Kafodya, I., De Risi, R., Macdonald, J., & Goda, K. (2019). *Seismic Vulnerability Assessment of Non-engineered Masonry Buildings in Malawi*. Paper presented at 7th International Conference on Computational Methods in Structural Dynamics and Earthquake Engineering , Crete, Greece.

SEISMIC VULNERABILITY ASSESSMENT OF NON-ENGINEERED MASONRY BUILDINGS IN MALAWI

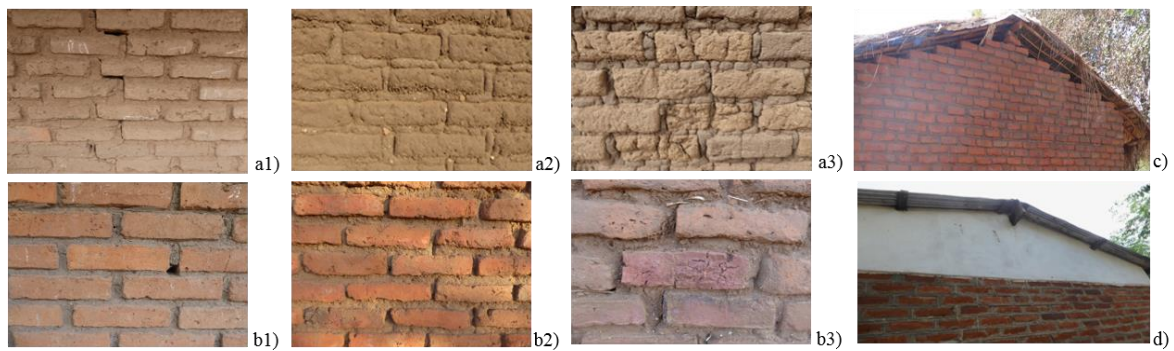
Figure 2: a1) and b1) good; a2) and b2) medium and a3) and b3) poor fabric quality of unfired and fired bricks, respectively c) thatched roof and d) metallic sheet roof

Most of the observed buildings (82%) were made of fired bricks, since these are affordable materials to be sourced on-site, and they do not require high construction skills. Mud mortar was identified for 76% of the inspected buildings, while cement mortar, observed for the remaining inspected houses, is gradually being adopted. Fabric quality varies considerably from poor to good and underlines the need of assessing the building performance by defining me-

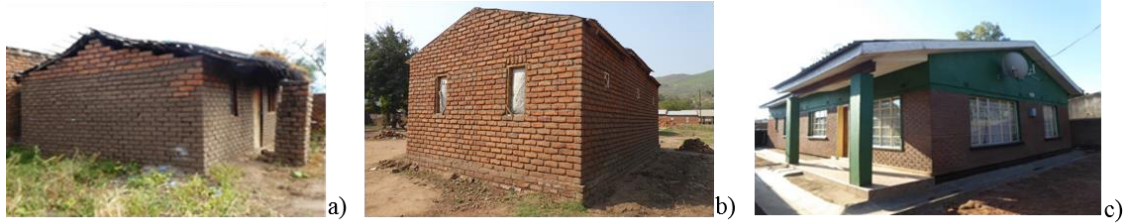
The most common typology observed in Malawi, B, representing 52 % of the buildings, is rated as medium seismic vulnerability (see Figure 3(b)). These buildings were made of fired bricks characterized from poor to a good quality fabric (Figure 2(b1), (b2), and (b3)). Due to the presence of mud mortar in these houses, the bonding between bricks is considered poor, therefore connections between walls were assumed weak. The construction details varied significantly, as well as maintenance levels.

Typology C covers 28% of the inspected houses (see Figure 3(c)). These were made of fired bricks from poor to good quality fabric (Figure 2(b1), (b2), and (b3)) and cement mortar. Generally, these houses had a larger floor plan than the typical plan. Due to the extended plan size, irregularities were likely to occur (e.g. portico and re-entrant corner). Most of these houses had corrugated metallic sheets supported by timber elements or truss, and good structural detailing (e.g. adjacent walls and walls/roof are connected). The good structural quality of these houses can be also attributed to the presence of strengthening elements (e.g. ring beams).

Figure 3: Typical one-story masonry building in Malawi. a) typology A; b) typology B; c) typology C
