# Ground Motion Characteristics of the 2015 Gorkha Earthquake, Survey of Damage to Stone Masonry Structures and Structural Field Tests

**Keywords:** Gorkha earthquake, ground motion characteristics, damage survey, stone masonry, field test, Schmidt hammer test

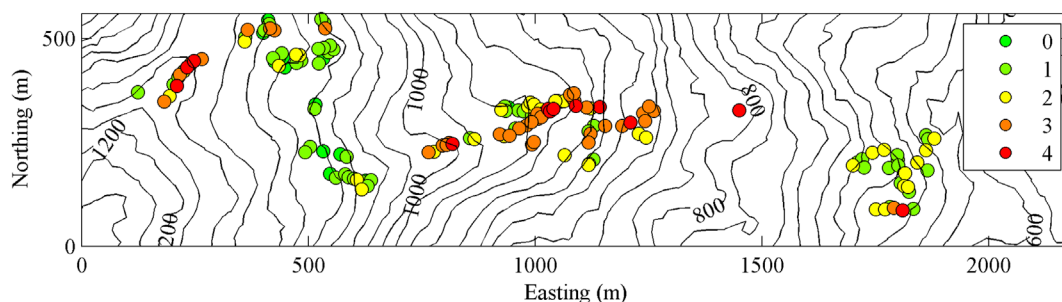
FIGURE 7 | Topographic map of the study area showing structural damage grade.

In the study cluster, there are 149 structures consisting of 58 large, 68 medium, and 23 small-sized buildings with 39, 46, and 15% of weightage, respectively. Damage grade and location were recorded using GPS at the site. **Figure 7** shows the damaged structures on a topographic map. Green colored dots represent grade 0 structures, whereas red dots represent the location of grade 4 structures (as we do not have any grade 5 structures). **Figure 8** shows the damage grade of structures with percentages of structures that include categories of structure sizes. We found that 8% of the structures had a damage grade of 0; 38% were in grade 1; and grade 2 and grade 3 structures were 24% each. The remaining 6% of the structures were damaged severely, at grade 4.

Here, we can see most of the structures fall under damage grades 1, 2, and 3, with less coming from grades 0 and 4. From the survey, we found that most of the buildings on ridge lines suffered heavy damage but those on side-slopes were not damaged as much. The study area comprises an area that includes a mountain ridge along with a local ridge line formed on the middle of the slope. Hence, we categorized the structures as ridge-line structures, those that are located on the ridge line. There are a total of 52 structures located on the ridge line, including the main and local ridge lines. Damage grade details of the structures on the ridge line are shown in **Figure 9**. There are no structures that fall under grade 0; in fact only 15% of the structures graded as 1 with 19% in grade 2. More than half of the structures, i.e., 52%, were grade 3 and the remaining 14% fell under grade 4. A small structure that was graded as 3 on the ridge line is shown in Image S1 in Supplementary Material.

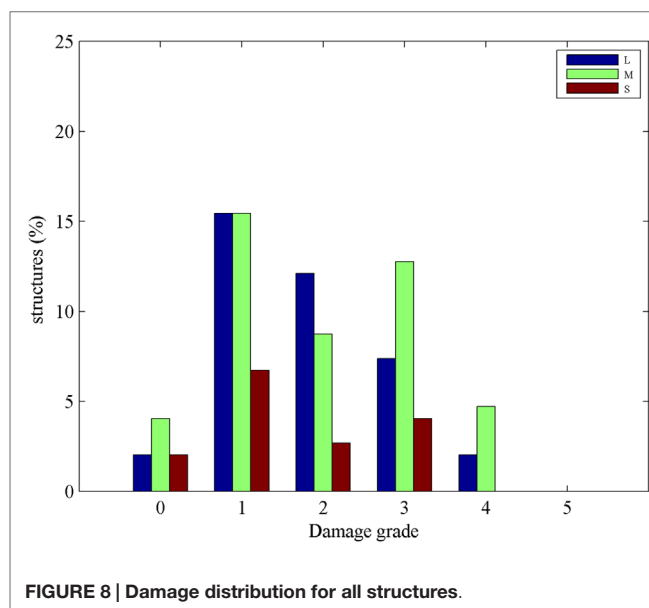
FIGURE 8 | Damage distribution for all structures.

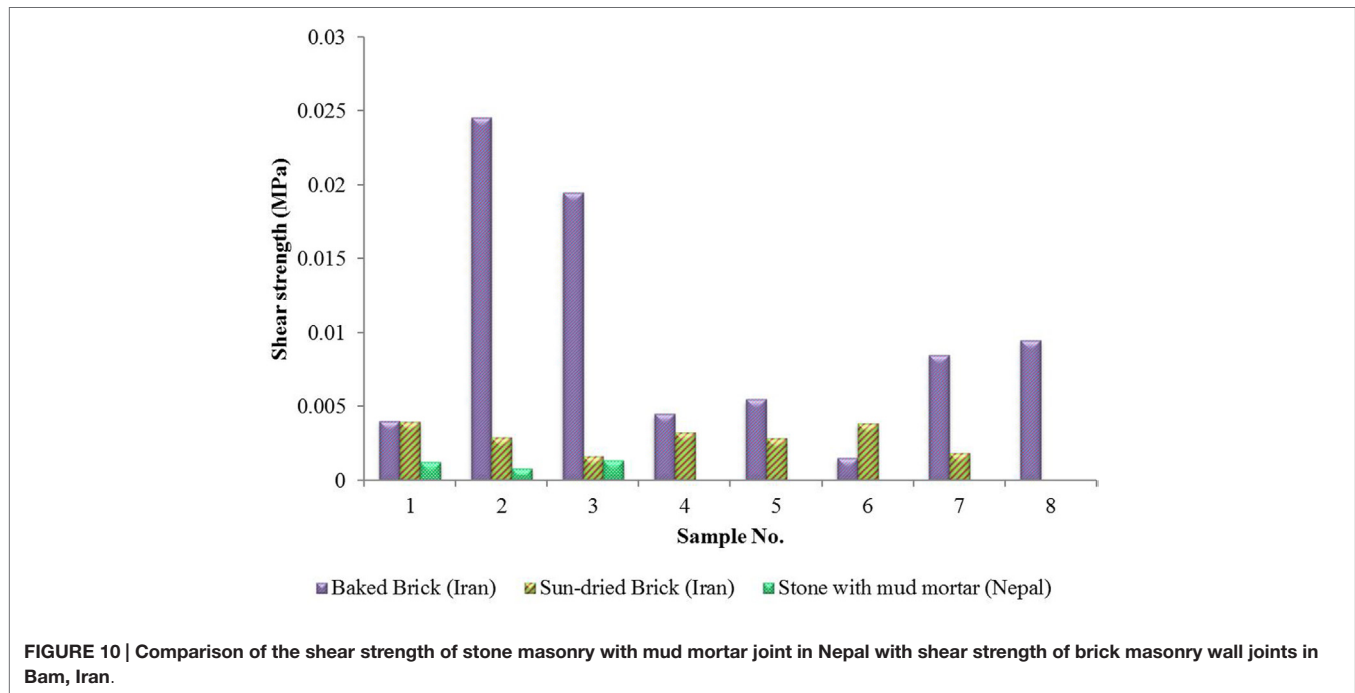
In fitting the data from the test result, we found the value of cohesive strength (c) and coefficient of friction ( $\mu$ ) of stone masonry with mud mortar joints to be 0.001137 MPa, and 0.6, respectively.

Samples of the test are not enough to conclude the material strength; hence, we compare these values with the test results from the 2003 Iran Bam earthquake damage survey (Kiyono and Kalantari, 2004). Results of the test conducted in Iran and Nepal are shown in **Figure 10**. In Iran, tests were conducted for sun-dried and baked brick masonry structures, where the shear

strengths of mortar bonding were estimated to be 0.0029 and 0.0097 MPa, respectively. The frictional coefficient for the joint was found to be 0.62 and 0.54, respectively, for sun dried and baked brick masonry. Test results from Nepal show that the frictional coefficient lies between the values of sun-dried and baked masonry structures in Iran, but shear bonding strength is much lower than that of both brick masonry structures.

**FIGURE 10 | Comparison of the shear strength of stone masonry with mud mortar joint in Nepal with shear strength of brick masonry wall joints in Bam, Iran.**
