# Multi-Source Data Integration to Investigate a Deep-Seated Landslide Affecting a Bridge

Received: 13 June 2019; Accepted: 9 August 2019; Published: 12 August 2019

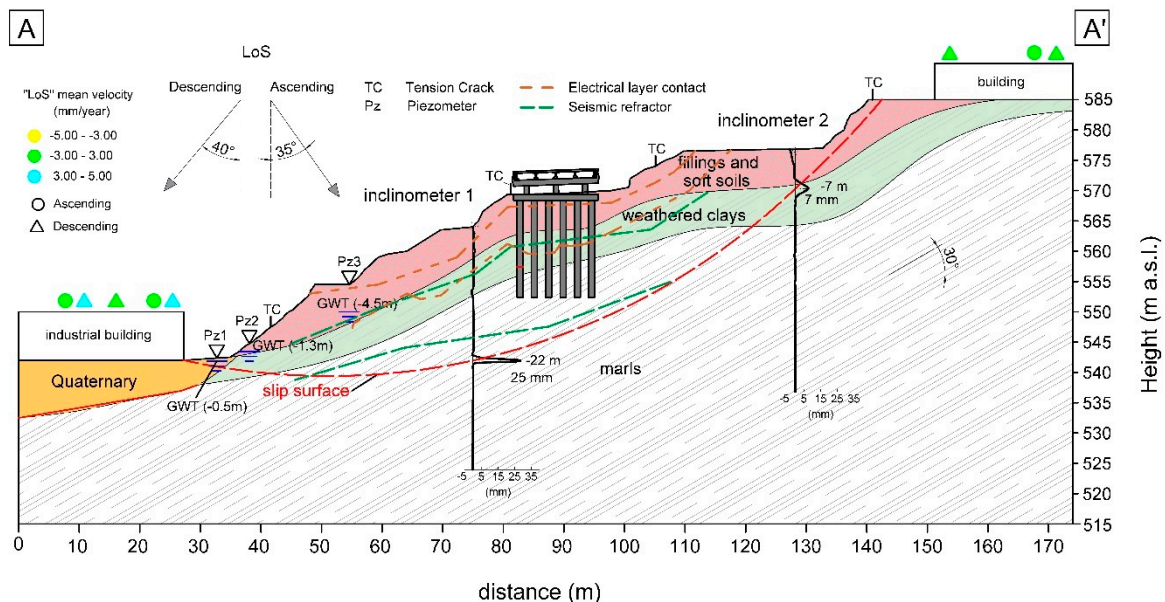
A two-dimensional back analysis of the slope stability by the limit equilibrium method was performed to assess the slip surface that is depicted in Figure 3. This analysis was performed while using the limit equilibrium method. The Rocscience Slide software was used for this task. The integration of monitoring in the stability analysis was done by introducing location and depth of the slip surface and of the groundwater table, detected in both inclinometers and in the three piezometers, respectively.

**Figure 3.** Integrated Cross-section A-A' of the slope where Differential Interferometry Synthetic Aperture Radar (DinSAR) information, inclinometers and the potential slip surface have been included. Note that the plotted displacements correspond to the time period November 2012 to February 2013.

The inclinometer data are shown in Figure 3, where a sliding failure surface located at a depth of 22 m in the inclinometer 1 and of 7 m in the inclinometer 2 is depicted. The rate of displacement is different for both inclinometers. The maximum shear displacement that was recorded in the inclinometer 1 was near 50 mm (on the slope surface) in less than three months with a mean rate of displacements of about 20 mm per month. The inclinometer 2 showed a maximum shear displacement of less than 10 mm. Both inclinometers were installed in November 2012, being the casing of the inclinometer 1 broken in February 2013 due to the shear deformation that was caused by the landslide.

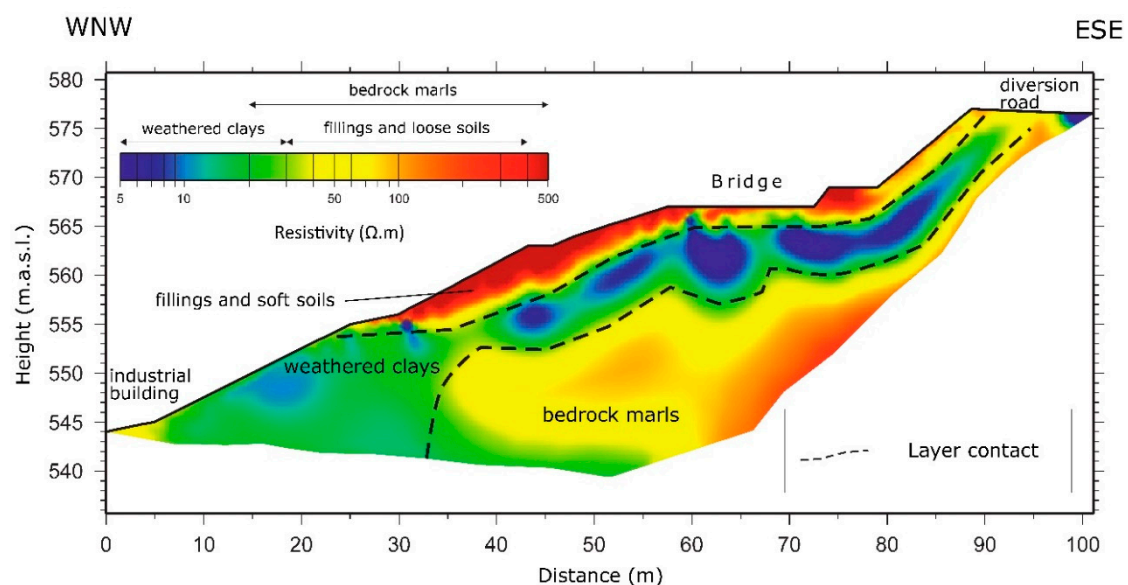
The electrical resistivity profile shows a shallow resistive layer (resistivity between 100 to 200  $\Omega\cdot\text{m}$ ) with a thickness of few meters (Figure 4). This corresponds to the colluvial deposits that were composed of clayey sands with some gravels. Below this layer, a low resistivity layer (5 to 30  $\Omega\cdot\text{m}$ ) is detected, probably corresponding to fine soils unit with high moisture content. The depth of the top of this layer is approximately the same, where the groundwater level was detected in the piezometers, see Figure 3. Finally, a last deep layer is shown in the profile with a resistivity ranging from 40 to 300  $\Omega\cdot\text{m}$ , which could correspond to the marls stratum. The electrical layer contacts detected in the resistivity profile (Figure 4) have been drawn as brown dashed lines in the integrated cross-section depicted in Figure 3. Although the resistivity profile is not exactly in the same position as the integrated cross-section, see Figure 1, some interesting results can be observed when joining this information. Both electrical contacts seem to correspond with the contact layers between the soft soils and weathered clays and between the weathered clays and marls. The lowest contact could also correspond to the groundwater table depth as a low resistivity layer was detected. This contact depth is similar to the groundwater level depth that was observed at the piezometers, although a difference in depth is observed, which is

**Figure 4.** Electrical Resistivity Tomography (ERT) oriented mostly perpendicular to the slope (TM in Figure 1). Three types of soils have been identified according to their resistivity. The black dashed lines show the contact between these soils.

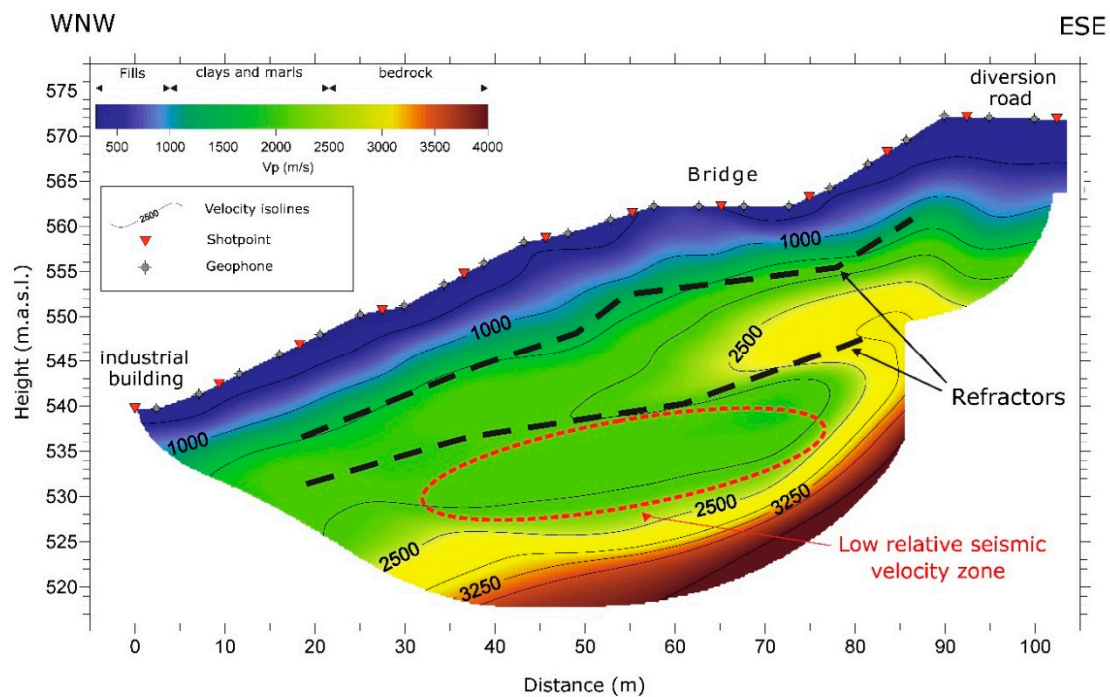
Figure 5 shows the seismic tomography profile along the landslide axis. From this figure, three distinct layers can be distinguished with P-wave velocities increasing with depth. A relatively thin surficial layer with low velocity (less than 1000 m/s) can be observed in this figure. This seismic layer corresponds to the colluvial deposits. A second seismic layer is distinguished below the first one with a P-wave velocity between 1000 and 2000 m/s. Lastly, a bedrock layer with a P-wave velocity higher than 2500 m/s is distinguished in greater depth. These three seismic layers correspond to the stratum of clays and marls. The lower seismic velocity that was measured in the top stratum is because the top stratum is superficially weathered. The refracting interfaces that were observed at the seismic tomography profile (Figure 5) have been drawn as green dashed lines in the integrated cross-section that is depicted in Figure 3. As for the resistivity profile, the tomography profile is not exactly in the same position as the integrated cross-section, see Figure 1, but some interesting results can also be seen when joining this information. While the highest seismic refractor seems to be a contact layer, the lowest one could correspond to the slip surface, as it is nearly at the same depth as the observed in the inclinometer 1 and is very similar to the slip surface, as assessed by the slope stability analysis (red dashed line).

**Figure 5.** Seismic tomography oriented mostly perpendicular to the slope (TM in Figure 1). The black dashed lines show the refractors within the soil body.

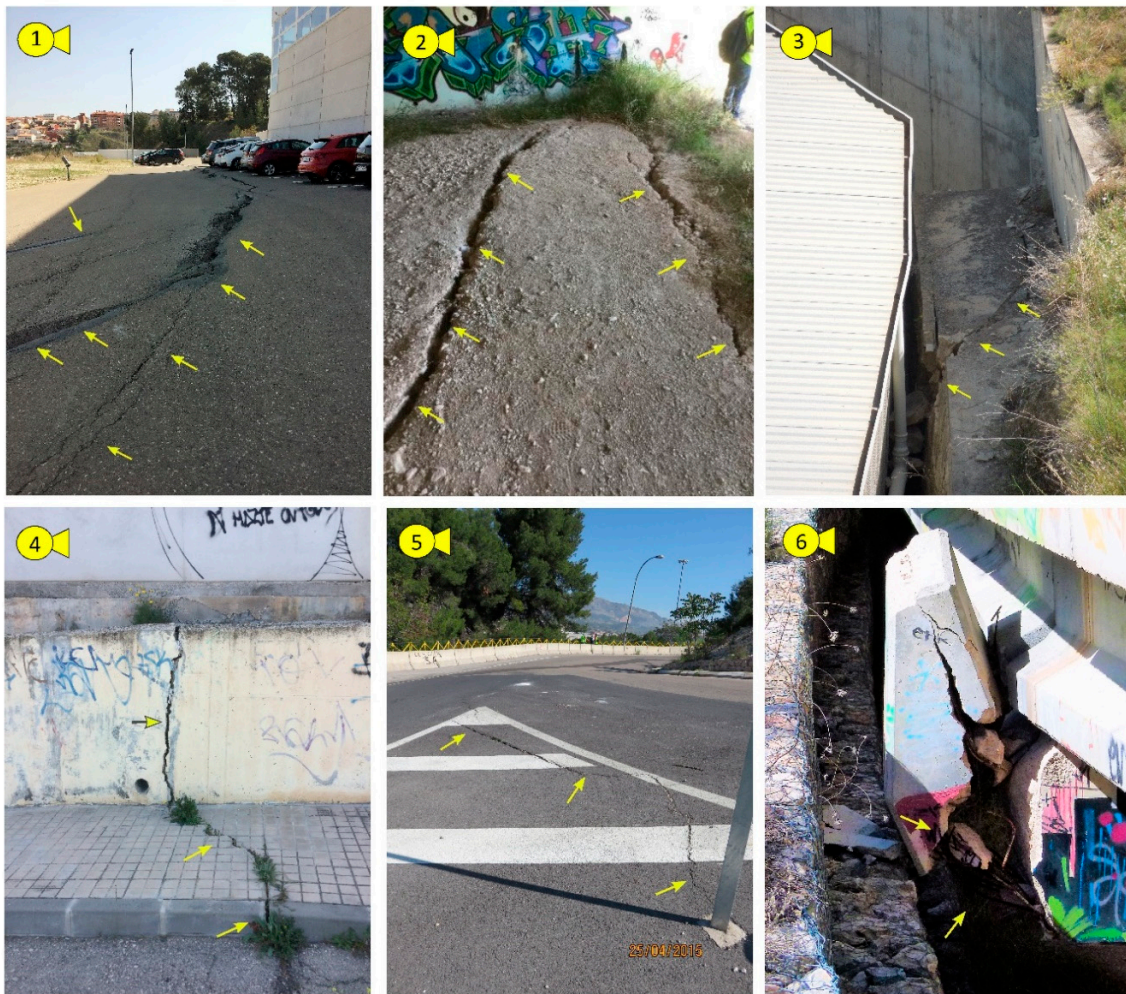
The damage inventory that developed during the field campaigns and the location of the crack is shown in Figure 1. A remarkable long tension crack, over 100 m, was observed on the top of the slope, not just located above the bridge, but also spreading towards the southwest. This tension crack affects the outside pavement of the industrial building located south from the bridge on the top of the slope (Figures 3 and 6-1). It is also noteworthy the number of tension cracks on the soil surface some meters above the bridge and below the structure (Figure 6-2). However, fewer cracks were observed at the toe of the slope, although the retaining wall of one of the industrial buildings is clearly cracked and tilted (Figure 6-3). Tension cracks have also been clearly detected north of the bridge, in the concrete fence of some plots and by the roundabout pavement (Figure 6-4,5).

Damage has also been observed on the bridge structure. The level of damage is so severe that some precast beams that were placed on the supporting piers have been displaced out from its elastomeric bearing pads, breaking some exterior shear keys (Figure 6-6). The broken exterior shear keys are those located in the east part of the bridge, the top slope side of the bridge.

**Figure 6.** Photography of damages. (1) Crack at the head of the slope. (2) Crack on the soil surface beneath the bridge. (3) Broken wall at the bottom of the slope. (4) Cracked concrete fence located north of the bridge. (5) Crack on the pavement at the roundabout, north of the bridge and tilting of the lamppost. (6) Shear key broken because of precast beam lateral movement. Photos location are shown in Figure 1.

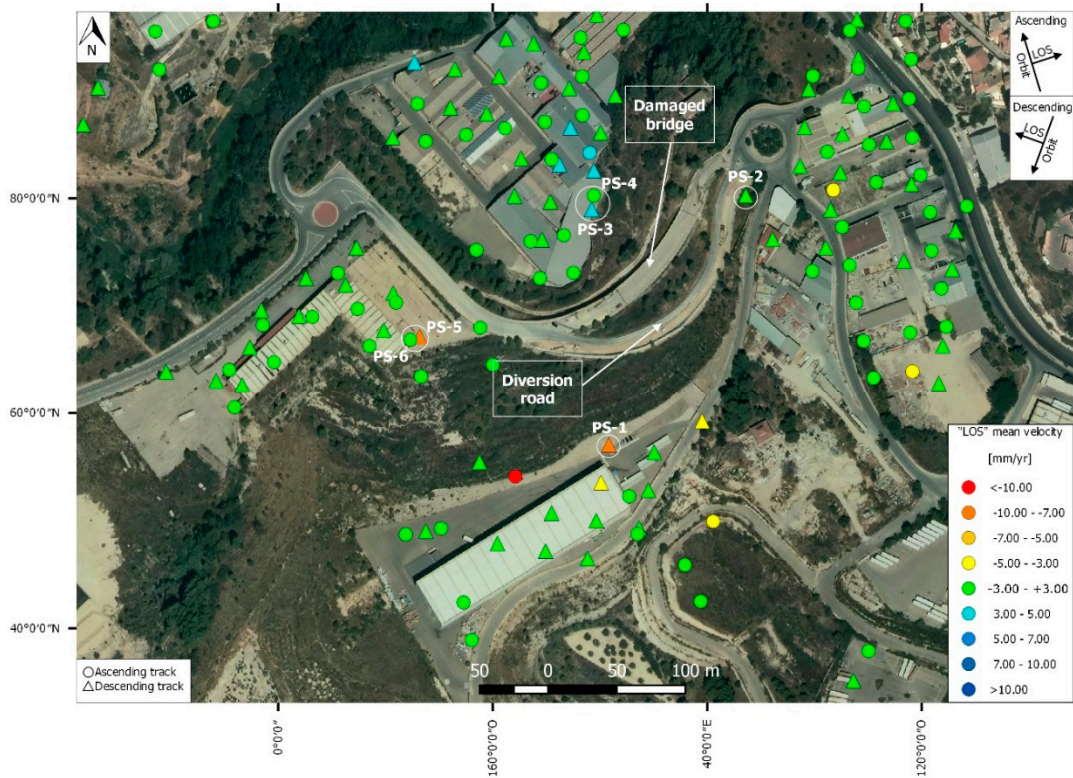
It is well known that the DInSAR technique is insensitive to N-S displacements. Additionally, significant topographic variations can cause distortions in the SAR images (i.e., foreshortening and layover) and to obscure areas from view (i.e., shadowing). Therefore, these limitations have been evaluated while using the R-index [42] and the percentage of the real movement [43] in the nearby area of the monitored bridge. The results that were obtained for both indexes suggest that the bridge area presents high visibility for the descending track (R-index higher than 0.4) and a good percentage of the detectable deformation (higher than 40%) and, therefore, PS detection mainly depends on land use. Despite that, only some PS give us information regarding the displacements' pattern of the bridge and the nearby built areas. The results of the DInSAR analysis are shown in Figure 7. The stability range is coloured in green and it represents a velocity of  $\pm 3.0$  mm/year. Unfortunately, most of the PS are located in built areas and few PS are on the bridge and in the vicinity areas. One of these points is PS-1, located at the top of the slope and showing a Line of Sight (LoS) movement with a velocity of  $-7.43$  mm/year. Nevertheless, the velocity of other points located inward the top of the slope is within the stability range. This may mean that the top boundary of the slide is a few meters from the edge of the slope. PS-2 is within the stability range and this could mean that it is outside the east boundary of the slope, as other points located further east do not show any movement. Other interesting points are those that are located at the toe of the slope, for example, PS-3 and PS-4. These points show an upward velocity of  $3.02$  mm/year, which could mean that a rotational slide is affecting the slope, moving down the points that are located at the zone of depletion and upward those points that are located at the zone of accumulation. This information can be seen at the displacement time series in Figure 8. In this figure, it is depicted the rainfall data corresponding to the same time-span of the satellite acquisition, every 12 days, and the cumulative displacement of the points (red and blue lines for ascending and descending tracks, respectively). It can be seen as the velocity of these points increased after the rainfall period starting at the end of 2016 for the descending and ascending tracks.

**Figure 7.** Results of DInSAR analysis. Mean displacement velocity recorded by ascending (circle) and descending (triangle) tracks.

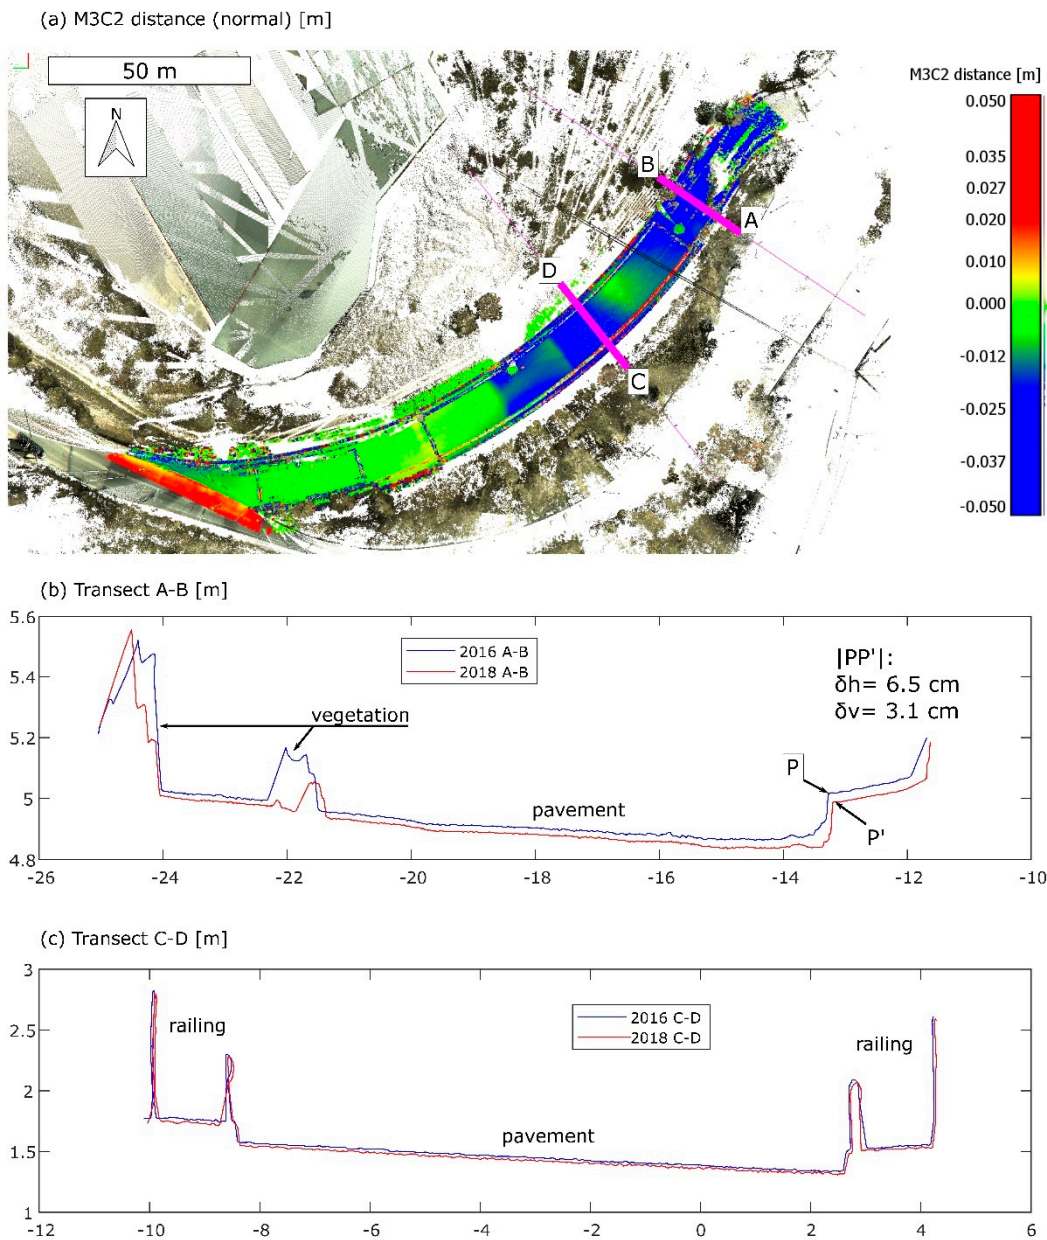
Figure 9 shows the results of the relative M3C2 normal distance between the two scans that were carried out in May 2016 and April 2018. For each estimated distance the M3C2 method computes the distance uncertainty. The uncertainty presents a mean value of 5.685 mm, being the standard deviation of 11.975 mm (the closer to zero the better) [41,44]. Figure 9 suggests a relative downward movement of the north abutment and of the bridge deck. Nevertheless, the south abutment can be considered to be stable. The downward movements that were detected are approximately 3 and 2 cm for the north abutment and the top of the deck, respectively. Two cross-sections of the bridge are shown in Figure 9b,c. Figure 9b depicts the relative displacement of the point P. This point corresponds to the location of the upper corner of the kerb in May 2016, whilst point P' corresponds to the location of the same point in April 2018. As can be seen in this figure, the relative horizontal displacement of this point is equal to 6.5 cm and it moves towards the outer part of the slope. Regarding the vertical displacement, point P has a descending movement that is equal to 3.1 cm. The uplifts (red area in Figure 9a) that are located on the west part of the processed area are due to the resurfacing of the diversion road.

**Figure 9.** (a) Comparison of LiDAR models between May 2016 and April 2018 and location of the extracted steepest slope transects; (b,c) transects of the 3D point cloud of stages 2016 and 2018.

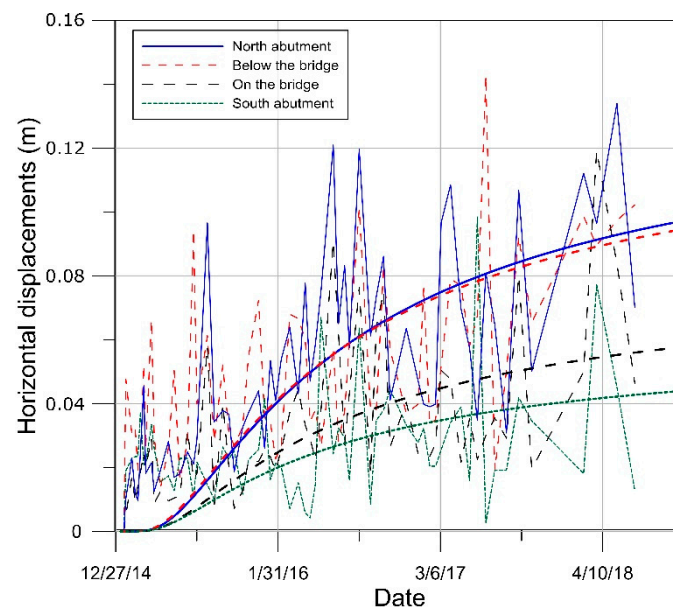
(upper side of the cap piles), and (d) south abutment. As can be seen in Figure 10, the control points were checked from January 2015 to July 2018. Although the time-series are quite noisy, the south abutment presents the lowest total horizontal displacement, while the north abutment and the points located below the bridge show the highest displacement. A differential movement is observed between the points that are located below and on the bridge, being those below the bridge, which present higher displacements. Looking at Figure 10 seems that human errors such as inconsistent setup could have considerably reduced the accuracy of the survey. For this monitoring proceedings such as redundancy of observations could have reduced the possibility of blunders [45]. Despite that, the trend of the different areas' movements can be seen in the figure while looking at the general trends of the displacements throughout the sigmoidal regression lines of these four groups. North abutment points and points that are below the bridge have similar movements and trends. Nevertheless, the points on the south abutment show a totally different trend and displacements. The points that are located on the bridge pavement show a similar trend to those that are located on the north abutment and below the structure, although the points located on the pavement show smaller displacements than those that are located below the structure. It is worth highlighting that the only purpose of these regression lines is to show the general trends of the four areas, not the prediction of displacements.

**Figure 10.** Average horizontal displacements evolution of the control points sorted by its location: (a) north abutment, (b) On the bridge pavement, (c) below the bridge (upper side of the cap piles), and (d) south abutment.

When looking at the horizontal displacements of the points that were located on the bridge pavement, Figure 10, an intermediate value between the horizontal displacements of the points located below the bridge and those on the south abutment is observed. The general trend of the points located on the pavement of the bridge is similar to that observed on the points below the bridge, although the points located on the pavement show a dampened movement when compared to those located below the structure. This difference in the rate of the horizontal displacement between the bridge, the ground below the bridge and the south abutment is also confirmed by the movement of the precast beams placed on the supporting piers. The precast concrete beams of pier 3 (the closest to the south abutment) show a relative displacement eastward, the opposite direction to the landslide movement, as compared to the pier and its foundation. This relative displacement between beams and piers is also shown for piers 2 and 1, although it is gradually decreasing as we move away from the south abutment (i.e., from

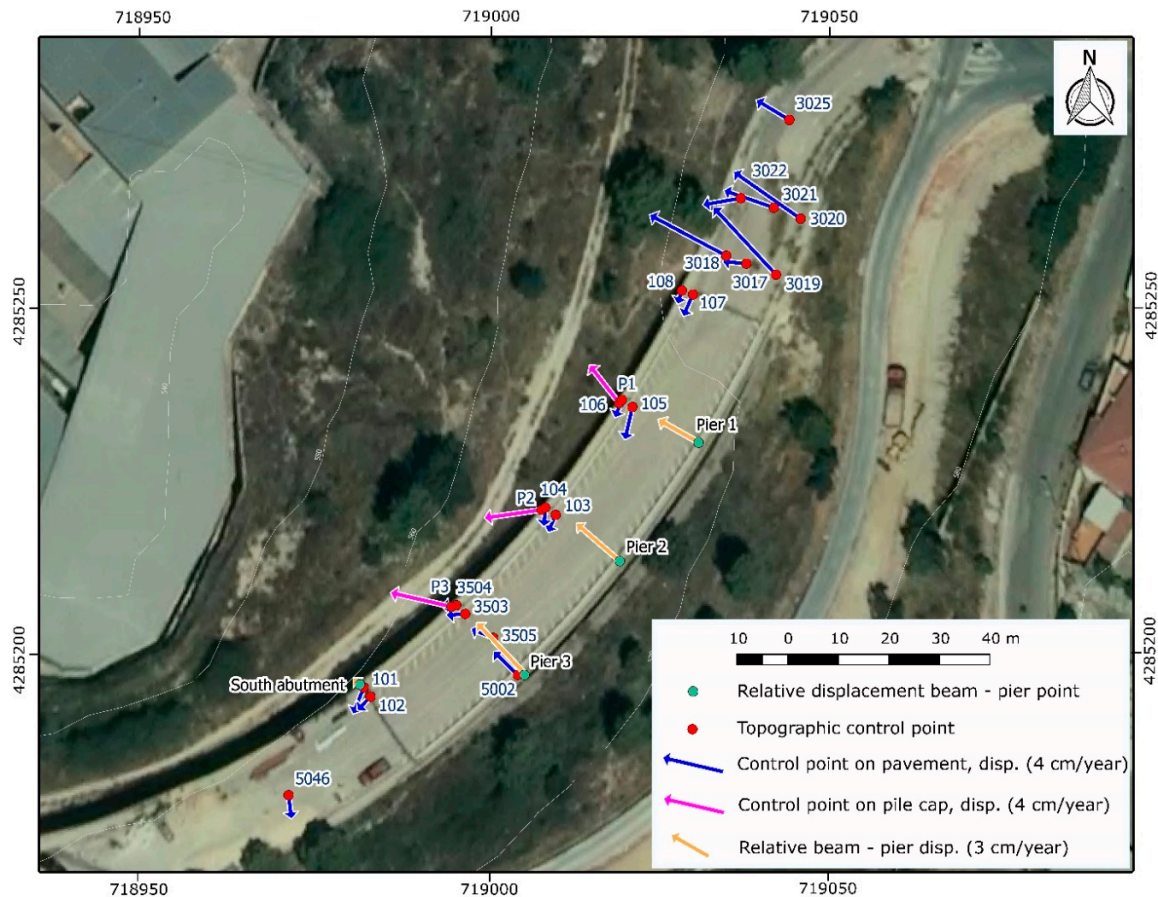
The relative movement between the precast concrete beams and the support piers have been measured for six years, from 2012 to 2018. The mean displacement of the beams that were supported by each pier has been assessed. Figure 11 shows the magnitude and the direction of the relative displacements of the precast concrete beams as well as the position of the piers. The mean values of

the total displacements during this period are 17.2, 23.7, and 30.3 cm for piers 1, 2, and 3 (Figure 11), respectively. The mean rates of displacements are 2.9, 3.9, and 5.1 cm/year for piers P1, P2, and P3, respectively.

**Figure 11.** Horizontal displacements of the control points measured by topographic surveys and relative displacements between the precast concrete beams and the supporting piers. All the topographic control points are located on the road pavement, except for P1, P2 and P3 which are on the pile cap surface below the bridge.
