Seismic Performance of Multistorey Masonry Structure with Openings Repaired with CFRP Grid

Gu, J-B, Tao, Y, Xin, R, Yang, Z & Shi, QX 2018, 'Seismic Performance of Multistorey Masonry Structure with Openings Repaired with CFRP Grid' *Advances in Civil Engineering*.

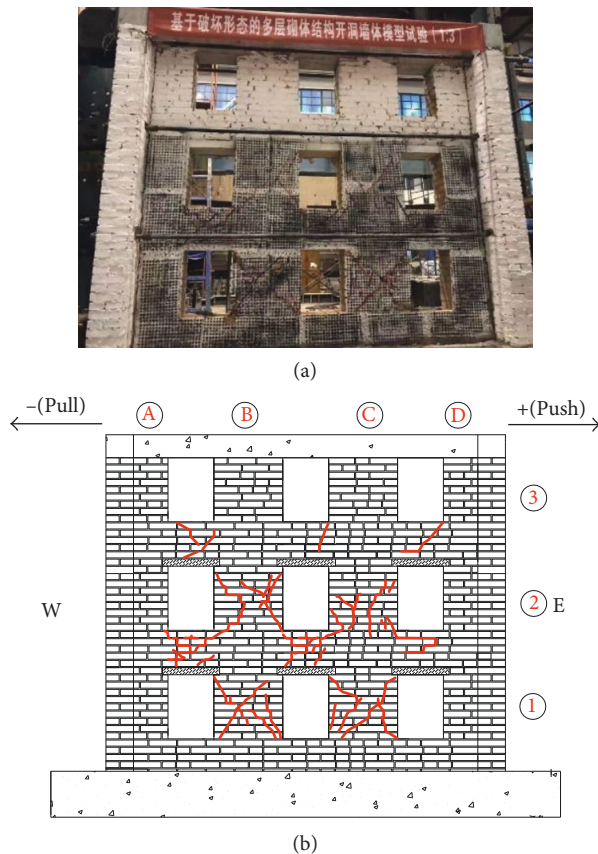
FIGURE 6: Final failure and crack pattern of the URM wall. (a) Final failure of the URM wall from the south side. (b) Crack schematic diagram of URM wall.

The final failure mode and cracking schematic diagram of the URM wall are presented in Figure 6. The cracks in the spandrels of the second floor firstly occurred, the piers of the first floor cracked thereafter, and the piers of the second floor then cracked, the spandrels of the third floor finally cracked. The failure mechanism of the URM wall was thus the weak spandrel failure corresponding to the sequence of cracking [1]. The URM wall failed due to shear failure in accordance with the cross diagonal cracks.

4.1. Failure Mechanism. In the present study, the URM wall under the in-plane quasistatic loading failed in the shear-dominant failure mode, which was mainly characterized by the cross diagonal cracks occurred in both spandrels and piers. Also, the failure mechanism was considered as a typical weak spandrel failure because the spandrels of second floor cracked before the occurrence of cracks in piers of the first floor.

3.2. URM Wall Repairing. In order to develop an effective and convenient repair scheme for the earthquake damaged masonry walls, the damage mechanism and the magnitude of damage of the URM wall were the key parameters to be considered. The purpose of the present study is to evaluate the seismic performance and recovery results of the CRM wall which utilize limited CFRP grid. Therefore, only the severely damaged areas, including the spandrels of second floor and the piers of the first floor, were repaired with CFRP grid in the present study. It was expected to address the lower limit of repairing demand and its performance. Additionally, although double-side strengthening is usually recommended in the available design codes, like [25, 26], a single side repair scheme was adopted in the present study with consideration of the application convenience and less interruption.

The repair procedure of the earthquake-damaged masonry wall could be summarized as follows: the broken bricks and mortar were firstly remedied using same strength mortar, but the completely broken bricks need to be replaced using same bricks. The surface of the repair areas were then cleaned to remove the irregularities and dust after the repaired mortar being hardened. In order to secure the performance of the CFRP grid repair scheme and prevent the premature cutting fracture of the CFRP grids, CFRP sheets were bonded at the edges of openings before bonding CFRP grids as presented in Figure 7. The CFRP sheet width was 100 mm, and the fiber direction was across the edges. The epoxy resin was only applied to the repaired area, and the CFRP grids were then bonded. The CFRP grid repairing system was cured for 24 hours before testing. The repaired masonry wall is schematically presented in Figure 7.

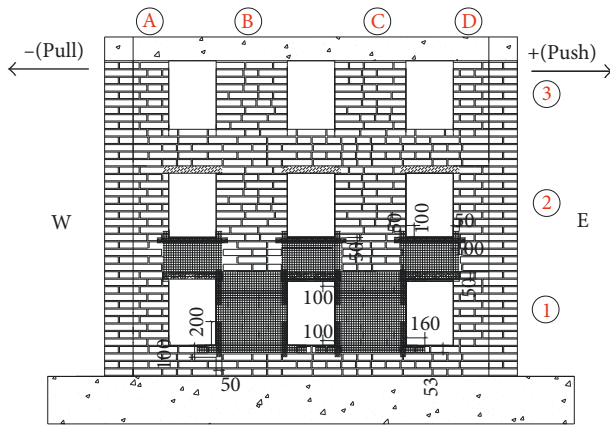
FIGURE 7: Repair scheme of the damaged URM wall.

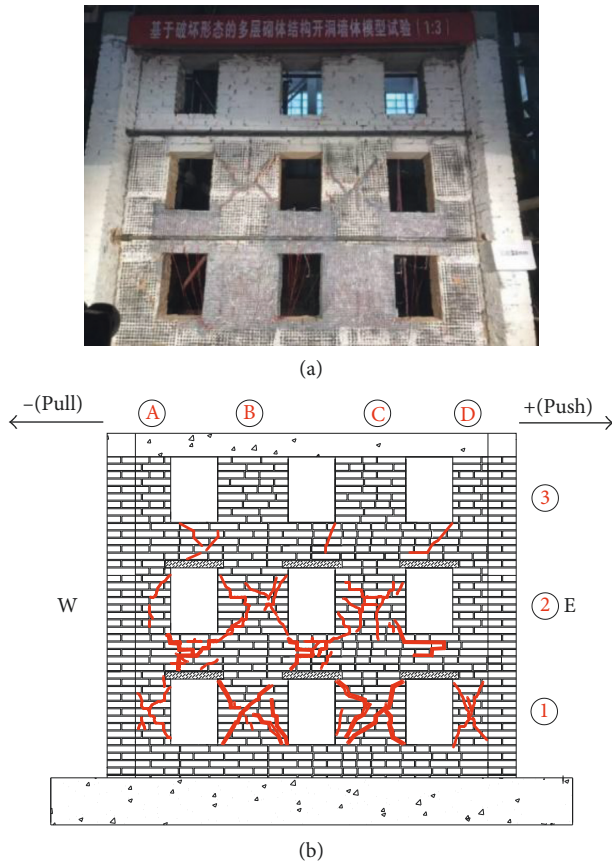
The final failure and cracking schematic diagram of the CRM wall are presented in Figure 8. The details of failure were shown in Figure 9. The debonding failure mostly initiated from the center of repaired regions and propagated to the edges. It was noticed that the CFRP grid was not fully debonded from the masonry because the additional CFRP sheets bonded at the edges of openings which can effectively prevent the propagation of debonding failure. It may be concluded that the failures of the CRM wall developed from the lower floor to the higher floor according to the sequence of failure. Furthermore, the unrepaired areas cracked before the occurrence of debonding failure of the same floor.

It needs to be stressed that the failure of CRM wall was largely affected by the magnitude of damage and repair scheme [13, 19]. The failure of CRM wall in the present study consisted of the CFRP grid debonding failure and shear diagonal cracks in the unrepaired masonry areas. The sequence of CRM wall failure strongly depended on

FIGURE 8: Final failure and crack pattern of CRM wall. (a) Failure of the CRM wall from the south side. (b) Crack schematic diagram of CRM wall.

the magnitude of damage, extent of damage, and repair scheme. The unrepaired piers of the first floor cracked prior to the debonding failure of repaired piers at the same floor, indicating that the failure mechanism shifted from the weak spandrel failure to the weak pier failure due to the application of CFRP grids. The weak pier failure is the preference because it rarely leads to the collapse of the entire wall compared with the weak spandrel failure [1, 7]. Also, the reason why no fiber fracture occurred may be due to the weaker strengthening. The failure mode usually corresponding to strong strengthening, like fiber fracture, is the preference because the advantages of high strength of FRP can be fully utilized.

- (5) According to the findings of the present study, it is efficient to prevent the cutting fracture of FRP grids and restrain the development of debonding by bonding FRP sheet across the edges of opening.

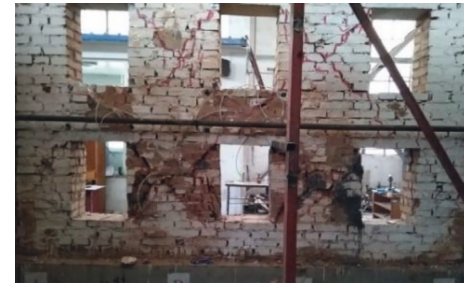
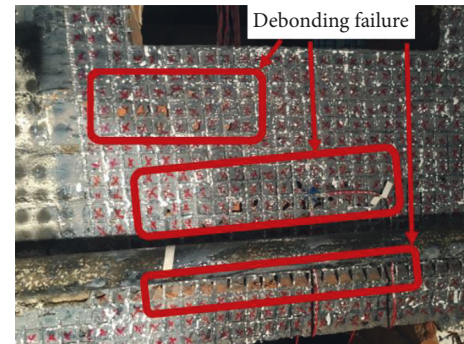
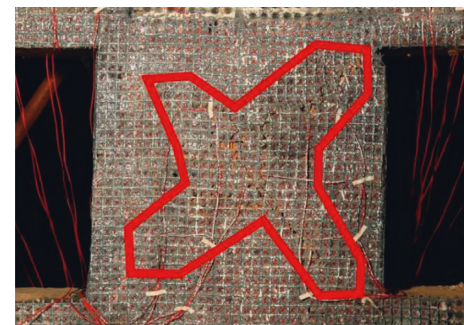
FIGURE 9: Failure details of CRM wall. (a) Failure of the CRM wall from the north side. (b) Debonding failure in 2-CD region. (c) Debonding failure in 1-B region.
