Earl, S., Rankin, K.E., Lewis, R. orcid.org/0000-0002-4300-0540 et al. (2 more authors) (2019) Verification of the use of micro-CT scanning to assess the features of entire squat type defects. *Wear*. ISSN 0043-1648

1
2 **VERIFICATION OF THE USE OF MICRO-CT SCANNING TO ASSESS THE FEATURES OF**
3 **ENTIRE SQUAT TYPE DEFECTS**

22 Squats and studs are defects in railheads that share features, but have different causes. This paper examined four squat
23 and stud samples from three different traffic environments to compare features using μ -CT X-ray scans, surface and
24 subsurface inspection. μ -CT scanning has been used before as a non-destructive method to investigate rail defects, but
25 not the entire defect. The scans were verified and allowed the identification of areas of interest when sectioning the
26 samples further. The scan volumes were also used to create 3D models of the crack networks for the 3 samples that were
27 scanned. All defects contain similar superficial features but the depth and severity of the subsurface damage varies.

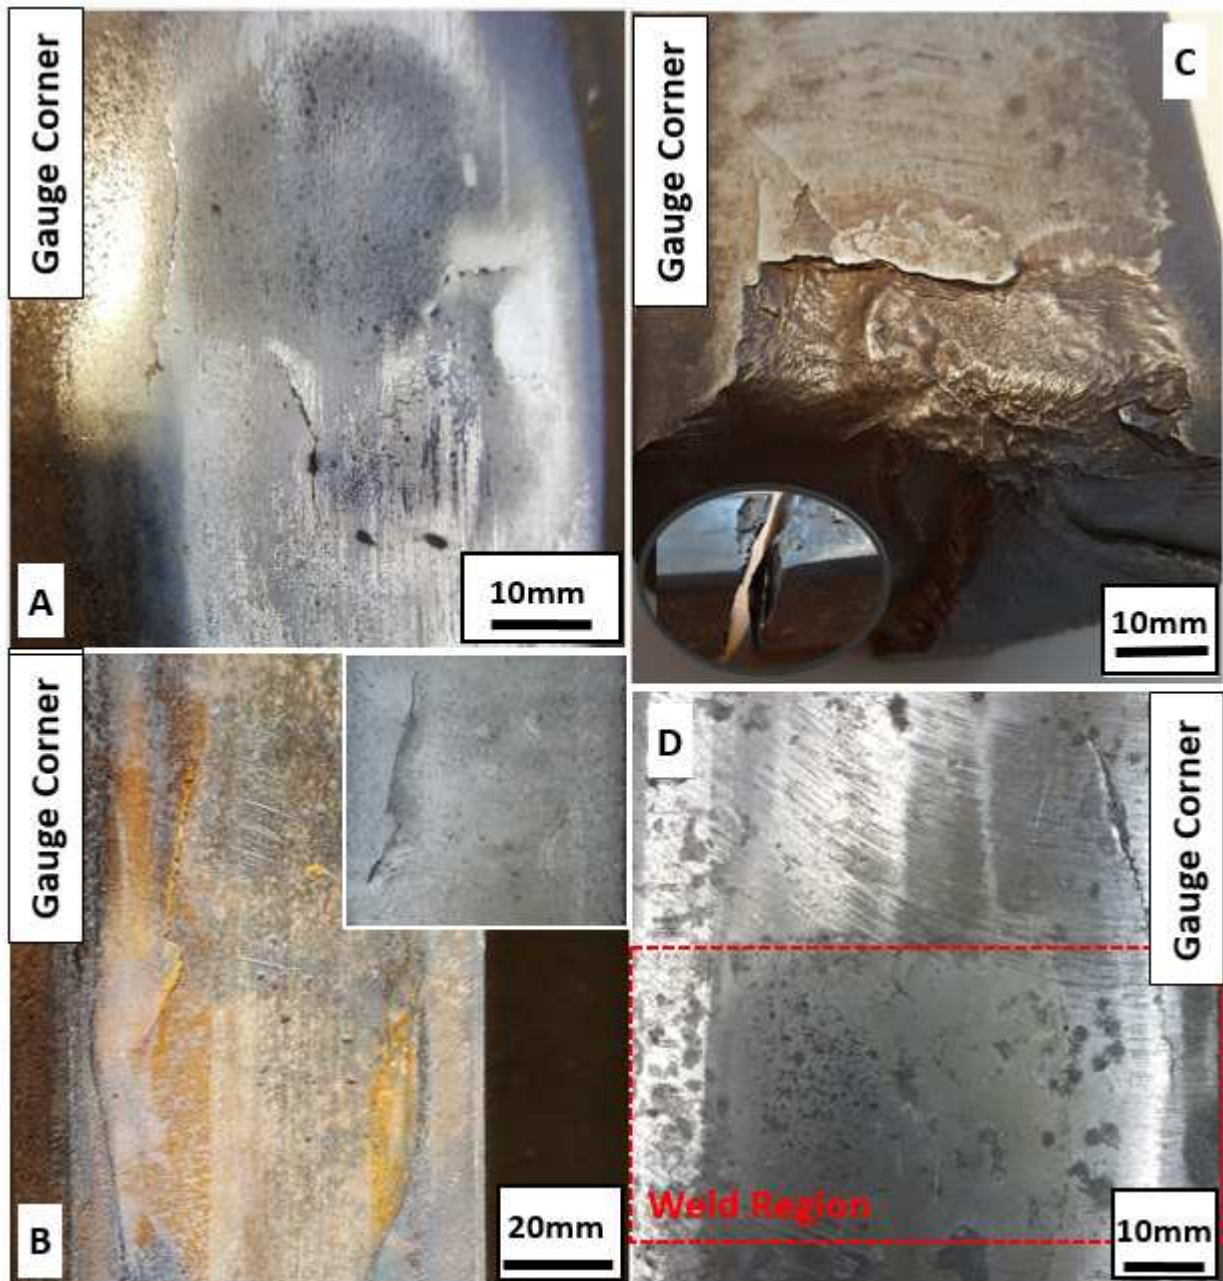
94 Not much is known about the track location and traffic experienced by sample 1 other than it was from an inclined track
95 near a station on a metro line. Sample 1 is shown in Figure 3a. It shows signs of sliding surface damage and the dark spots
96 are quite well developed. It contains a lot of surface damage including four obvious surface cracks, streaks of what is
97 assumed to be white etching layer (WEL), a pit in one of the cracks, what seems to be 'snakeskin' damage just outside
98 the widened running band. WEL is shown in results. 'Snakeskin' is also known as running surface checking or flaking
99 and is a precursor to spalling of the rail surface [12]. There is also the very common V-shaped crack that squats are known
100 to exhibit, although the angle within the V in this crack is more obtuse than expected. There is also a faint series of small
101 cracks along a ridge that extends from the apex of the V-shaped crack out between the two lobes which is often observed

113 Sample 2 is shown in Figure 3b, and is post MPI (magnetic particle inspection): a non-destructive test that uses magnetic
114 ink on a white contrasting background to highlight defects in the surface. The long crack seen on the left of Figure 3b,
115 seems to be a combination of the long cracks found at the edge of the running band in samples 1 and 4 (Figure 3a and d
116 respectively) and the expected V-shaped crack typically seen in a classic squat. The crack also has sharp edges unlike the
117 embedded cracks found on the other samples, possibly a sign that the crack is very recent. Sample 2 also has significant
118 discreet material removal. These look like corrosion pits, but are more likely localised delamination and flaking
119 characteristic of "ratchetting" [14]. Ratchetting is incremental plastic deformation of the upper surface of the rail material
120 due to cyclic strain build-up. Unique features in sample 2 are possibly because of traction control being used by the rolling

Figure 3: Images of the samples, all of which are a full rail width (~75mm wide) a) Sample 1 b) Sample 2 with magnetic particle inspection image inset to show apex cracks on field side c) Sample 3 with the other half of the defect inset d) Sample 4 with the weld region highlighted

Sample 3 is a broken rail of unknown MGT, which failed due to a transverse defect, within a squat defect, shown in Figure 3c. Most of the squat was damaged in the break, removing any surface evidence of the expected V-shaped crack. There was not much information to be gained from the shelled lobe either. However, the unbroken lobe of the squat was still available to view. The second lobe was very close to shelling and so presented the opportunity to remove the almost separated plate of surface material from the top of the defect. This allows the inspection of the crack plane below the squat. This plane was covered in oxide but the presence of water may have come from the cutting process due to the coolant flooding the sample. The plane was dry ice blasted to remove the oxide. The plastic flow shown by the folded material right next to the shelled section makes this most likely to be a squat.

Sample 4, shown in Figure 3d, was initially identified as a squat on an alumina-thermic weld and following an ultrasound test, was believed to be a combination of a squat interacting with a weld defect. The longitudinal crack that runs along the edge of the sample shows that the squat is slightly elongated, possibly linked to the higher train speeds [16]. The lack of deformation in the squat and the traffic total of ~28MGT makes it likely that this is in fact a stud, although a study has shown that 17% of squats are found at welds [17].

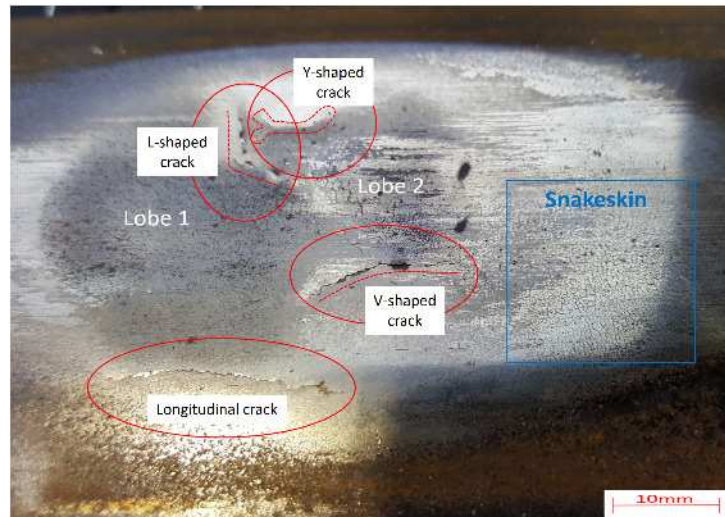
On sample 1 there were quite a few differences in surface finish, such as the shiny running surface next to the dark corroded region of the black spots, as well as the cracked 'snakeskin' region. There are four obvious cracks on the surface that are identified in: Figure 4 and the scanned images of them are in Figure 5. The longitudinal and obtuse V-shaped crack are found in the other samples, but the L-shaped and Y-shaped cracks are not (shown in Figure 4). The Y-shaped crack has been seen before in a squat sample reported on previously by Tata Steel [20] along with the 'snakeskin' surface damage (see Figure 6). In the Tata Steel report the snakeskin was also found on an area of the rail that did not contain a squat. The dark spot within the V-shaped crack is believed to be a spalled piece of snakeskin as the snakeskin can be faintly seen close to the crack (Figure 5c).

Figure 4: Sample 1 with the cracks marked in red and the snakeskin marked in blue

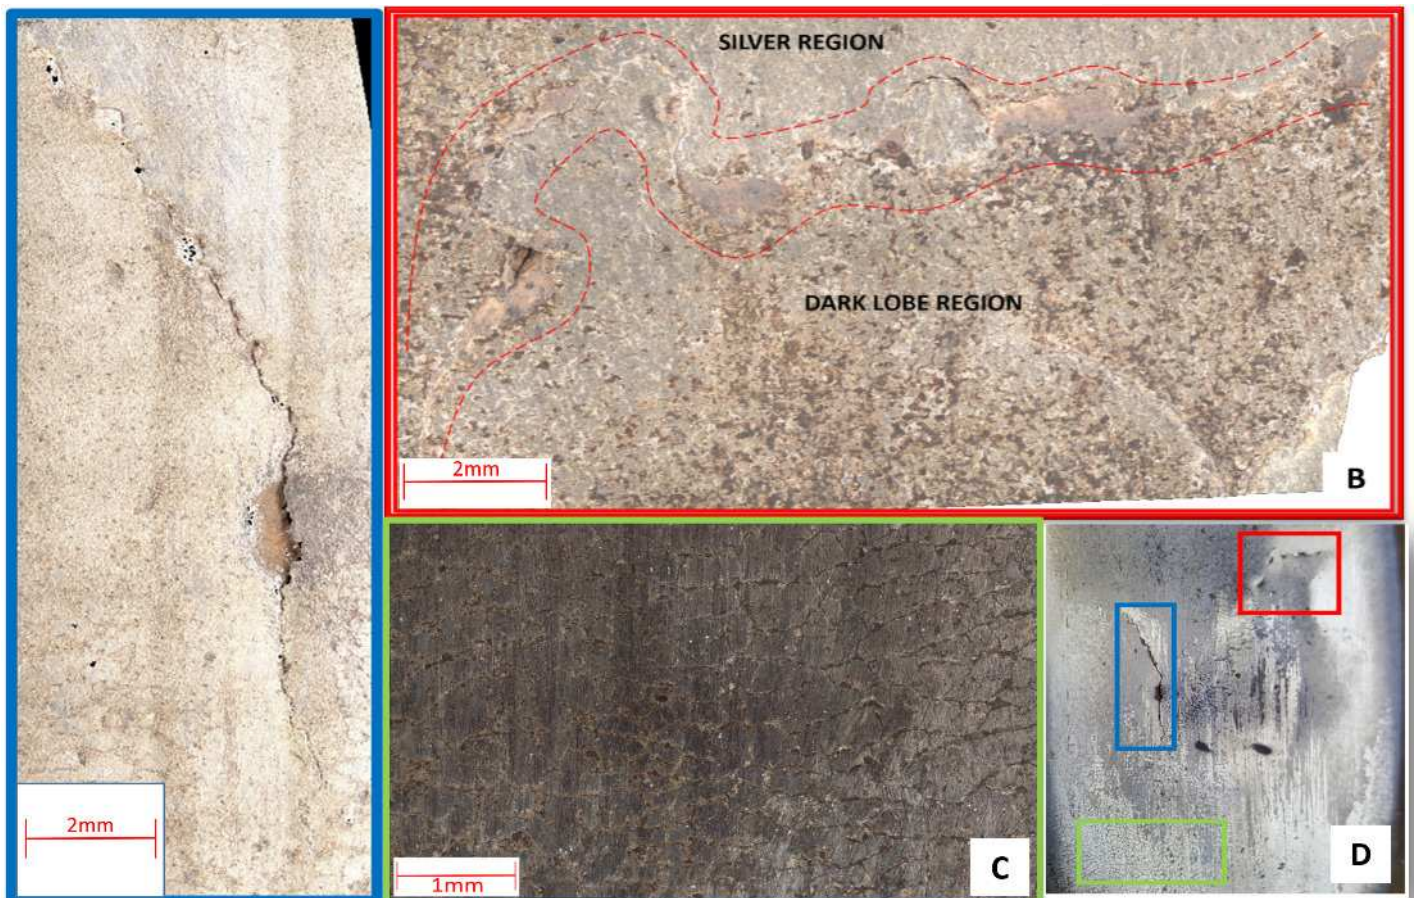
Figure 5: Some of the surface features imaged from sample 1 a) The L-shaped crack with 'islands' that appear pink in the scan b) The V-shaped crack with a pit that penetrates into the substructure c) 'Snakeskin' microcracks across the surface of the rail just beyond the defect d) A colour coded overview showing where the images are taken from

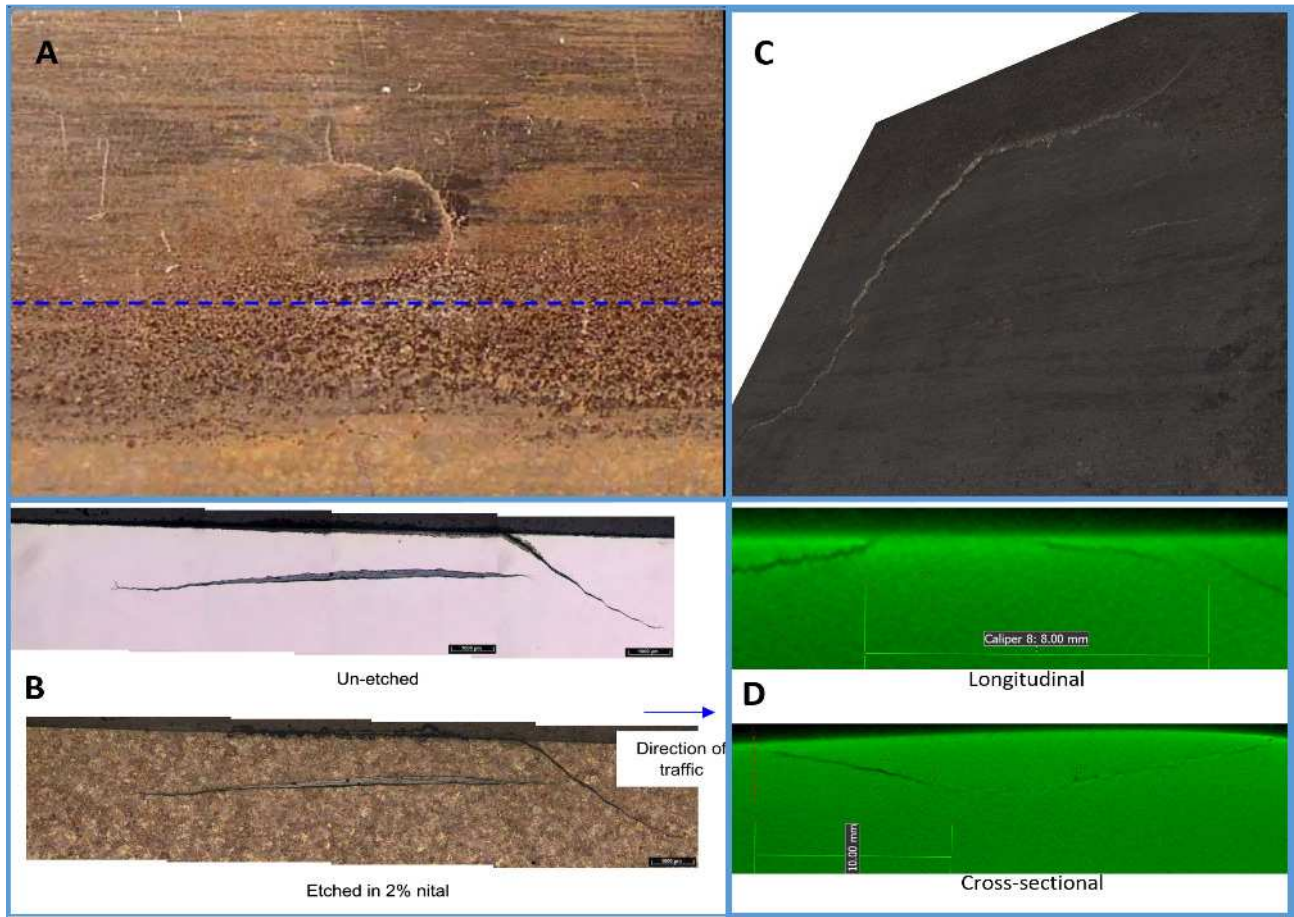
Figure 6 shows the Y-shaped cracks in sample 1 and the Tata Steel report as surface and subsurface defects. As the Y-shaped crack was the only surface crack in the Tata Steel report it can be assumed that this crack forms first. The shallow depth of the defect in the report compared to sample 1 also suggests that sample 1 is much more developed. Both samples are believed to be from the same metro network. The presence of the two cracks suggests the possibility of one crack initiating subsurface whilst the other initiated on the surface. Using the x-ray scanned volume that Figure 6d was taken from, it can be seen that moving through the sample towards the field corner shows that the cracks stay separate, although they may have connected within the region that was worn away. Moving through the sample towards the gauge corner shows the two cracks connecting as a very shallow crack parallel to the surface that makes up the bottom portion of the Y shape (when viewing the Y as written here).

Figure 6: Comparison of features of a squat from a Tata Steel report [20] with scan results from sample 1. a) The surface of the squat from the report, b) Longitudinal cross sections from the report, c) Surface scan from Alicona of sample 1, d) Longitudinal and cross sectional x-ray scans of sample 1 (red dotted line shows where orthogonal slices cross)

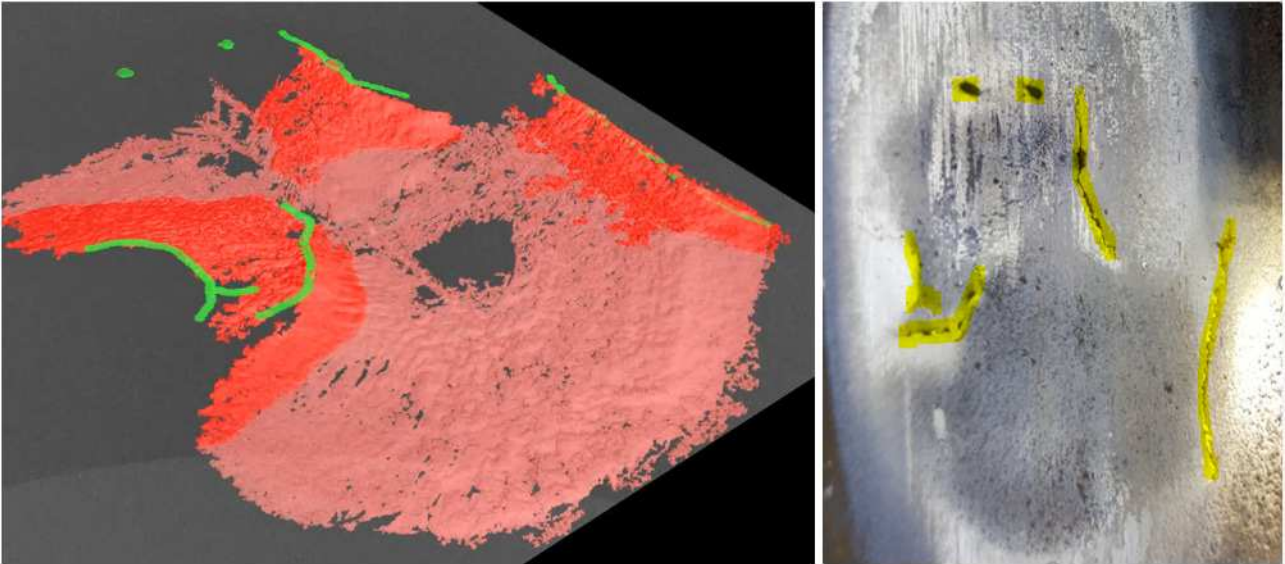
Comparing the report to the scans makes it highly likely that the initiation was in this area, and the branching of the longitudinal crack occurs within 4mm of the longitudinal slice in Figure 6d, moving towards the gauge corner. Being that the Y-shaped crack is closer to the field corner than the gauge corner suggests that a two point contact between the wheel and the rail may have been responsible. High surface temperatures occur with lower creepage and train speed when the contact patch is reduced like in a two point contact [21]. Sample 2 also contains a similar Y-shaped crack in a similar region but the clarity of the two cracks is not as clear, although a higher resolution scan of that area is planned for future work due to the branching of a possible transverse crack being in the same region. The L-shaped crack tracks the boundary between the dark lobe of the squat and the shiny surface of the running band, it also appears to contain islands of a different phase of steel, possibly martensite. This crack will be the subject of further investigations. For each of the 3 samples scanned, a 3D model was created both in Avizo and in VGStudio MAX. The model shown in Figure 7 was created in VGStudio MAX. The crack plane continues through the hole in the centre of the model: that region was not detected by the automatic construction module, but the crack was discernible manually. The crack plane also extends slightly further beyond the two green dots on the model.

Figure 7: Left) The model of the crack network in sample 1 created in VGStudio MAX showing a plane than runs parallel to the running surface to give a gauge or depth Right) a photographic reference of the surface cracks that are green in the model and yellow in the photograph

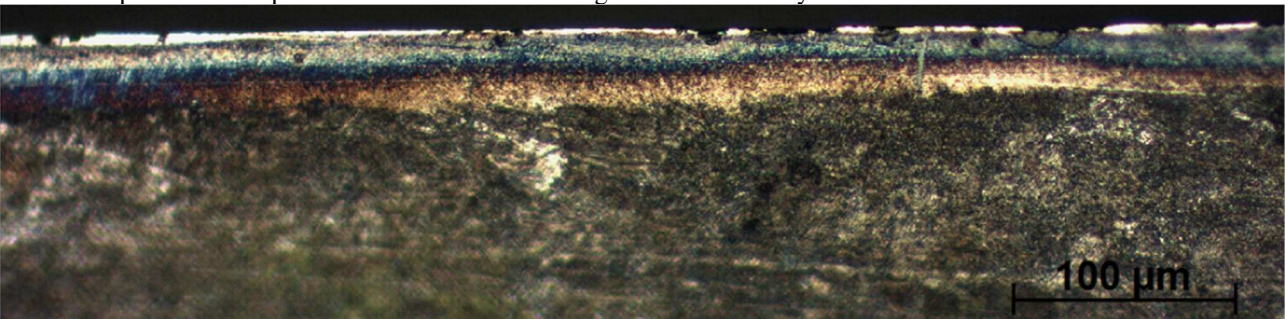
293 WEL varied; it appeared as both islands and long stretches, often within the same sample. An aerial view of the railhead
 294 showed long streaks of WEL and some are visible as contrast in the right image of Figure 7. Depending if the sample is
 295 cut in parallel or perpendicular to a streak probably partly explains this. The other part to consider is that WEL breaks
 296 away easily due to its brittle nature. Figure 8 shows one of the more unusual WEL found and is taken as a longitudinal
 297 slice from between the crack with a hole and the more central of the two black spots (Figure 7). It shows a bright white,
 298 fairly continuous band of WEL that seems very brittle as it has spalled in various places. This is on top of another fairly
 299 continuous WEL that has a distinct boundary with the upper layer and a more diffuse boundary with a deeper yellow
 300 patch of discrete WEL. The lower layer also has a diffuse boundary with the parent steel. It is believed that the lowest

301 layer may have been caused by a grinding stone facet due to its discrete nature, like Figure 14, which is from outside
 302 running band. The other two layers were created by wheel slips of different magnitudes, leading to different temperatures
 303 being reached. Different temperatures will lead to differences in how much of the material reaches full austenisation as
 304 well as the penetration depth of the heat. Further investigation into these layers will be conducted in future work.

Figure 8: Three layers of WEL. The upper brighter WEL and middle duller WEL are fairly continuous for ~15mm of the 25mm sample. The upper layer is ~5 microns thick and the middle layer is ~19 microns thick. The lower, more yellow layer is a patch not much larger than the image and is ~14 microns at its thickest. A grey crack can be seen growing vertically through all 3 layers to the right of the image.

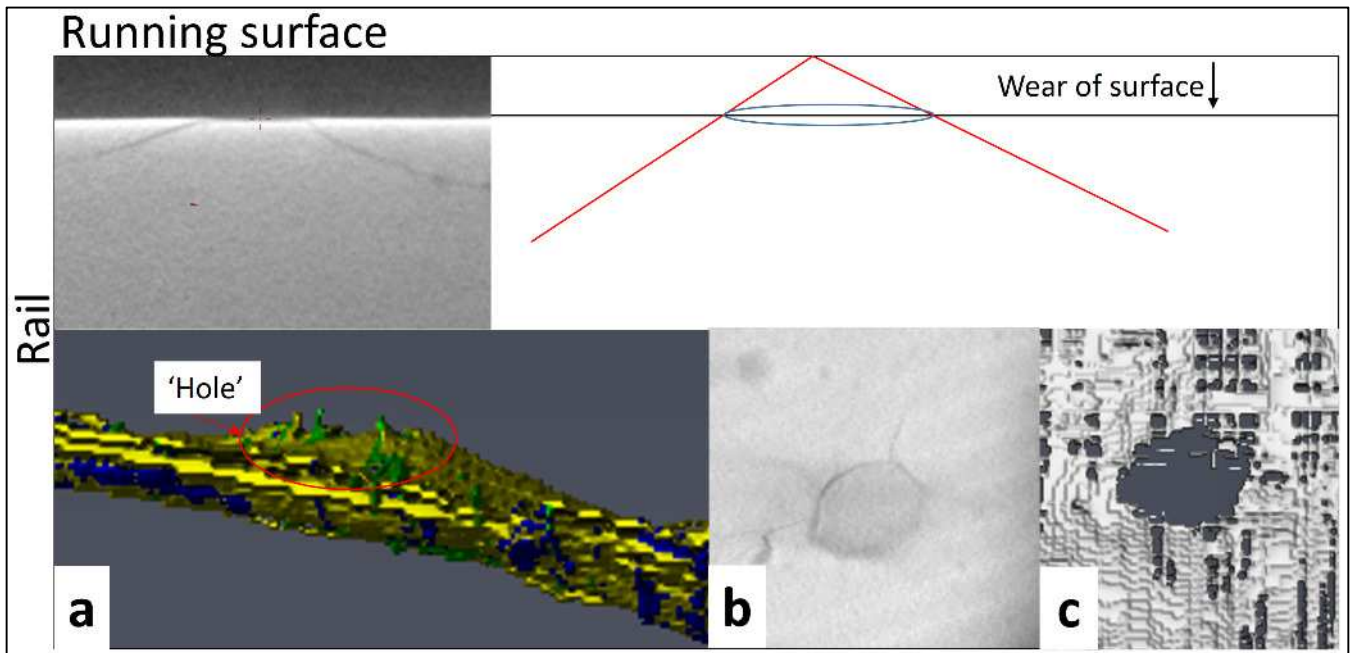
316 Another detail that showed through the full construction of the models was that the ‘C’ and ‘O’ shaped cracks found in
 317 the centre of the surface of samples 2 and 4 were the location where the inverted v-shaped crack had been truncated by
 318 wear (Figure 10). Sample 1 did not have this feature but sample 3 had a surface breaking crack in the same region but of
 319 a different morphology.

Figure 10: A diagram showing how wear truncates a pair of cracks to leave what is seen in the scan slice. Inset; a) The ‘hole’ from the longitudinal view as modelled in the Avizo model of sample 2, b) The original scan image of the surface of sample 2, c) The same view as (b), but of the Avizo model

430
 431 Samples 2 and 4 have a 'hole' in the running band where the conical crack has been truncated as the tip is worn down.
 432 This hole had a loose piece of material in the centre that was lost during cutting, so it was beneficial to have preserved
 433 this information in the scans. The next few paragraphs will discuss each sample in turn;
 434

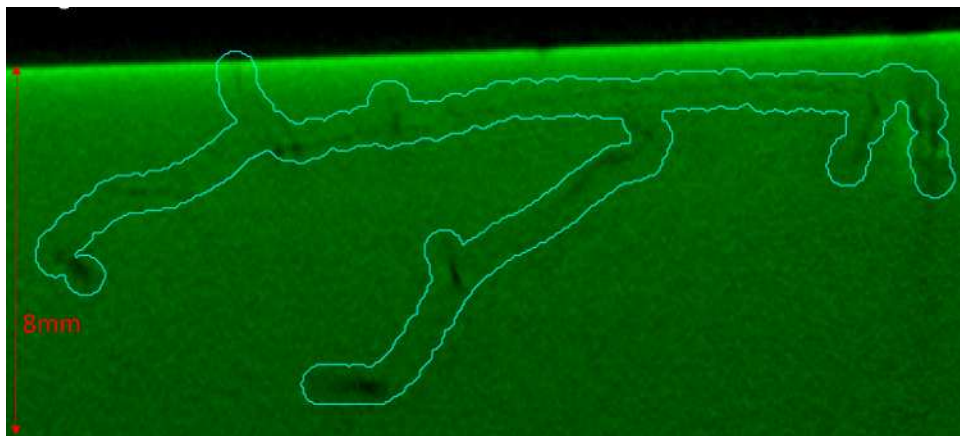
Figure 9: Longitudinal orthoslice of sample 2 showing the branching cracks

320 Sample 2 had much more damage than expected. Figure 9 shows a longitudinal section from the scan: although the
 321 resolution of the scan is low due to the size of the sample, parts of the transverse crack can be discerned up to 8mm deep
 322 into the railhead. Cracks can be seen reaching 10mm deep in other regions of lower clarity. A higher resolution scan will
 323 be conducted on this region to clarify the structure of the deeper crack and hopefully identify the region that caused the
 324 crack to start growing into what could become a transverse defect.

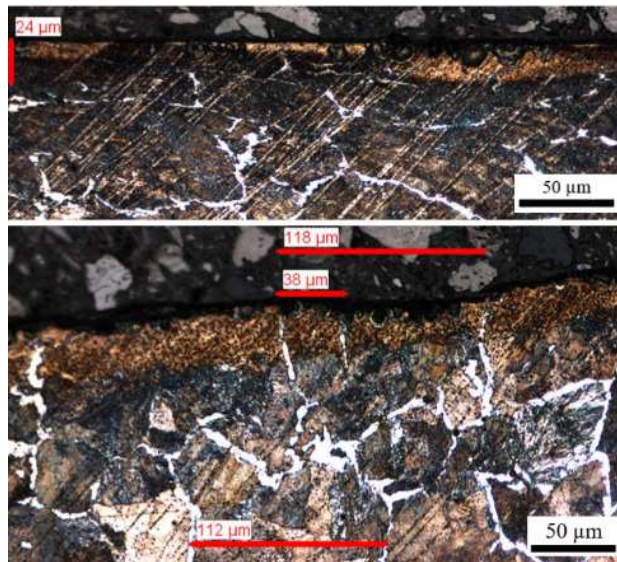
325 WEL was found at a fairly consistent depth of 5-10 μm in some locations inside and outside the defect. There were some
 326 locations where the thickness of the WEL varied even in a very small area such as in Figure 11. Figure 10 also shows
 327 one region that was found very close to the field side of the running band, where the widened band started to
 328 narrow again. This region contained WEL with the ferrite on the grain boundary still visible as shown in the
 329 first documentation of a stud [5].

Figure 11: Above) WEL thickness varying from 1- 24 microns thick in sample 2. Below) Ferrite grain boundaries still visible within the WEL.

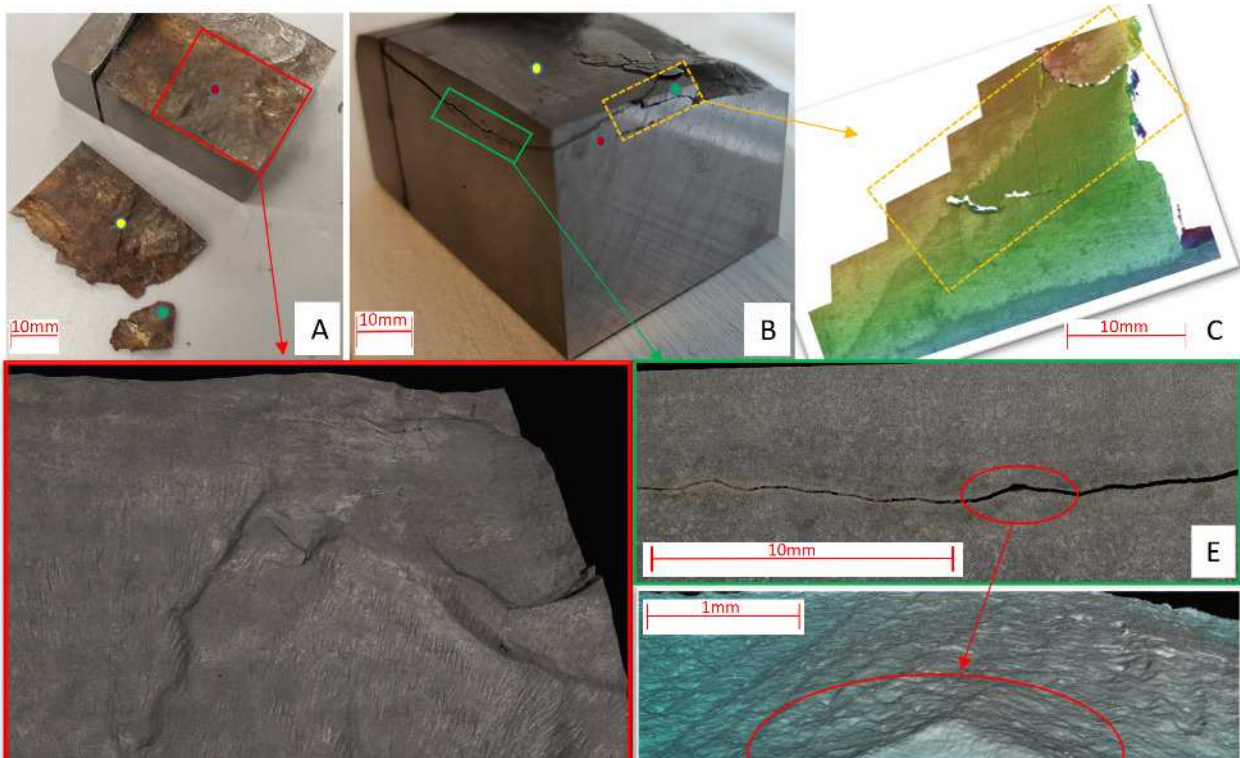
Due to the in-service break, the results obtainable from sample 3 were limited compared to the other samples. Its inclusion in the comparison was due to the known transverse defect. The undamaged lobe of the squat was still intact and it was possible to remove the upper plate using a cross-sectional cut between two of the longitudinal surface breaking cracks. This revealed a structure similar to the models of the scans along with a discrete vertical crack that broke the surface as a wide crack and penetrated slightly deeper into the rail as seen in Figure 12. The scan in Figure 12c shows the surface area before it was cut, which includes features that appear as two white cracks in the scan due to the information being lost within the crack rather than being captured by the detector. These fairly wide crack mouths are believed to be part of the remnant of the initiation site. Judging by the amount of folded over material just next to the ‘white holes’ there were high contact forces in this area. The material may have flowed from the ridge that often occurs between the two lobes of a squat as this ridge experiences very high contact forces. Figure 12e shows what appears to be a small void in the crack in area highlighted by the orange box in Figure 12b. This area was scanned (Figure 12f) and the morphology suggests that

Figure 12: The fracture surface under the remaining second lobe/ spot of the squat in sample 3. A) The fracture surface immediately after removing the upper surface. B) The sample before the removal of the surface showing the two cracks propagating down into the rail from a possible initiation point. C) The 3D model of the possible initiation area taken before cutting with the orange box showing the common area D) The 3D model of the crack plane shown in A. E) An enlarged view of the green box in B showing where material has spalled away during cutting. F) A 3D model of the ‘pore’ in E

344 an isolated region of material ('island') caused by a branching, then converging crack. These 'islands' are found
 345 throughout the crack networks of all scanned defects and cause shadows to appear as shown in Figure 17.
 346 Micrographs of longitudinal slices through the region confirmed the presence of many long inclusions as well as an
 347 unexpected overall microstructure (Figure 13). Inclusions were distributed throughout the steel orientated in the rolling
 348 direction, the same direction as the unusual ferrite 'stripes' within the microstructure. The presence of these two unusual
 349 features suggests an ingot cast steel, meaning this was probably a very old rail as many companies have moved to
 350 continuous casting rather than ingot casting to produce cleaner steel. The cracks that travelled through the subsurface of
 351 the rail also match the orientation of the inclusions and ferrite 'stripes' and so there is a very good chance that this unusual

449 The wider crack in the V on sample 3 is where the cracks meet near the surface making this a likely initiation point due
 450 to ductility exhaustion. Sample 3 was had long inclusions running parallel to the cracks that caused the failure, so they
 451 are believed to have been heavily responsible. However, the whole rail probably had these inclusions so there must have
 452 been an event that initiated it, but not enough is known about the rail or its location. The presence of so many inclusions
 453 suggest that the steel was from ingot casting rather than the cleaner method of continuous casting.
 454

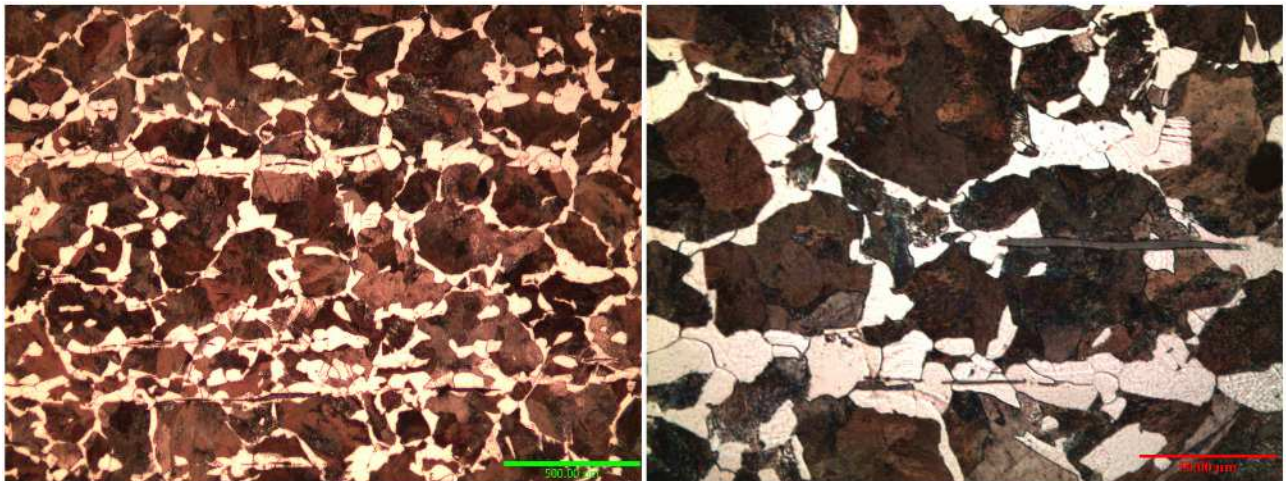
352 microstructure was the cause of the shelling and failure of this rail.
 353 WEL was found in thick islands in cross sectional micrographs from the gauge corner of sample 3 as shown in Figure 14.
 354 This is one of three discrete but deep patches of WEL from just before the defect / widening of the band.
 355

Figure 13: Micrographs of sample 3 at two different magnifications, showing the unusual microstructure and the inclusions found throughout the steel

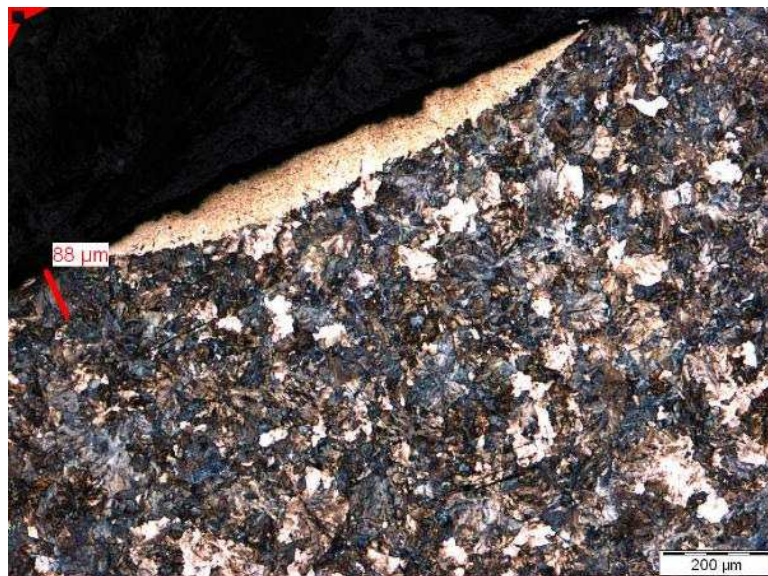
Figure 14: Thick white etching layers on the gauge corner of sample 3

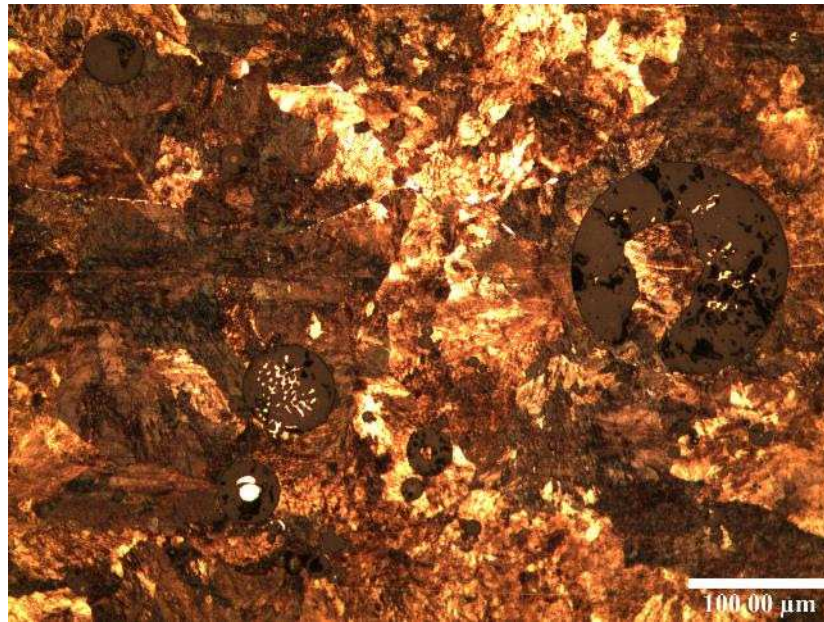
368
 369
 370
Figure 15: Spheres or bubbles found in the microstructure of the weld edge of sample 4 from within the green box in Figure 18. Probably either gas trapped in the melt or slag from the welding process

455 Contamination in the very upper part of the weld is believed to be responsible for the initiation of the defect in sample 4.
 456 The contamination consists of just a few spheres/ bubbles of unknown composition (probably gas or slag) very close to
 457 the surface. Cracks were observed between these spheres/ bubbles.

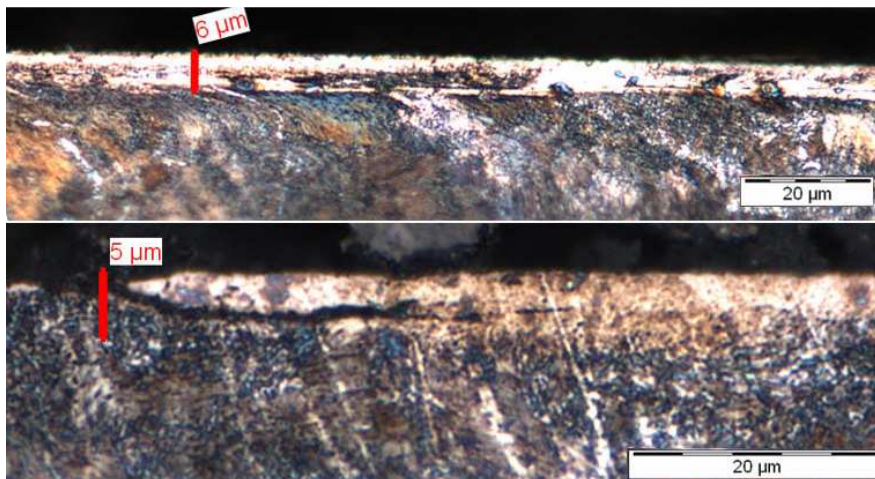
371
 372
 373
 374
Figure 16: Above) WEL from within the defect. Below) WEL outside the defect

375
 376
 377
 378
 379
 380
 381
 382
 383
 384
 385
 386
 387
 388
 389
 WEL was also found at a very consistent depth of 5-7 microns inside and outside the defect (Figure 16). The visible grinding marks on the surface make it probable that this WEL is due to the grinding process. The WEL inside the defect had a more distinct boundary with the parent material compared to outside the defect.

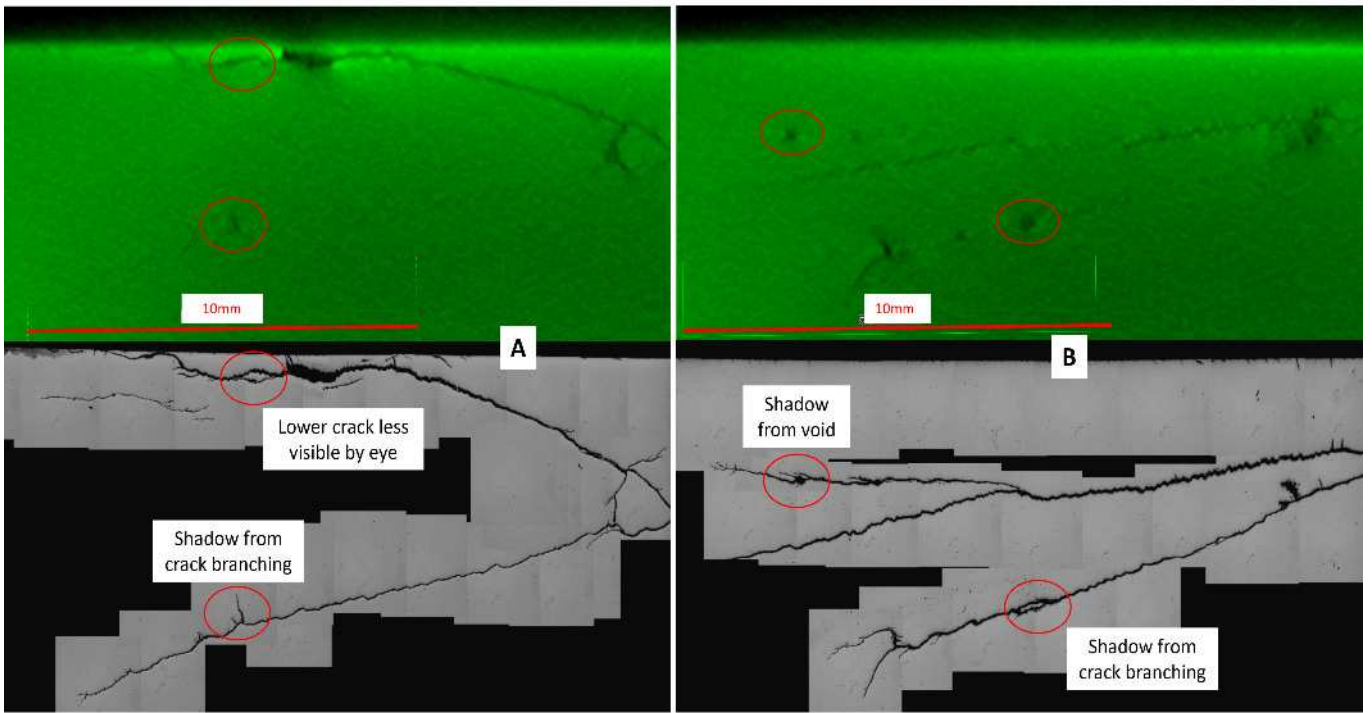
In sample 1, an orthoslice of interest was one that showed a crack branch down from what appeared to be a small void on the surface, which was visible from the surface scans. The crack then displayed interesting behaviour by branching in a circular shape as though propagating around something that it could not penetrate. There were also small shadows on the scans, which were investigated to see how real they were. Figure 17 shows the two comparisons of the scan slices mentioned and their accompanying micrograph. The upper red circle shows a region where the finer crack does not show but the larger crack does and the lower circle shows how a branching crack can create a shadow. Sample 4 also showed a shadow near the surface breaking feature in the centre of the rail and the verification of that scan is shown in Figure 18. Figure 18 shows; a shadow found on the crack within the CT scan, the cause of that shadow and verification of the structure shown in the green box, which is responsible for the C shaped crack that breaks the surface of the running band. It also shows a zoomed image of the area that caused the shadow to appear: a small void. These voids are believed to develop from the small 'islands' like the one labelled "shadow from crack branching" in Figure 17b due to rubbing of the crack surfaces wearing away and eventually breaking up the 'island'. The broken debris from the island could cause variations in the x-ray interaction that, when reconstructed into a CT volume, would appear like a void. The broken debris would then be washed out during sample preparation.

Figure 17: Comparison of longitudinal CT scan orthoslice to longitudinal section in sample 2 a) The surface void visible from the surface scans with a shadow and its cause highlighted b) Branching that shows shadows in the scan and the same cause as (a) in the micrograph.

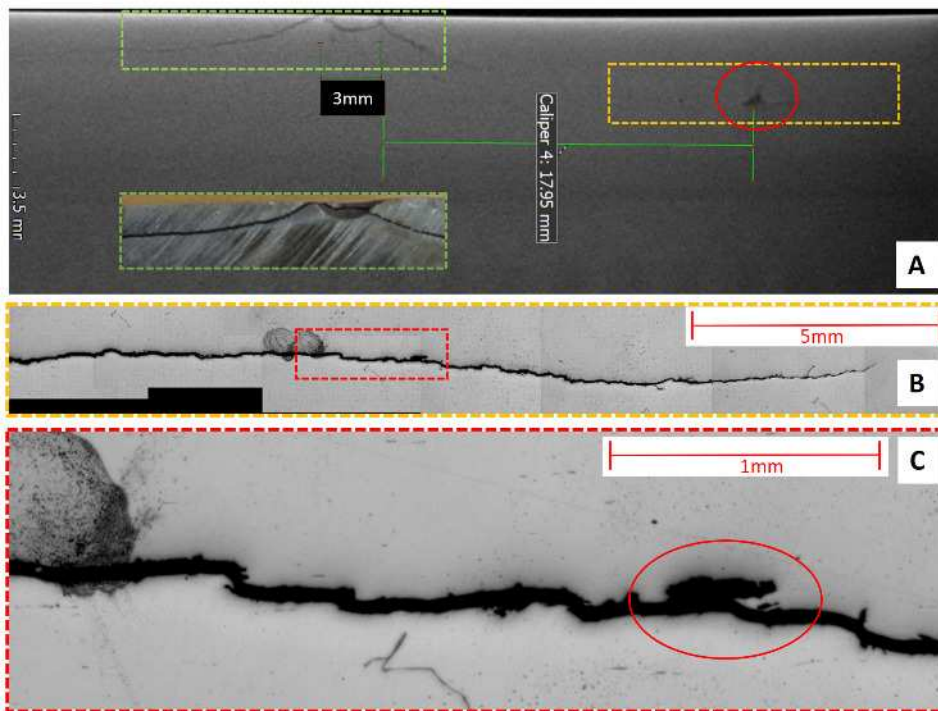
Figure 18: Longitudinal slice through the c-shaped crack in the centre of the surface of sample 4. a) CT scan orthoslice showing the surface breaking crack highlighted in the green box with a photo of the sectioned sample inset in the lower green box b) An unetched micrograph of the area highlighted in the orange box c) An expanded view of B, with a red circle showing the cause of the shadow in the CT scan orthoslice (a).

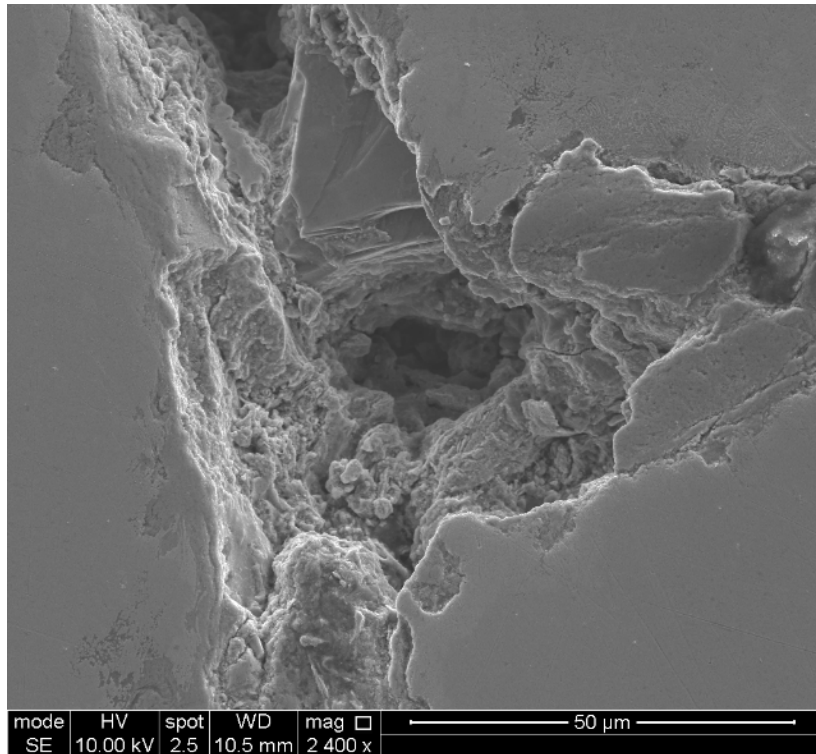
392 These voids are possible branching points for the crack as features like these voids have been noticed at the junction of
 393 crack boundaries as shown in the SEM image in Figure 19. The void is from the circular crack in Figure 17a, and may
 394 have been why a crack branched down from the main crack, or may be due to fretting after the crack branched. It is hard
 395 to be sure due to so much damage and corrosion. Sample preparation will also cause some material loss from the area
 396 shown.

397
398
399 **Figure 19:** SEM image of a junction where a crack branched off deeper into the rail.

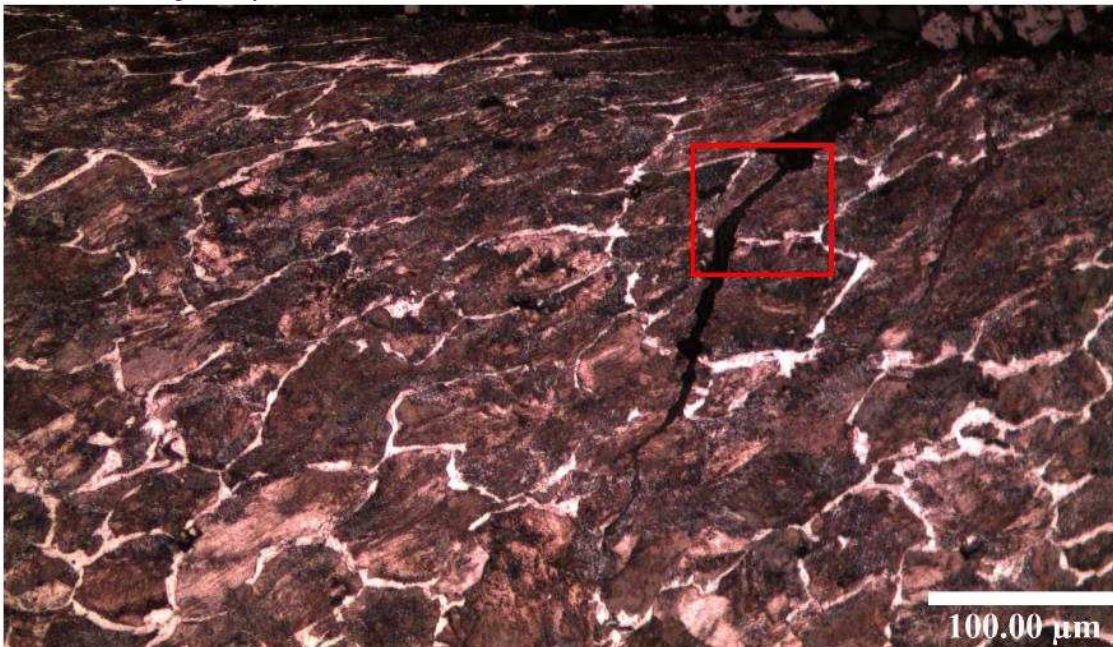
Figure 20 shows an optical micrograph of sample 3 with a surface breaking crack. The crack travels fairly vertically through the material rather than at an acute angle to the surface as is usually expected from RCF cracks. This is seen in thermally damaged steel [22]. The interesting behaviour regarding the crack path is that unlike squats, which typically follow inter-granular ferrite, this crack seems to cut across the grain as documented by Grassie et al. [5]. However, unlike the studs investigated by Grassie et al. this behaviour also occurs within 450 microns from the surface as well as below.

404
405 **Figure 20:** Optical micrograph of sample 2 showing a surface crack with apparent non-sensitivity to microstructure. The red box shows where SEM images were taken from (shown in Figure 21)

406 It should be noted that although the crack seems to ignore the grain in this orthoslice of the rail, it may follow the microstructure more carefully closer to its origin and lose that sensitivity as it propagates out in 3D.

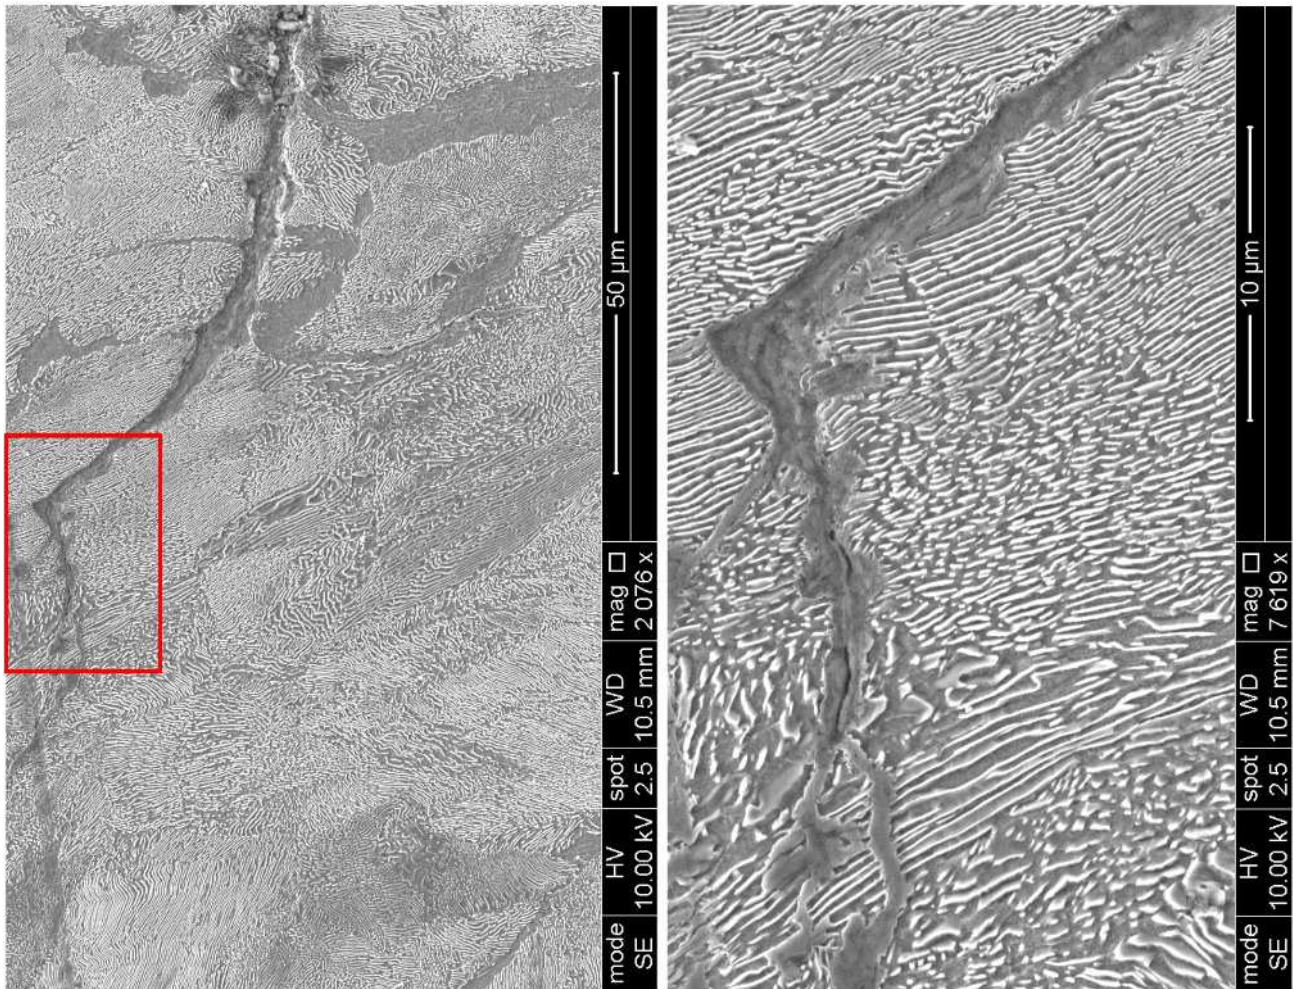
408 As seen in Figure 21, the cracks travel between lamellae plates a majority of the time but not always. They seem to be able to change direction when the plates become small and more spheroidal. There are places where this is not true such

410 as the bottom of the right SEM image where the cracks cut straight through plates. This could be because the crack was
 411 well developed in orientation to the lamellae of a neighbouring grain and so continued in that orientation as it widened.
 412 This would mean that the crack did not initially grow within this slice following these grain orientations. Looking at the
 413 CT scan data in 3D the crack plane grows down into the rail and diagonally across the rail as it propagates longitudinally
 414 and laterally at the same time. This means that the initial crack path cannot be viewed in its entirety, with regards to the
 415 microstructure, within one micrograph. Many thin slices will need to be taken around the possible initiation site to
 416 investigate the relationship between microstructure and the crack path to its full extent. This will be part of further work.

Figure 21: Left) SEM image of the box from Figure 20 showing that the crack still prefers to travel between the lamellae plates of the pearlite when cutting across grains. Right) magnified view of the box in the left image.
