# The real issues with in-ground SUDS in Scotland

W. Schlüter<sup>1\*</sup> and C. Jefferies<sup>2</sup>

## ABSTRACT

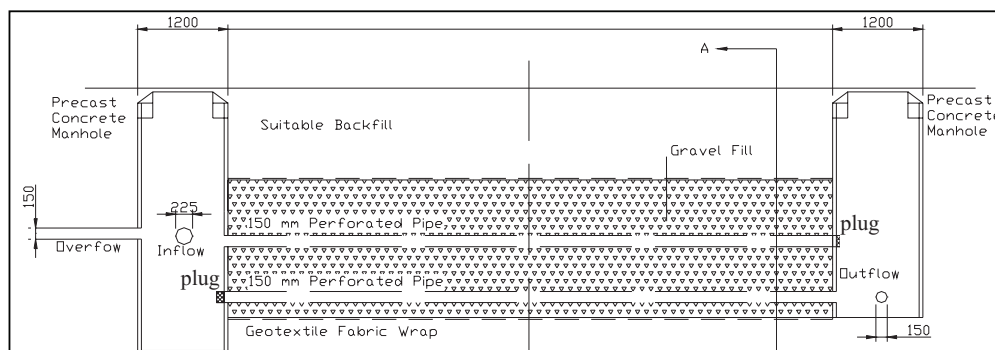
*Good detailing.* Only one of the systems under investigation was found to be performing excellently and this is shown in Figure 2. The inlet pipe of the infiltration trench runs for the system's full length and this maximises the inflow capacity. This system is 43m long and 0.75m wide, the sump is 1.0m deep and the inlet and outlet pipes (of the inlet sump/ chamber) are level, promoting good debris settlement.

**Figure 2:** Infiltration trench at Broxden

Crucial for the performance of the system at Broxden are the two plugs, cutting-off flow at either end of the drainpipes. They can be removed for inspection and to enable cleaning by high pressure jetting and flushing of drainpipes. However, there are a number of points, which could further improve the system at Broxden: Installing a dip plate in the inlet to retain floating debris; Raising the elevation of the outlet to utilise additional storage; raising the top perforated pipe to improve filtration; Increasing the elevation of the overflow to provide additional storage.

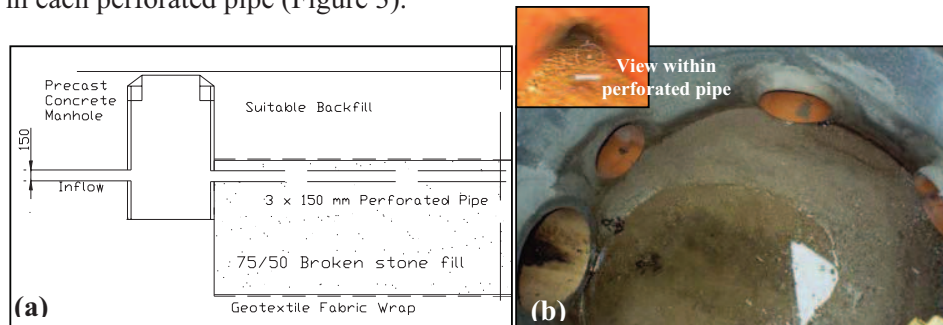
*Good flow distribution.* An alternative an end-pipe soakaway arrangement is illustrated in Figure 3. It is also located downstream from a conventionally drained suburban development (of around 24 houses). In this case there is a reasonable chance of longer-term good behaviour, firstly because there are three routes from the inlet manhole into the filter material, providing good flow distribution and giving a reduced pollutant load per length of pipe. The elevation of the pipe maximises the system's storage as it is located close to the top of the filter material. The site visit to this location provided unexpected findings as the inlet sump

of the system was filled with sediments and there was also a considerable amount of sediment in each perforated pipe (Figure 3).

**Figure 3.** Shallow soakaway arrangement (a); sedimentation in chamber (b)

Findings at this site show the typical impact of construction runoff and poor site management. Although both the design and construction of the system showed good practice, the system silted up quickly as it was connected to the surface drainage too early and sediment management was poor.

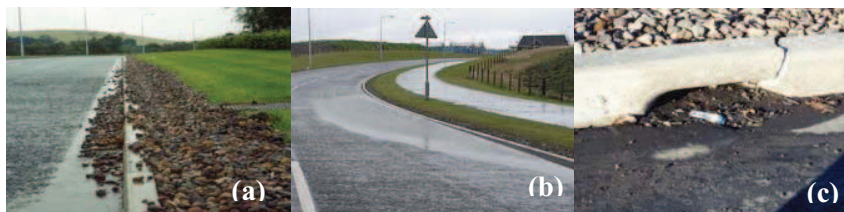
- Filter material was distributed onto the road (see figure 4(a)).
- Blocked lateral inlets resulted in local flooding (see figure 4(b)).
- Broken lateral inlets at three locations (see figure 4(c)).

**Figure 4:** Problems with offlet kerb arrangements along Spine Road

Offlet kerbs were found to be problematic as inlets to filter drains. This was mainly due to the inability to clean and maintain the inlets. Blocked inlets were found at both sites which incorporated offlet kerbs. Road safety was an issue at one site, where filter material had spilled onto the road

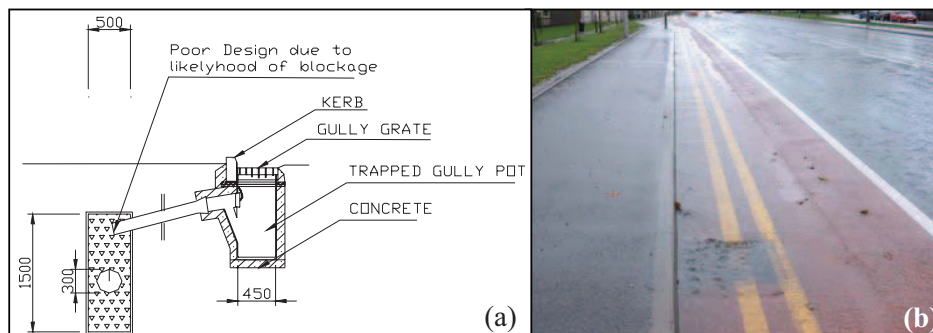
*Insufficient flow capacity.* The next example is a filter drain along a busy commuter route in an older urban area (known as Lang Stracht). The inlets to this system (shown in figure 5) comprise trapped gully pots which discharge directly into the filter media and these were found to have failed hydraulically due to blockage.

**Figure 5:** Road side filter drain arrangement (a); Flooding due to blocked gully outlets (b)

The flow capacity at this type of inlet is extremely low and small amounts of debris were found to have blocked the gully pot outlets. Figure 5 shows flooding of the system after an event of relatively small rainfall intensity of 13.2 mm/h.
