Flow Analysis through CollectorWell Laterals: A Case Study from Sonoma County Water Agency, California

Flow Analysis through Collector Well Laterals: A Case Study from Sonoma County Water Agency, California

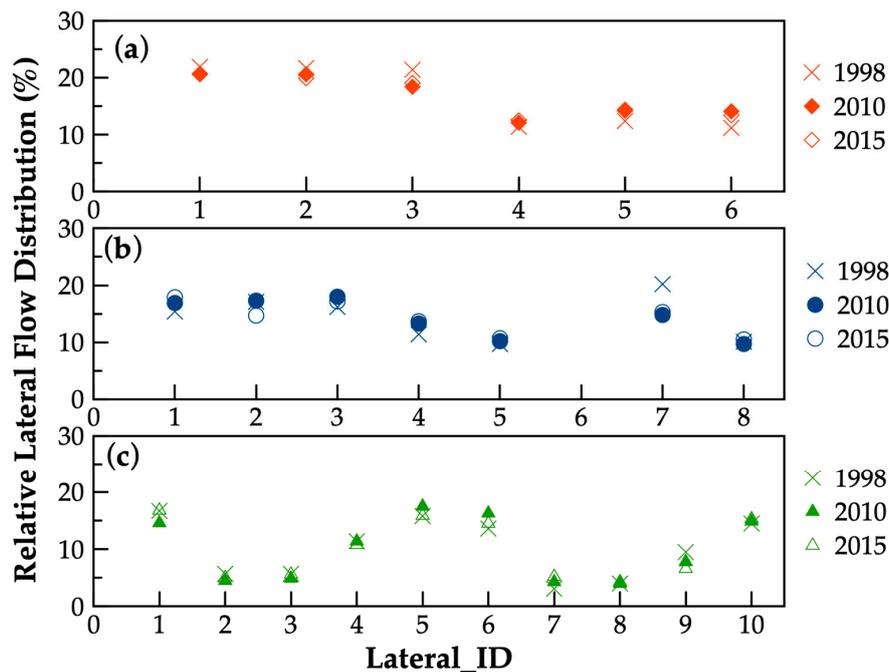
Throughout the three investigations (1998, 2010, and 2015), minimal changes in relative percentage flow were observed (Figure 4). In Collector 3, the laterals (1, 2, and 3) closest to the river had the largest percentages of flow (Figure 4). The collective gain in flow in these three riverward laterals balances the collective loss of flow in the three landward laterals. During the 2015 evaluation, the relative distribution of flow among Collector 3 laterals ranged between 12.5 (Lateral 4) and 20.7% (Lateral 1). Lateral 6 had the largest decline in flow (-2.7%) compared to the 2010 results [1,3]. The limited changes observed may be related due to varying influence of recharge from the Russian River, as well as Infiltration Ponds 2 and 3 northeast and east of Collector 3 (Figure 2), respectively.

Figure 4. Relative lateral flow distribution (%) in (a) Collector 3, (b) Collector 4, and (c) Collector 5.

In Collector 4, during the three investigations, the productions of most of the laterals slightly improved over time. Laterals 1 and 2 (oriented toward the river) and Laterals 7 and 3 (parallel to the river) showed the highest percentages of flow. On the other hand, the lateral with the lowest percentage of flow (Lateral 8) is oriented on about a 45-degree angle towards the river, similar to Lateral 2, but it is also the shortest lateral (29.41 m) (Figure 2). The two landward laterals projected towards the infiltration ponds collectively provided 24.4% of the well's total production. During the 2015 evaluation the relative flow percentages ranged between 10.5% (Lateral 8) to 17.9% (Lateral 1). Lateral 2 showed a decline (-2.5%) in production between 2010 and 2015 (Figure 2) [1,3]. Based on the video obtained, this decline was probably due to the presence of sand and gravel within the lateral.

In contrast with the trend observed in Collectors 3 and 4, in Collector 5, the laterals showed contrasting results. The production slightly increased in Laterals 1 and 7, slightly decreased in Laterals 4, 5, and 9, and remained constant in the remaining laterals. In addition, the impact of the 10 laterals is different. Four laterals individually produced 14.5% or more of the total capacity, while five laterals individually produced less than 6.6% (Figure 4). The orientation of the laterals had no impact on the percentage of flow distributions. On the other hand, the length of the laterals impacted the flow distribution. The four longest laterals (>51.20 m) were also four of the five highest producing laterals, while the three shortest laterals (<26.52 m) were also the three lowest producing laterals. The three remaining laterals were of intermediate lengths (37.49 to 40.54 m), as well as in producing capability [1,3].

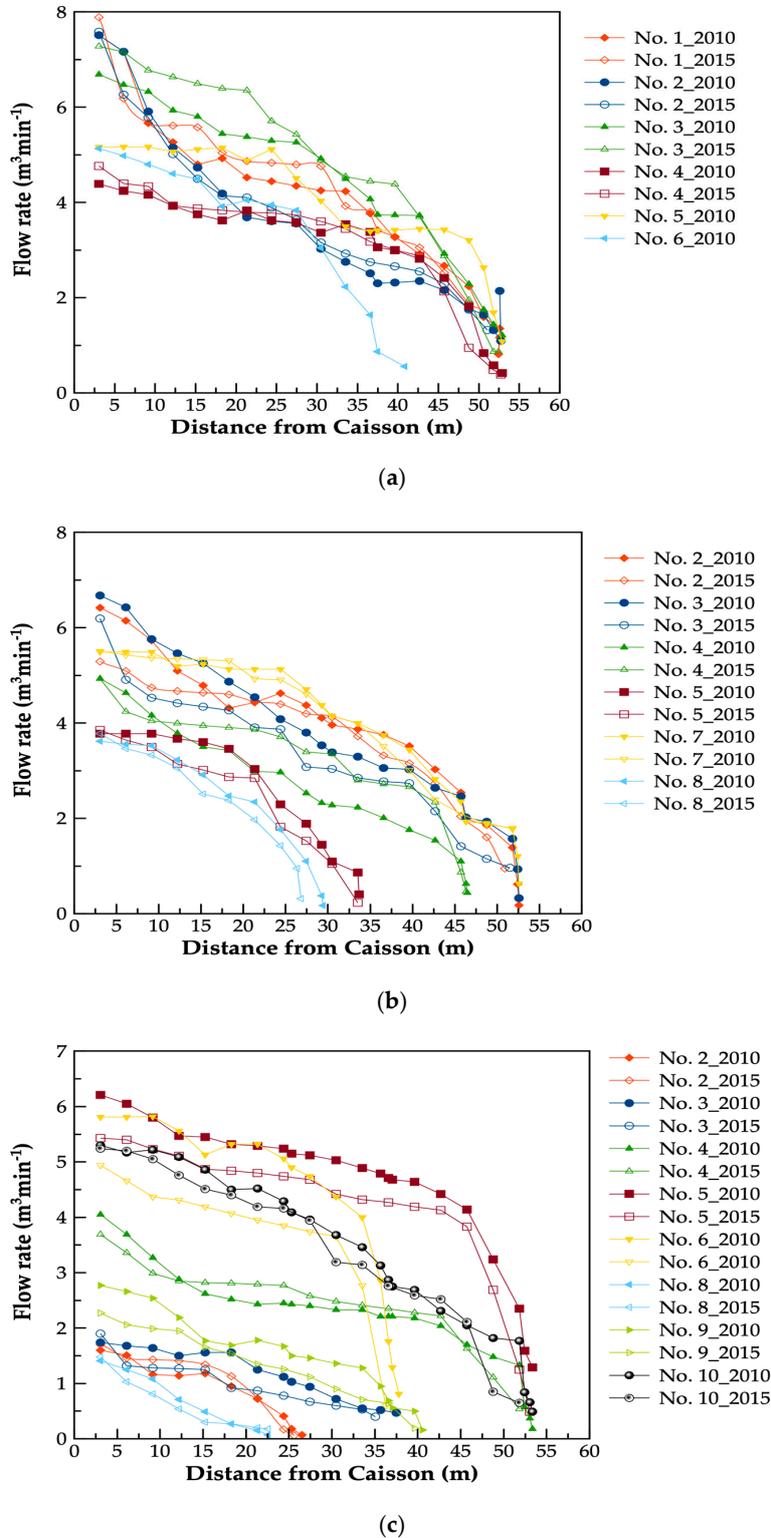
Non-uniform flow occurred along the laterals from the three collectors (Figure 5). In fact, for uniform flow along the lateral, the trend for each lateral would be a straight line beginning with zero m min^{-1} at the outer end of the lateral and concluding with the total flow for the lateral where it enters the caisson. However, none of the laterals follow this straight-line trend of uniform distribution. Each lateral displays steeper gaining trends in production in the outermost segments of their length where they are obtaining most of their flow. After these steep gains in flow in the outer segments, the remaining trends of flow while moving progressively closer to the caisson were more gradual because of the generally slower production in those segments. Similar overall trends were

observed during the 2010 and 2015 monitoring events. However, for Collector 3, regardless of the lateral, higher flow was observed during the 2015 campaign. On the other hand, for Collectors 4 and 5, a slightly higher flow was observed during the 2010 campaign [1,3].

Figure 5. Flow versus distance at (a) Collector 3, (b) Collector 4, and (c) Collector 5.

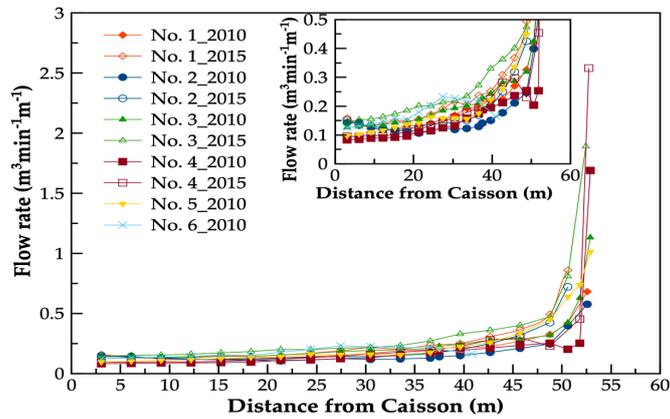
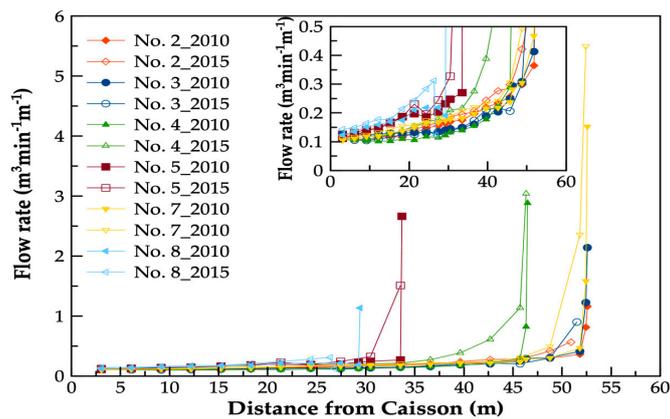
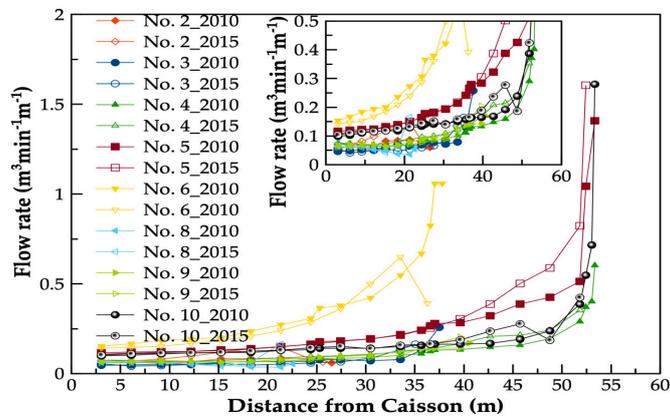
Average unit flow capacity of each lateral, which is also greater at the end of lateral flow, effects large gains in production within only a few meters. This is particularly noticeable in Laterals 3 and 4 from Collector 3. In these outermost few feet, unit flow capacities can approach or even exceed $2 \text{ m}^3 \text{ min}^{-1} \text{ per m}$. On the other hand, while moving along the lateral toward the caisson, the gains in flow progressively decrease and the average unit flow capacity begins to assume a more consistent trend (Figure 6).

Figure 6. Flow along different laterals at increasing distances between the screen length and the caisson for (a) Collector 3, (b) Collector 4, and (c) Collector 5.

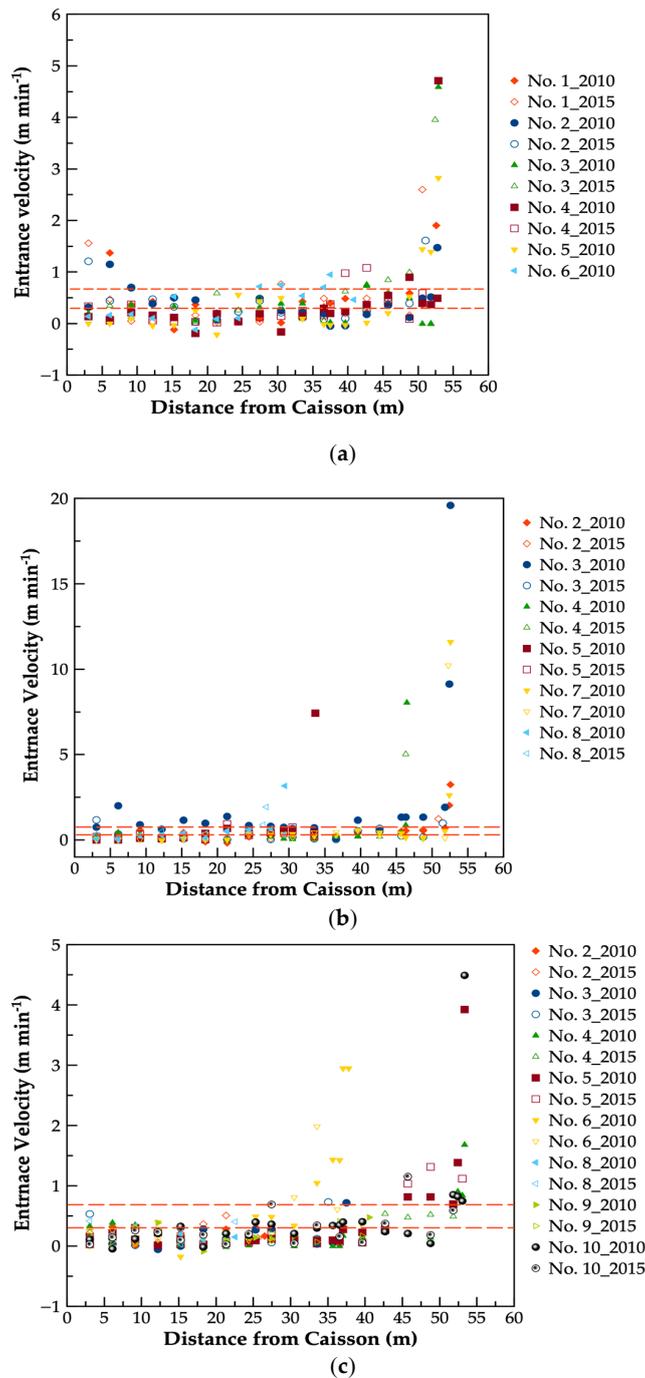
Overall, the three collectors are still within the optimal design parameters (entrance velocity < 0.305 m min⁻¹ and axial velocity < 1.524 m s⁻¹ [8,9]) (Figure 7 and Figure S3). Collector 6, constructed in 2002, consisted of a larger steel reinforced concrete caisson (5.49 m vs. 3.96 m inside diameter) with larger laterals (30.48 cm vs. 24. cm) than the Collectors discussed in this investigation, showed a lower entrance velocity (consistently < 0.610 m min⁻¹) and axial velocity (<1.524 m s⁻¹) during the 2010 monitoring campaign. This can also be related to lower presence of deposited materials and rust in Collector 6 (Figure S6) compared to the older collectors (Figure S2).

Figure 7. Entrance velocity through different laterals with increasing distances for their ends for (a) Collector 3, (b) Collector 4, and (c) Collector 5. Ideal and optimal design < 0.305 and < 0.610 m min⁻¹ (bottom and top red line).
