FACTA UNIVERSITATIS

Series: **Working and Living Environmental Protection** Vol. 12, N° 1, 2015, pp. 111 - 121

BELT CONVEYOR DRIVE GEARBOX PROBLEM CAUSED BY UNPAIRED GEARS- A CASE STUDY

**Dragan Jovanović¹, Milena Jovanović², Nenad Živković²,
Ljiljana Živković², Miomir Raos²**

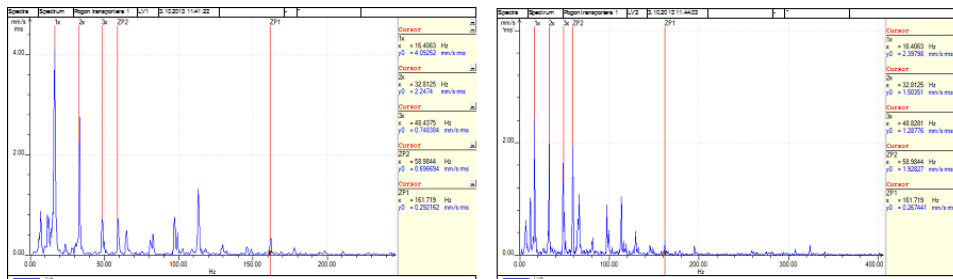
Driving unit 1 - When analyzing the frequency spectrum measured on electric motor, it is clear that both parallel and angular misalignment is present (Fig. 9 and Fig.10)

Fig. 9 Drive unit 1- LV1 and LV2 frequency spectrums–parallel misalignment

LV1 [mm/s]	LV2[mm/s]	LV3[mm/s]
1x - 16.4Hz	4.1	2.4	5.9
2x - 32.8Hz	2.2	1.5	2.2
3x - 49.2Hz	0.75	1.3	0.53

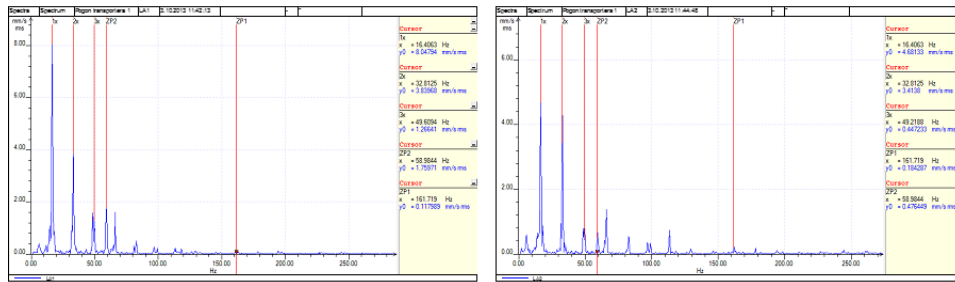
Fig. 10 Drive unit 1 - LA1 and LA2 frequency spectrums-angular misalignment

LA1 [mm/s]	LA2[mm/s]
1x - 16.4Hz	8,0	4,7
2x - 32.8Hz	3,8	3,4
3x - 49.2Hz	1,3	0,44

Excessive vibrations on drive units 1 are mainly caused by shaft misalignment between electric motors and corresponding gearboxes. Gear misalignment on drive unit 1 gearbox is noticeable but it could be fixed relatively easily.

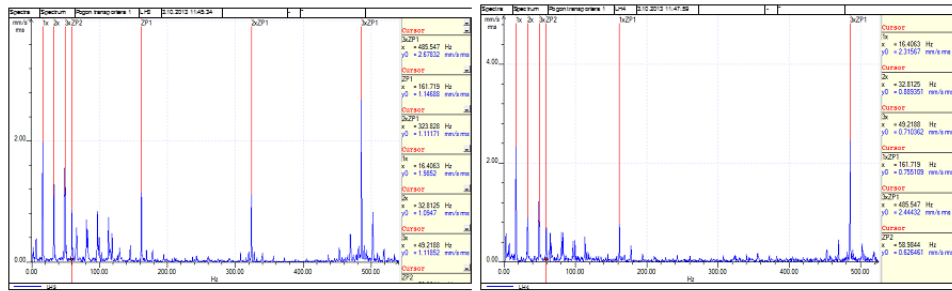
Frequency spectrums measured on gearbox indicate that higher vibration levels are caused by first stage gears misalignment. This is determined by high amplitudes of first stage gear mesh frequencies harmonics – GMF1, GMF2 and GMF3.

LH3 [mm/s]	LV3 [mm/s]	LH4 [mm/s]
1xGMF1 - 161.7Hz	1.15	3.26	0,75
2xGMF1 - 323.8Hz	1.1	2,84	2,44
3xGMF1 - 485.5Hz	2.8	1,15	2,35
1xGMF2– 58.88Hz	0.2	0.4	0.3

Fig. 11 Drive unit 1-LH3, LH4 gearbox input shaft-frequency spectrums first stage gears misalignment

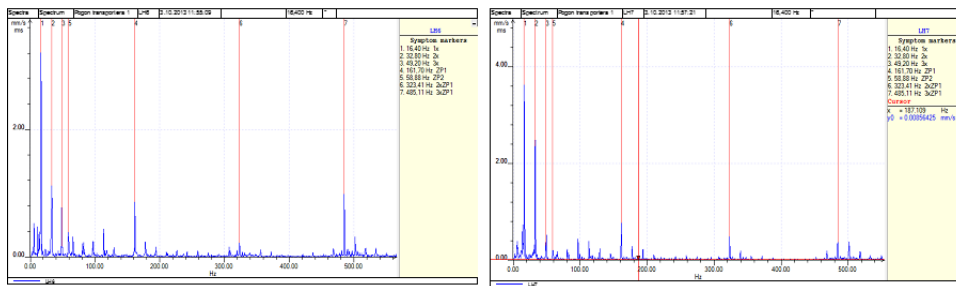
LH5 [mm/s]	LH6 [mm/s]	LH7 [mm/s]
1xGMF1 - 161.7Hz	0.7	0.8	0.8
2xGMF1 - 323.8Hz	1.2	0.4	0.6
3xGMF1 - 485.5Hz	1.0	1.1	0.4
1xGMF2 - 58.88Hz	0.2	0.4	0.3

Fig.12 Drive unit 1–LH6, LH7 gearbox middle and output shaft–frequency spectrums first stage gears misalignment

Second stage gears are working properly which is indicated by low amplitudes of GMF2.

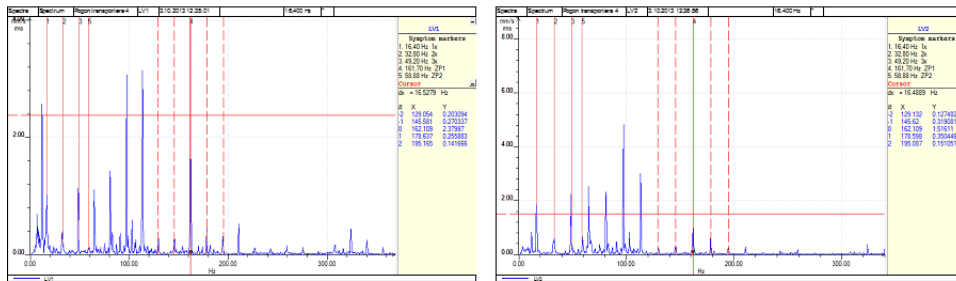
Driving unit 4 - When analyzing the frequency spectrum measured on electric motor it is clear that both parallel and angular misalignments are present as in the drive unit 1, as shown on Figure 13 and Figure 14.

Fig. 13 Drive unit 4 - LV1 and LV2 frequency spectrums – parallel misalignment

LV1 [mm/s]	LV2[mm/s]	LV3[mm/s]
1x - 16.4Hz	1.1	1.9	4.3
2x - 32.8Hz	0.2	0.5	0.4
3x - 49.2Hz	1.2	2.4	1.8

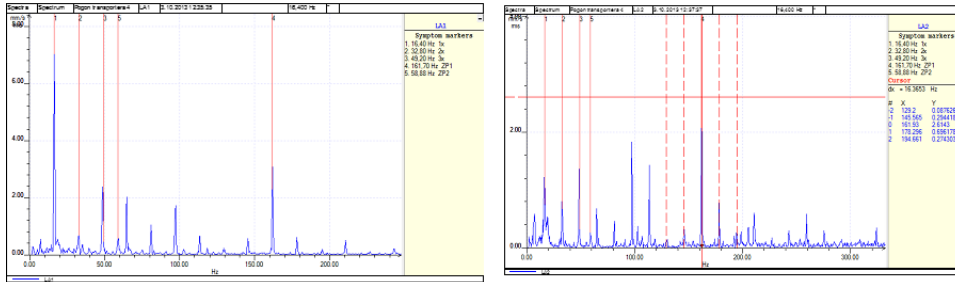
Fig. 14 Drive unit 4 - LA1 and LA2 frequency spectrums - angular misalignment

LA1 [mm/s]	LA2[mm/s]
1x - 16.4Hz	6,8	1,2
2x - 32.8Hz	0,8	0,8
3x - 49.2Hz	2,3	1,6

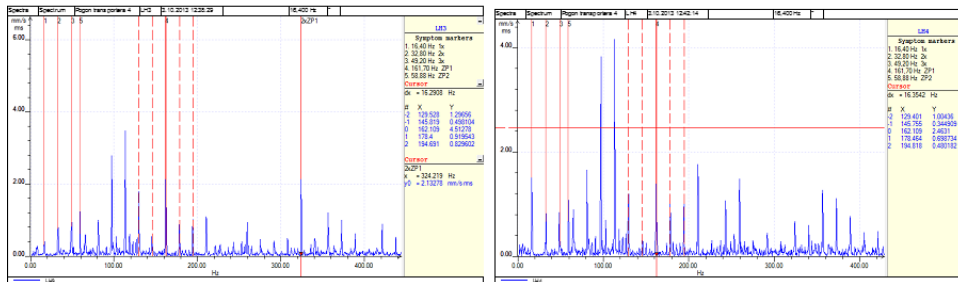
Frequency spectrums measured on gearbox indicate that higher vibration levels are caused by first stage gears tooth wear. This is determined by high amplitudes of first stage gear mesh frequencies harmonics – GMF1, GMF2 and GMF3 and surrounding sidebands.

LH3 [mm/s]	LV3 [mm/s]	LH4 [mm/s]
1xGMF1 - 161.7Hz	4.5	4.2	2.4
1xGMF sidebands	3.8	2,6	4,4
2xGMF1 - 323.8Hz	2.1	3.9	1.6
1xGMF2 – 58.88Hz	0.3	0.5	0.4

Fig. 15 Drive unit 4 - LH3, LH4 gearbox input shaft - frequency spectrums first stage gears misalignment + gear tooth wear

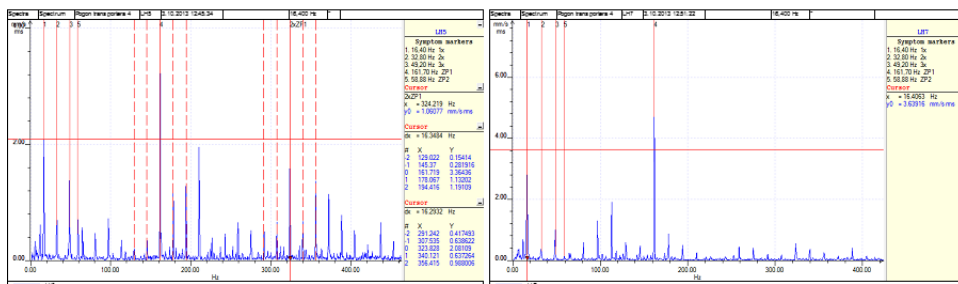
LH5 [mm/s]	LH6 [mm/s]	LH7 [mm/s]
1xGMF1 - 161.7Hz	3.2	6.4	4.6
1xGMF sidebands	1,2	0,8	2,1
2xGMF1 - 323.8Hz	2.1	1.1	0.4
1xGMF2 – 58.88Hz	0.6	0.5	0.3

Fig. 16 Drive unit 4 – LH5, LH7 gearbox middle and output shaft - frequency spectrums first stage gears misalignment

Second stage gears are working properly which is indicated by low amplitudes of GMF2.

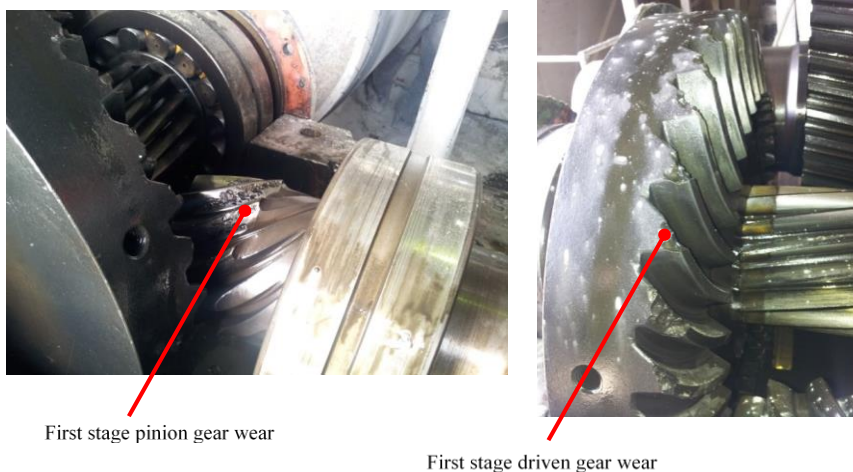
First stage pinion gear wear

First stage driven gear wear

Fig. 17 Drive unit 4 – First stage gears wear

The situation with drive unit 4 gearbox is much more complex. Due to unfortunate chain of events, the gearbox had been working with unpaired set of first stage gears for a while. Unpaired gears means that gear teeth are not fitted to one another, causing the load to be transferred from one gear to another with very small gear tooth surface. This small contact surface has resulted in very large contact pressure causing gear tooth wear.
